Contract No. DC/2018/08
Inter-reservoirs Transfer Scheme –
Water Tunnel between Kowloon Byewash Reservoir and Lower Shing Mun Reservoir
Monthly Environmental Monitoring and Audit (EM&A) Report
(October 2022)

Independent Environmental Checker Services for Inter-Reservoirs Transfer Scheme (IRTS) – Water Tunnel between Kowloon Byewash Reservoir and Lower Shing Mun Reservoir
40th Monthly EM&A Report (Rev. 0)

- E2. This is the 40th Monthly Environmental Monitoring and Audit (EM&A) Report presents EM&A works undertaken in the period from 1 to 31 October 2022. EM&A works were performed in accordance with the approved EM&A Manual and conditions stipulated in the amended Environmental Permit EP-345/2009/A.

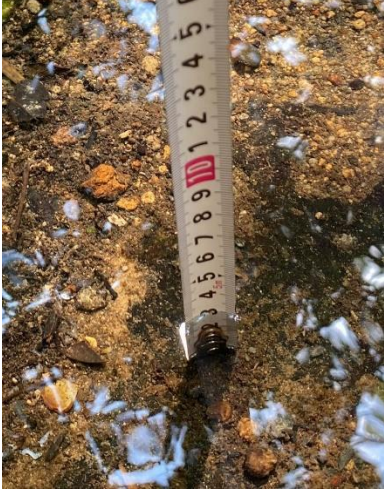
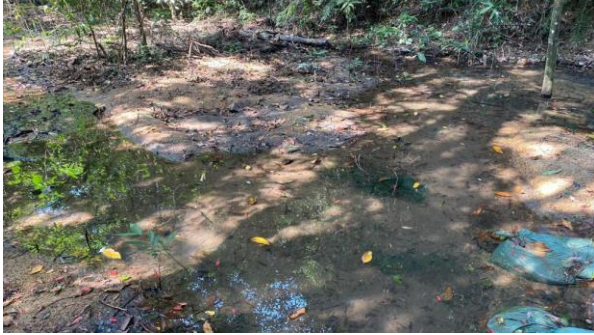
C1b	C2

3.18 A temporary standby pump and associated drainage pipe were installed on 7 February 2022 behind the sampling location C2 as a precautionary measure against site flooding. The standby pump would only operate when there is heavy rainstorm. The pump was in operation in the reporting month of October 2022.

3.19 After the joint water sampling inspection with the ER, the IEC representative, the Contractor and the ET on 15 October 2021, on days when very shallow flow (<11cm of water depth) were observed at the control points, actions will be taken to collect samples at the sampling locations. At the control point C1b, a small plastic bottle was used to collect samples according to the flow chart below. At the control point C2, samples were collected at original access to the water body. The fencing of the foot bridge across the catchwater at C1b monitoring location was restored on 15 October 2022, original access is the only access point for sampling event for C1b monitoring location since 15 October 2022.

<p>A close-up photograph showing a white measuring tape with black markings and a red logo, partially buried in dark, moist soil. The tape is oriented vertically, with the numbers 1 through 5 visible. The soil appears to be a mix of fine particles and small rocks.</p> <p>*Photos taken on 24 October 2022</p>

<p>A wide-angle photograph of an outdoor site. The ground is a mix of dirt and sparse vegetation. A large blue tarp is visible on the right side of the frame. The background shows some trees and a clear sky.</p> <p>*Photos taken on 24 October 2022</p>

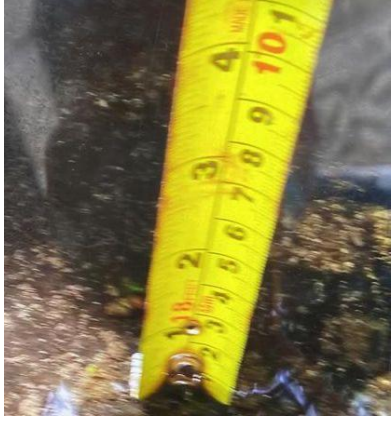
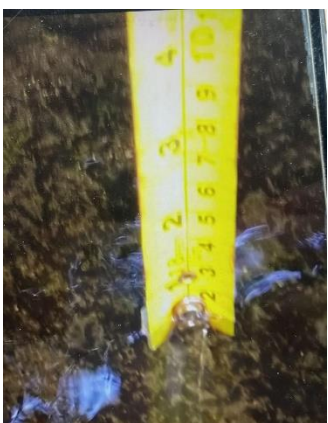
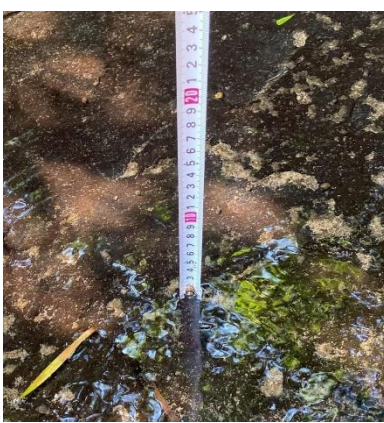
C1b on Days with Insufficient Water Available for Water Sampler at Original Access		
3/10/2022	5/10/2022	7/10/2022

Remark: The water depth was less than 3cm for the above-mentioned dates at C1b.

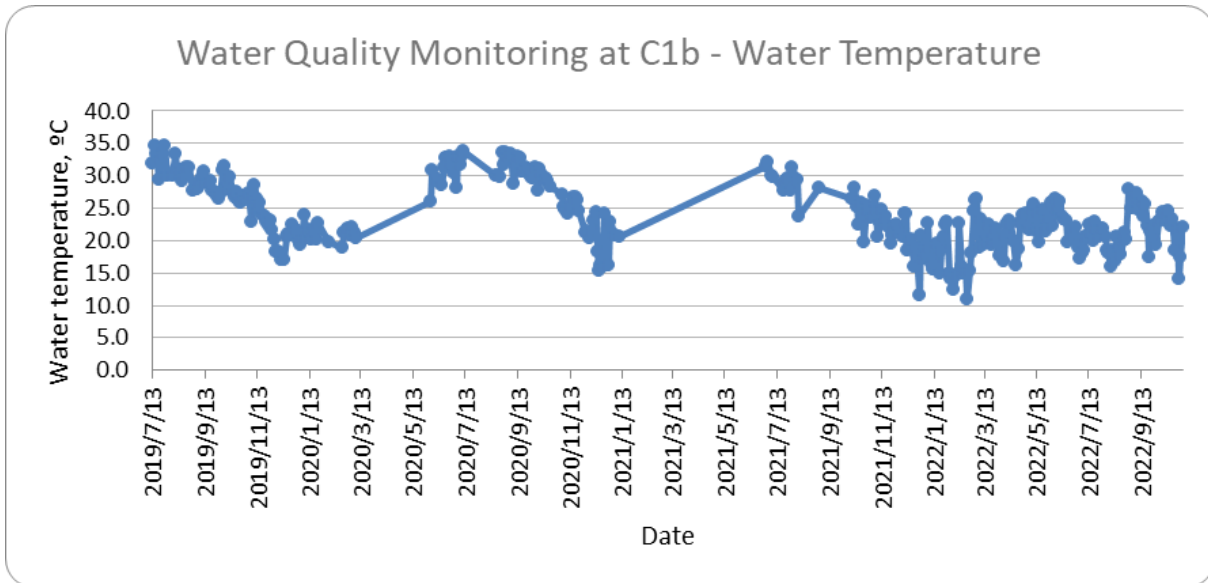
Note 1: Period without data implied that water in location C1b was dried up, insufficient water was available for sample collection

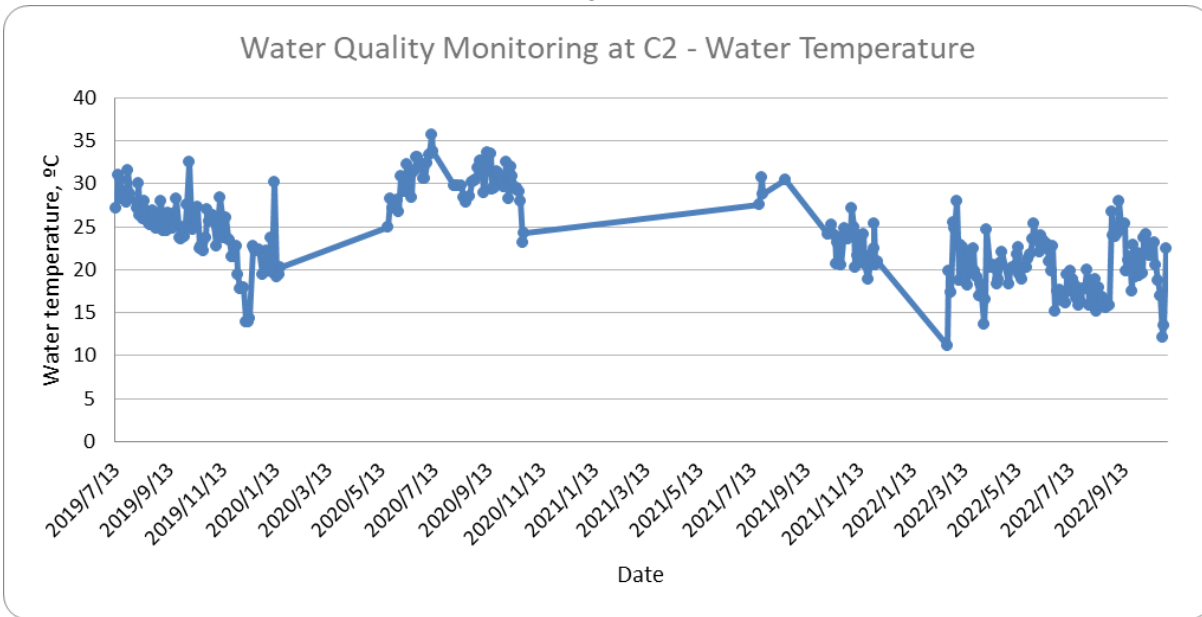
Note 1: Period without data implied that water in location C2 was dried up, insufficient water was available for sample collection

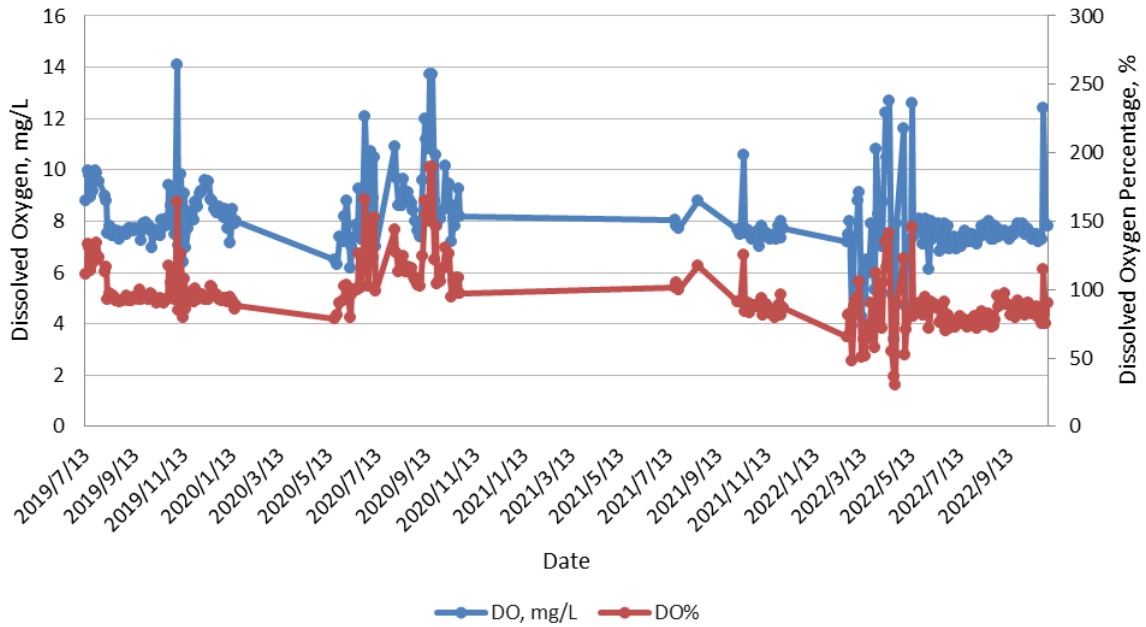
Water Quality Monitoring at C2 - Dissolved Oxygen

Note 1: Period without data implied that water in location C2 was dried up, insufficient water was available for sample collection

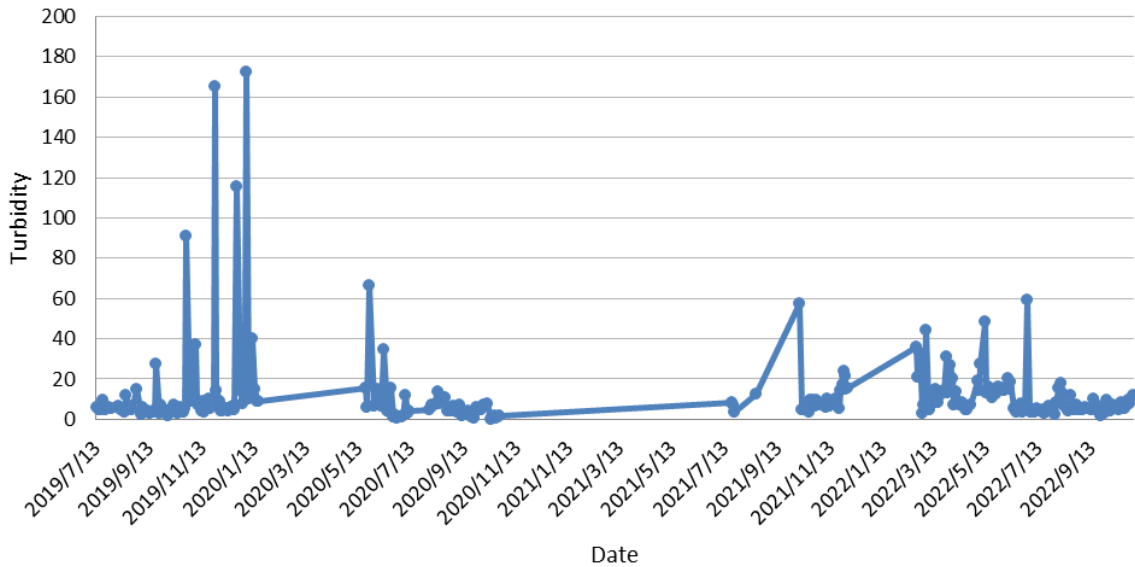
Water Quality Monitoring at C2 - Turbidity

Note 1: Period without data implied that water in location C2 was dried up, insufficient water was available for sample collection
