Hong Kong Offshore LNG Terminal Project

Quarterly Environmental Monitoring and Audit (EM&A) Summary Report for January to March 2022

23 May 2022

Project No.: 0505354

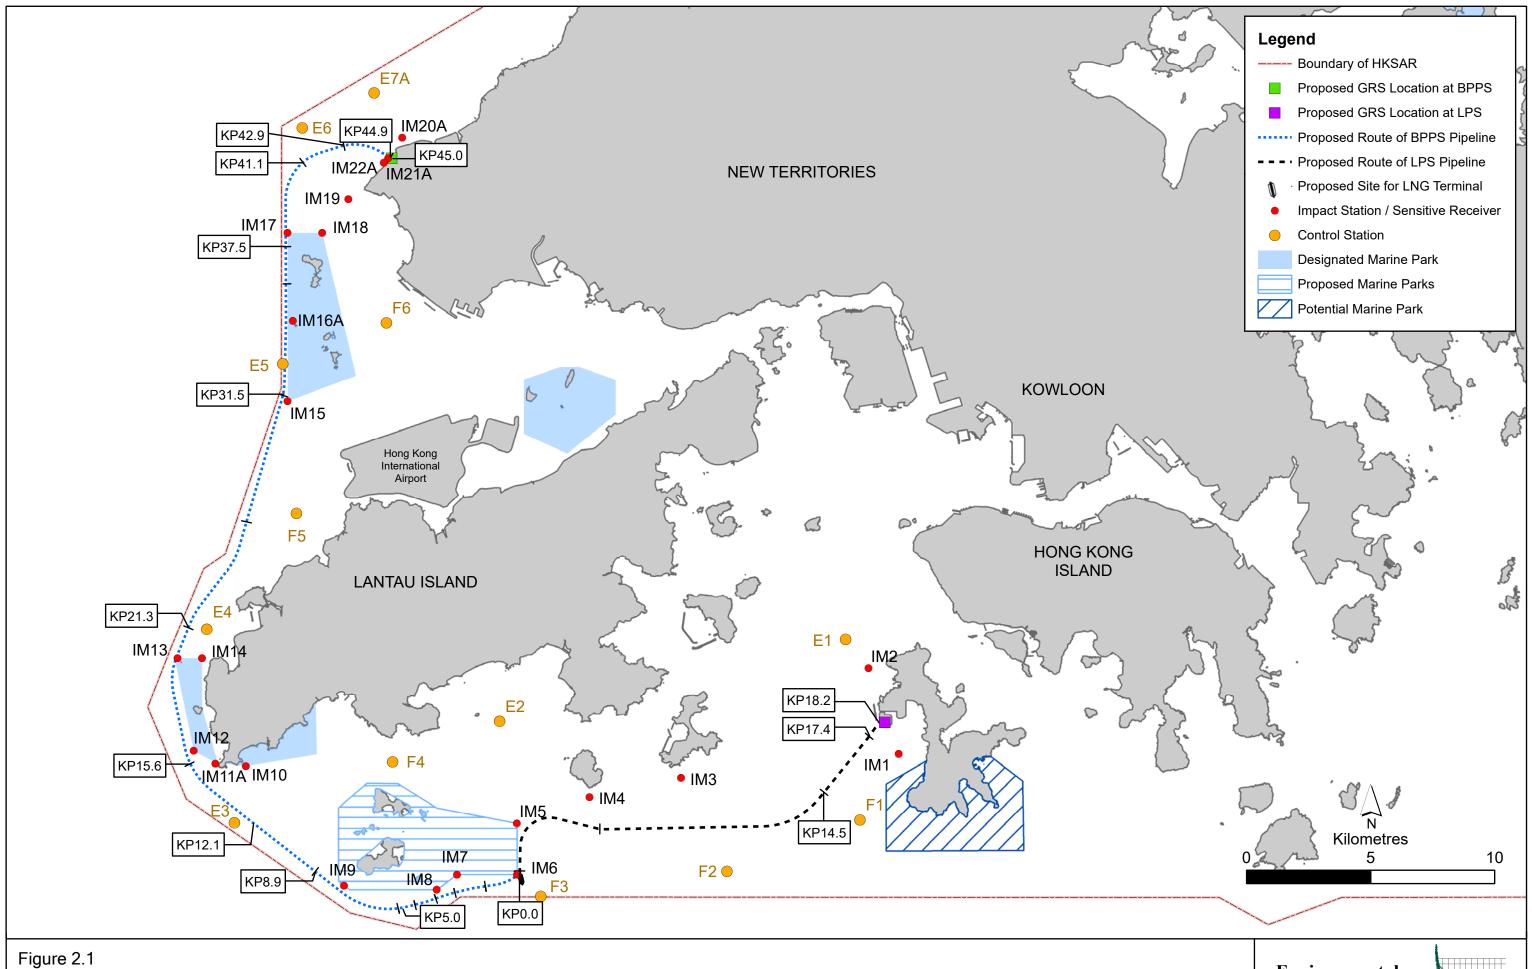
Marine Water Quality Monitoring Location

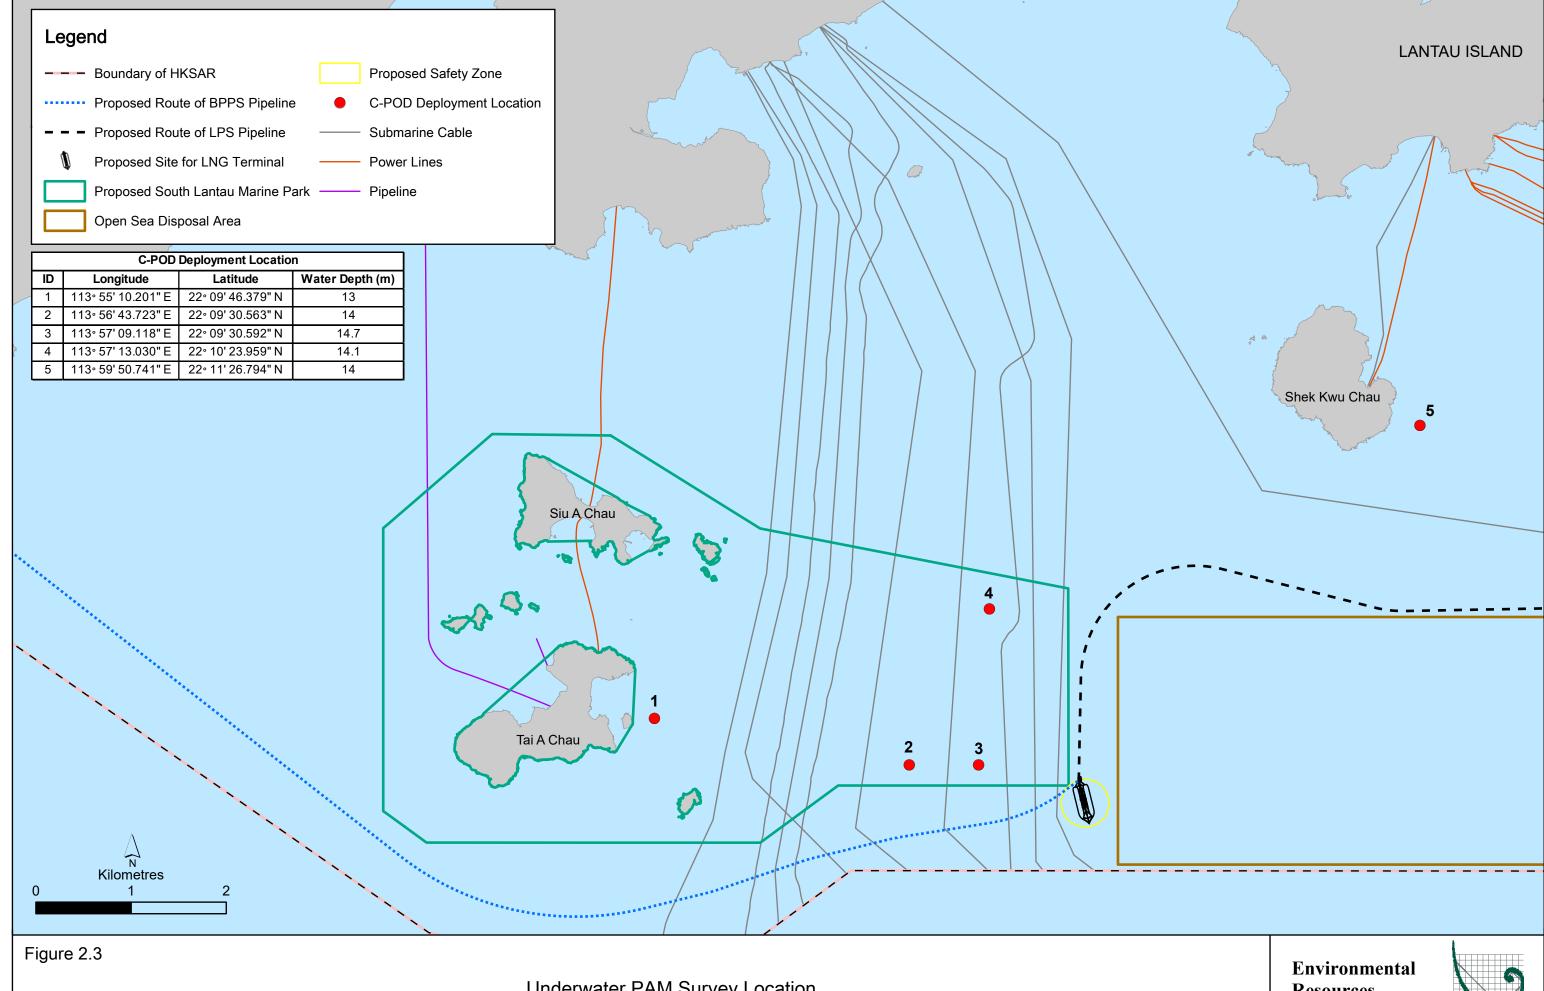
In accordance with the Updated EM&A Manual, underwater PAM survey using C-POD (Cetacean-Porpoise Detector) was conducted at five locations as presented in *Figure 2.3*. C-PODs are left in place during construction of the LNG Terminal. Such duration should allow for a robust record of marine mammal usage of the area to be obtained and allow for the inter-seasonal differences already known for finless porpoises. The C-PODs have to be serviced every two to four months, subject to review on an as-needed basis, to download accumulated data and replace batteries.
