Issue No.: Issue 1
Issue Date: January 2024
Project No.: 2075

EcoPark Operation

Annual Environmental Monitoring & Audit Report 2023

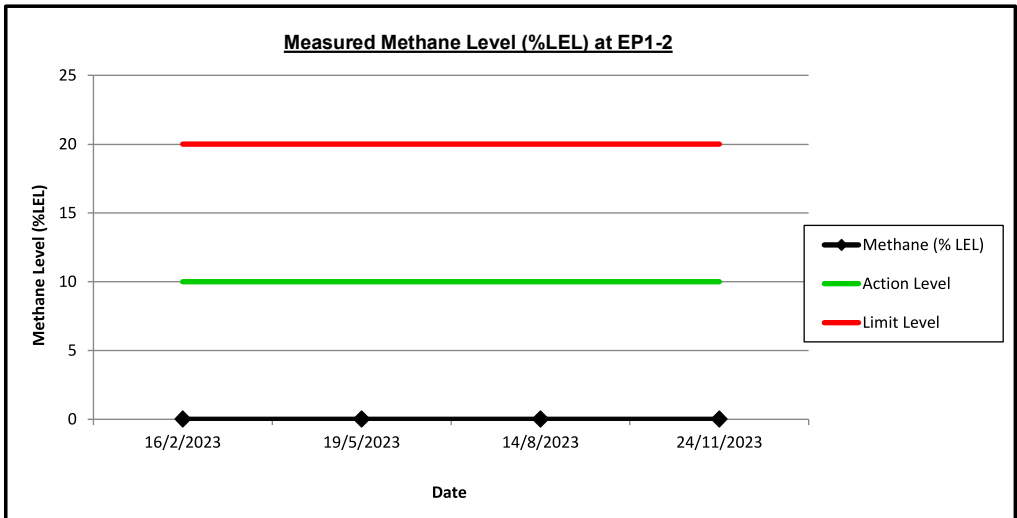
Monitoring Station ID	Monitoring Locations	Weather Conditions	Temperature (°C)	Start Time	End Time	Measurement Results					Action Level			Limit Level			Remarks
						Methane		Oxygen	Carbon Dioxide	Barometric Pressure	Methane	Oxygen	Carbon Dioxide	Methane	Oxygen	Carbon Dioxide	
						% v/v	% LEL	% v/v	% v/v	mBar (absolute)	% LEL	% v/v	% v/v	% LEL	% v/v	% v/v	
16/2/2023																	
EP1-1	Inside the landscaping area of Administration Building	Sunny	19	09:40	09:42	0.0	0.0	20.9	0.0	1018	> 10	< 19	> 0.5	> 20	< 18	> 1.5	Nil
EP1-2	PCCW below-ground chamber outside Lot T1		19	09:45	09:47	0.0	0.0	20.9	0.0	1018							Nil
EP1-3	HGC Broadband below-ground chamber outside Lot T3		19	09:50	09:52	0.0	0.0	20.9	0.0	1018							Nil
EP2-1	HGC Broadband below-ground chamber outside Lot P1		19	10:00	10:02	0.0	0.0	20.9	0.0	1018							Nil
EP2-2	HGC Broadband below-ground chamber outside Lot P3		19	10:10	10:12	0.0	0.0	20.9	0.0	1018							Nil
