**Service Contract No. WD/04/2020  
Development of Lok Ma Chau Loop:  
Main Works Package 1 –  
Environmental Team**

**Environmental Permit No.: EP-  
477/2013/A - Development of Lok Ma  
Chau Loop**

**Monthly Environmental Monitoring and  
Audit Report for January 2022**

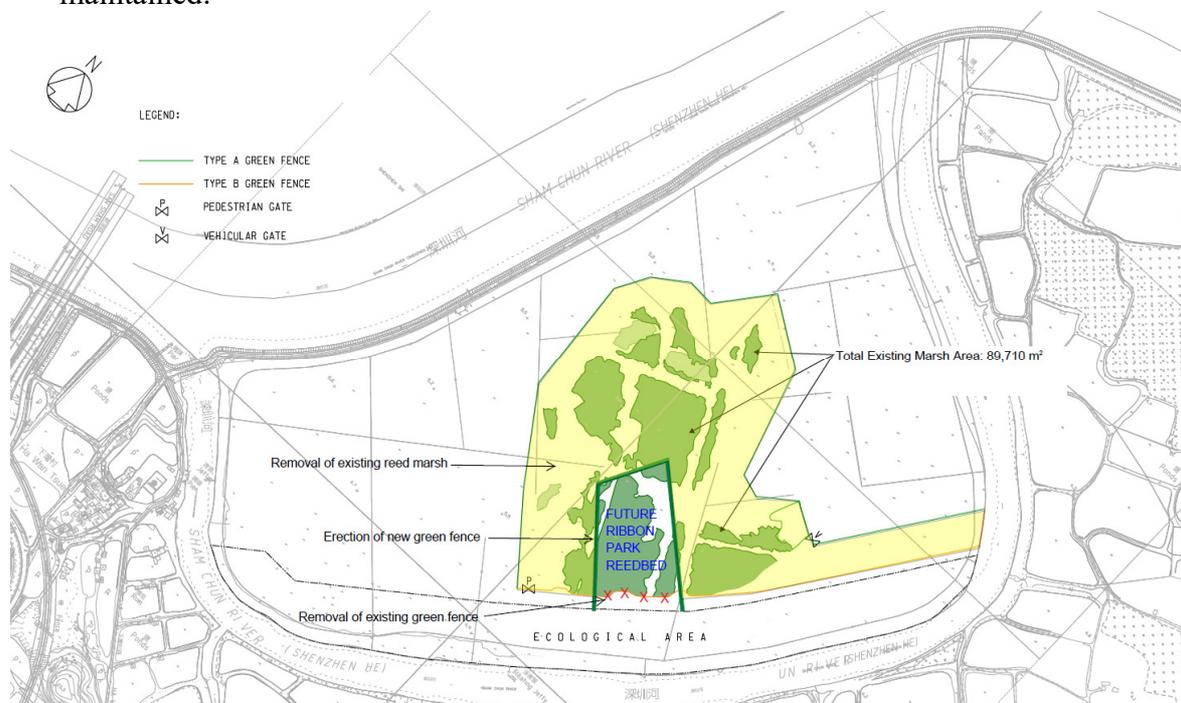
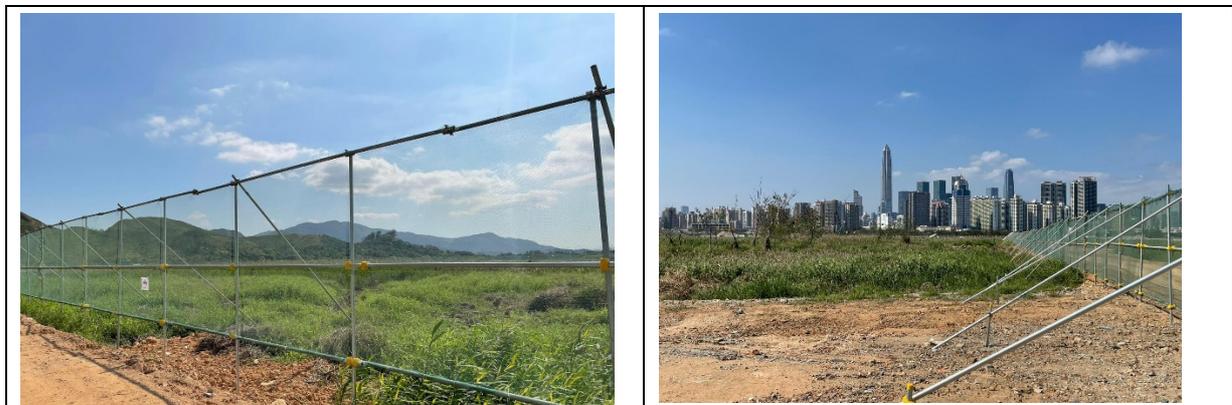
### Ecological Mitigation Measures – Installation of 3m-high Olive Green Fence

- 10.7 In January 2022, the green fence around the future Ribbon Park Reedbed was properly maintained:

- 10.8 The Contractor was reminded to maintain and re-arrange the green fence around construction areas and ensure no disturbance to the existing trees and reed marsh habitat.

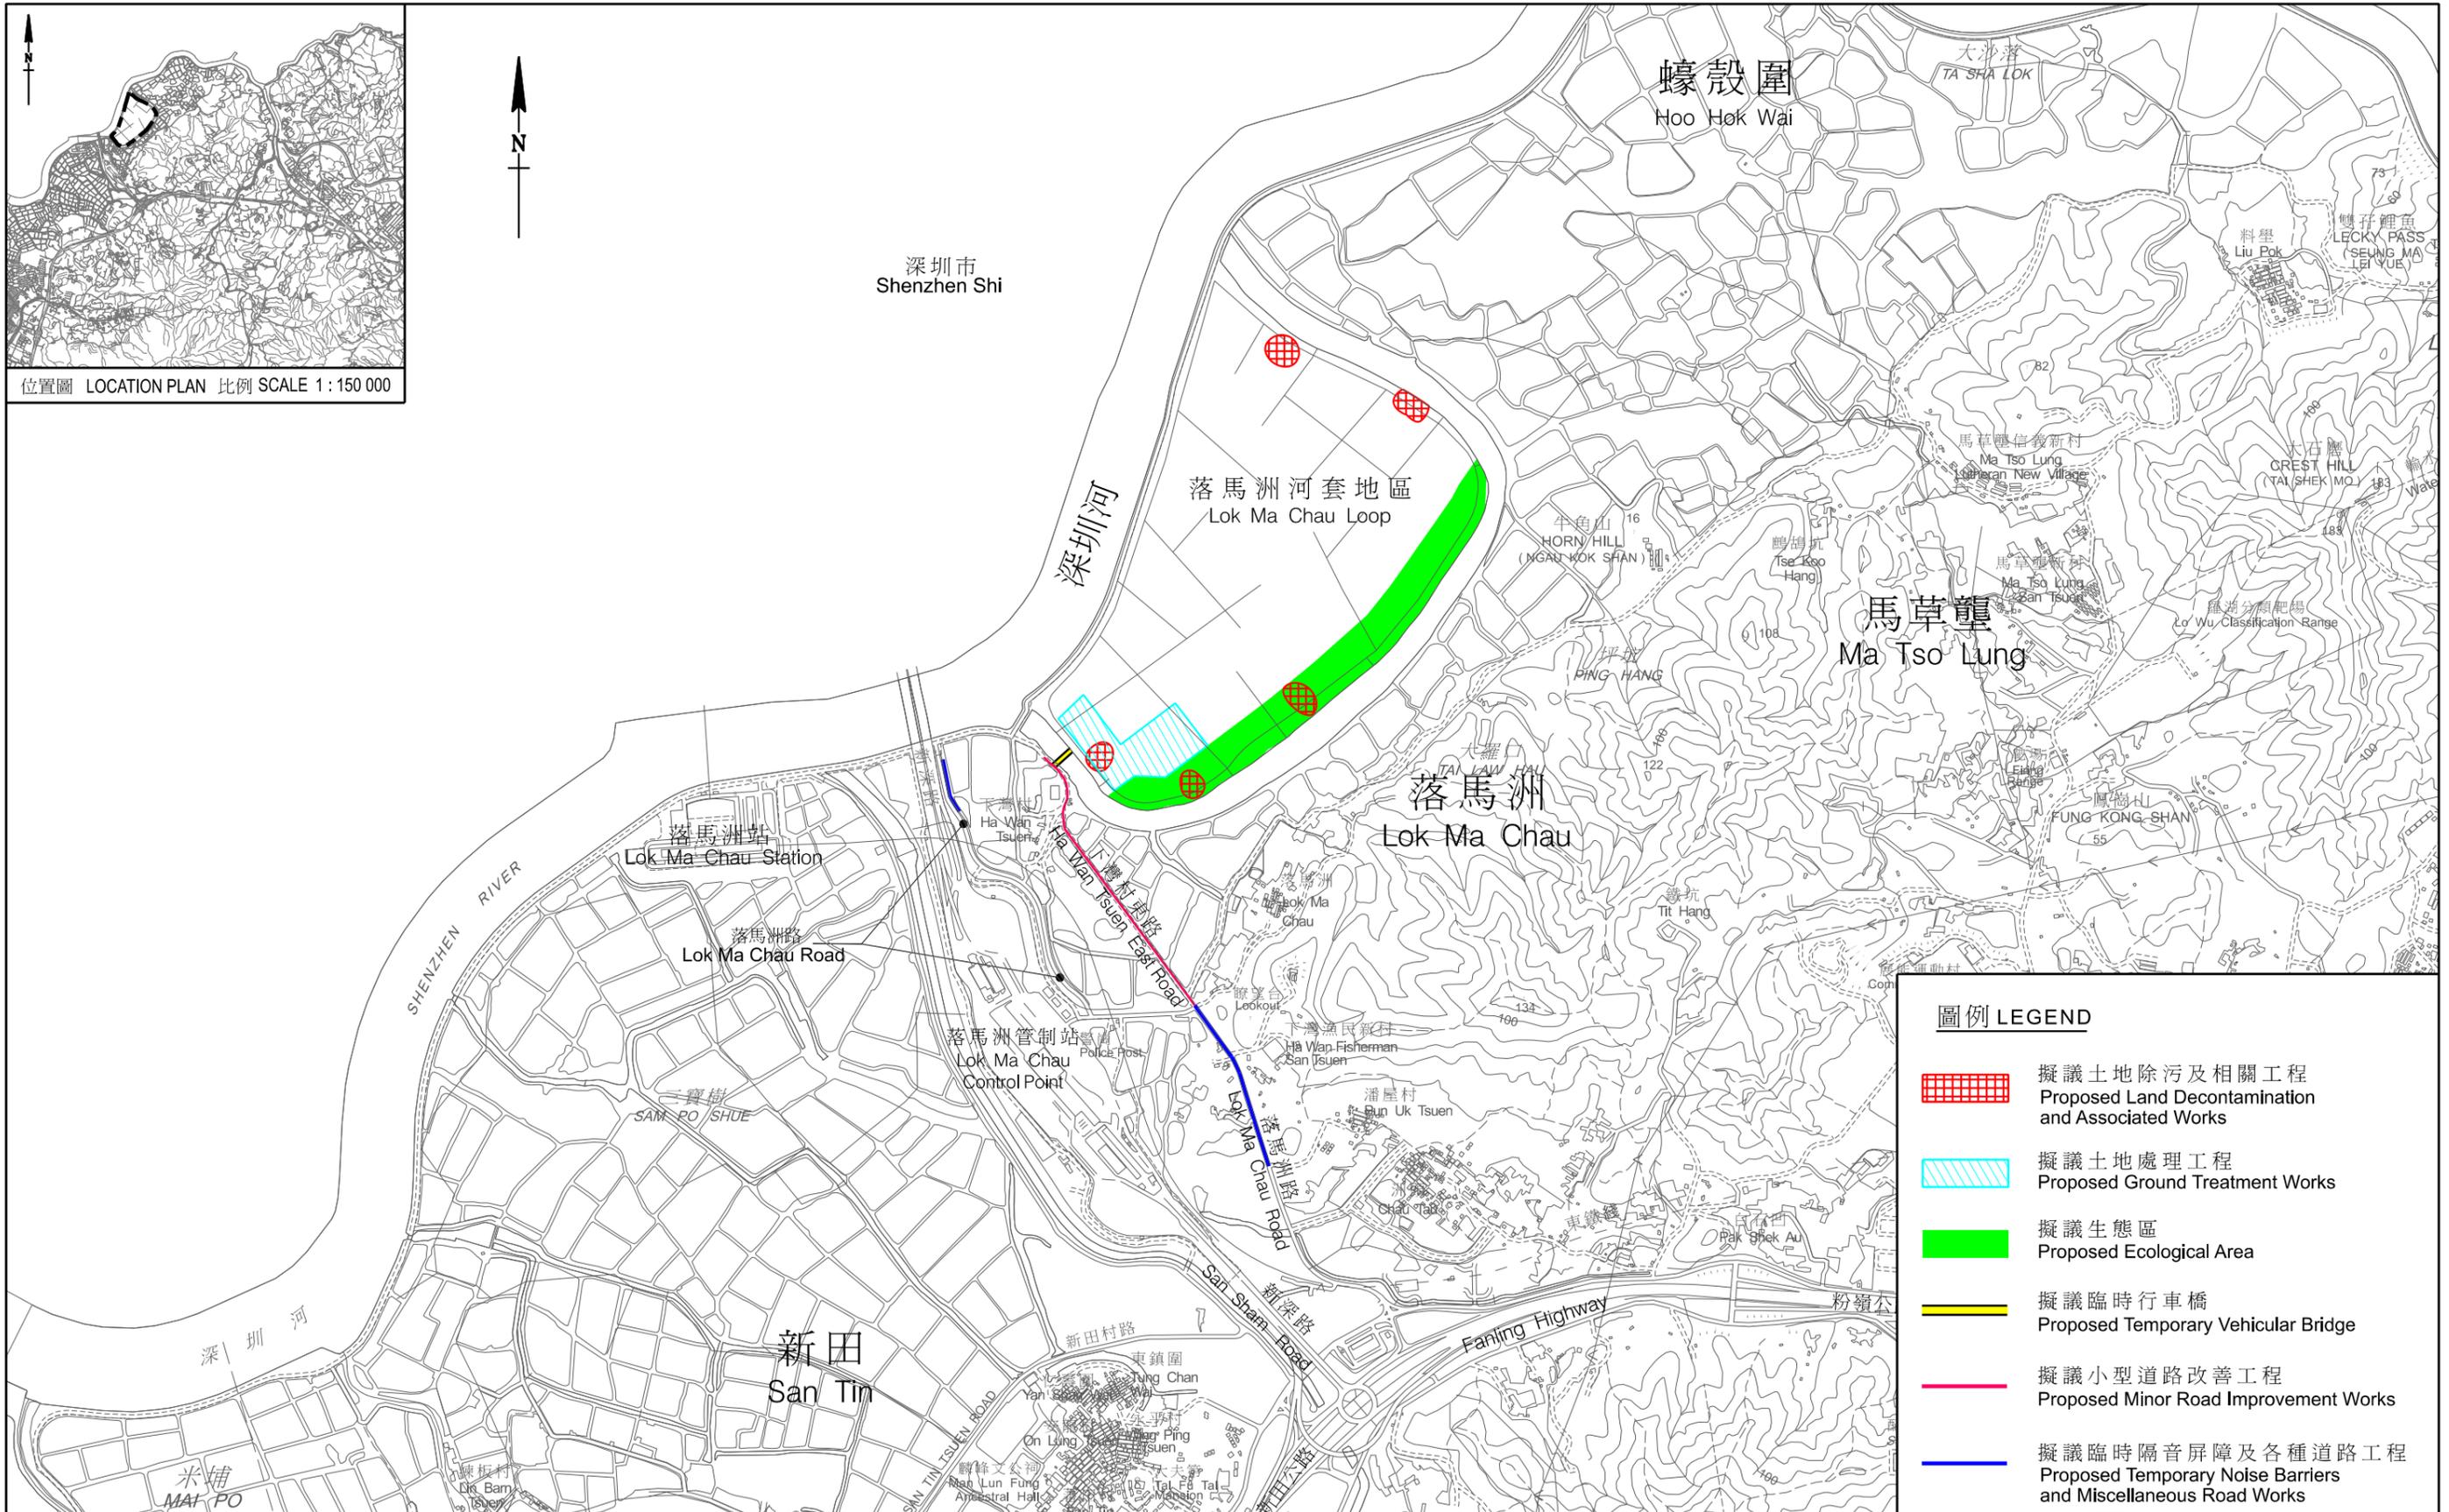
FIGURE 1 a  
 LAYOUT PLAN

工務計劃項目第748CL號—落馬洲河套地區發展：土地除污及前期工程  
 PWP ITEM No. 748CL-DEVELOPMENT OF LOK MA CHAU LOOP :  
 LAND DECONTAMINATION AND ADVANCE ENGINEERING WORKS

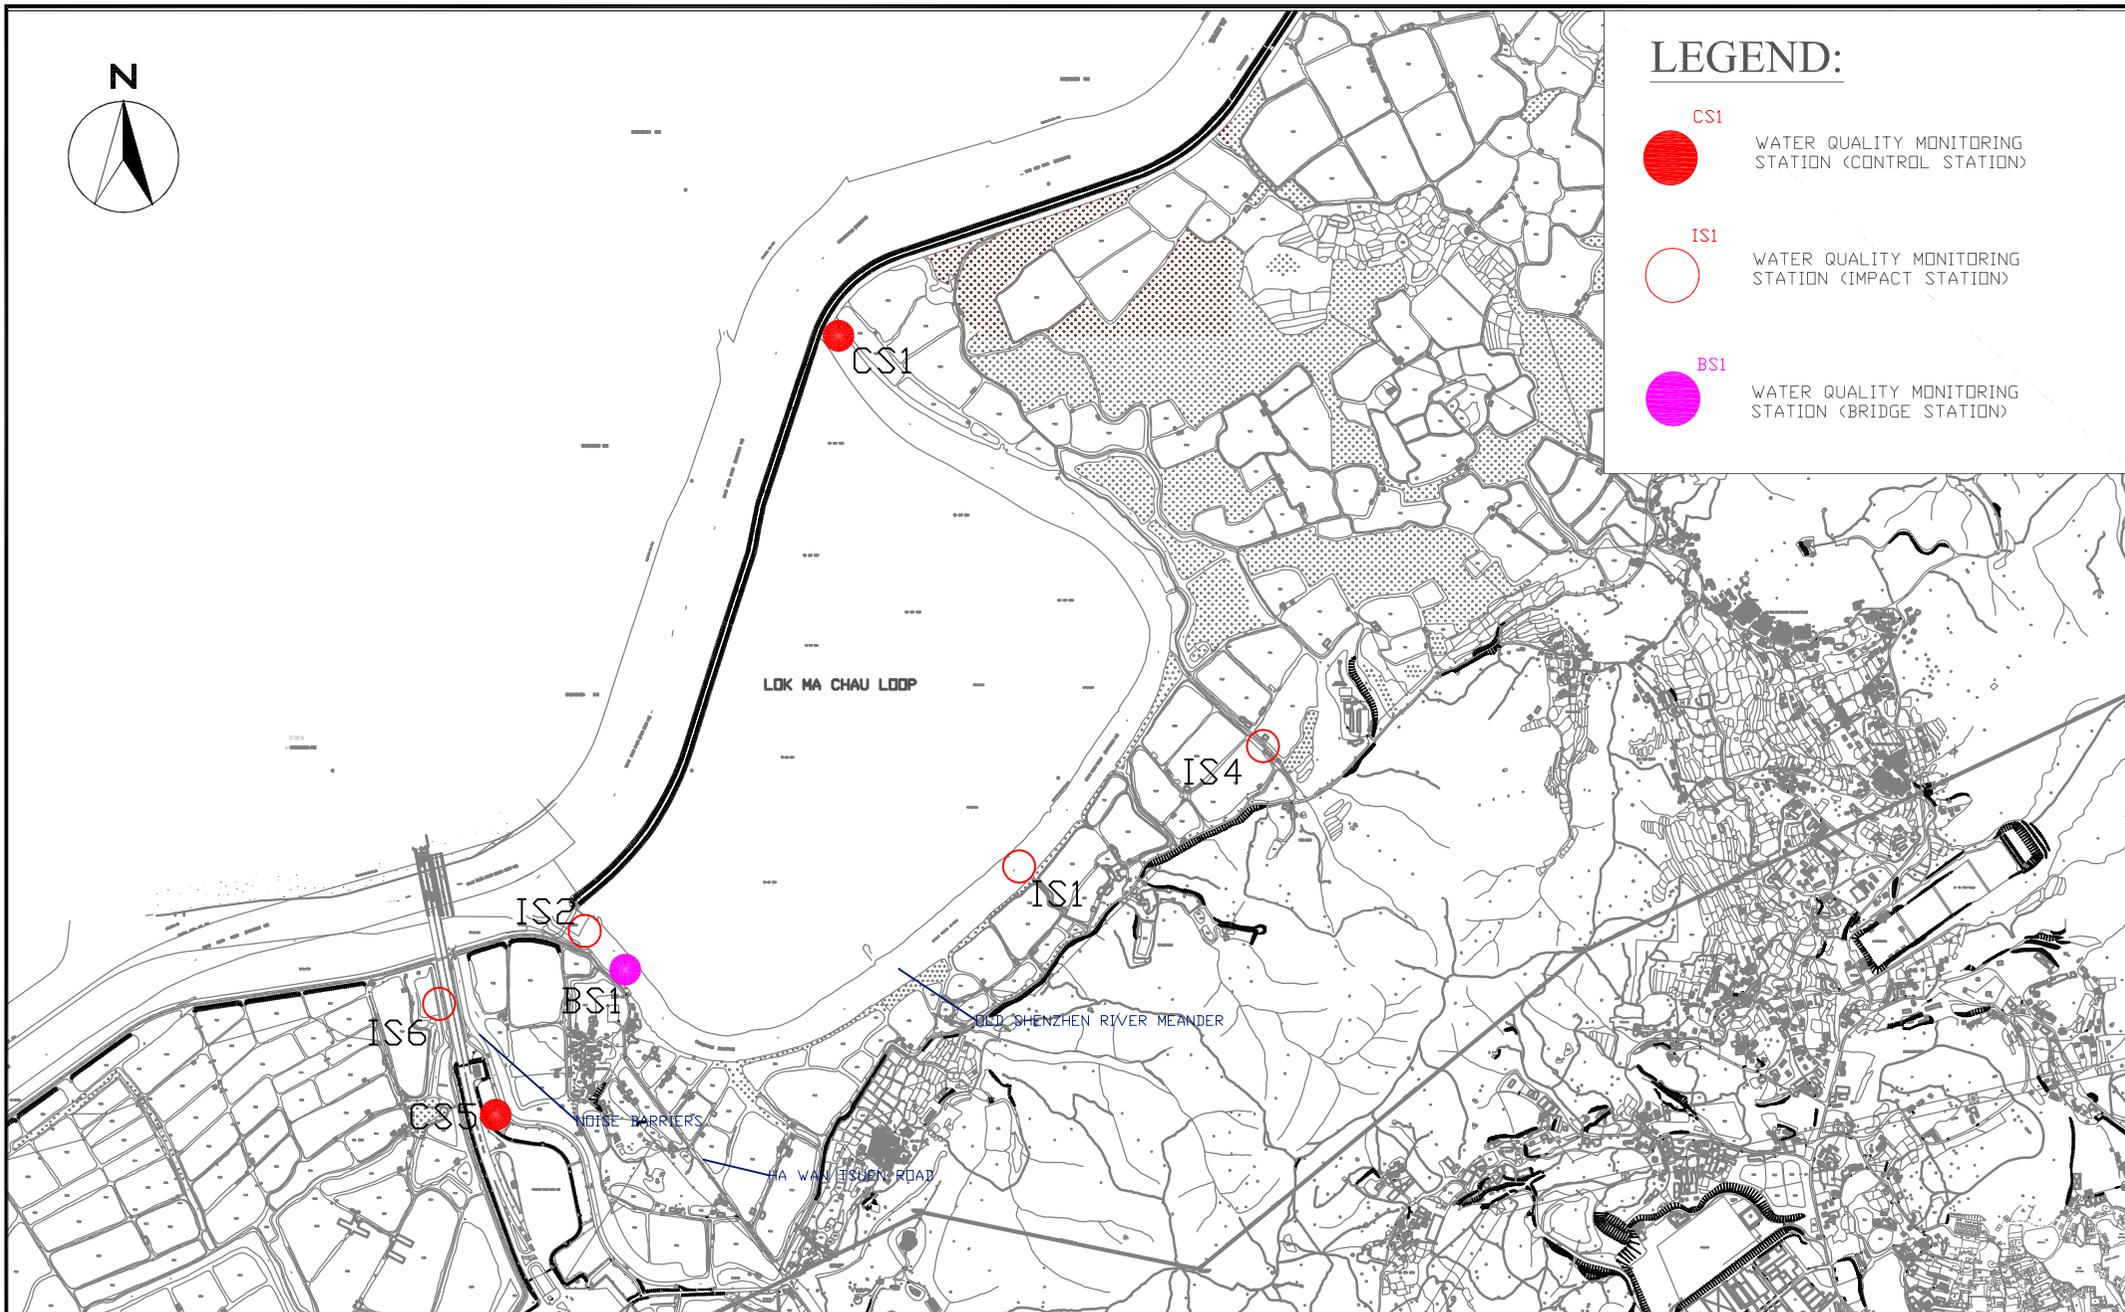
SCALE	1:400 A4	DATE	May 2021
CHECK	PC	DRAWN	IT
JOB No.	WMA 21009	FIGURE NO.	Fig 4
		REV	-

- CS1 WATER QUALITY MONITORING STATION (CONTROL STATION)
- IS1 WATER QUALITY MONITORING STATION (IMPACT STATION)
- BS1 WATER QUALITY MONITORING STATION (BRIDGE STATION)

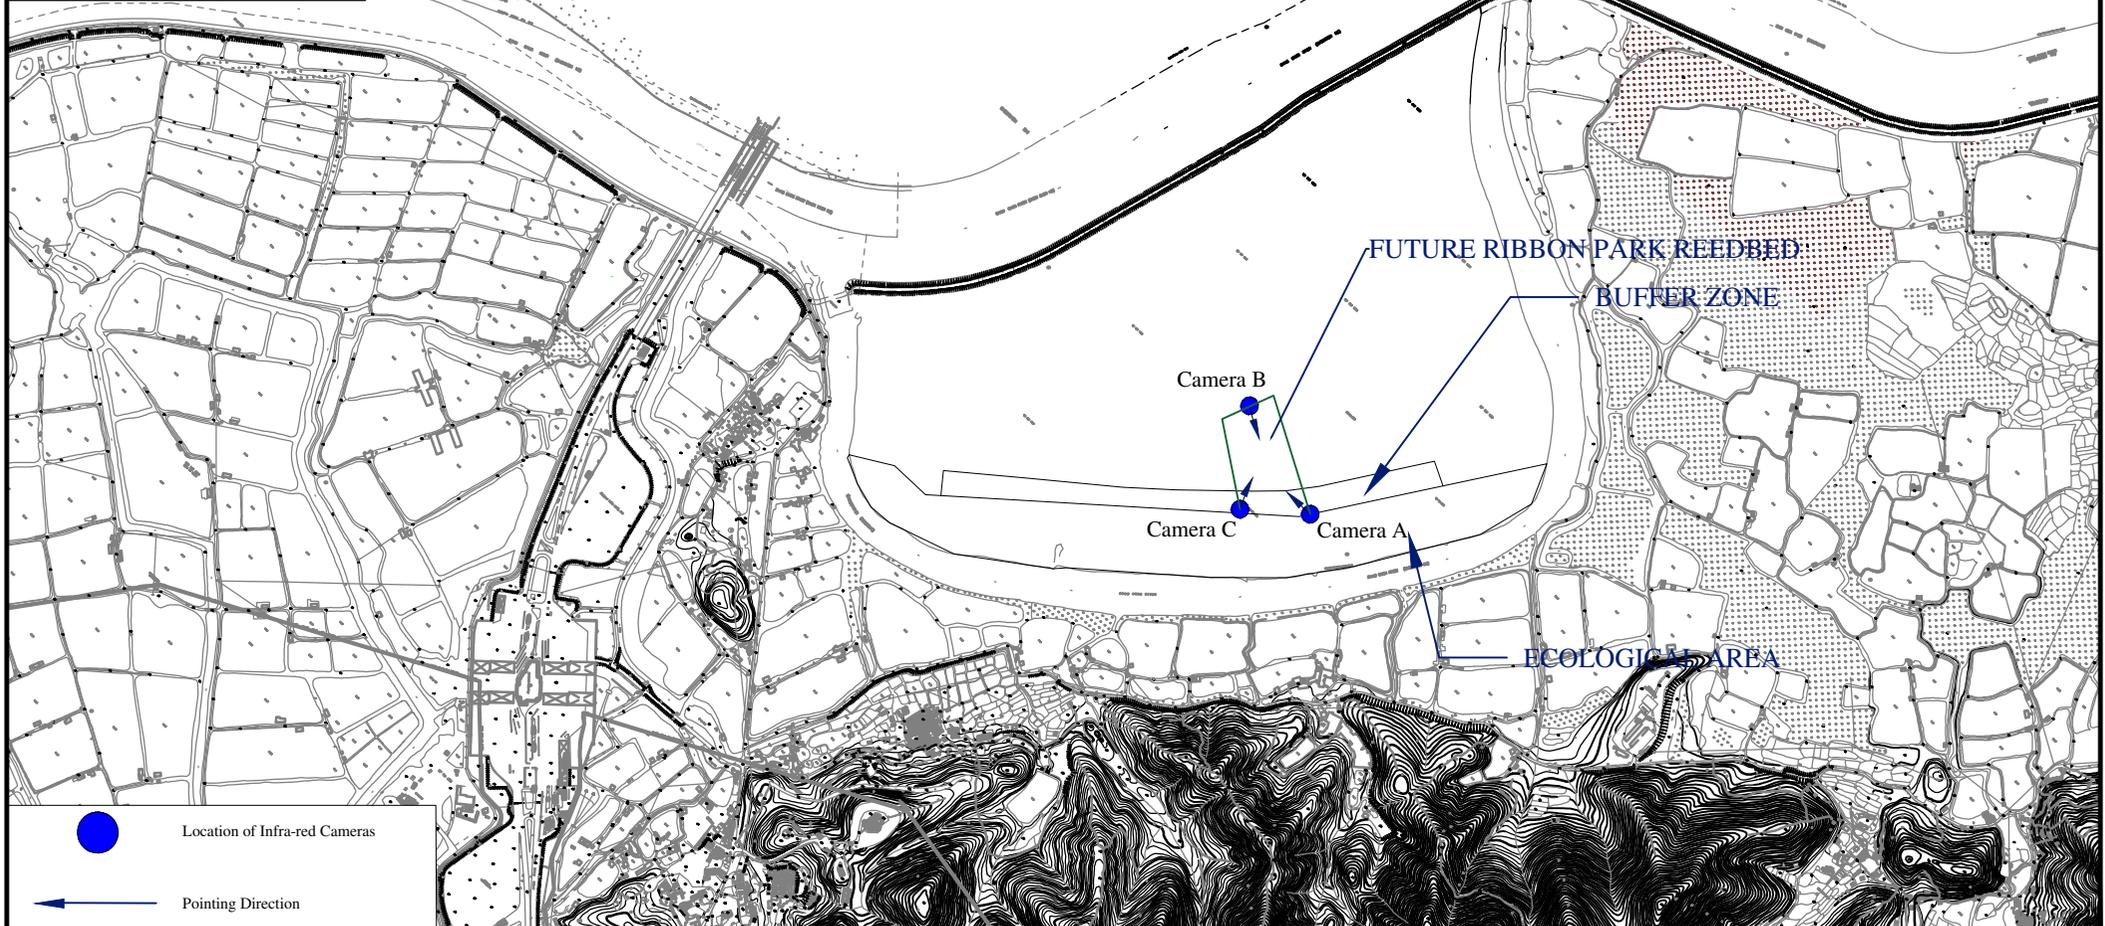
SCALE	1:14000 @ A4	DATE	DEC 2021	
CHECK	IT	DRAWN	ML	
JOB No.	WMA 21009	FIGURE NO.	Fig 5	REV
				-

Location of Infra-red Cameras

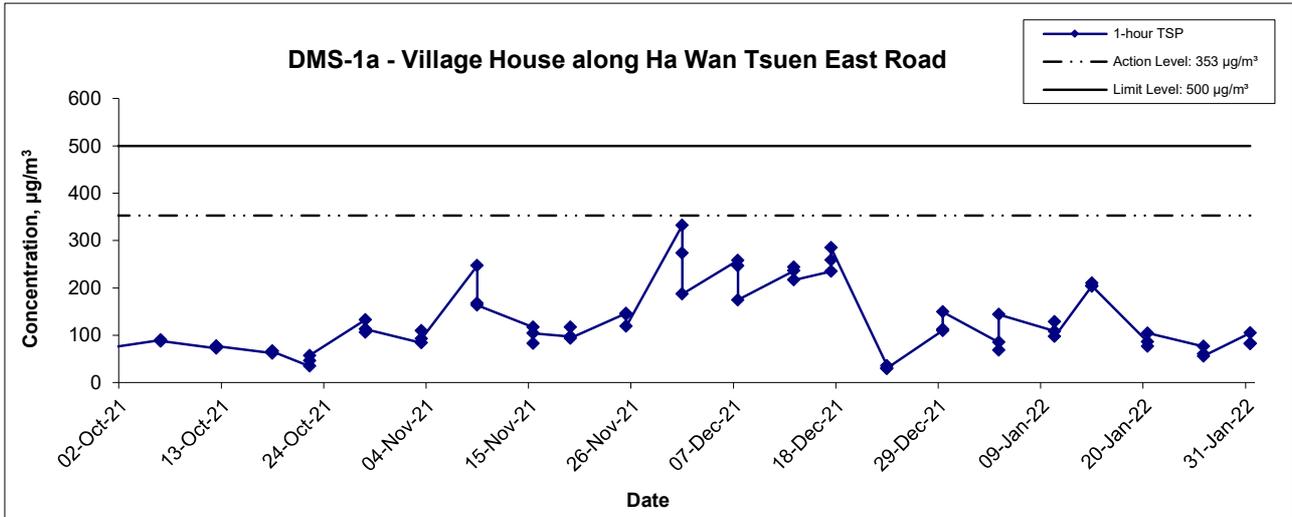
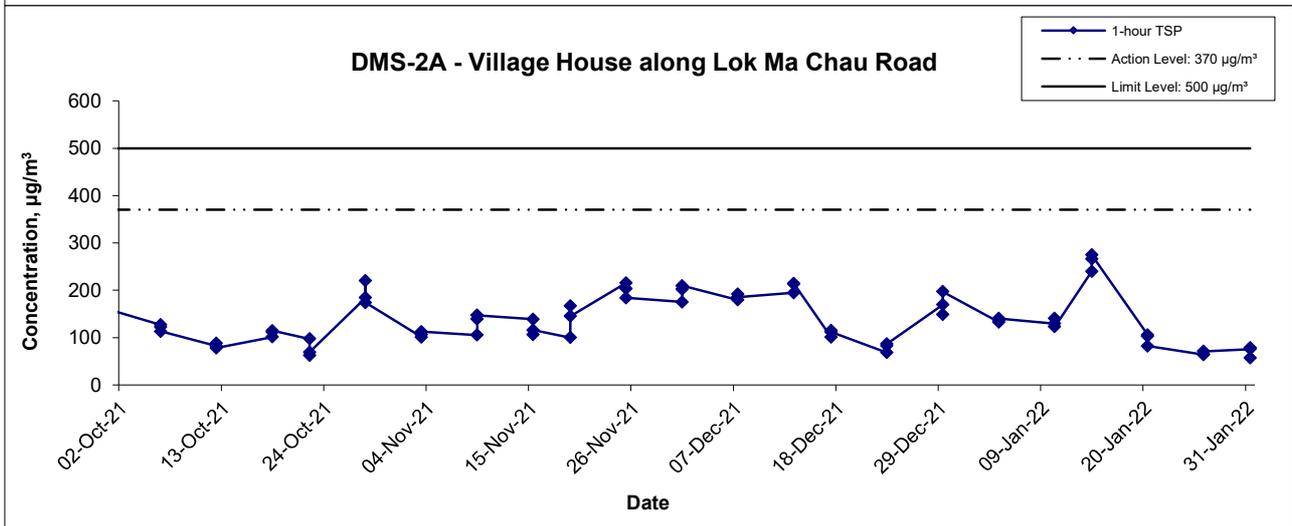
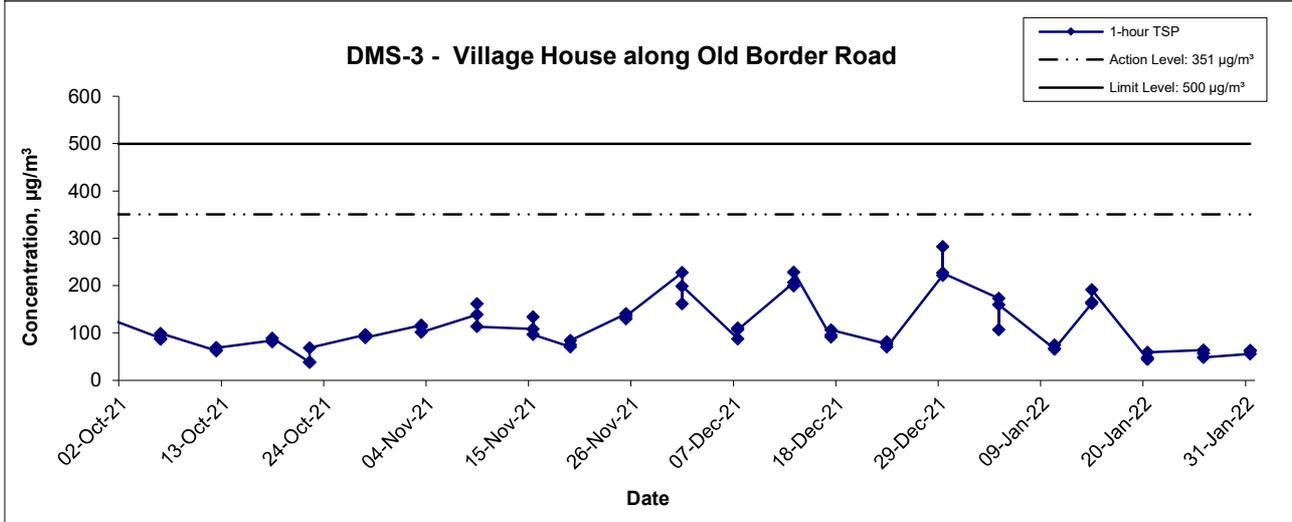
# 1-hour TSP Concentration Levels

Title Service Contract No. WD/04/2020  
 Development of Lok Ma Chau Loop:  
 Main Works Package 1 - Environmental Team  
 Graphical Presentation of 1-hour TSP Monitoring Results

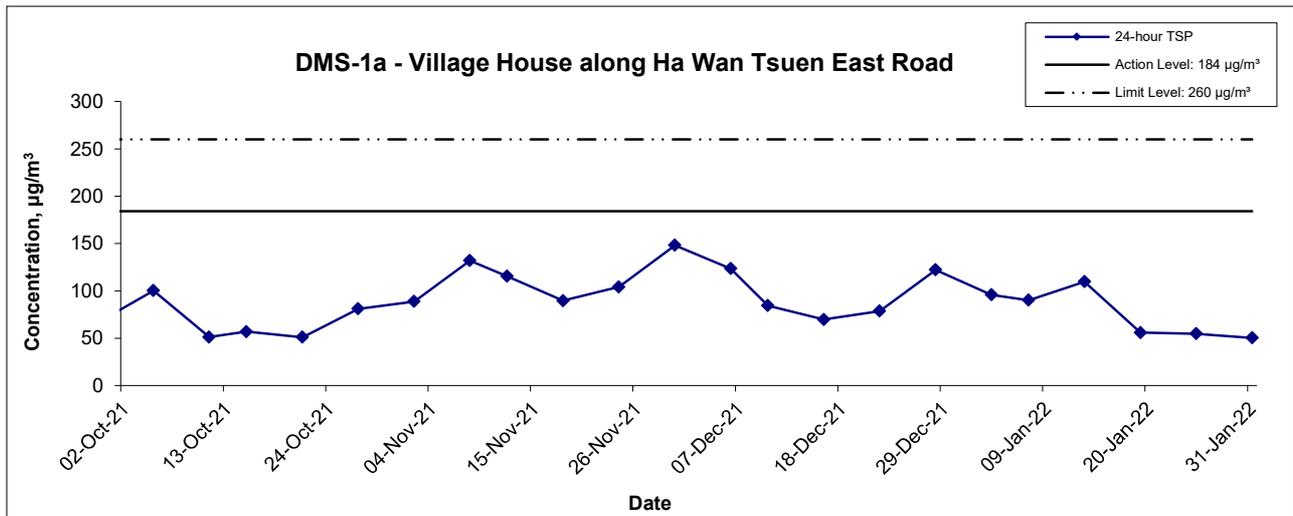
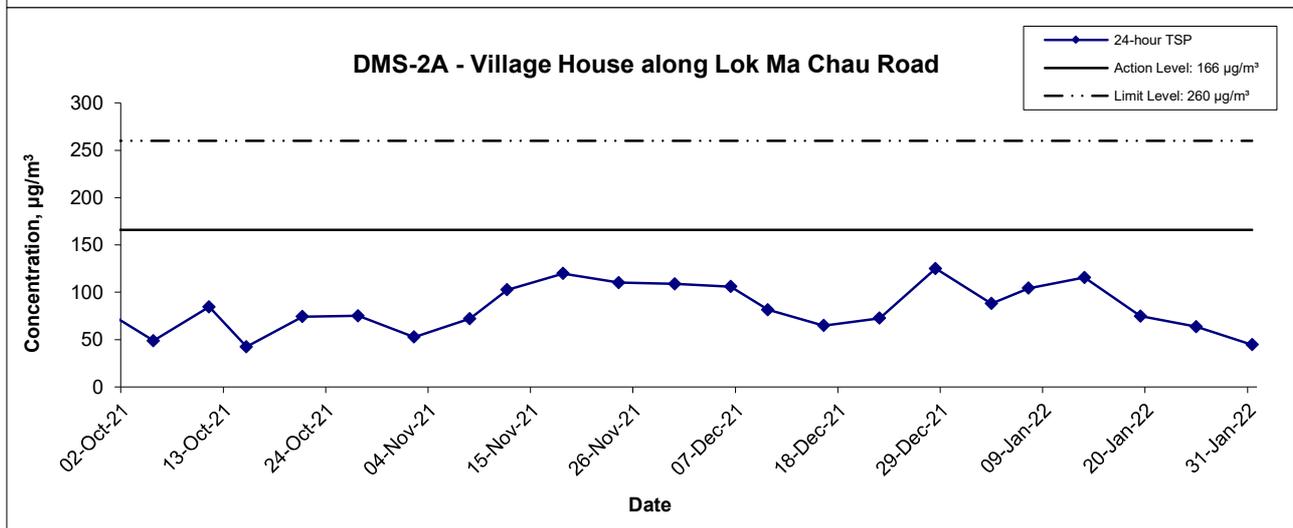
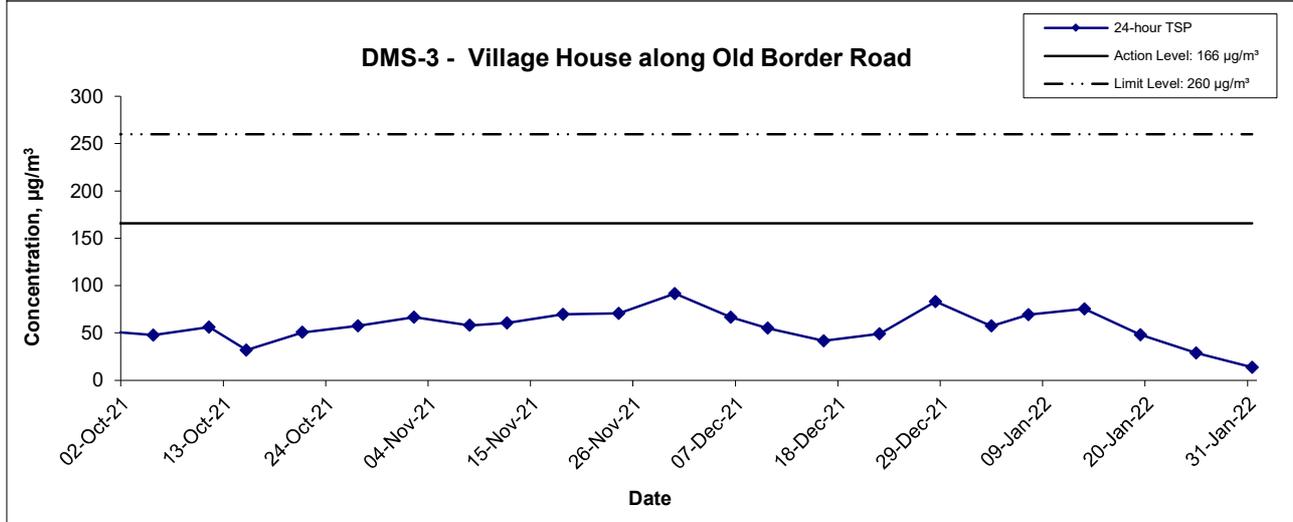
## 24-hour TSP Concentration Levels

Title Service Contract No. WD/04/2020 Development of Lok Ma Chau Loop: Main Works Package 1 - Environmental Team Graphical Presentation of 24-hour TSP Monitoring Results	Scale	N.T.S	Project No.	WMA21009
	Date	Jan 22	Appendix	F

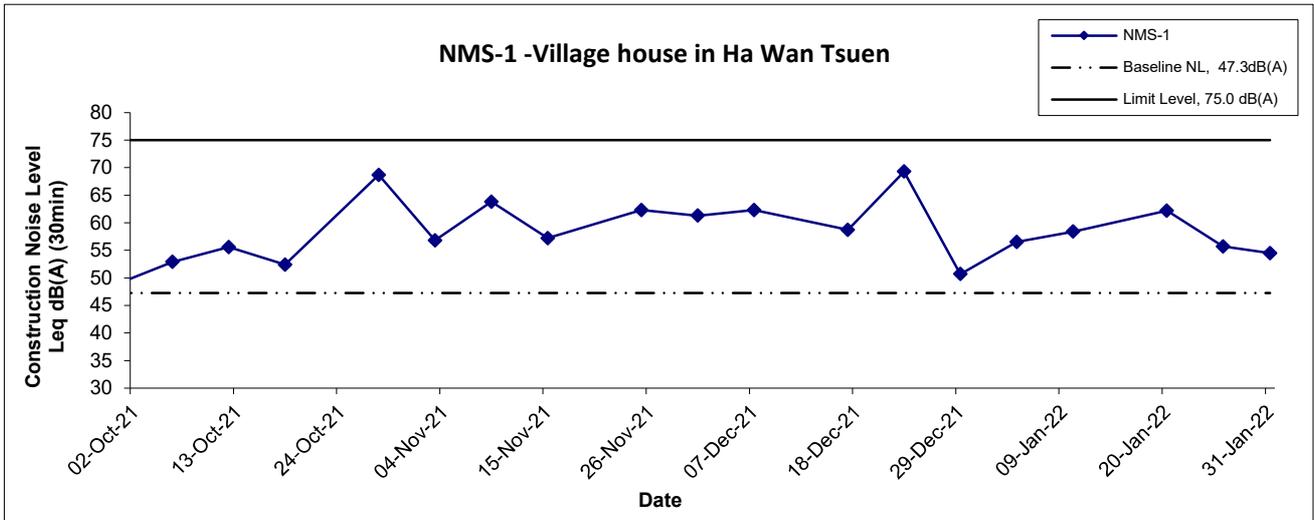
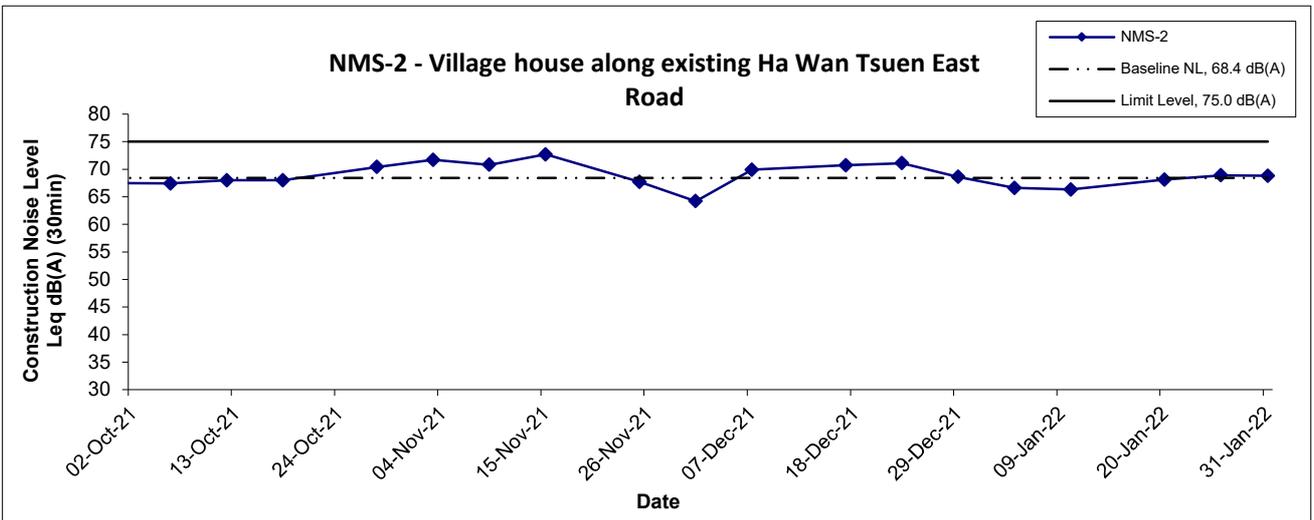
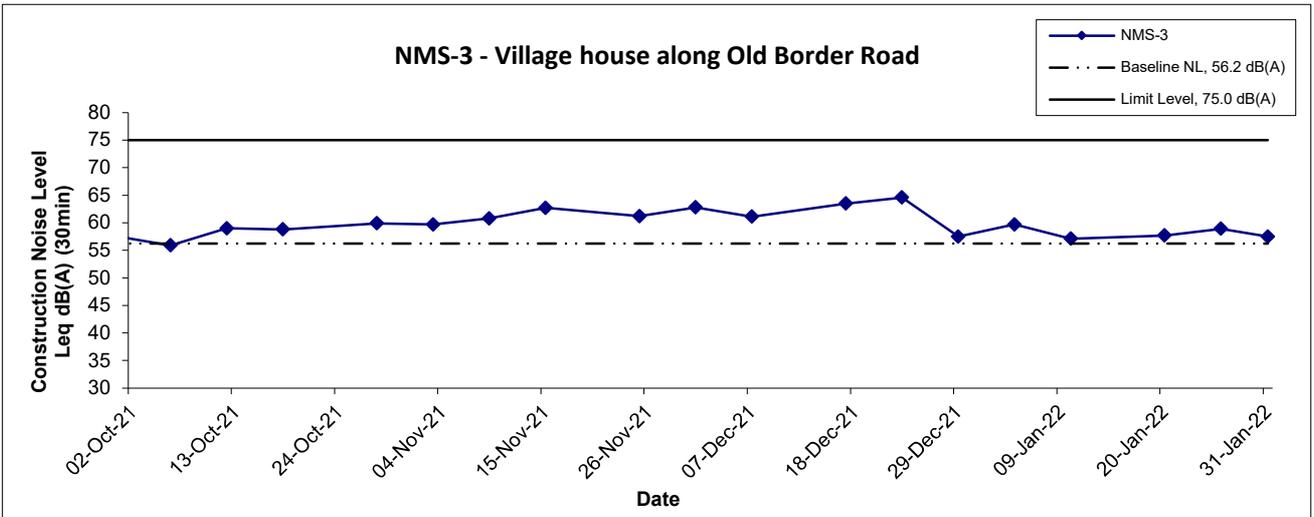
## Noise Levels

Title Service Contract No. WD/04/2020 Development of Lok Ma Chau Loop: Main Works Package 1 - Environmental Team Graphical Presentation of Construction Noise Monitoring Results	Scale N.T.S	Project No. WMA21009	consulting . testing . research
	Date Jan 22	Appendix G

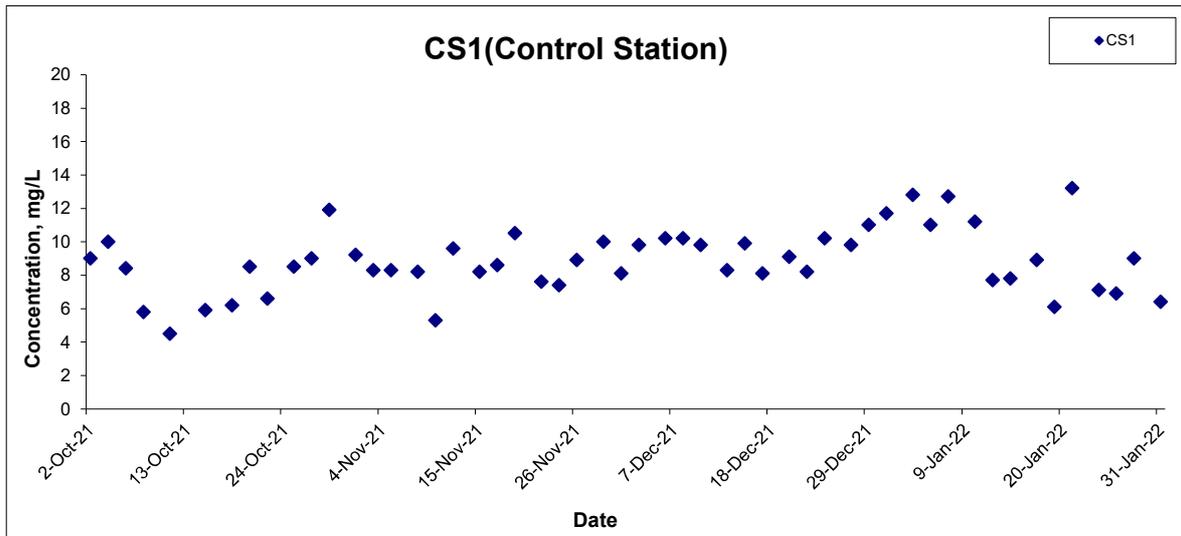
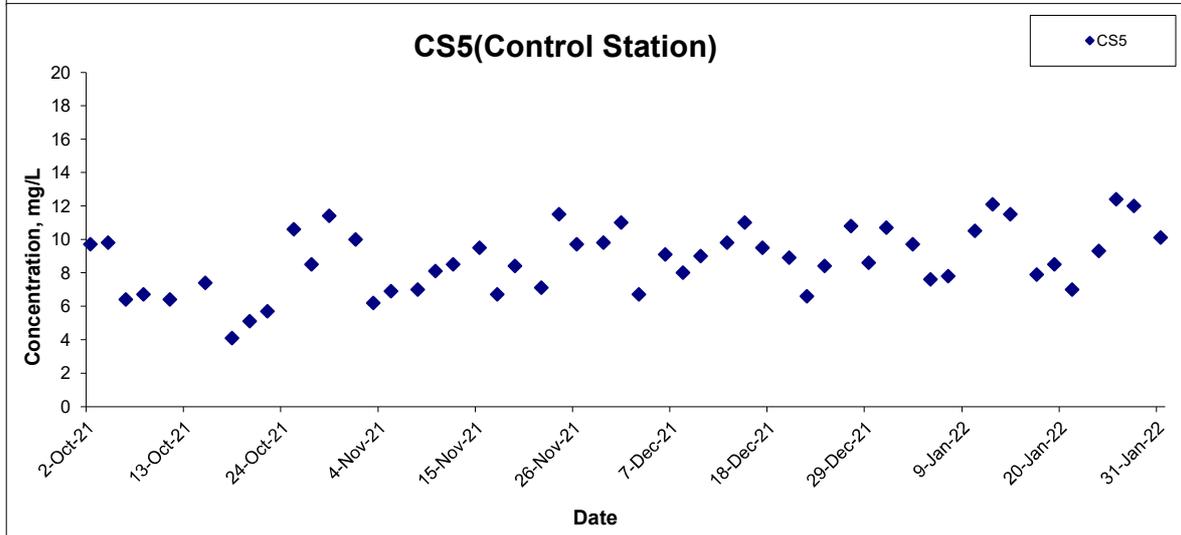
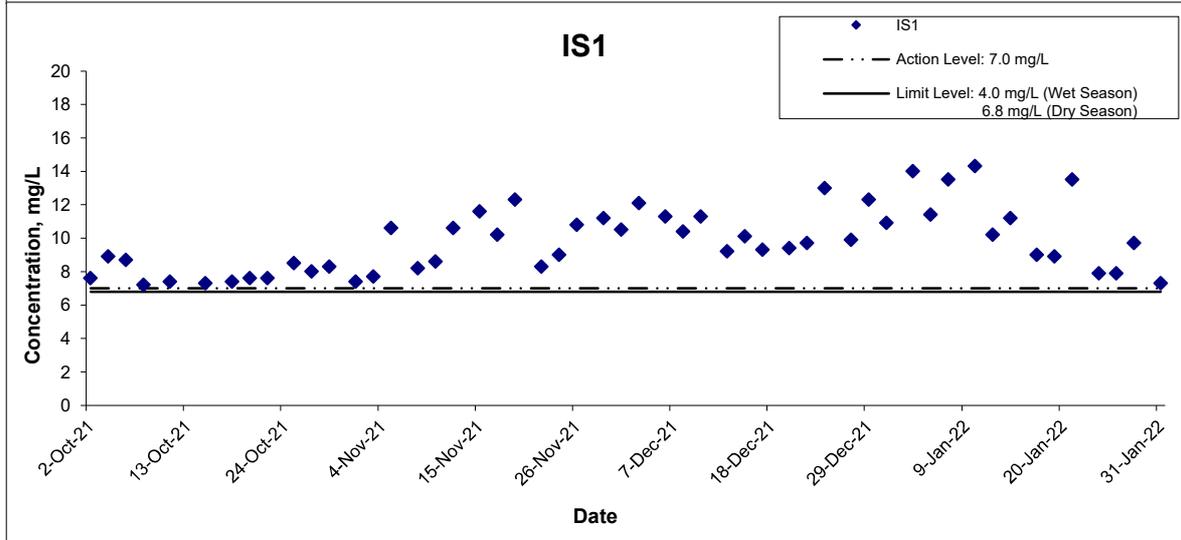
## Dissolved Oxygen

Title  
 Service Contract No. WD/04/2020  
 Development of Lok Ma Chau Loop:  
 Main Works Package 1 - Environmental Team  
 Graphical Presentation of Water Quality Monitoring  
 Results

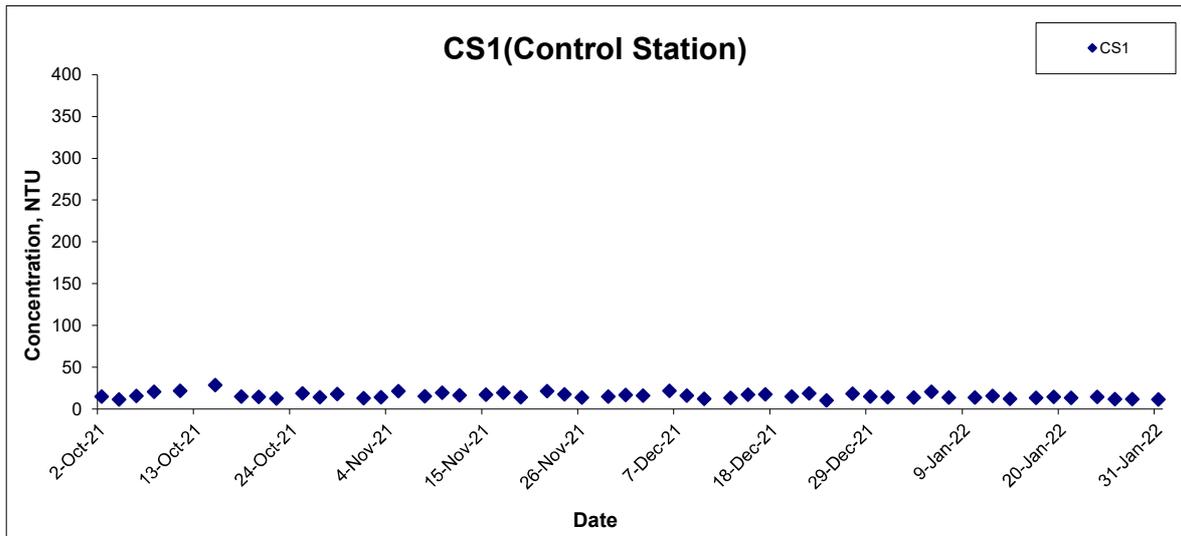
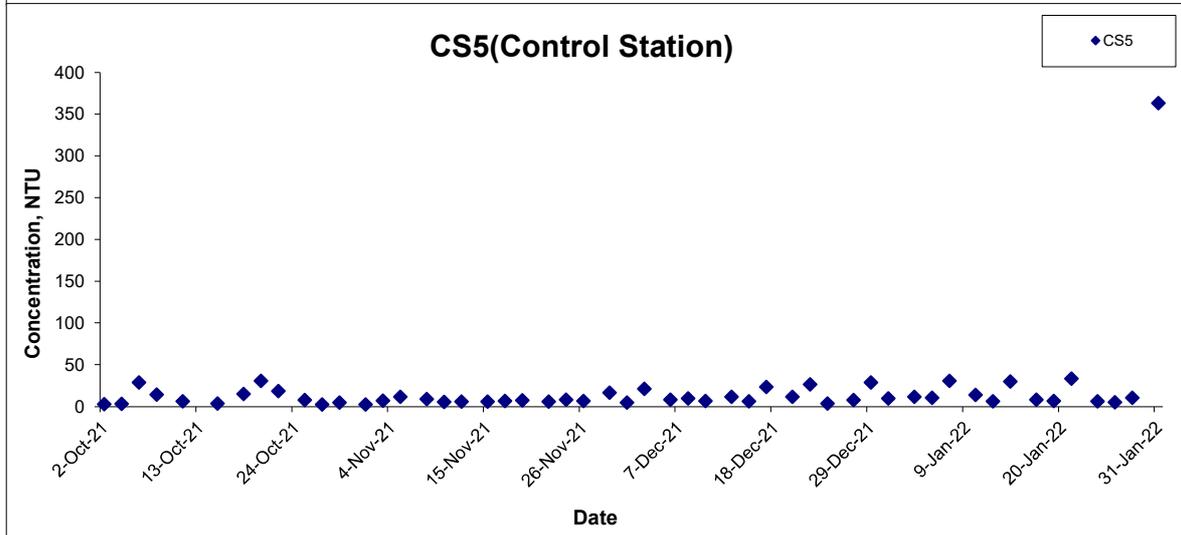
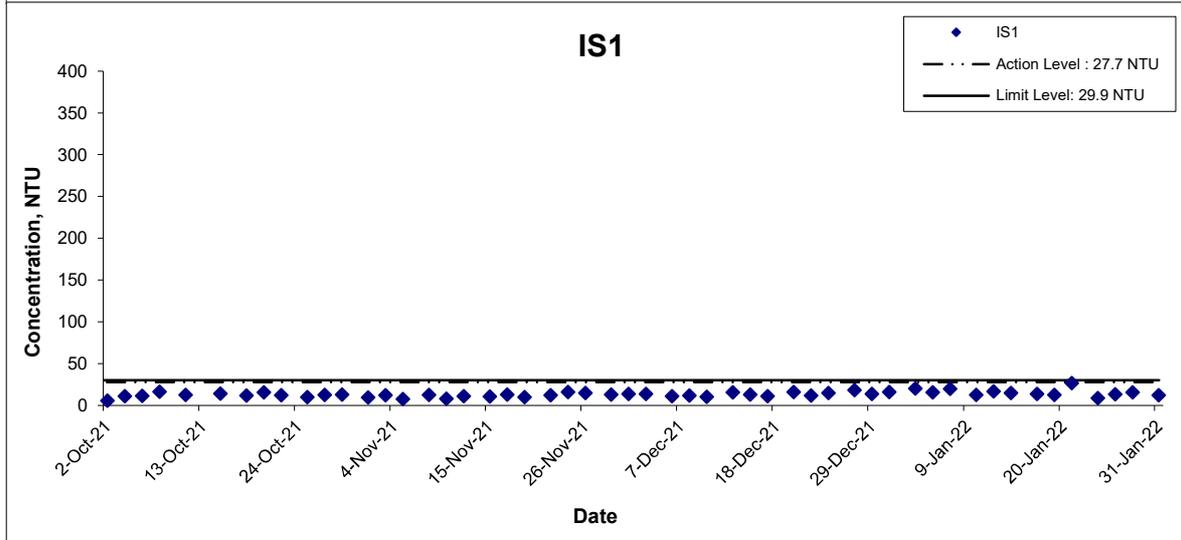
## Turbidity

Title  
 Service Contract No. WD/04/2020  
 Development of Lok Ma Chau Loop:  
 Main Works Package 1 - Environmental Team  
**Graphical Presentation of Water Quality Monitoring Results**

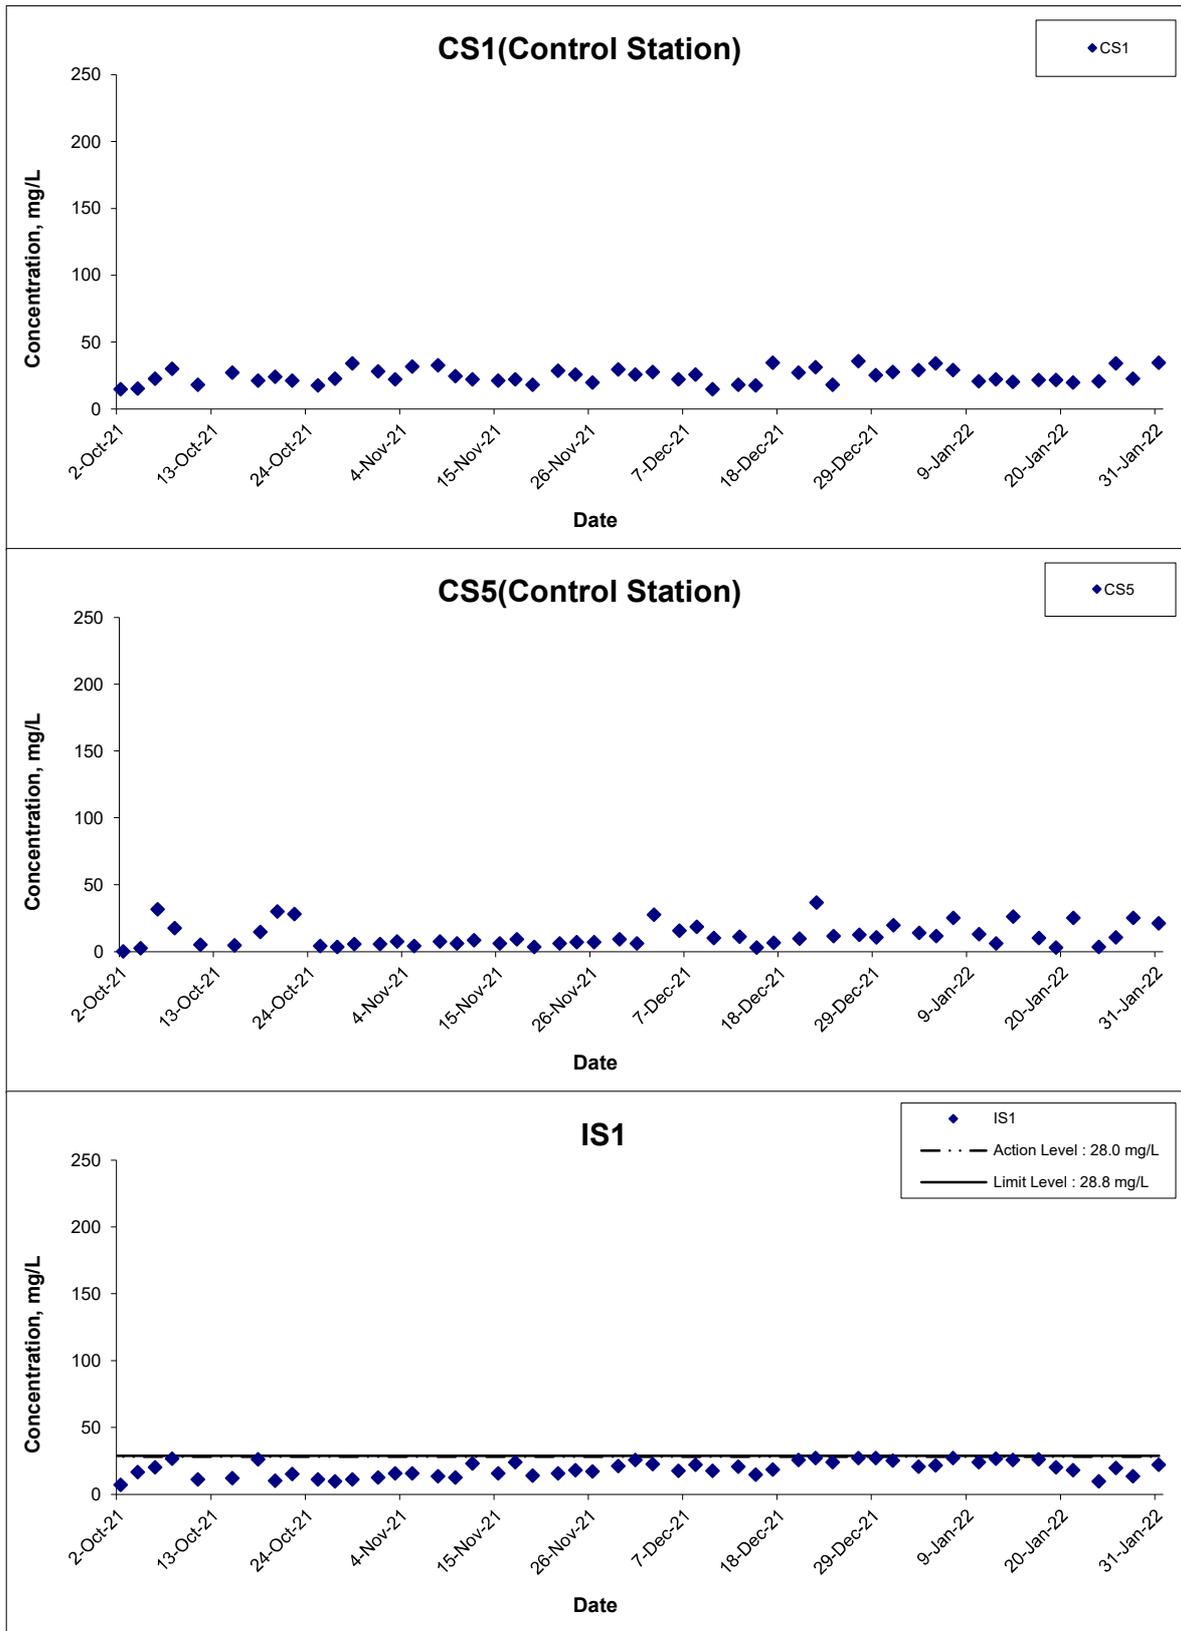
## Suspended Solids

Remark: The graphical point at zero concentration is presented as <2.5 mg/L
