**Service Contract No. WD/04/2020  
Development of Lok Ma Chau Loop:  
Main Works Package 1 –  
Environmental Team**

**Environmental Permit No.: EP-  
477/2013/A - Development of Lok Ma  
Chau Loop**

**Monthly Environmental Monitoring and  
Audit Report for January 2022**

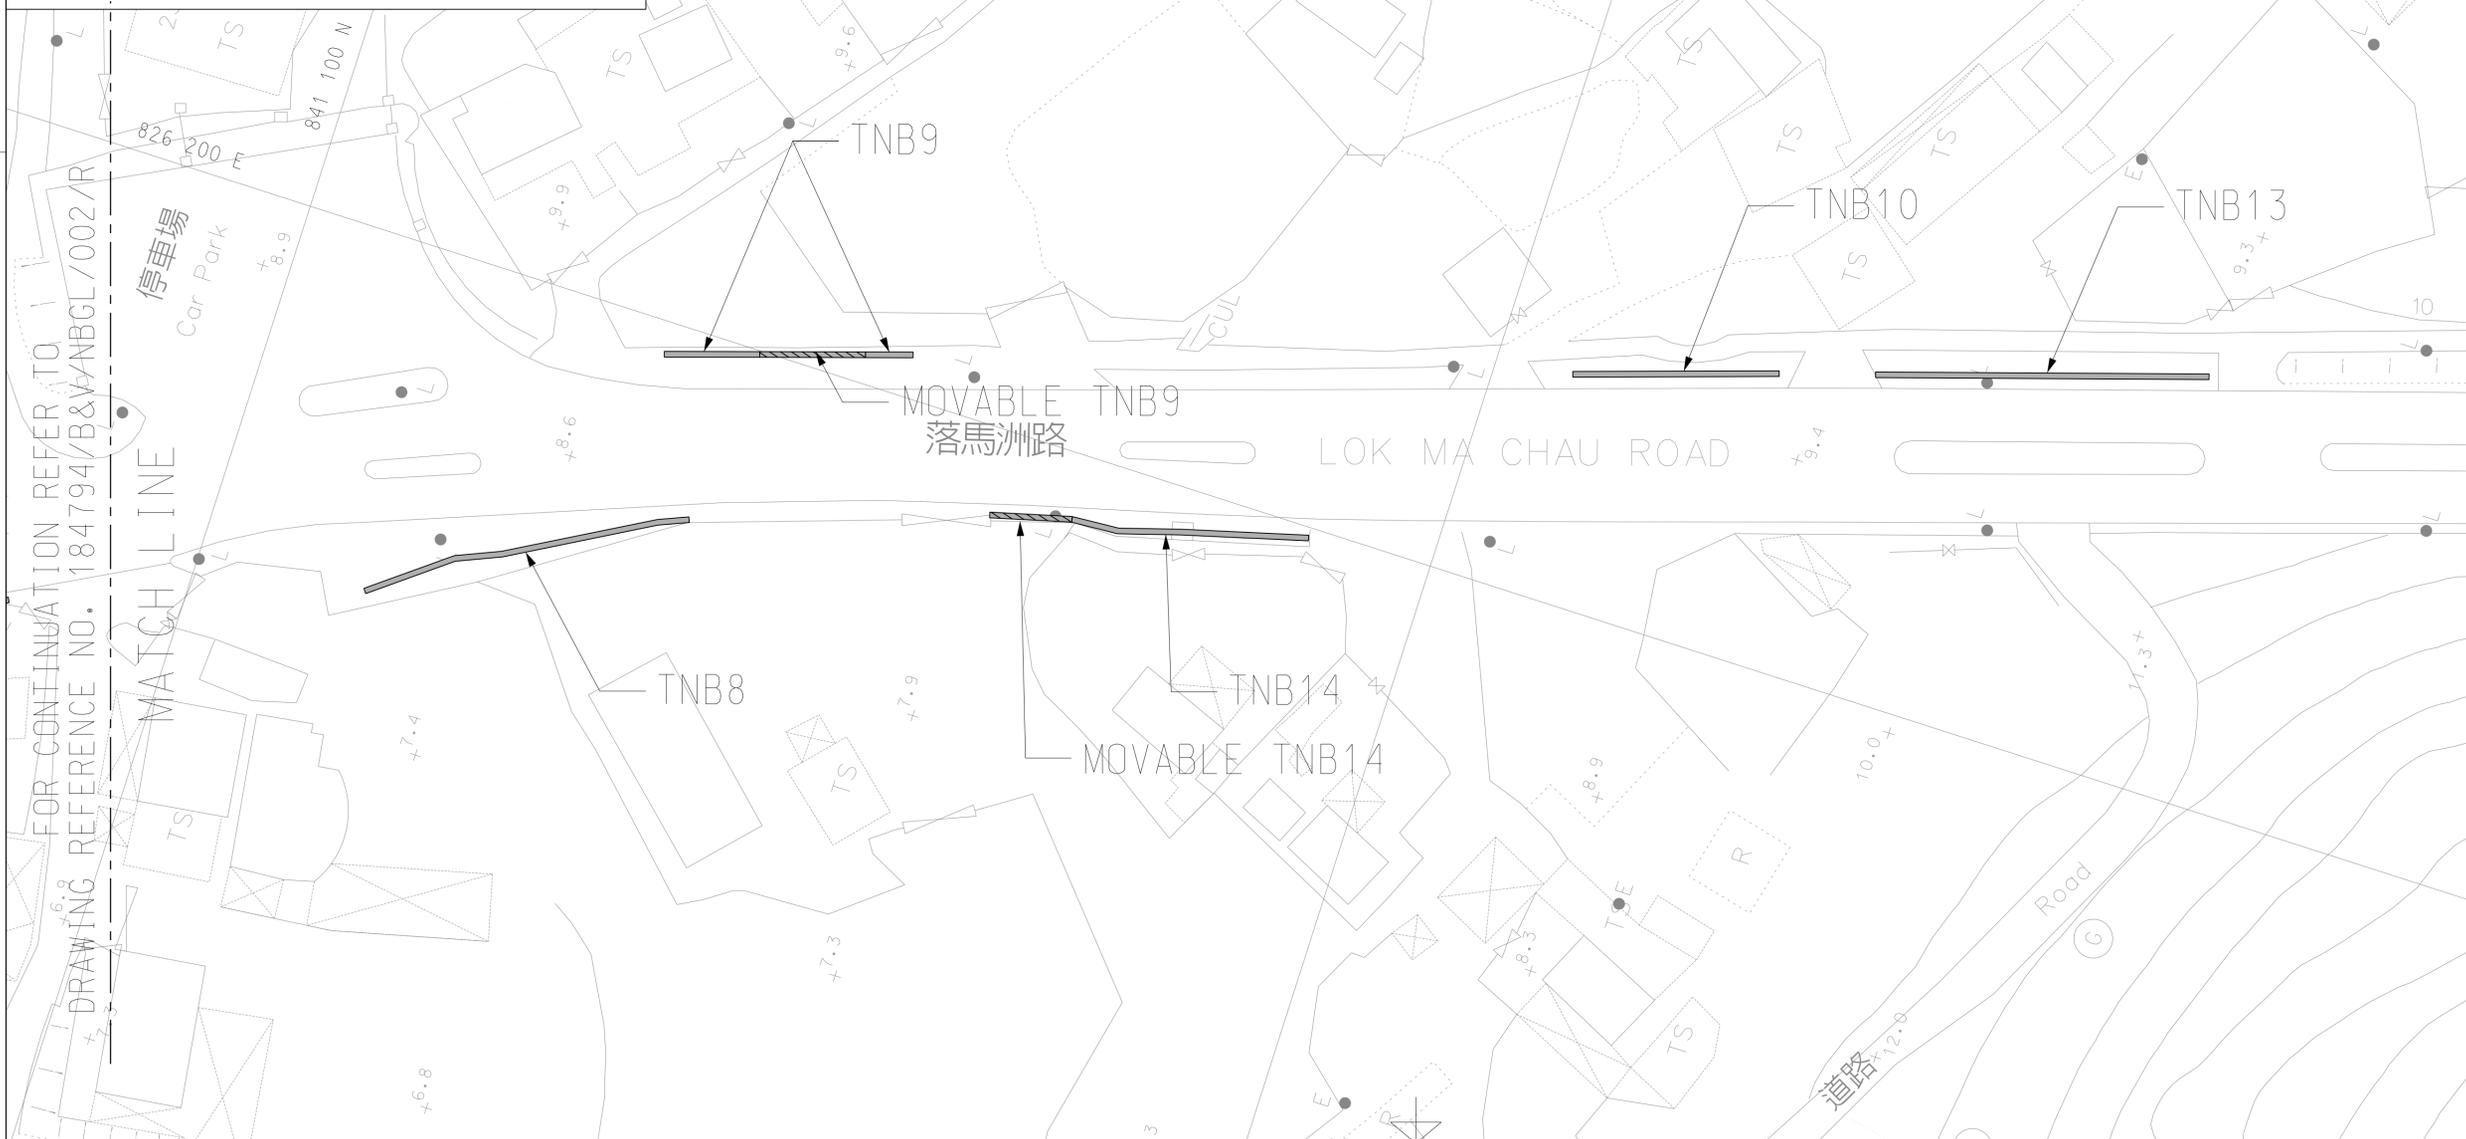
1. FOR DETAILS OF NOISE BARRIER, PLEASE REFER TO DRAWING NO. 184794/B&V/NB15/001/R & NO. 184794/B&V/NB15/002/R.

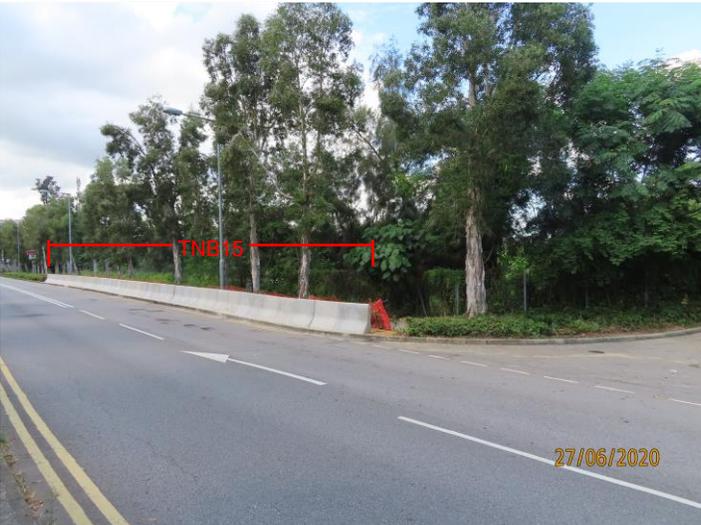
A photograph showing a temporary noise barrier (TNB15) along a road. The barrier is a concrete wall. In the background, there are trees. A red rectangle highlights the barrier, with the text "TNB15" written above it. A date stamp "27/06/2020" is visible in the bottom right corner of the photo.
