**Service Contract No. WD/04/2020
Development of Lok Ma Chau Loop:
Main Works Package 1 –
Environmental Team**

**Environmental Permit No.: EP-
477/2013/A - Development of Lok Ma
Chau Loop**

**Monthly Environmental Monitoring and
Audit Report for April 2022**

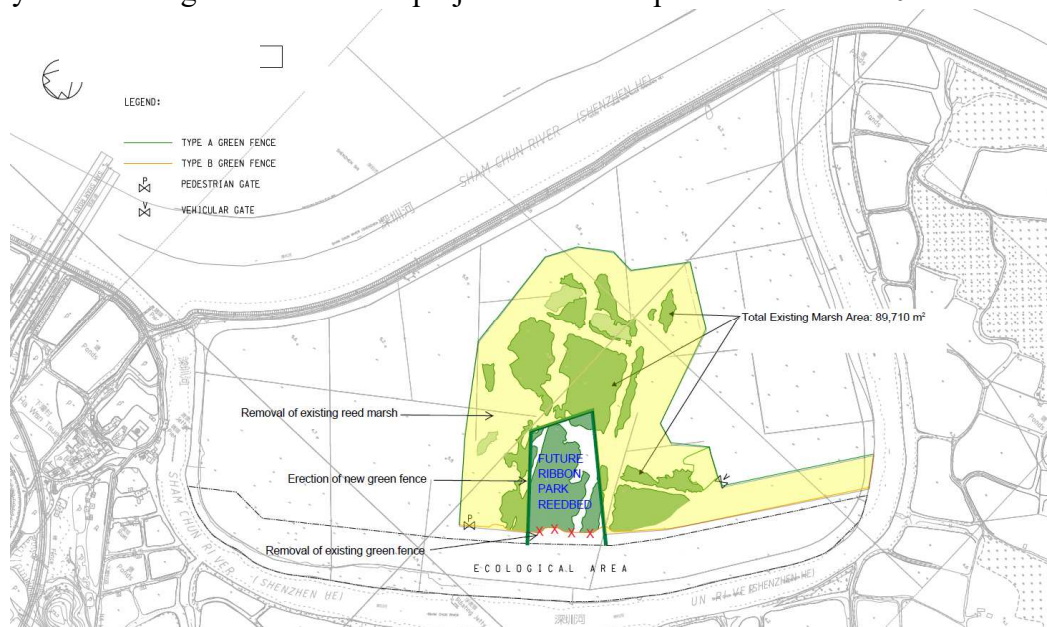
Ecological Mitigation Measures – Installation of 3m-high Olive Green Fence

- 10.7 The green fence around the future Ribbon Park Reedbed has been removed and replaced by the hoarding due to the other project's land occupier since March 2022.

- 10.8 Due to the site area in Loop has been handed over for the construction of emergency hospital on 21 February 2021, the planning for re-arrangement of the green fence around construction areas will be updated in due course subject to the latest situation of LMC Loop.
- 10.9 The Contractor was reminded to maintain and re-arrange the green fence around construction areas and ensure no disturbance to the exiting trees and reed marsh habitat subject to the latest situation of LMC Loop.

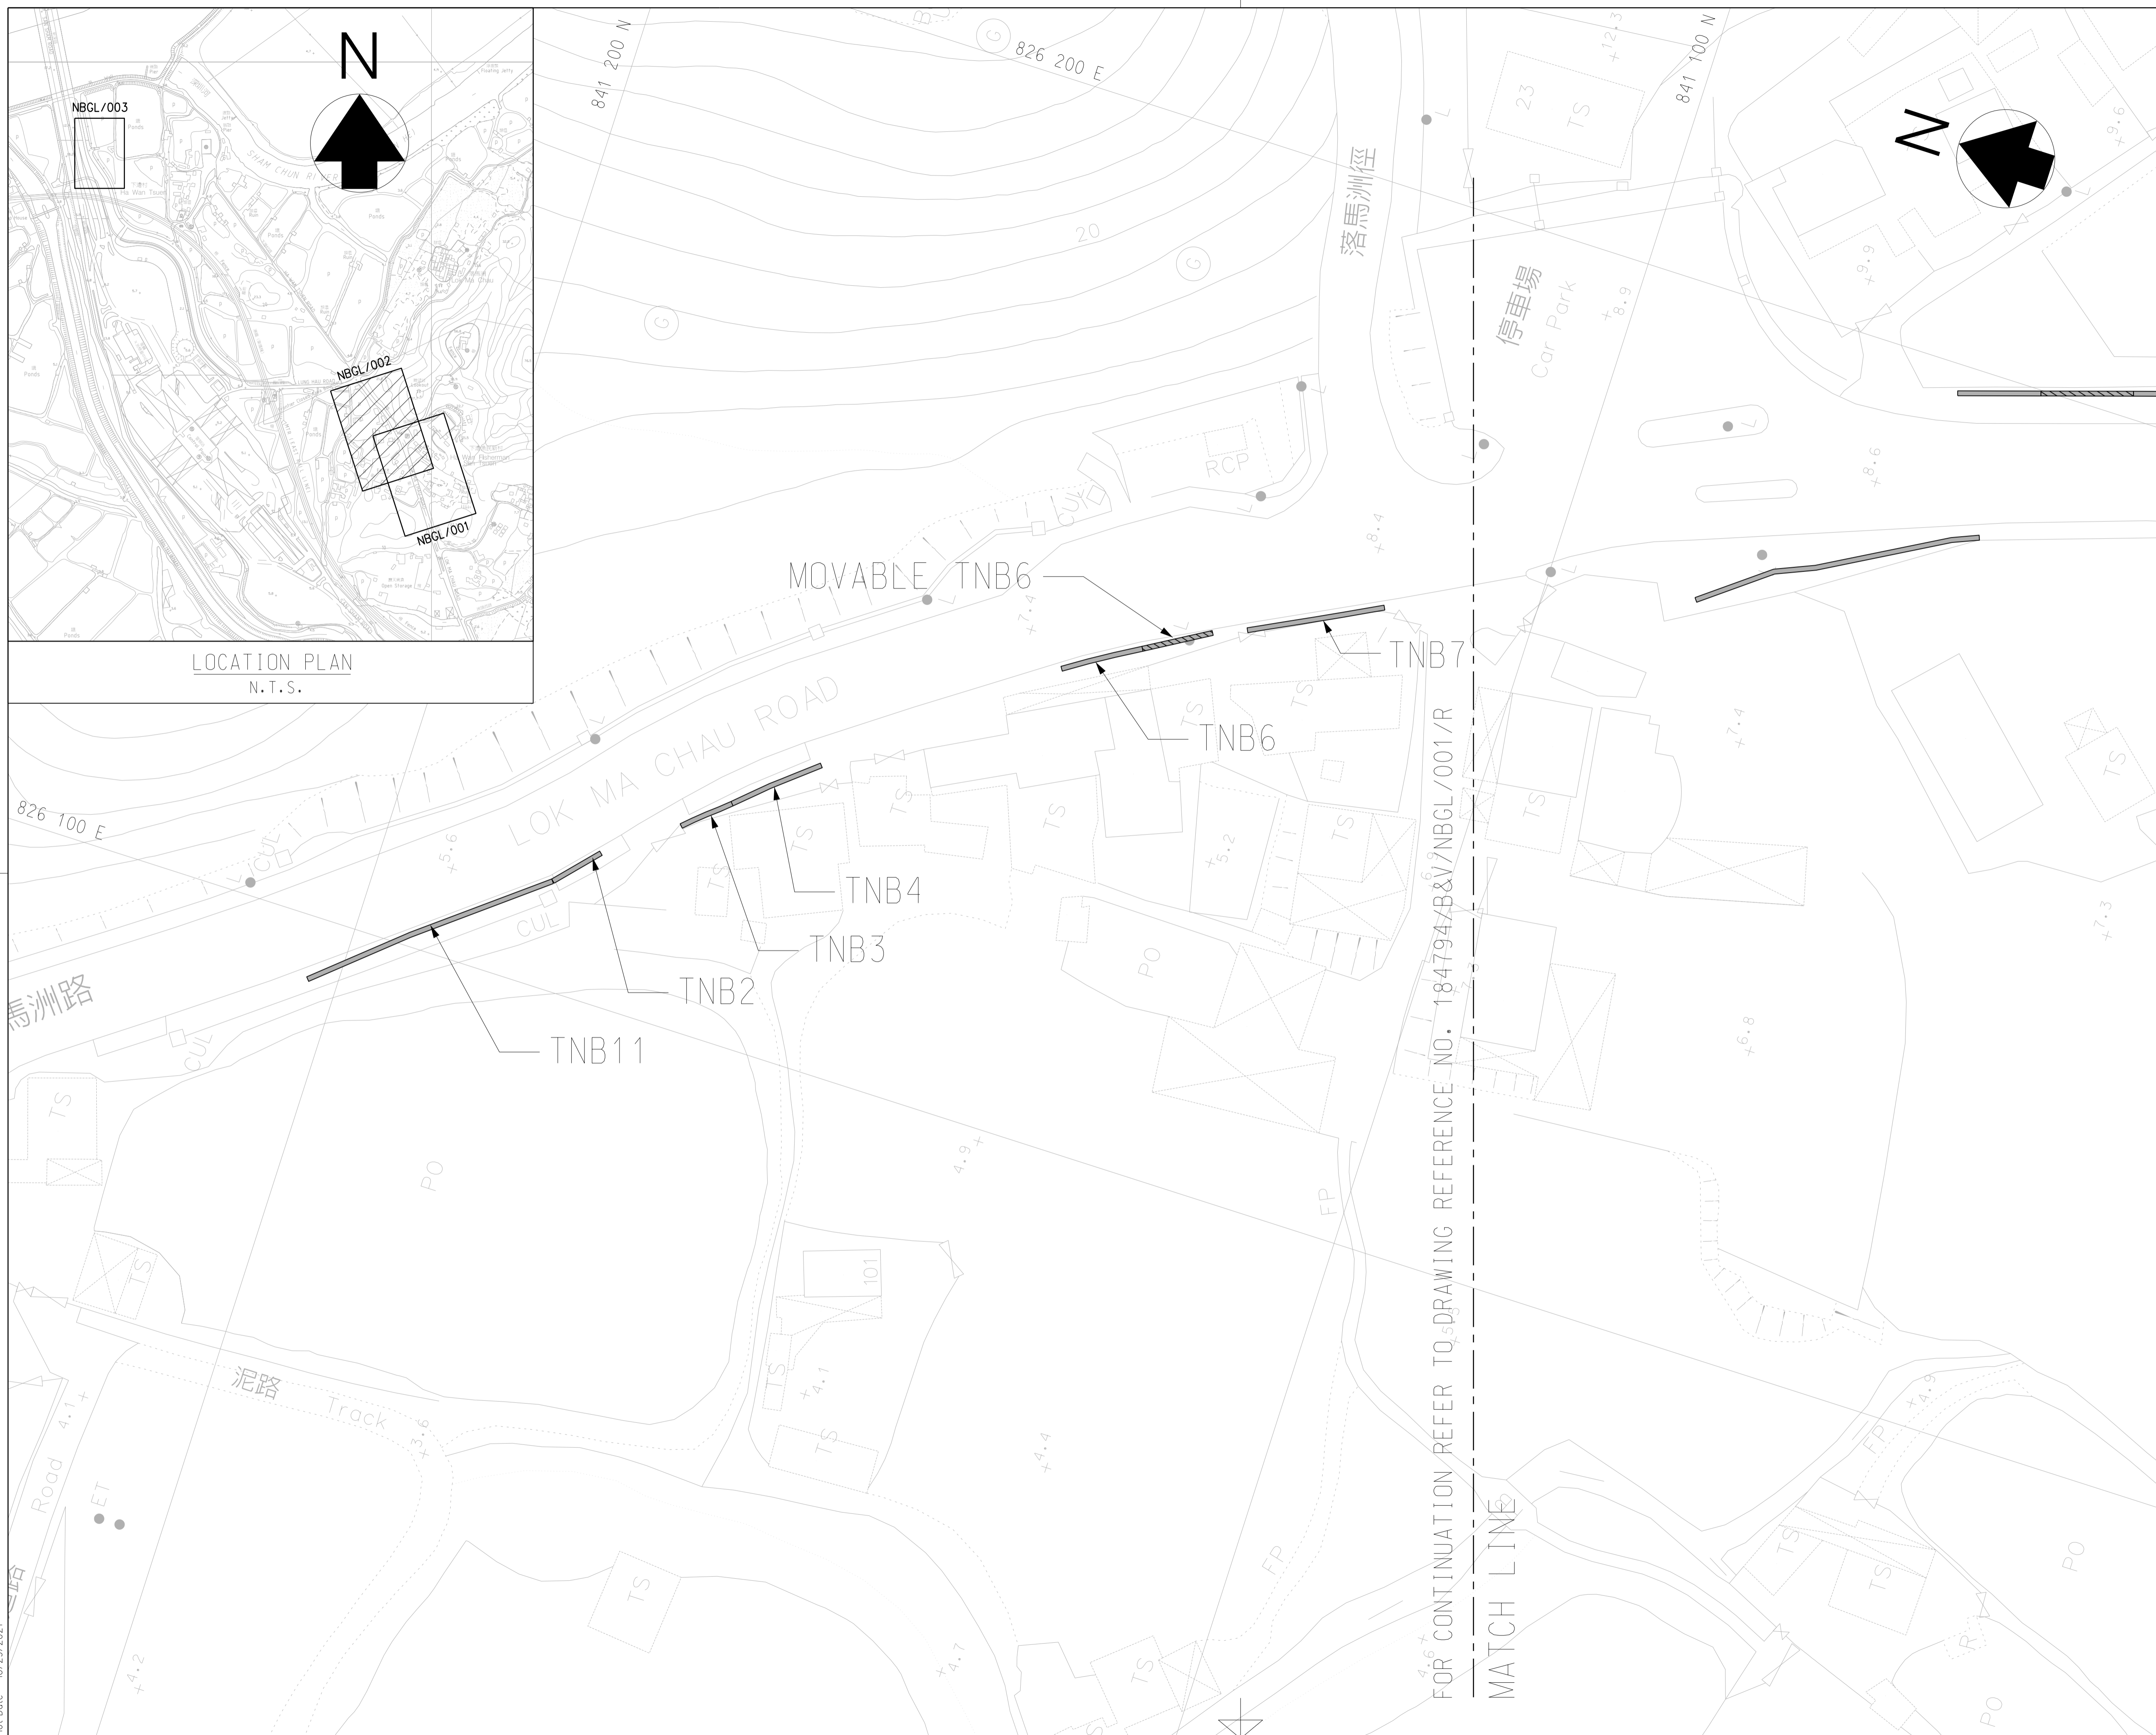
LOCATION PLAN
N.T.S.

- 0.8m - HIGH TEMPORARY NOISE BARRIER (TYPE A)
- 0.8m - HIGH TEMPORARY NOISE BARRIER (TYPE B)

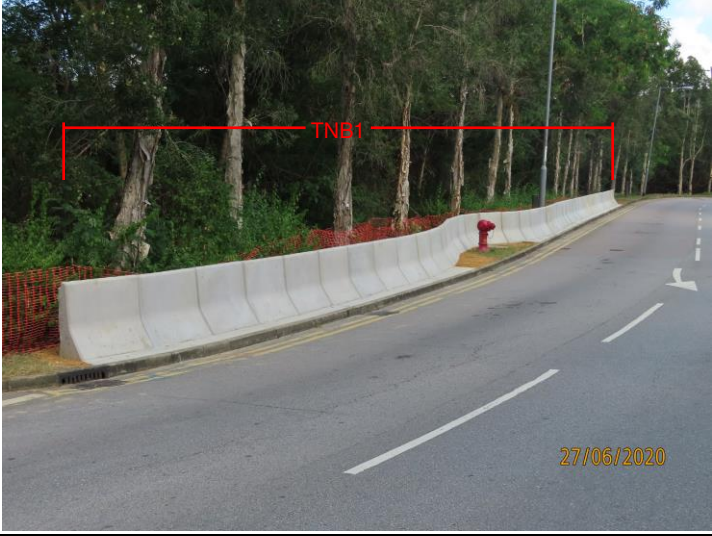
| TNB ID | Photo |
|---|--|
| TNB1 | |

Development of Lok Ma Chau Loop – Land Decontamination and Advance Engineering Works
Record Photographs for Temporary Noise Barriers at Lok Ma Chau Road
