**Service Contract No. WD/04/2020
Development of Lok Ma Chau Loop:
Main Works Package 1 –
Environmental Team**

**Environmental Permit No.:
EP-477/2013/A
- Development of Lok Ma Chau Loop**

**Monthly Environmental Monitoring and
Audit Report for May 2022**

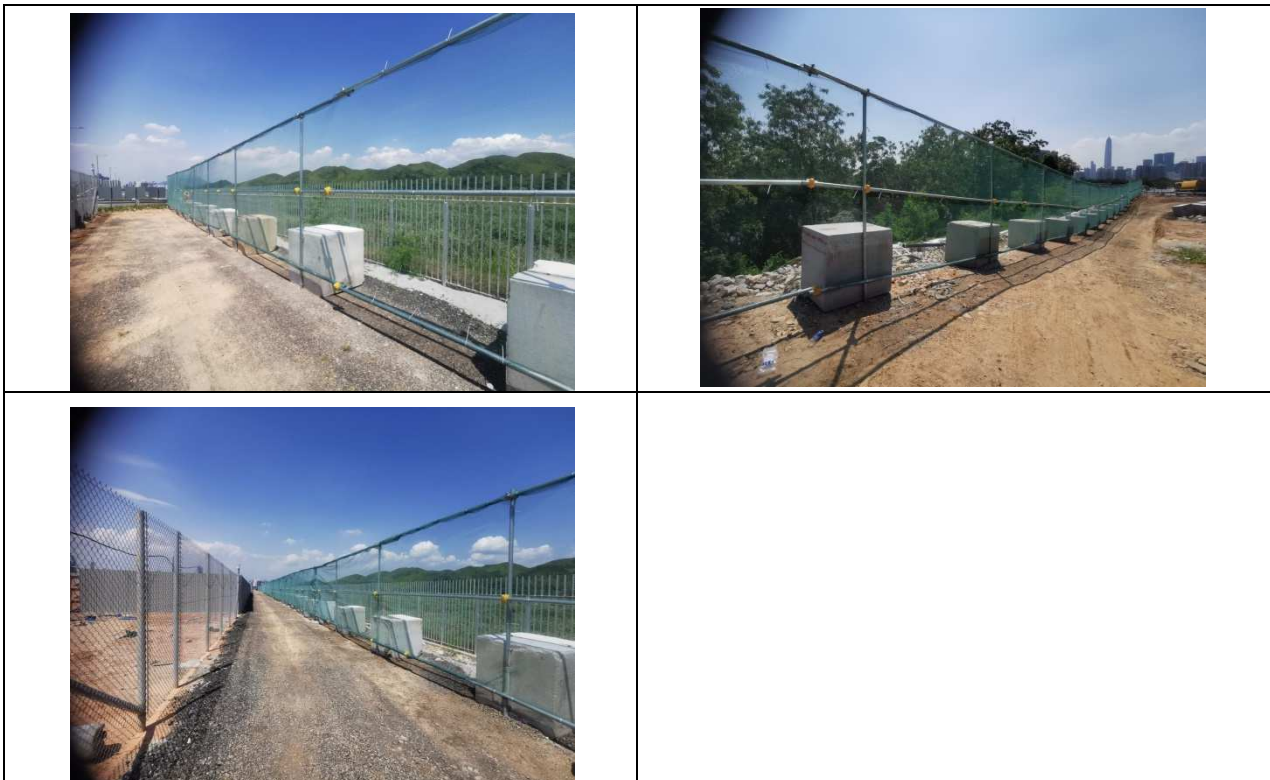
- 10.8 Installation of the green fence alongside the Ecological Area and the Meander was proposed and completed on 20th May 2022. The layout plan and photographic records of the green fence installation are shown below:-

10.9 The Contractor was reminded to maintain the green fence around construction areas and ensure no disturbance to the exiting trees and reed marsh habitat subject to the latest situation of LMC Loop.

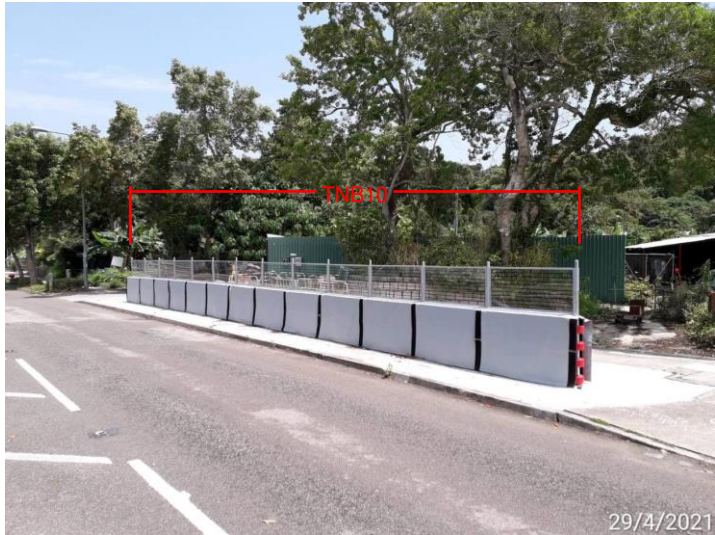
A photograph showing a temporary noise barrier (TNB10) along a road. The barrier consists of grey concrete blocks with a chain-link fence on top. In the background, there are trees and a building. A red box highlights the barrier, with the label 'TNB10' in red text above it. The date '29/4/2021' is visible in the bottom right corner.
TNB13

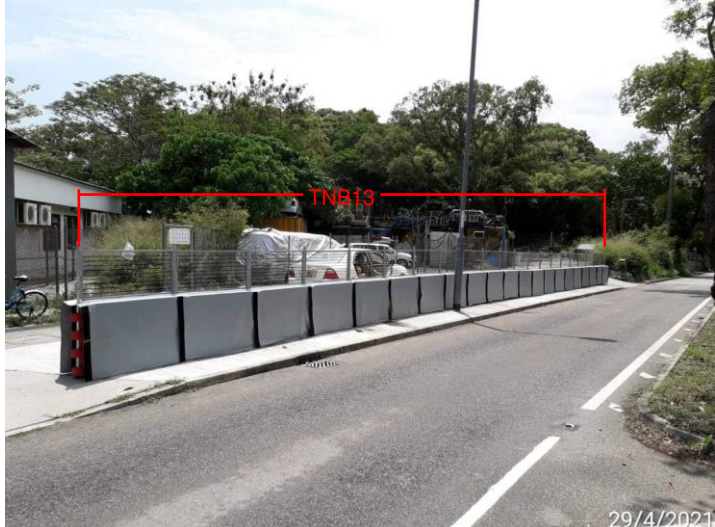
A photograph showing a temporary noise barrier (TNB13) along a road. The barrier consists of grey concrete blocks with a chain-link fence on top. In the background, there are trees and a building. A red box highlights the barrier, with the label 'TNB13' in red text above it. The date '29/4/2021' is visible in the bottom right corner.

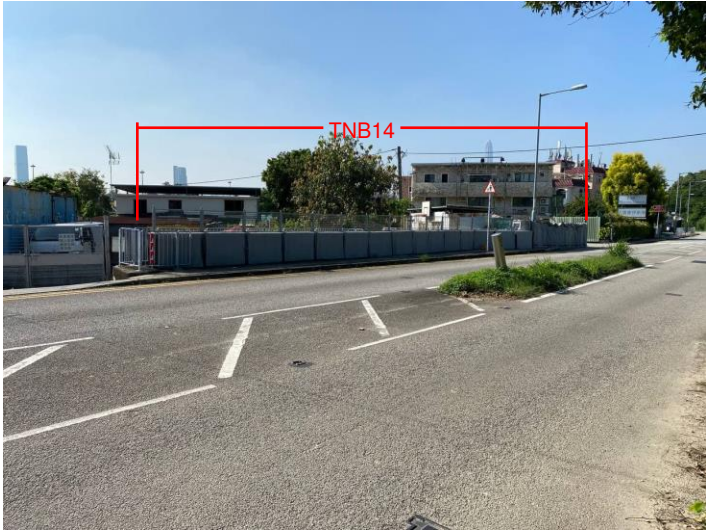
TNB ID	Photo
TNB14

A photograph showing a temporary noise barrier (TNB14) along a road. The barrier is a grey metal fence. In the background, there are buildings and trees. A red rectangle highlights the barrier, with the label 'TNB14' in red text above it.
TNB15
