**Service Contract No. WD/04/2020  
Development of Lok Ma Chau Loop:  
Main Works Package 1 –  
Environmental Team**

**Environmental Permit No.:  
EP-477/2013/A  
- Development of Lok Ma Chau Loop**

**Monthly Environmental Monitoring and  
Audit Report for August 2022**

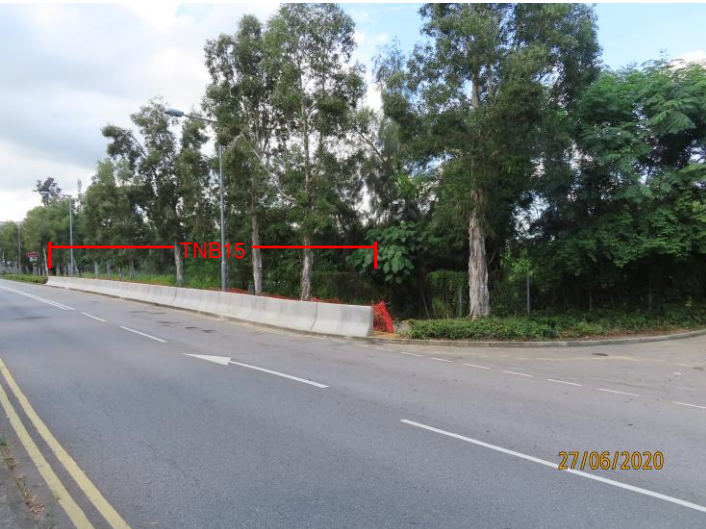
A photograph showing a temporary noise barrier (TNB15) along a road. The barrier is a concrete wall. In the background, there are trees. A red rectangle highlights the barrier, with the label 'TNB15' in red text above it. A date stamp '27/06/2020' is visible in the bottom right corner of the photo.

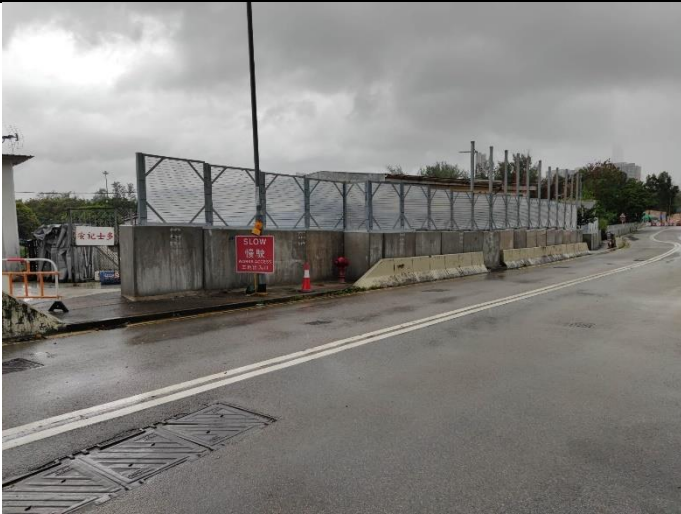
A photograph showing a completed construction site. A road with white lane markings runs alongside a newly installed metal fence. A red sign with the word 'SLOW' and Chinese characters is visible. The sky is overcast.	Completed
7

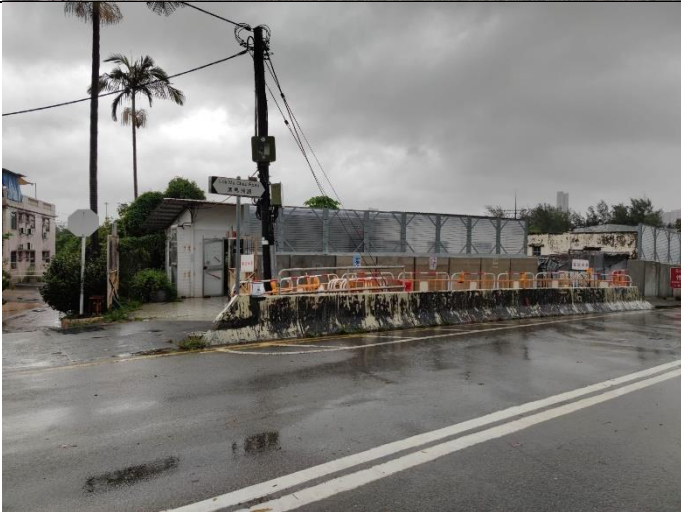
A photograph of a street corner where construction is complete. A utility pole stands near a street sign. A metal fence and concrete barriers are visible. Palm trees and buildings are in the background under a cloudy sky.	Completed
8

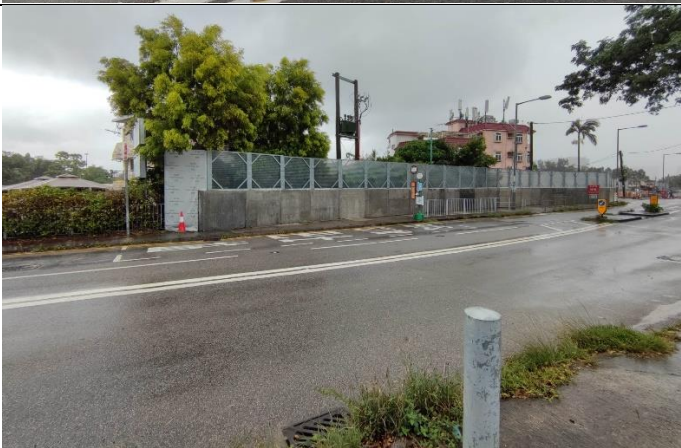
A photograph showing a long, completed metal fence along a road. A concrete pillar is in the foreground. Trees and buildings are visible in the background under an overcast sky.	Completed
