**Service Contract No. WD/04/2020
Development of Lok Ma Chau Loop:
Main Works Package 1 –
Environmental Team**

**Environmental Permit No.:
EP-477/2013/A
- Development of Lok Ma Chau Loop**

**Monthly Environmental Monitoring and
Audit Report for November 2022**

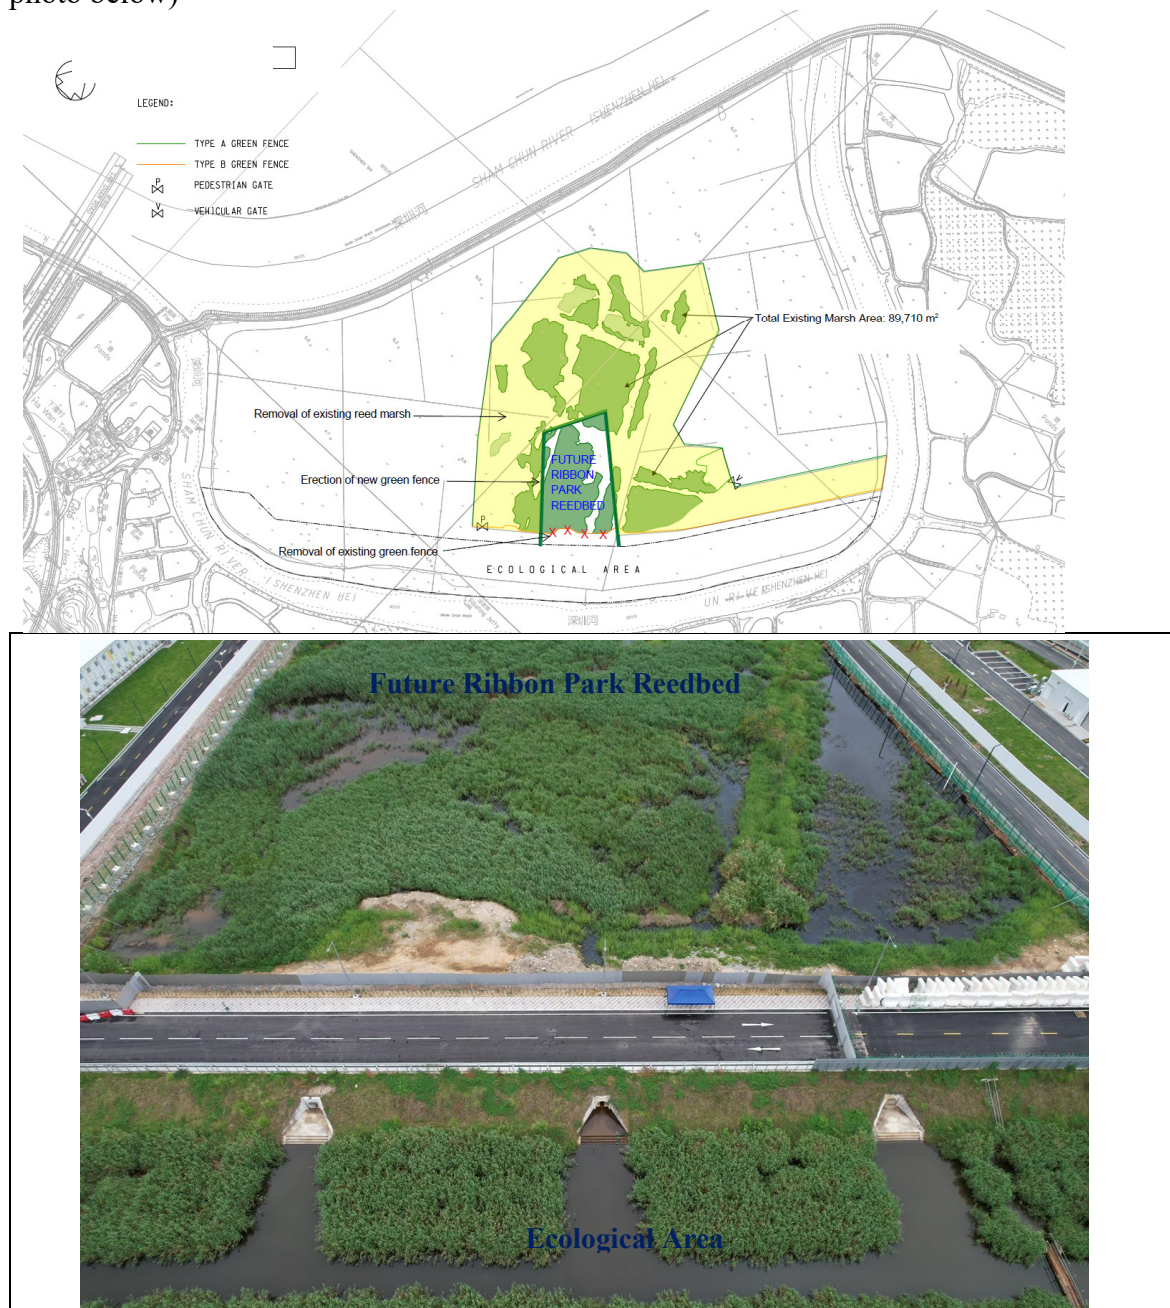
- 10.8 The green fence around the future Ribbon Park Reedbed has been removed and replaced by the hoarding due to the other project’s land occupier since March 2022. (See Figure & photo below)

10.10 The Contractor was reminded to maintain the green fence around construction areas and ensure no disturbance to the exiting trees and reed marsh habitat subject to the latest situation of LMC Loop.

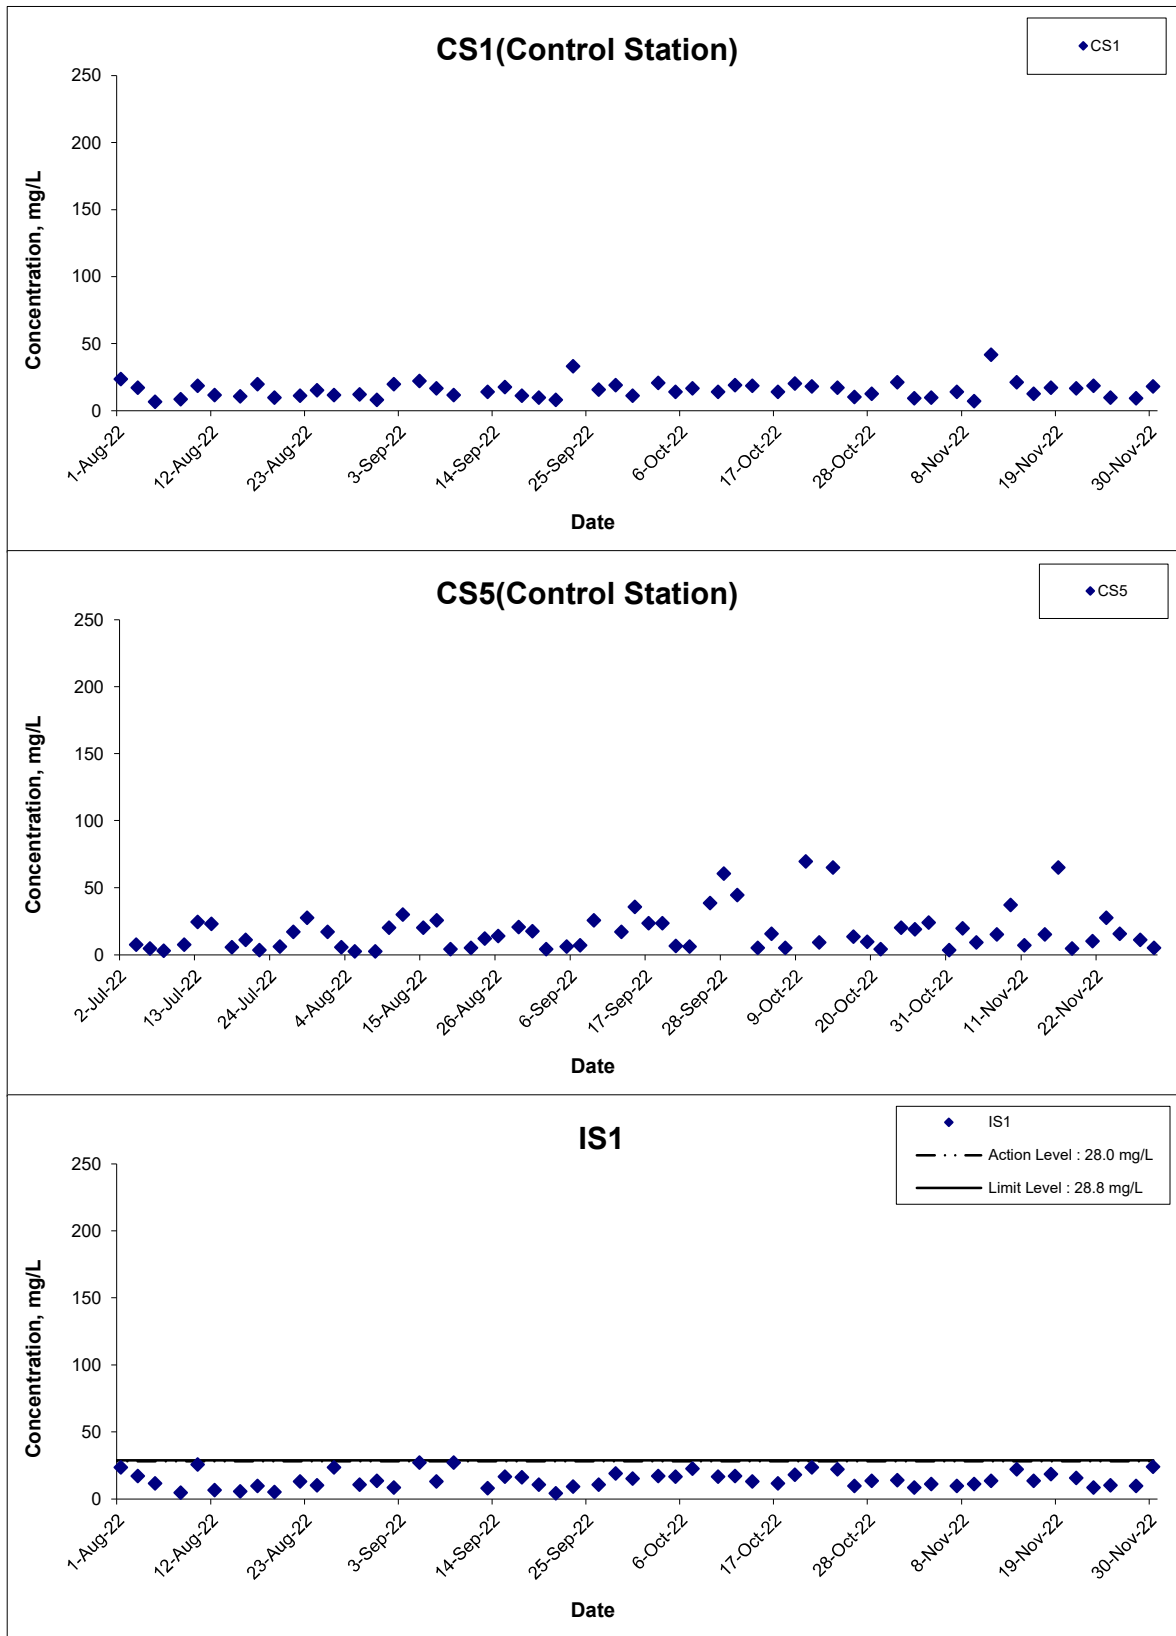
Suspended Solids

Remark: The graphical point at zero concentration is presented as <2.5 mg/L
