**Service Contract No. WD/04/2020
Development of Lok Ma Chau Loop:
Main Works Package 1 –
Environmental Team**

**Environmental Permit No.:
EP-477/2013/A
- Development of Lok Ma Chau Loop**

**Monthly Environmental Monitoring and
Audit Report for February 2023**

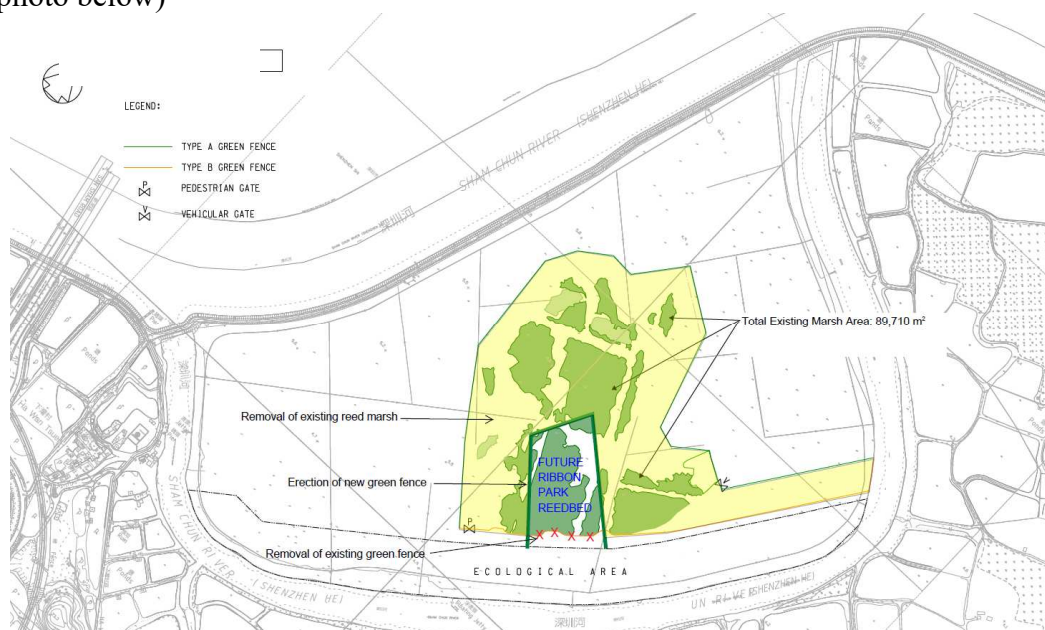
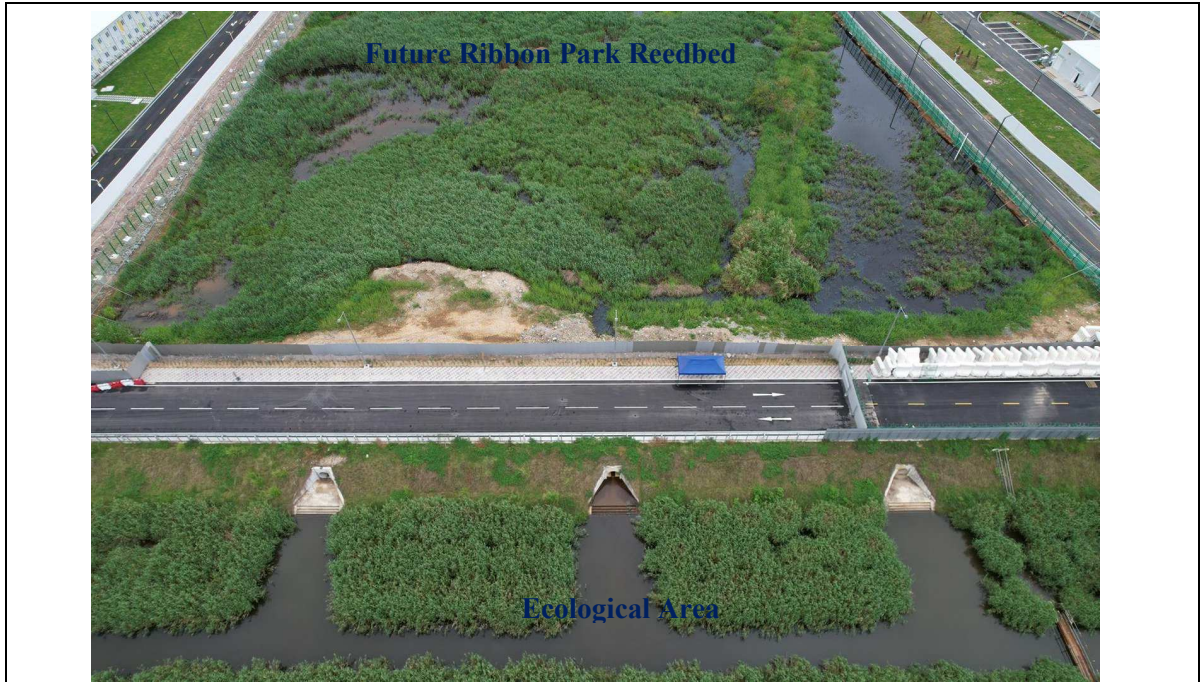
- 10.8 The green fence around the future Ribbon Park Reedbed has been removed and replaced by the hoarding due to the other project's land occupier since March 2022. (See Figure & photo below)

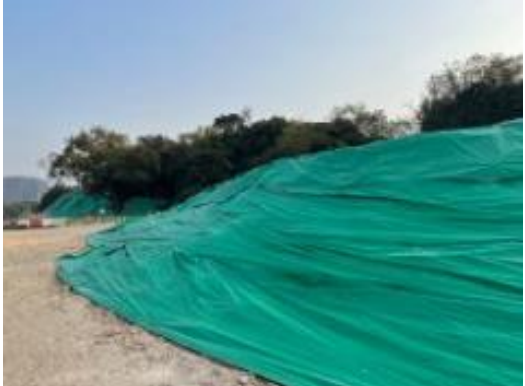
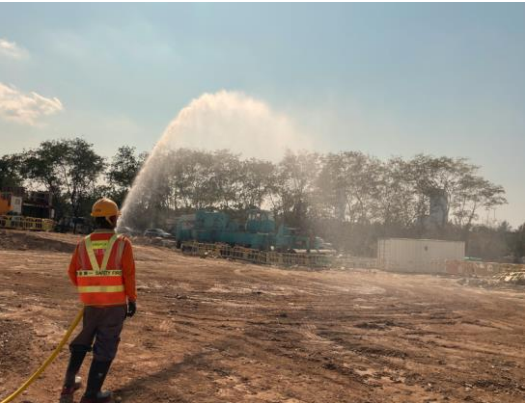
Ref	Location/ Working Period	Anticipated Major Impacts	Recommended Mitigation Measures	Photo Records (Partial)
EIA S3.8	All site area	Dust impact	<ul style="list-style-type: none"> Any excavated or stockpile of dusty material should be covered entirely by impervious sheeting or sprayed with water to maintain the entire surface wet and then removed or backfilled or reinstated where practicable within 24 hours of the excavation or unloading; Any dusty materials remaining after a stockpile is removed should be wetted with water and cleared from the surface of roads;

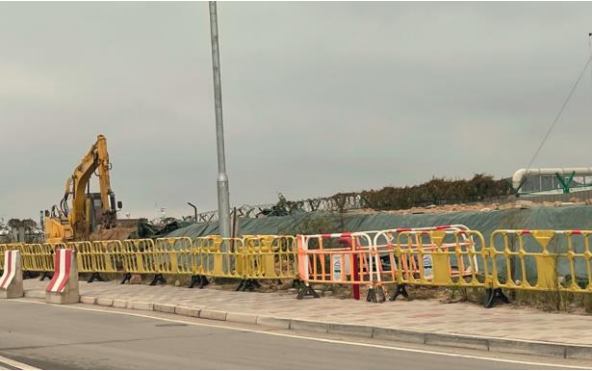
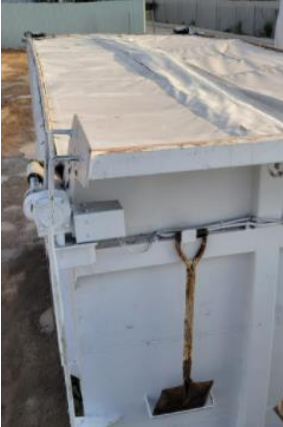
Ref	Location/ Working Period	Anticipated Major Impacts	Recommended Mitigation Measures	Photo Records (Partial)
EIA S3.8	All site area	Dust impact	<ul style="list-style-type: none"> • A stockpile of dusty material should not be extend beyond the pedestrian barriers, fencing or traffic cones; • The load of dusty materials on a vehicle leaving a construction site should be covered entirely by impervious sheeting to ensure that the dusty materials do not leak from the vehicle;

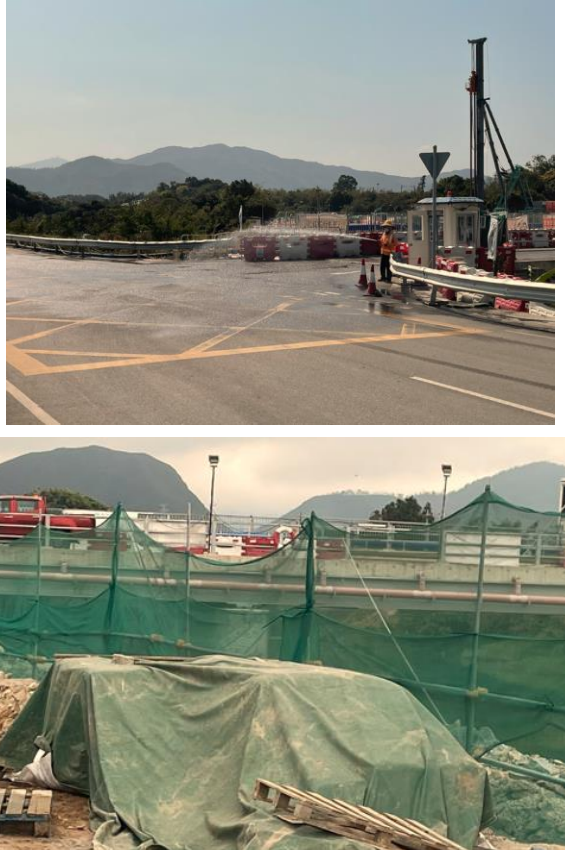
Ref	Location/ Working Period	Anticipated Major Impacts	Recommended Mitigation Measures	Photo Records (Partial)
EIA S3.8	All site area	Dust impact	<ul style="list-style-type: none"> • The portion of any road leading only to construction site that is within 30m of a vehicle entrance or exit should be kept clear of dusty materials; • Every stock of more than 20 bags of cement or dry pulverised fuel ash (PFA) should be covered entirely by impervious sheeting or placed in an area sheltered on the top and the 3 sides;

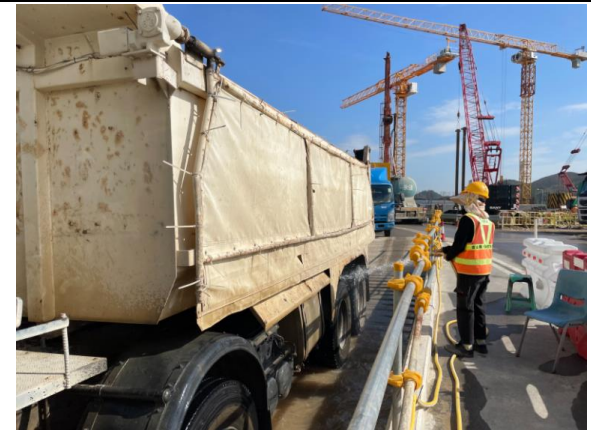
- Where practicable, vehicle washing facilities with high pressure water jet should be provided at every discernible or designated vehicle exit point. The area where vehicle washing takes place and the road section between the washing facilities and the exit point should be paved with concrete, bituminous materials or hardcores.

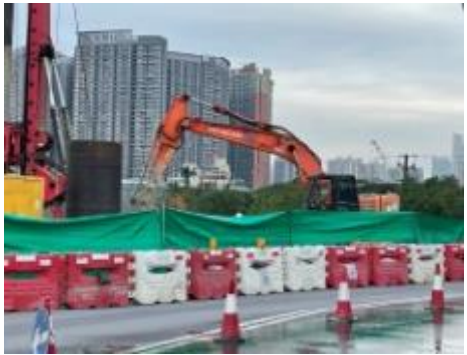
Ref	Location/ Working Period	Anticipated Major Impacts	Recommended Mitigation Measures	Photo Records (Partial)
EIA S4.8	All site area	Noise impact	<ul style="list-style-type: none"> • Mobile plant should be sited as far away from NSRs as possible and All generator used onsite are Quality Powered Mechanical Equipment (QPME) registered with EPD. • Install movable noise barriers and full enclosure, screen the noisy plants including air compressor and generator.

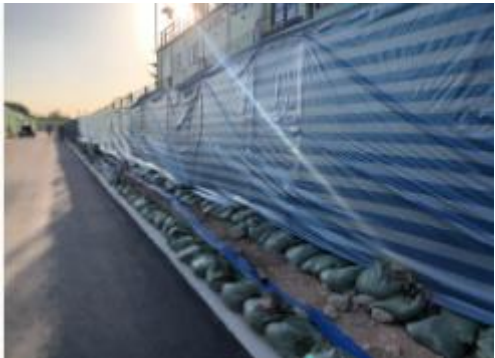
Ref	Location/ Working Period	Anticipated Major Impacts	Recommended Mitigation Measures	Photo Records (Partial)
EIA S5.7	All site area	Water Pollution Control	<ul style="list-style-type: none"> Update and implementation of Stormwater Pollution Control Plan. At the start of site establishment, perimeter cut-off drains to direct off-site water around the site should be constructed with internal drainage works and erosion and sedimentation control facilities implemented. Channels (both temporary and permanent drainage pipes and culverts), earth bunds or sand bag barriers should be provided on site to direct stormwater to silt removal facilities. The design of the temporary on-site 	<p><u>Temporary Drainage Arrangement Plan for The Loop and Meander Bridge</u></p>

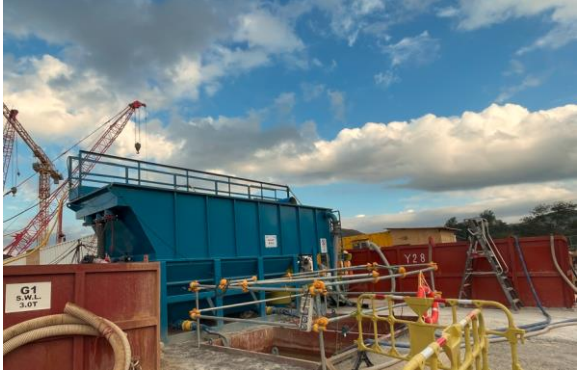
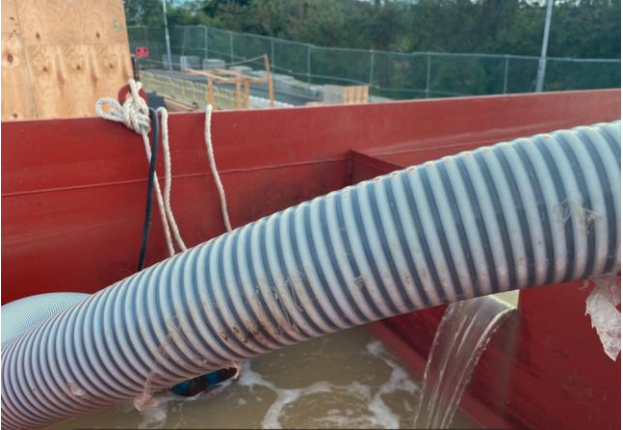
Ref	Location/ Working Period	Anticipated Major Impacts	Recommended Mitigation Measures	Photo Records (Partial)
			<p>drainage system will be undertaken by the contractor prior to the commencement of construction.</p> <ul style="list-style-type: none"> • Diversion of natural stormwater should be provided as far as possible. <p>The design of temporary on-site drainage should prevent runoff going through site surface, construction machinery and equipments in order to avoid or minimize polluted runoff.</p> <p>Sedimentation tanks with sufficient capacity, constructed from pre-formed individual cells of approximately 6 to 8 m³ capacities, are recommended as a general mitigation measure which can be used for settling surface runoff prior to disposal. The system capacity shall be flexible and able to handle multiple inputs from a variety of sources and suited to applications where the influent is pumped.</p>

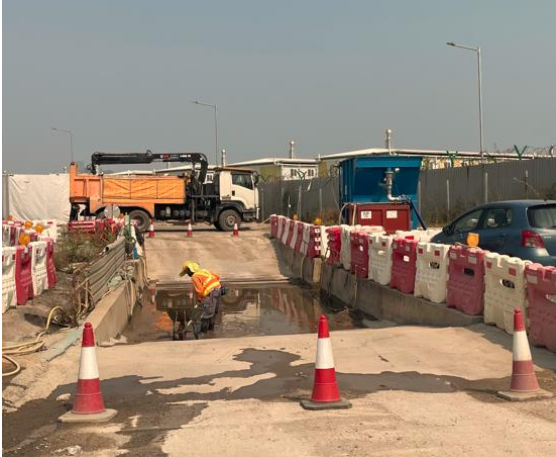
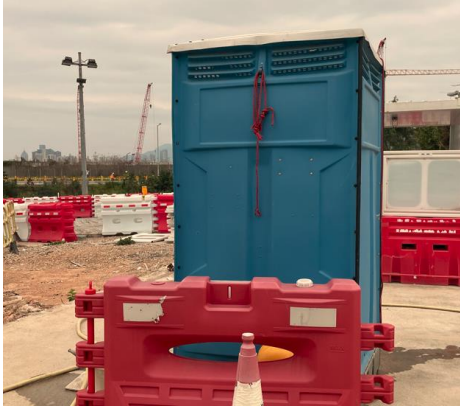
Ref	Location/ Working Period	Anticipated Major Impacts	Recommended Mitigation Measures	Photo Records (Partial)
			<ul style="list-style-type: none"> The design of efficient silt removal facilities should be based on the guidelines in Appendix A1 of ProPECC PN 1/94. The detailed design of the sand/silt traps should be undertaken by the contractor prior to the commencement of construction. <p>All drainage facilities and erosion and sediment control structures should be regularly inspected and maintained to ensure proper and efficient operation at all times and particularly following rainstorms.</p> <ul style="list-style-type: none"> Portable chemical toilets and sewage holding tanks should be provided for handling the construction sewage generated by the workforce. A licensed contractor should be employed to provide appropriate and adequate portable toilets to cater 0.15m³/day/employed populations and be responsible for appropriate disposal and maintenance.

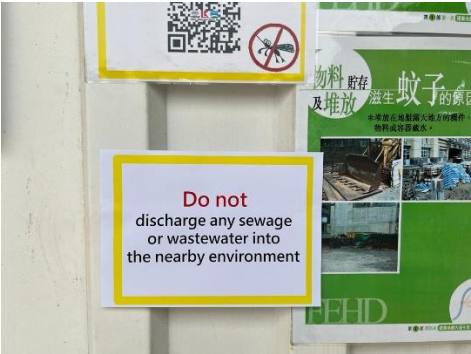
Ref	Location/ Working Period	Anticipated Major Impacts	Recommended Mitigation Measures	Photo Records (Partial)
			<ul style="list-style-type: none"> • Notices should be posted at conspicuous locations to remind the workers not to discharge any sewage or wastewater into the nearby environment during the construction phase of the Project. Regular environmental audit on the construction site should be conducted in order to provide an effective control of any malpractices and achieve continual improvement of environmental performance on site.

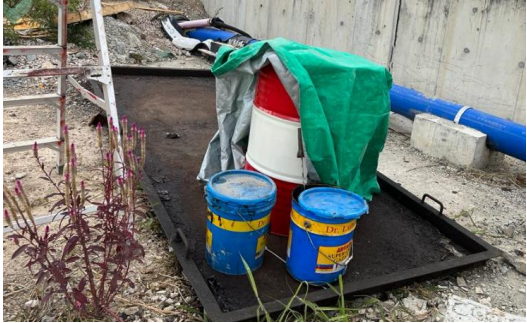
Ref	Location/ Working Period	Anticipated Major Impacts	Recommended Mitigation Measures	Photo Records (Partial)
EIA S7.6	All site area	Waste Generation	<ul style="list-style-type: none"> • Segregate and store different types of waste in different containers, skip or stockpiles to enhance reuse or recycling of materials and their proper disposal; • Proper storage and site practices to minimize the potential for damage and contamination of construction materials;

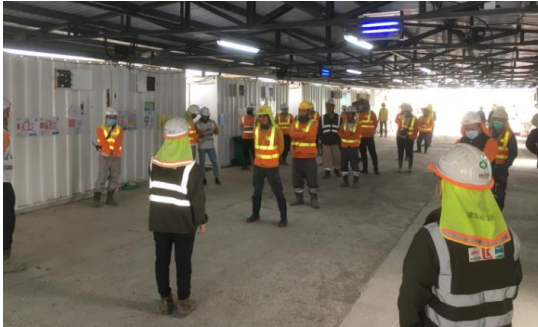
Ref	Location/ Working Period	Anticipated Major Impacts	Recommended Mitigation Measures	Photo Records (Partial)
			<ul style="list-style-type: none"> • Provide training to workers on the importance of appropriate waste management procedures, including waste reduction, reuse and recycling.

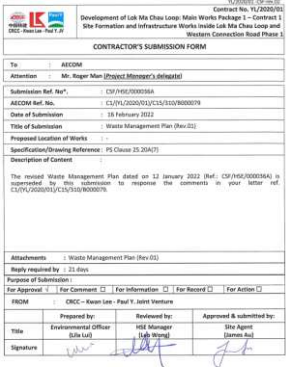
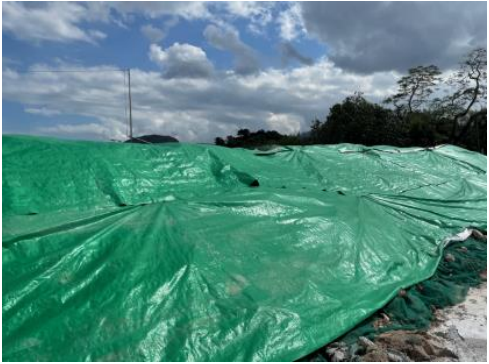
Ref	Location/ Working Period	Anticipated Major Impacts	Recommended Mitigation Measures	Photo Records (Partial)
			<ul style="list-style-type: none"> • Prepare Waste Management Plan and submit to the Engineer for approval • Proper storage and sorting of excavated inert materials to maximize on site reuse for backfilling

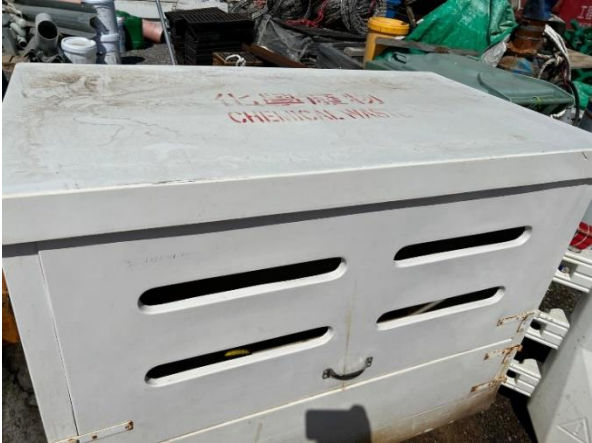
Ref	Location/ Working Period	Anticipated Major Impacts	Recommended Mitigation Measures	Photo Records (Partial)
			<ul style="list-style-type: none"> If chemical wastes are produced at the construction site, the Contractors should register with EPD as chemical waste producers. Chemical wastes should be stored in appropriate containers and collected by a licensed chemical waste contractor. Chemical wastes (e.g. spent lubricant oil) should be recycled at an appropriate facility as far as possible, while the chemical waste that cannot be recycled should be disposed of at either the Chemical Waste Treatment Centre, or another licensed facility, in accordance with the Waste Disposal (Chemical Waste) (General) Regulation.

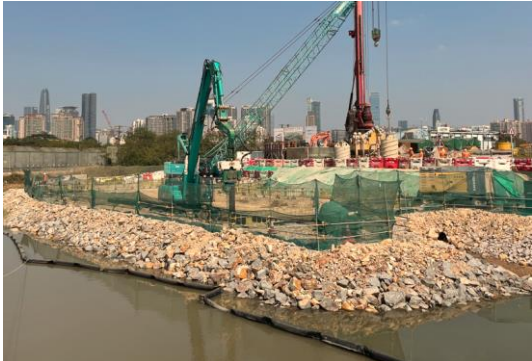
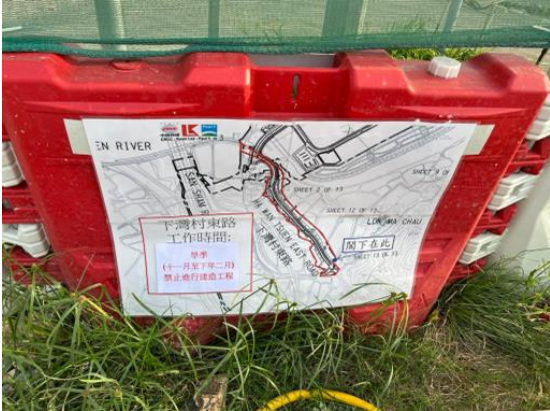
Ref	Location/ Working Period	Anticipated Major Impacts	Recommended Mitigation Measures	Photo Records (Partial)
EIA 12.7 EP 2.7	Constructi on site within the project Pond habitat along alignment (mainly Ha Wan Tsuen Road)	Ecology	Installing 3m high olive-green fence around construction areas to allow or deter different animal passages where appropriate; Carrying out outside dry-season (from November to February next year), the construction works associated with the site formation in the Ecological Area, stabilization of the bank of the old Shenzhen River meander, Western Connection Road along Ha Wan Tsuen Road, to minimise disturbances to migratory birds/water birds;

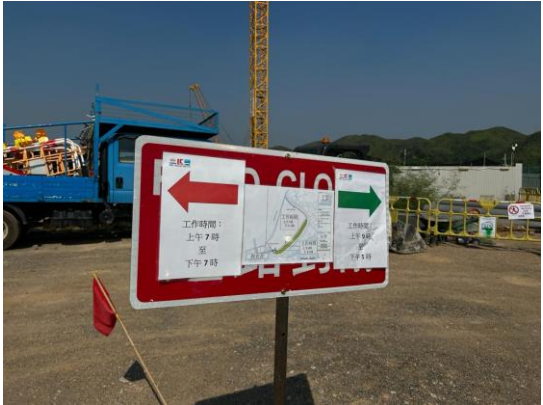
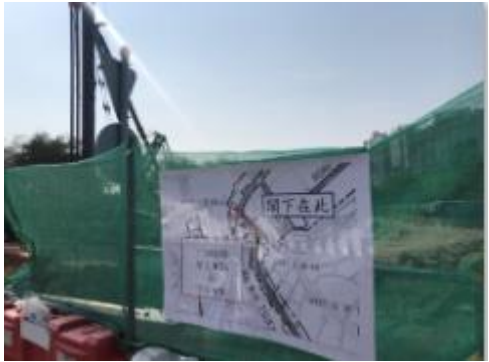
Ref	Location/ Working Period	Anticipated Major Impacts	Recommended Mitigation Measures	Photo Records (Partial)
	Old Shenzhen River meander and other identified important ecologically sensitive areas,		Using powered mechanical equipment for construction works only during the period 9am to 5pm at and near the old Shenzhen River meander and other identified important ecologically sensitive areas, if any;

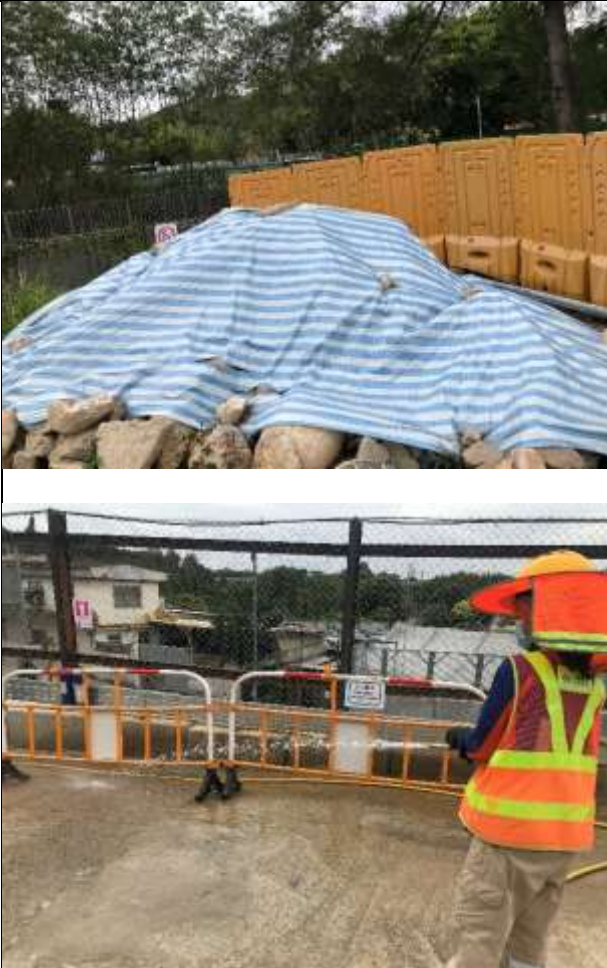
Ref*	Location/Working Period	Anticipated Major Impacts	Recommended Mitigation Measures	Photo Records (Partial)
EIA S3.8	All site area	Dust impact	<ul style="list-style-type: none"> Any excavated or stockpile of dusty material should be covered entirely by impervious sheeting or sprayed with water to maintain the entire surface wet and then removed or backfilled or reinstated where practicable within 24 hours of the excavation or unloading; Any dusty materials remaining after a stockpile is removed should be wetted with water and cleared from the surface of roads;

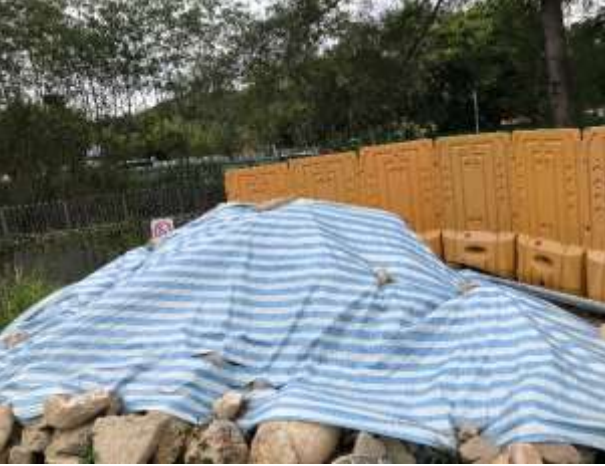
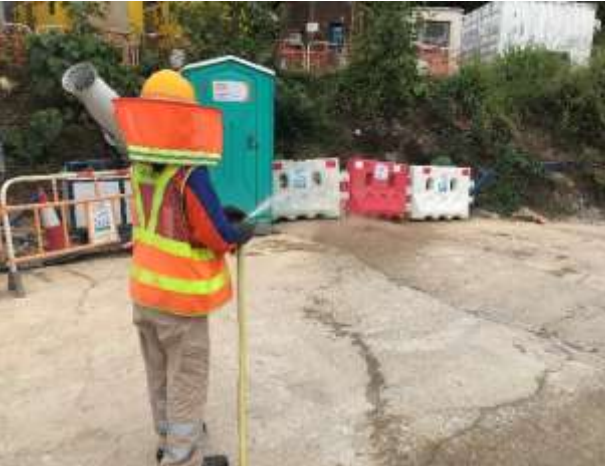
Ref*	Location/ Working Period	Anticipated Major Impacts	Recommended Mitigation Measures	Photo Records (Partial)
EIA S3.8	All site area	Dust impact	<ul style="list-style-type: none"> • A stockpile of dusty material should not be extend beyond the pedestrian barriers, fencing or traffic cones; • The load of dusty materials on a vehicle leaving a construction site should be covered entirely by impervious sheeting to ensure that the dusty materials do not leak from the vehicle;

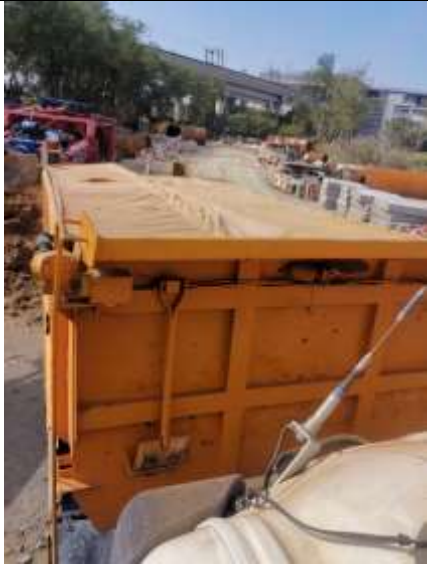
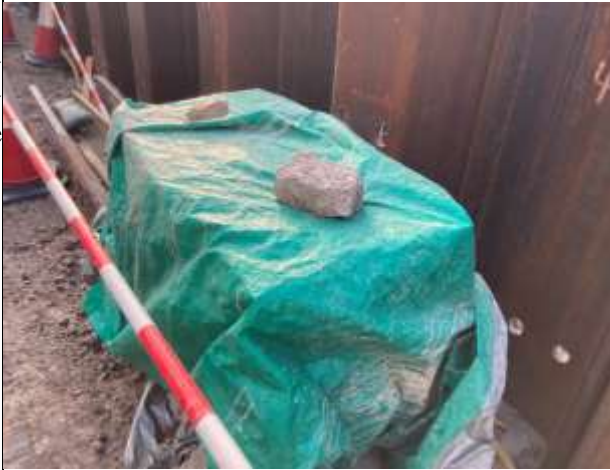
<ul style="list-style-type: none"> • The portion of any road leading only to construction site that is within 30m of a vehicle entrance or exit should be kept clear of dusty materials; • Every stock of more than 20 bags of cement or dry pulverised fuel ash (PFA) should be covered entirely by impervious sheeting or placed in an area sheltered on the top and the 3 sides;

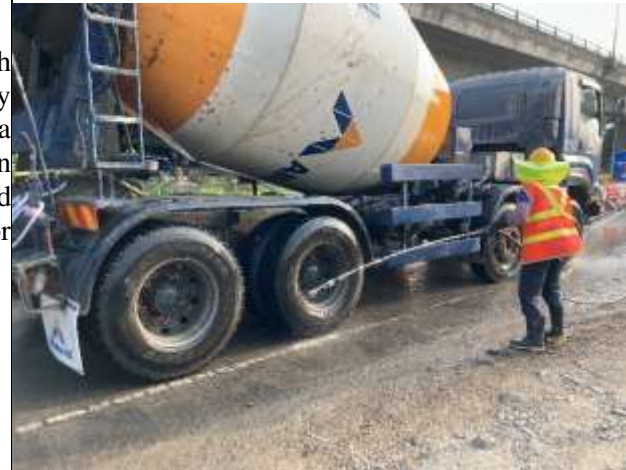
- Where practicable, vehicle washing facilities with high pressure water jet should be provided at every discernible or designated vehicle exit point. The area where vehicle washing takes place and the road section between the washing facilities and the exit point should be paved with concrete, bituminous materials or hardcores.

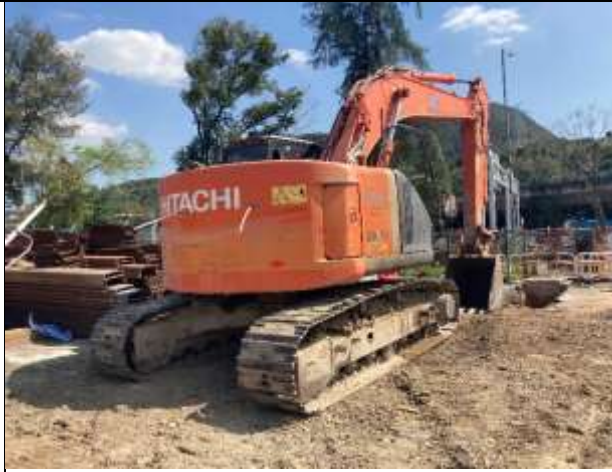
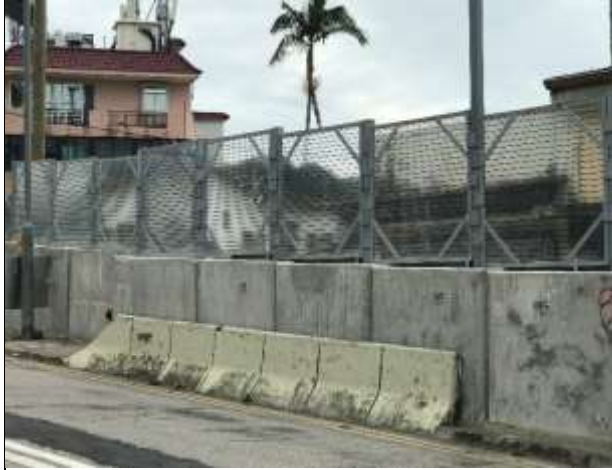
Ref*	Location/ Working Period	Anticipated Major Impacts	Recommended Mitigation Measures	Photo Records (Partial)
EIA S4.8	All site area	Noise impact	<ul style="list-style-type: none"> • Mobile plant should be sited as far away from NSRs as possible and practicable; • Install movable noise barriers and full enclosure, screen the noisy plants including air compressor and generator.

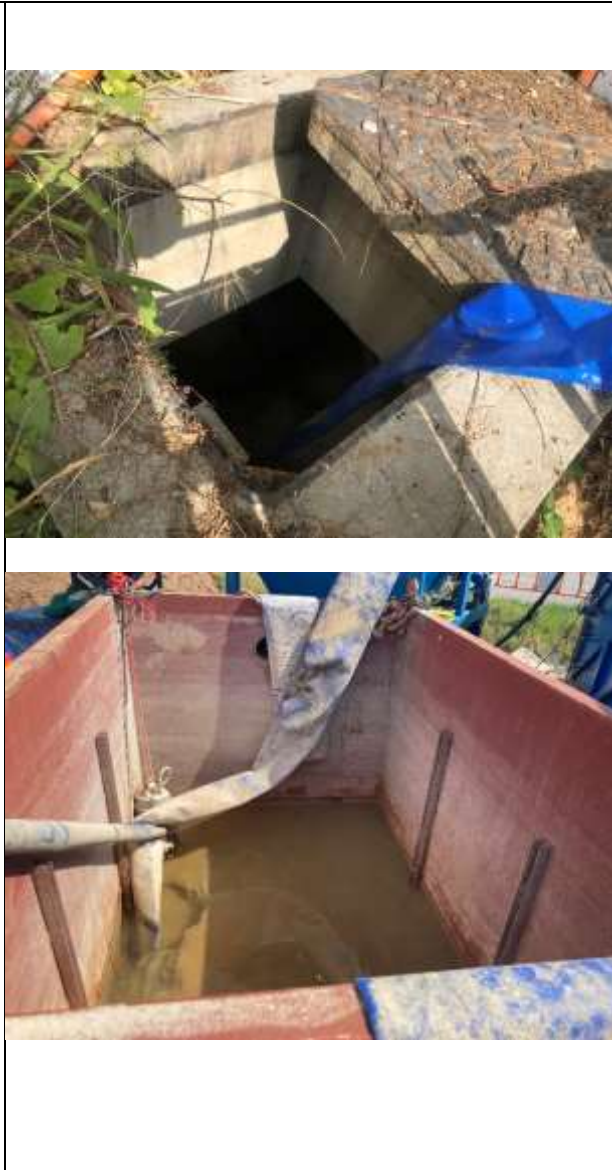
<p>EIA S5.7</p>	<p>All site area</p>	<p>Water Pollution Control</p>	<ul style="list-style-type: none"> • At the start of site establishment, perimeter cut-off drains to direct off-site water around the site should be constructed with internal drainage works and erosion and sedimentation control facilities implemented. Channels (both temporary and permanent drainage pipes and culverts), earth bunds or sand bag barriers should be provided on site to direct stormwater to silt removal facilities. The design of the temporary on-site drainage system will be undertaken by the contractor prior to the commencement of construction. • Diversion of natural stormwater should be provided as far as possible. The design of temporary on-site drainage should prevent runoff going through site surface, construction machinery and equipments in order to avoid or minimize polluted runoff.

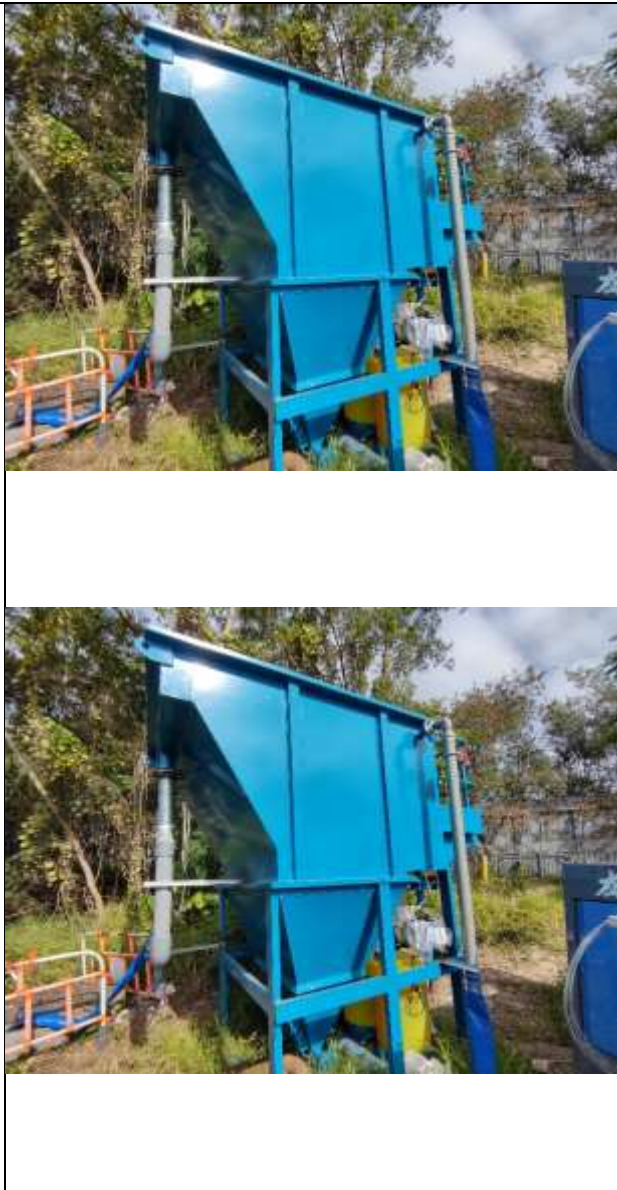
<ul style="list-style-type: none">• Sedimentation tanks with sufficient capacity, constructed from pre-formed individual cells of approximately 6 to 8 m³ capacities, are recommended as a general mitigation measure which can be used for settling surface runoff prior to disposal. The system capacity shall be flexible and able to handle multiple inputs from a variety of sources and suited to applications where the influent is pumped. • The design of efficient silt removal facilities should be based on the guidelines in Appendix A1 of ProPECC PN 1/94. The detailed design of the sand/silt traps should be undertaken by the contractor prior to the commencement of construction.

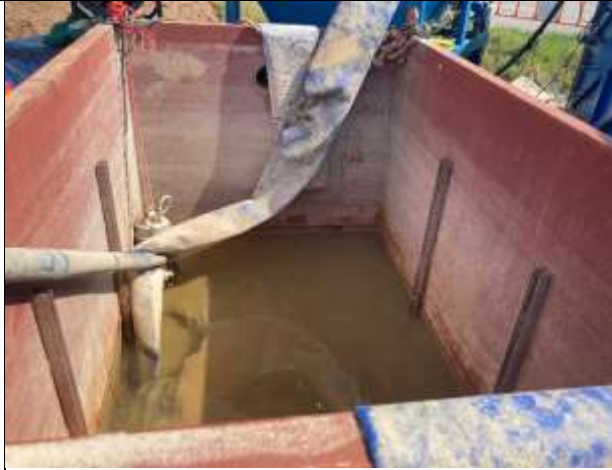
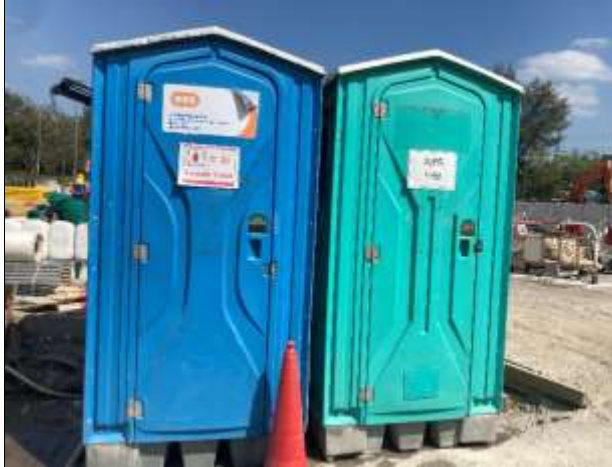
<ul style="list-style-type: none">• All drainage facilities and erosion and sediment control structures should be regularly inspected and maintained to ensure proper and efficient operation at all times and particularly following rainstorms. • Portable chemical toilets and sewage holding tanks should be provided for handling the construction sewage generated by the workforce. A licensed contractor should be employed to provide appropriate and adequate portable toilets to cater 0.15m³/day/employed populations and be responsible for appropriate disposal and maintenance.

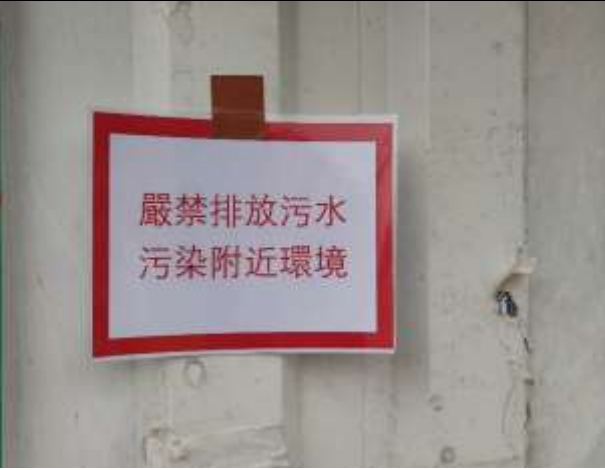
<ul style="list-style-type: none">• Notices should be posted at conspicuous locations to remind the workers not to discharge any sewage or wastewater into the nearby environment during the construction phase of the Project. Regular environmental audit on the construction site should be conducted in order to provide an effective control of any malpractices and achieve continual improvement of environmental performance on site.

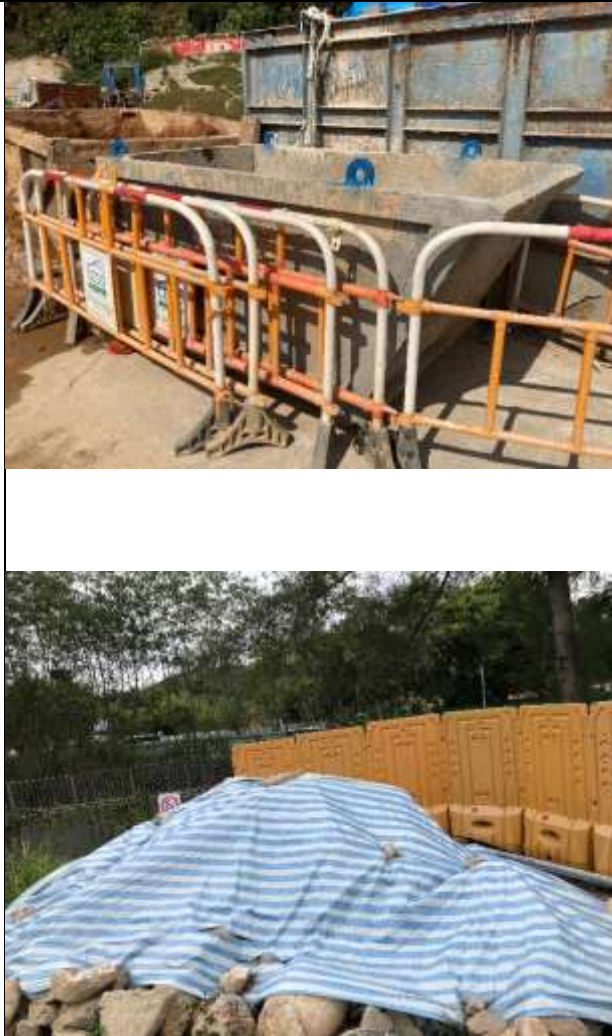
Ref*	Location/ Working Period	Anticipated Major Impacts	Recommended Mitigation Measures	Photo Records (Partial)
EIA S7.6	All site area	Waste Generation	<ul style="list-style-type: none"> • Segregate and store different types of waste in different containers, skip or stockpiles to enhance reuse or recycling of materials and their proper disposal; • Proper storage and site practices to minimize the potential for damage and contamination of construction materials;

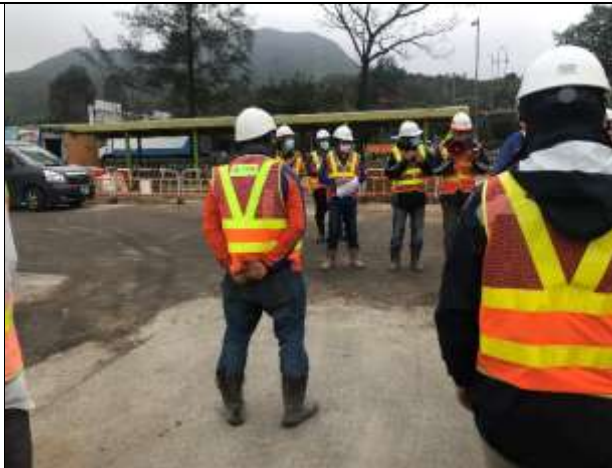
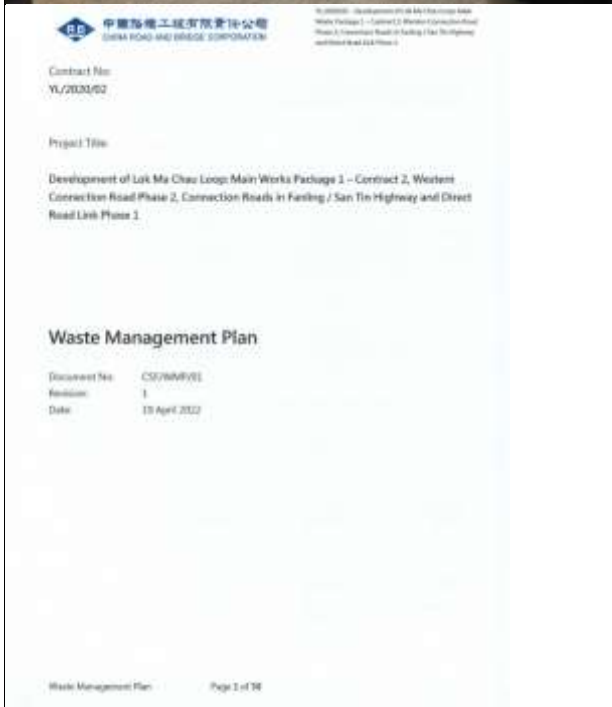
<ul style="list-style-type: none"> • Provide training to workers on the importance of appropriate waste management procedures, including waste reduction, reuse and recycling. • Prepare Waste Management Plan and submit to the Engineer for approval

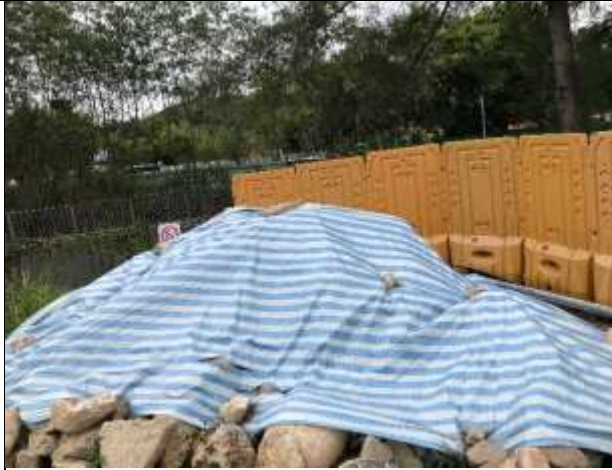
<ul style="list-style-type: none"> • Proper storage and sorting of excavated inert materials to maximize on site reuse for backfilling

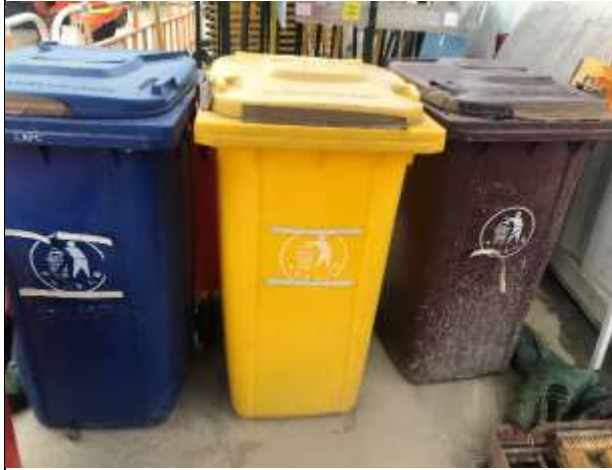
<ul style="list-style-type: none"> • General refuse should be stored in enclosed bins separately from construction and chemical wastes. Recycling bins should also be placed to encourage recycling.

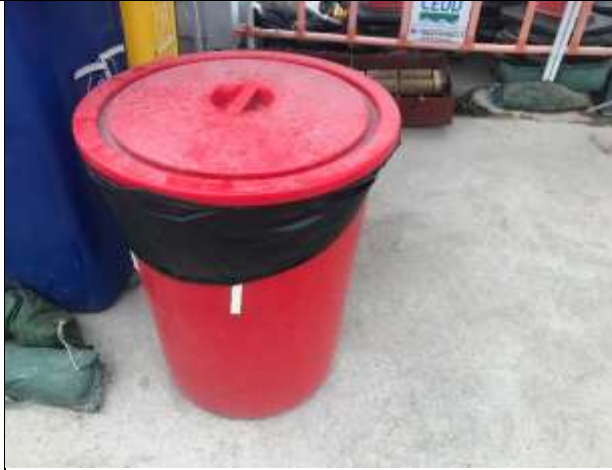
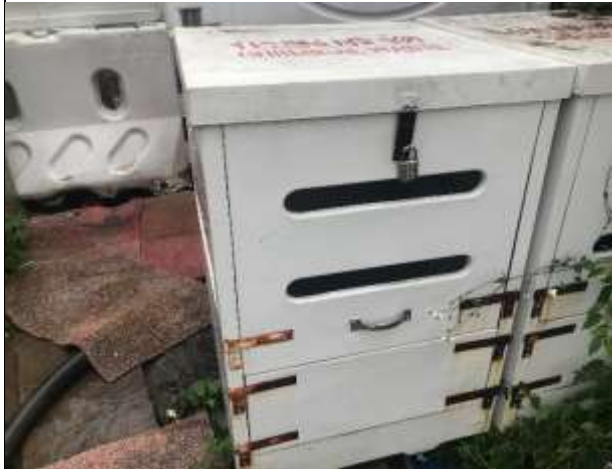
<ul style="list-style-type: none">• Preferably enclosed and covered areas should be provided for general refuse collection and routine cleaning for these areas should also be implemented to keep areas clean. • If chemical wastes are produced at the construction site, the Contractors should register with EPD as chemical waste producers. Chemical wastes should be stored in appropriate containers and collected by a licensed chemical waste contractor. Chemical wastes (e.g. spent lubricant oil) should be recycled at an appropriate facility as far as possible, while the chemical waste that cannot be recycled should be disposed of at either the Chemical Waste Treatment Centre, or another licensed facility, in accordance with the Waste Disposal (Chemical Waste) (General) Regulation.

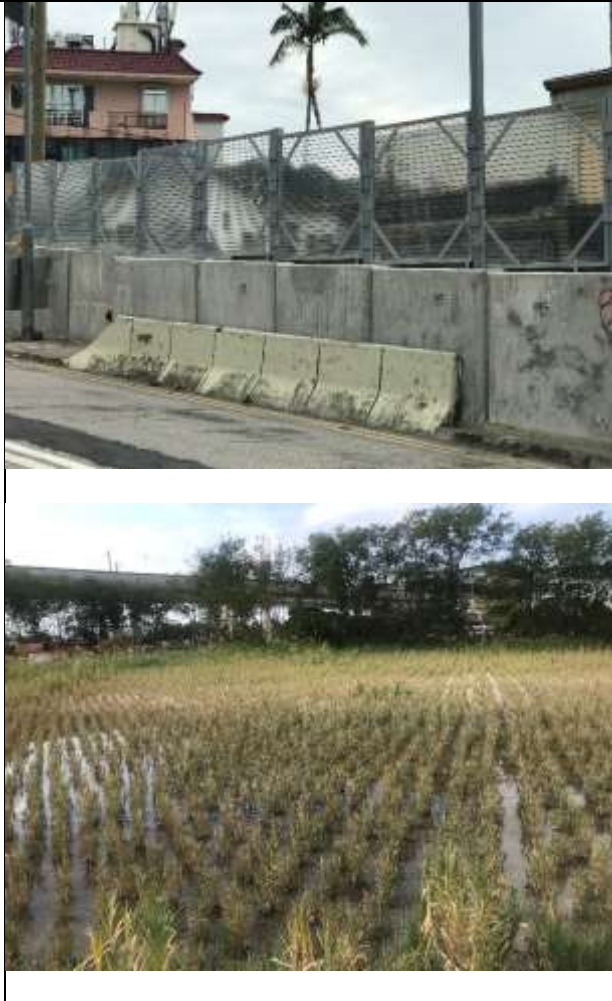
Ref*	Location/ Working Period	Anticipated Major Impacts	Recommended Mitigation Measures	Photo Records (Partial)
EIA S12.7	All site area	Ecology	<ul style="list-style-type: none"> • Use opaque, non-transparent, non-reflective noise barriers for all developments associated with the Project. • On-site compensate the same area of the occupied reedbed

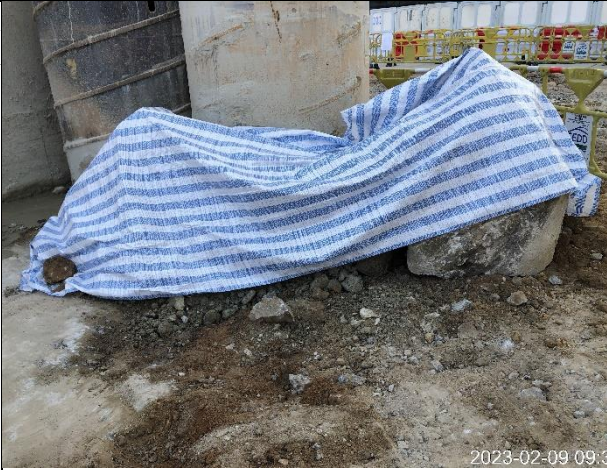
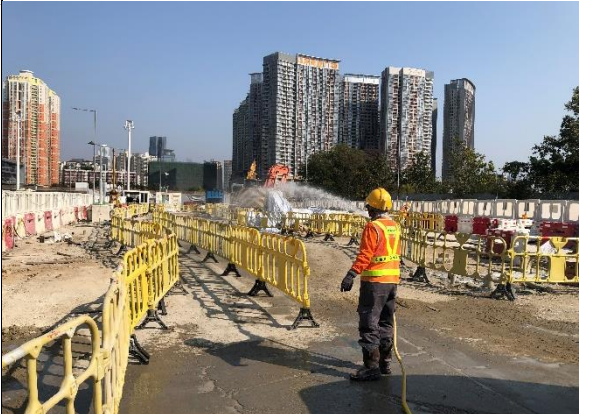
Ref*	Location/ Working Period	Anticipated Major Impacts	Recommended Mitigation Measures	Photo Records (Partial)
EIA S3.8	All site area	Dust impact	<ul style="list-style-type: none"> Any excavated or stockpile of dusty material should be covered entirely by impervious sheeting or sprayed with water to maintain the entire surface wet and then removed or backfilled or reinstated where practicable within 24 hours of the excavation or unloading; Any dusty materials remaining after a stockpile is removed should be wetted with water and cleared from the surface of roads;

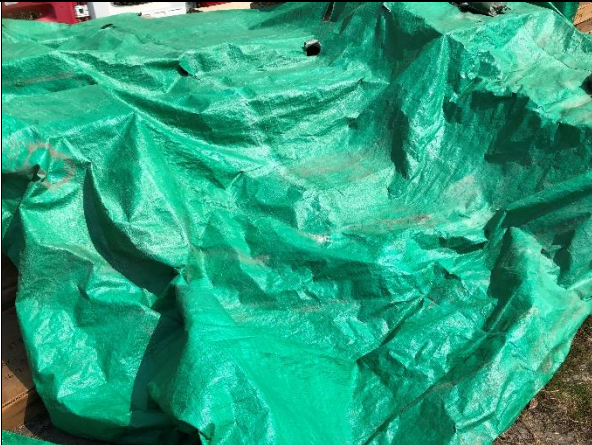
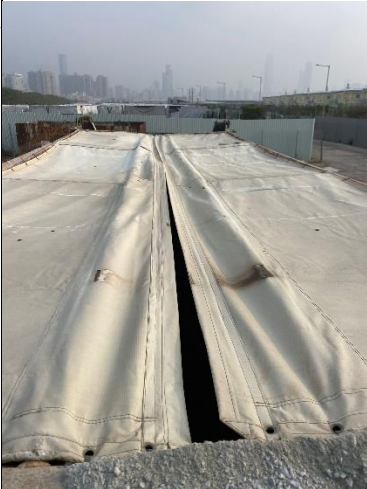
Ref*	Location/ Working Period	Anticipated Major Impacts	Recommended Mitigation Measures	Photo Records (Partial)
EIA S3.8	All site area	Dust impact	<ul style="list-style-type: none"> • A stockpile of dusty material should not be extend beyond the pedestrian barriers, fencing or traffic cones; • The load of dusty materials on a vehicle leaving a construction site should be covered entirely by impervious sheeting to ensure that the dusty materials do not leak from the vehicle;

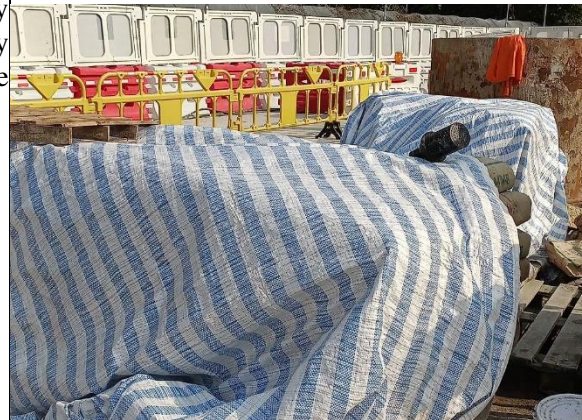
• Every stock of more than 20 bags of cement or dry pulverised fuel ash (PFA) should be covered entirely by impervious sheeting or placed in an area sheltered on the top and the 3 sides;

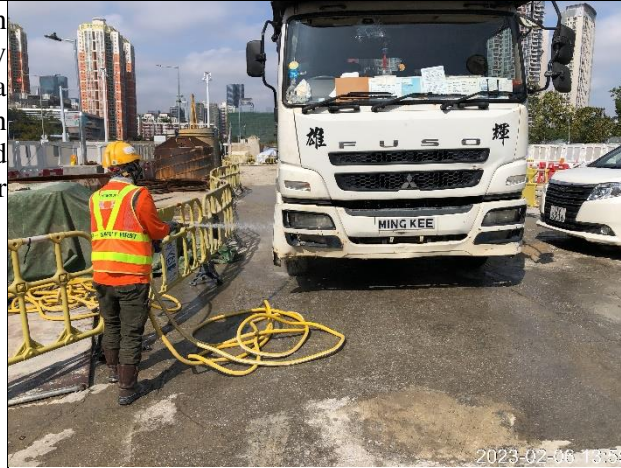
- Where practicable, vehicle washing facilities with high pressure water jet should be provided at every discernible or designated vehicle exit point. The area where vehicle washing takes place and the road section between the washing facilities and the exit point should be paved with concrete, bituminous materials or hardcores.

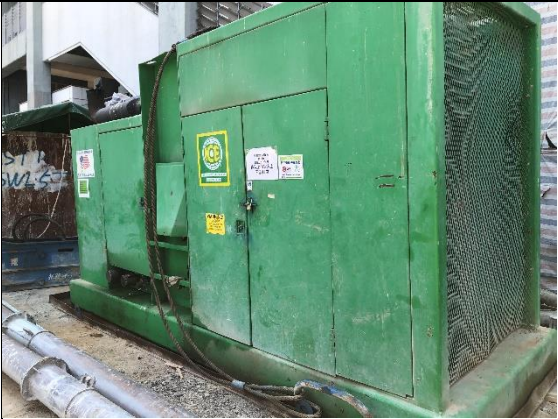
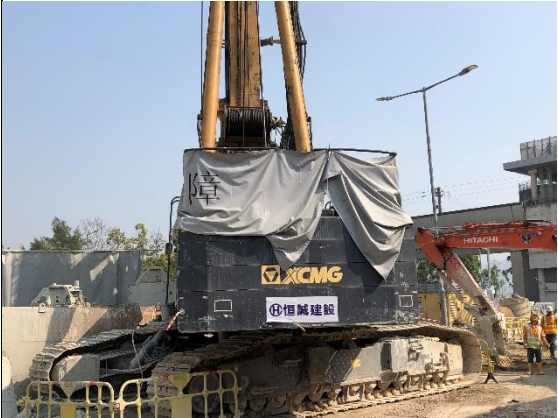
Ref*	Location/ Working Period	Anticipated Major Impacts	Recommended Mitigation Measures	Photo Records (Partial)
EIA S4.8	All site area	Noise impact	<ul style="list-style-type: none"> • Mobile plant should be sited as far away from NSRs as possible and practicable; • Install movable noise barriers and full enclosure, screen the noisy plants including air compressor and generator.

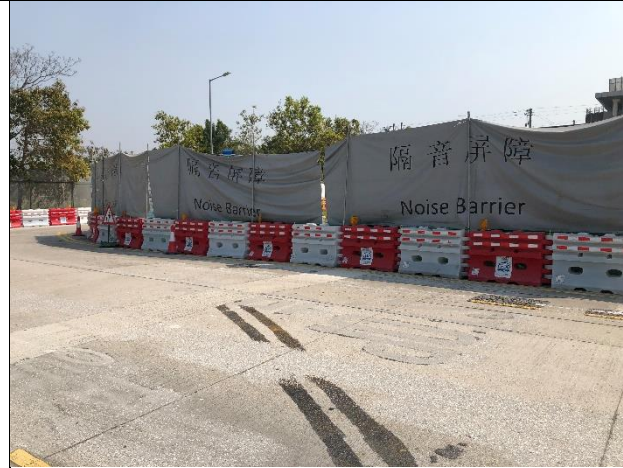
• An acoustic canvas had been deployed along the site boundary facing the resident of Shenzhen City.

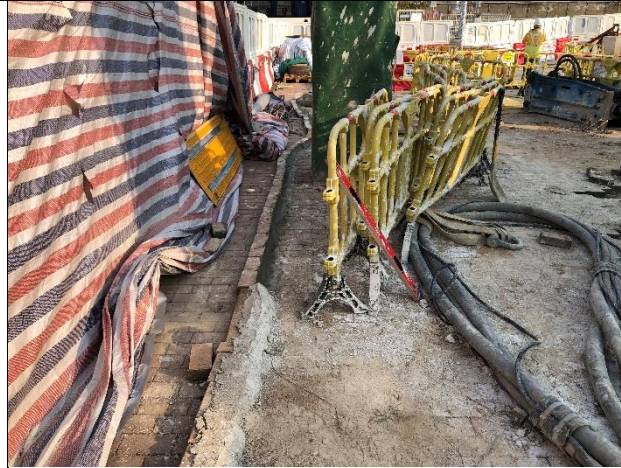
• Diversion of natural stormwater should be provided as far as possible. The design of temporary on-site drainage should prevent runoff going through site surface, construction machinery and equipments in order to avoid or minimize polluted runoff.

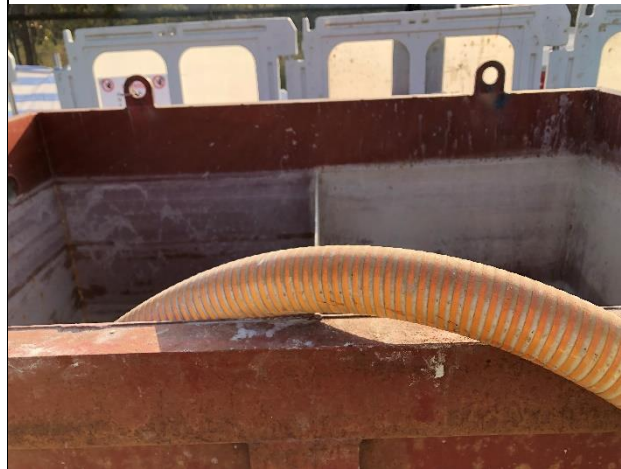
• Sedimentation tanks with sufficient capacity, constructed from pre-formed individual cells of approximately 6 to 8 m³ capacities, are recommended as a general mitigation measure which can be used for settling surface runoff prior to disposal. The system capacity shall be flexible and able to handle multiple inputs from a variety of sources and suited to applications where the influent is pumped.

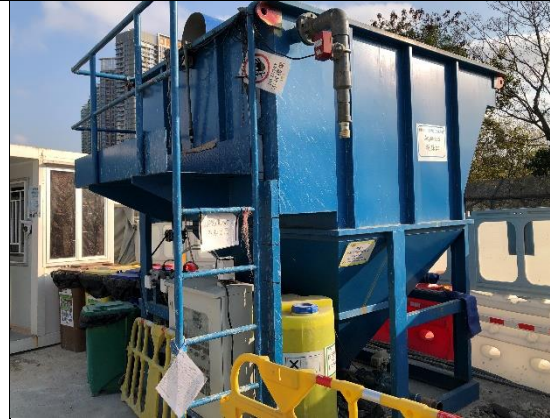
• The design of efficient silt removal facilities should be based on the guidelines in Appendix A1 of ProPECC PN 1/94. The detailed design of the sand/silt traps should be undertaken by the contractor prior to the commencement of construction.

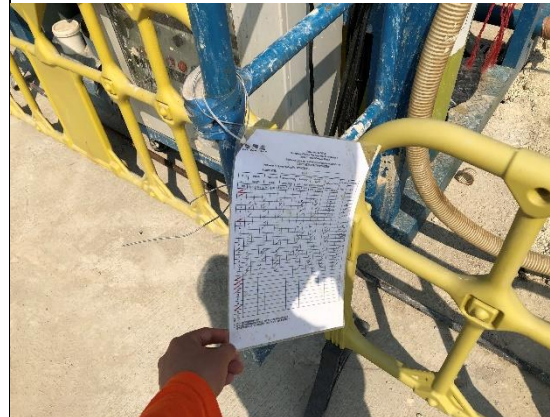
• All drainage facilities and erosion and sediment control structures should be regularly inspected and maintained to ensure proper and efficient operation at all times and particularly following rainstorms.
