**Service Contract No. WD/04/2020
Development of Lok Ma Chau Loop:
Main Works Package 1 –
Environmental Team**

**Environmental Permit No.:
EP-477/2013/A
- Development of Lok Ma Chau Loop**

**Monthly Environmental Monitoring and
Audit Report for February 2023**

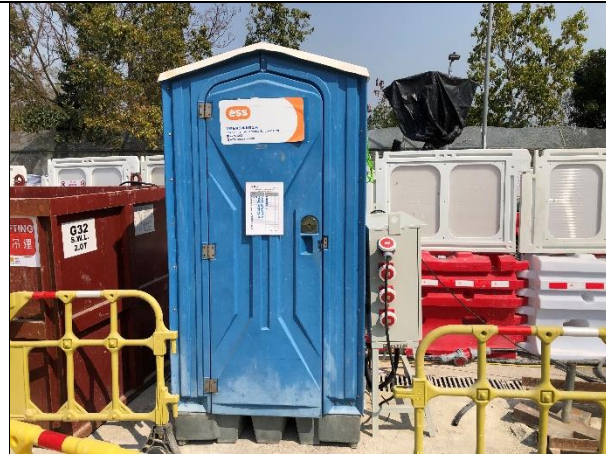
• Portable chemical toilets and sewage holding tanks should be provided for handling the construction sewage generated by the workforce. A licensed contractor should be employed to provide appropriate and adequate portable toilets to cater 0.15m³/day/employed populations and be responsible for appropriate disposal and maintenance.

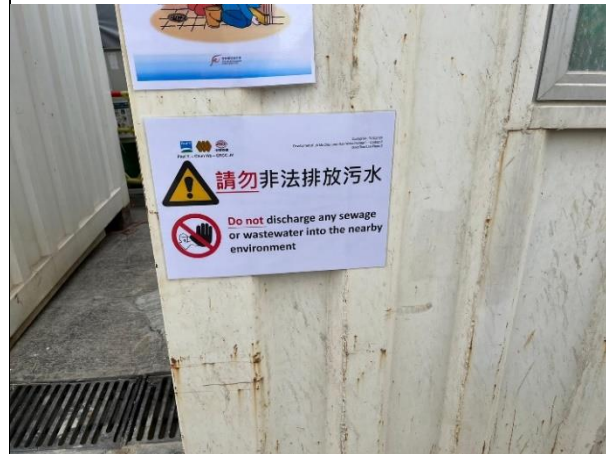
• Notices should be posted at conspicuous locations to remind the workers not to discharge any sewage or wastewater into the nearby environment during the construction phase of the Project. Regular environmental audit on the construction site should be conducted in order to provide an effective control of any malpractices and achieve continual improvement of environmental performance on site.

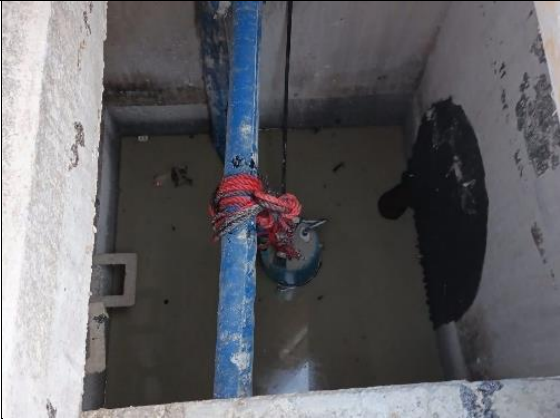
<ul style="list-style-type: none">•An additional water pump had been set up and the concerned outlet have been sealed up with concrete

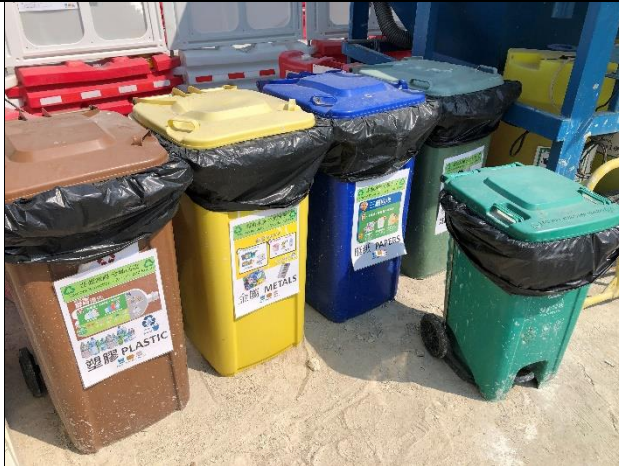
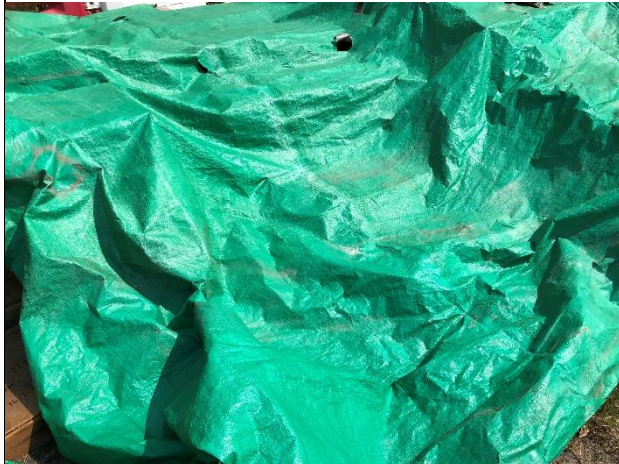
Ref*	Location/ Working Period	Anticipated Major Impacts	Recommended Mitigation Measures	Photo Records (Partial)
EIA S7.6	All site area	Waste Generation	<ul style="list-style-type: none"> • Segregate and store different types of waste in different containers, skip or stockpiles to enhance reuse or recycling of materials and their proper disposal; • Proper storage and site practices to minimize the potential for damage and contamination of construction materials;

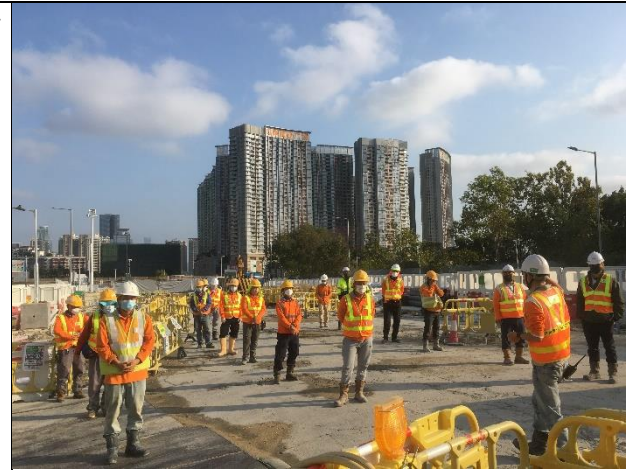
• Provide training to workers on the importance of appropriate waste management procedures, including waste reduction, reuse and recycling.

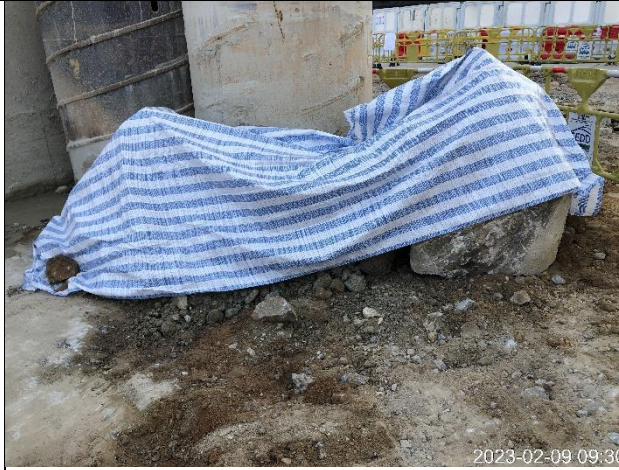
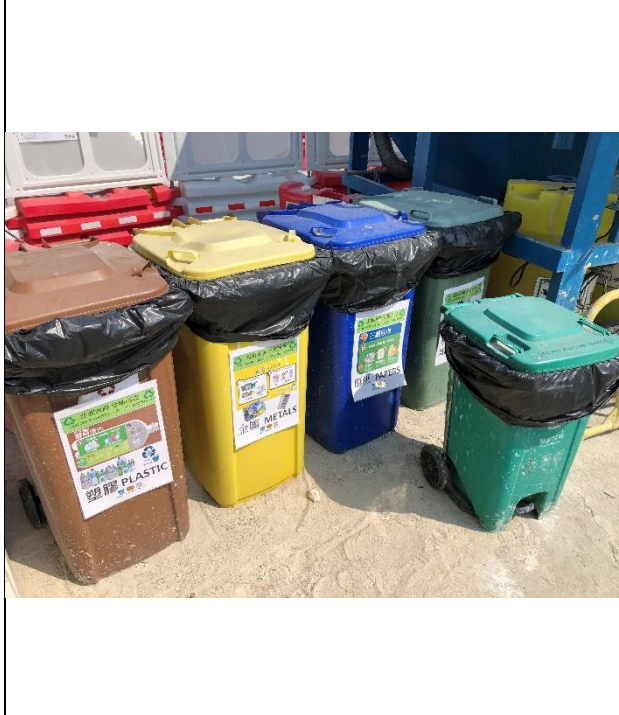
<ul style="list-style-type: none">• Proper storage and sorting of excavated inert materials to maximize on site reuse for backfilling • General refuse should be stored in enclosed bins separately from construction and chemical wastes. Recycling bins should also be placed to encourage recycling.

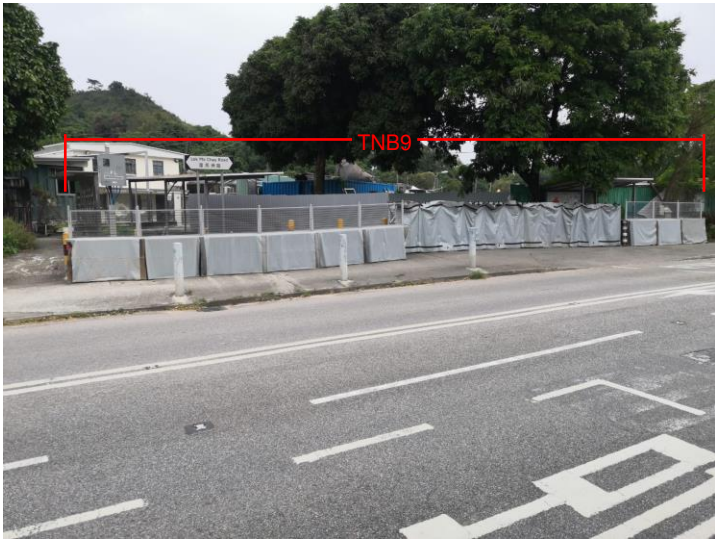
TNB ID	Photo
TNB9

A photograph showing a temporary noise barrier (TNB9) along a road. The barrier consists of grey concrete blocks with a chain-link fence on top. In the background, there are trees and a building. A red box highlights the barrier, with the label 'TNB9' in red text above it.
TNB10

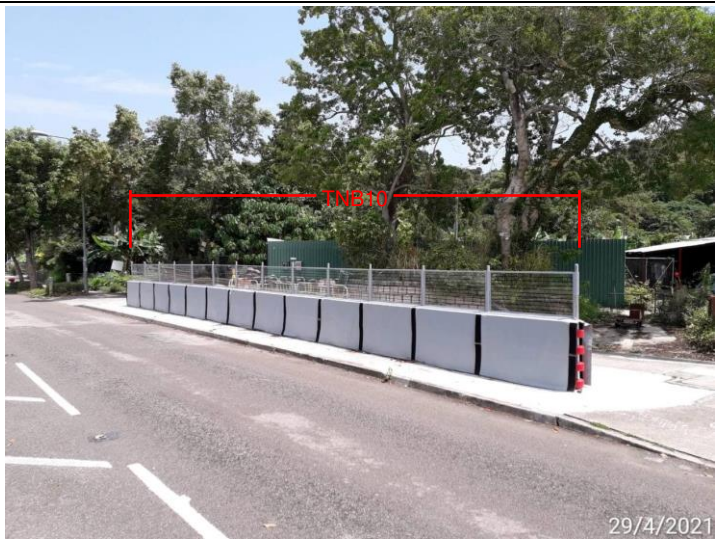
A photograph showing a temporary noise barrier (TNB10) along a road. The barrier consists of grey concrete blocks with a chain-link fence on top. In the background, there are trees and a building. A red box highlights the barrier, with the label 'TNB10' in red text above it. The date '29/4/2021' is visible in the bottom right corner.
TNB13

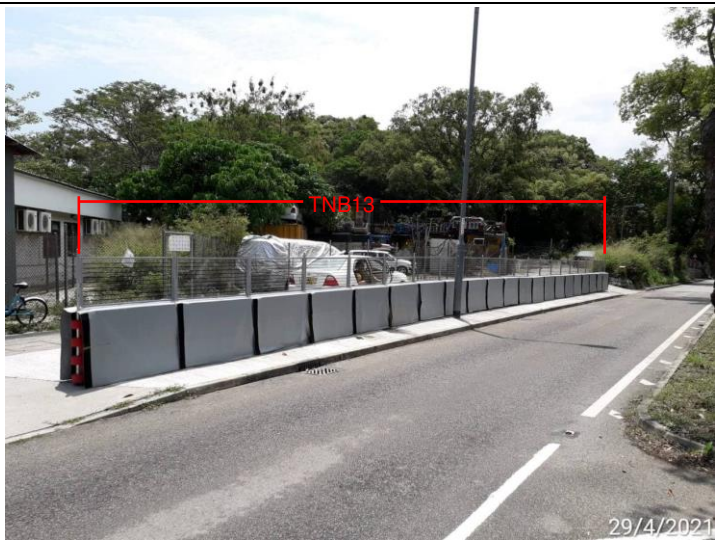
A photograph showing a temporary noise barrier (TNB13) along a road. The barrier consists of grey concrete blocks with a chain-link fence on top. In the background, there are trees and a building. A red box highlights the barrier, with the label 'TNB13' in red text above it. The date '29/4/2021' is visible in the bottom right corner.
