Service Contract No. WD/04/2020 Development of Lok Ma Chau Loop: Main Works Package 1 – Environmental Team

Environmental Permit No.: EP-477/2013/A - Development of Lok Ma Chau Loop

Monthly Environmental Monitoring and Audit Report for April 2023

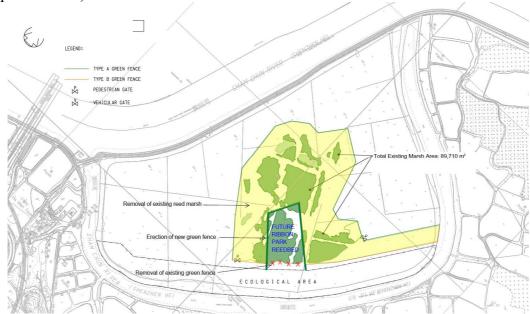
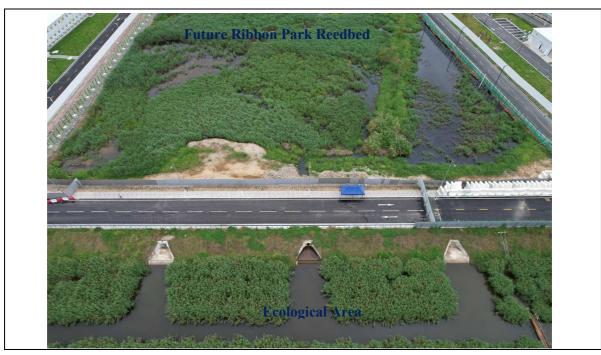
Ecological Mitigation Measures – Installation of 3m-high Olive Green Fence

10.8 The green fence around the future Ribbon Park Reedbed has been removed and replaced by the hoarding due to the other project's land occupier since March 2022. (See Figure & photo below)

10.10 The Contractor was reminded to maintain the green fence around construction areas and ensure no disturbance to the exiting trees and reed marsh habitat subject to the latest situation of LMC Loop.

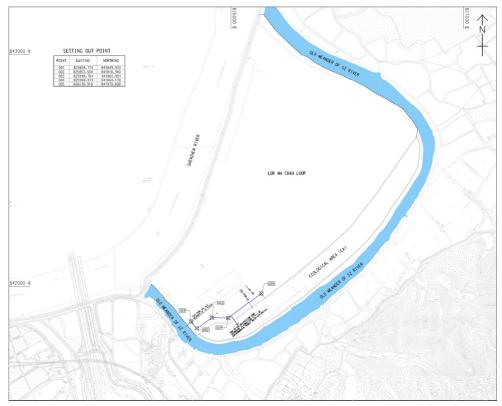
10.9 Installation of the green fence alongside the Ecological Area and the Meander was proposed and completed on 20th May 2022. The layout plan of the green fence installation is shown below: -

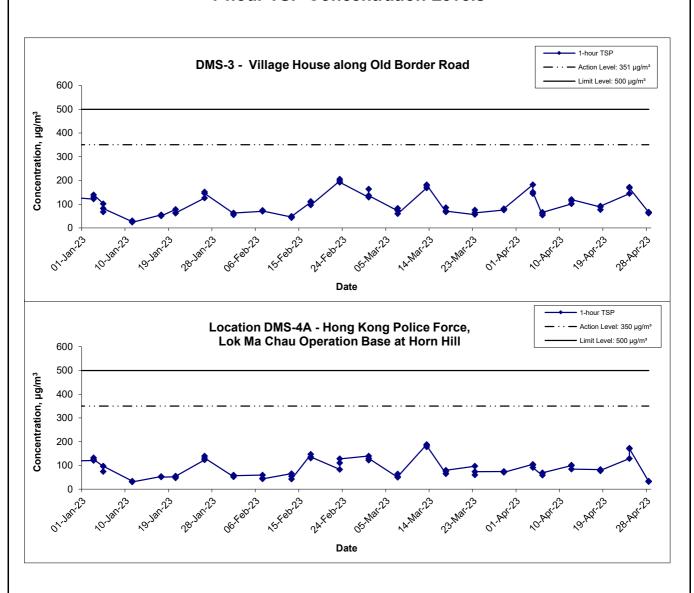
1-hour TSP Concentration Levels

Service Contract No. WD/04/2020
Development of Lok Ma Chau Loop:
Main Works Package 1 - Environmental Team
Graphical Presentation of 1-hour TSP Monitoring Results

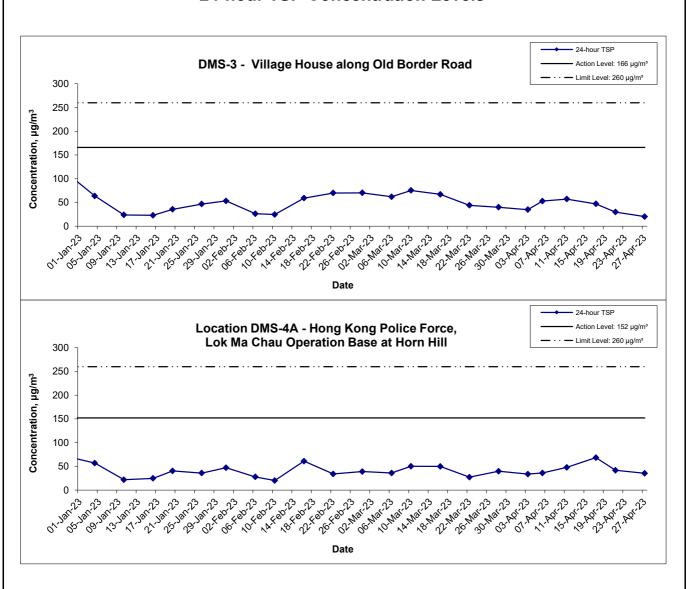
24-hour TSP Concentration Levels

Service Contract No. WD/04/2020
Development of Lok Ma Chau Loop:
Main Works Package 1 - Environmental Team
Graphical Presentation of 24-hour TSP Monitoring Results

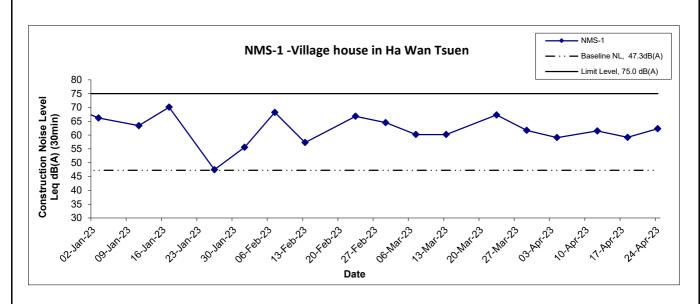
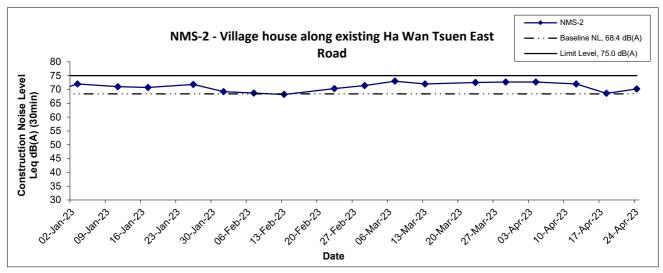
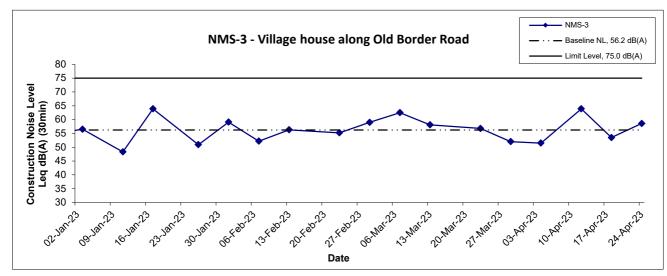
Noise Levels

Title Service Contract No. WD/04/2020
Development of Lok Ma Chau Loop:
Main Works Package 1 - Environmental Team
Graphical Presentation of Construction Noise Monitoring
Results

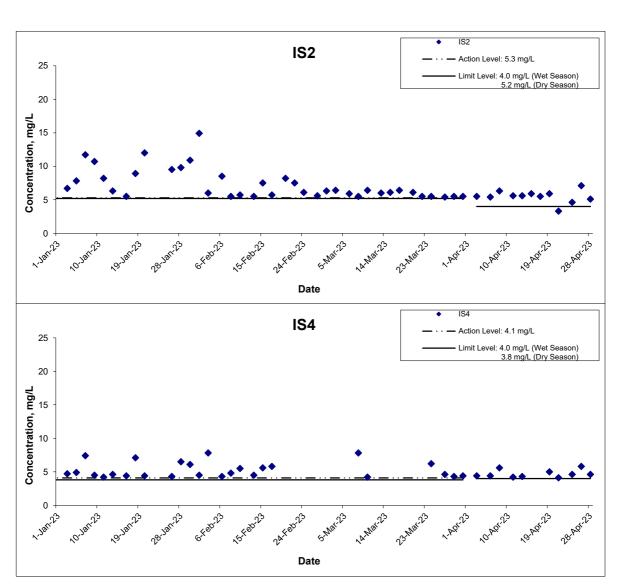
Dissolved Oxygen

riue	Service Contract No. WD/04/2020
	Development of Lok Ma Chau Loop:
	Main Works Package 1 - Environmental Team
	Graphical Presentation of Water Quality Monitoring
	Results

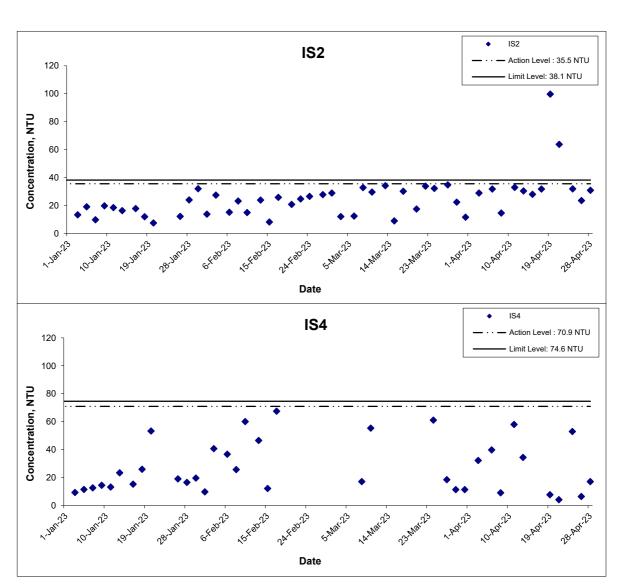
Turbidity

Service Contract No. WD/04/2020
Development of Lok Ma Chau Loop:
Main Works Package 1 - Environmental Team
Graphical Presentation of Water Quality Monitoring
Results

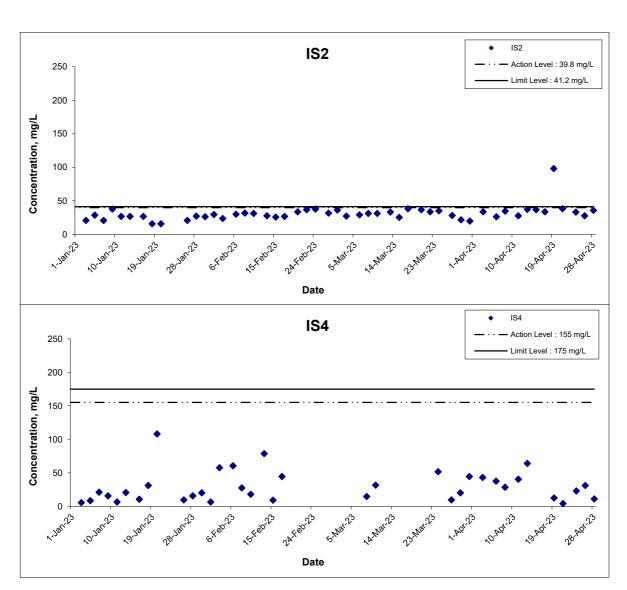
Suspended Solids

Service Contract No. WD/04/2020
Development of Lok Ma Chau Loop:
Main Works Package 1 - Environmental Team
Graphical Presentation of Water Quality Monitoring
Results

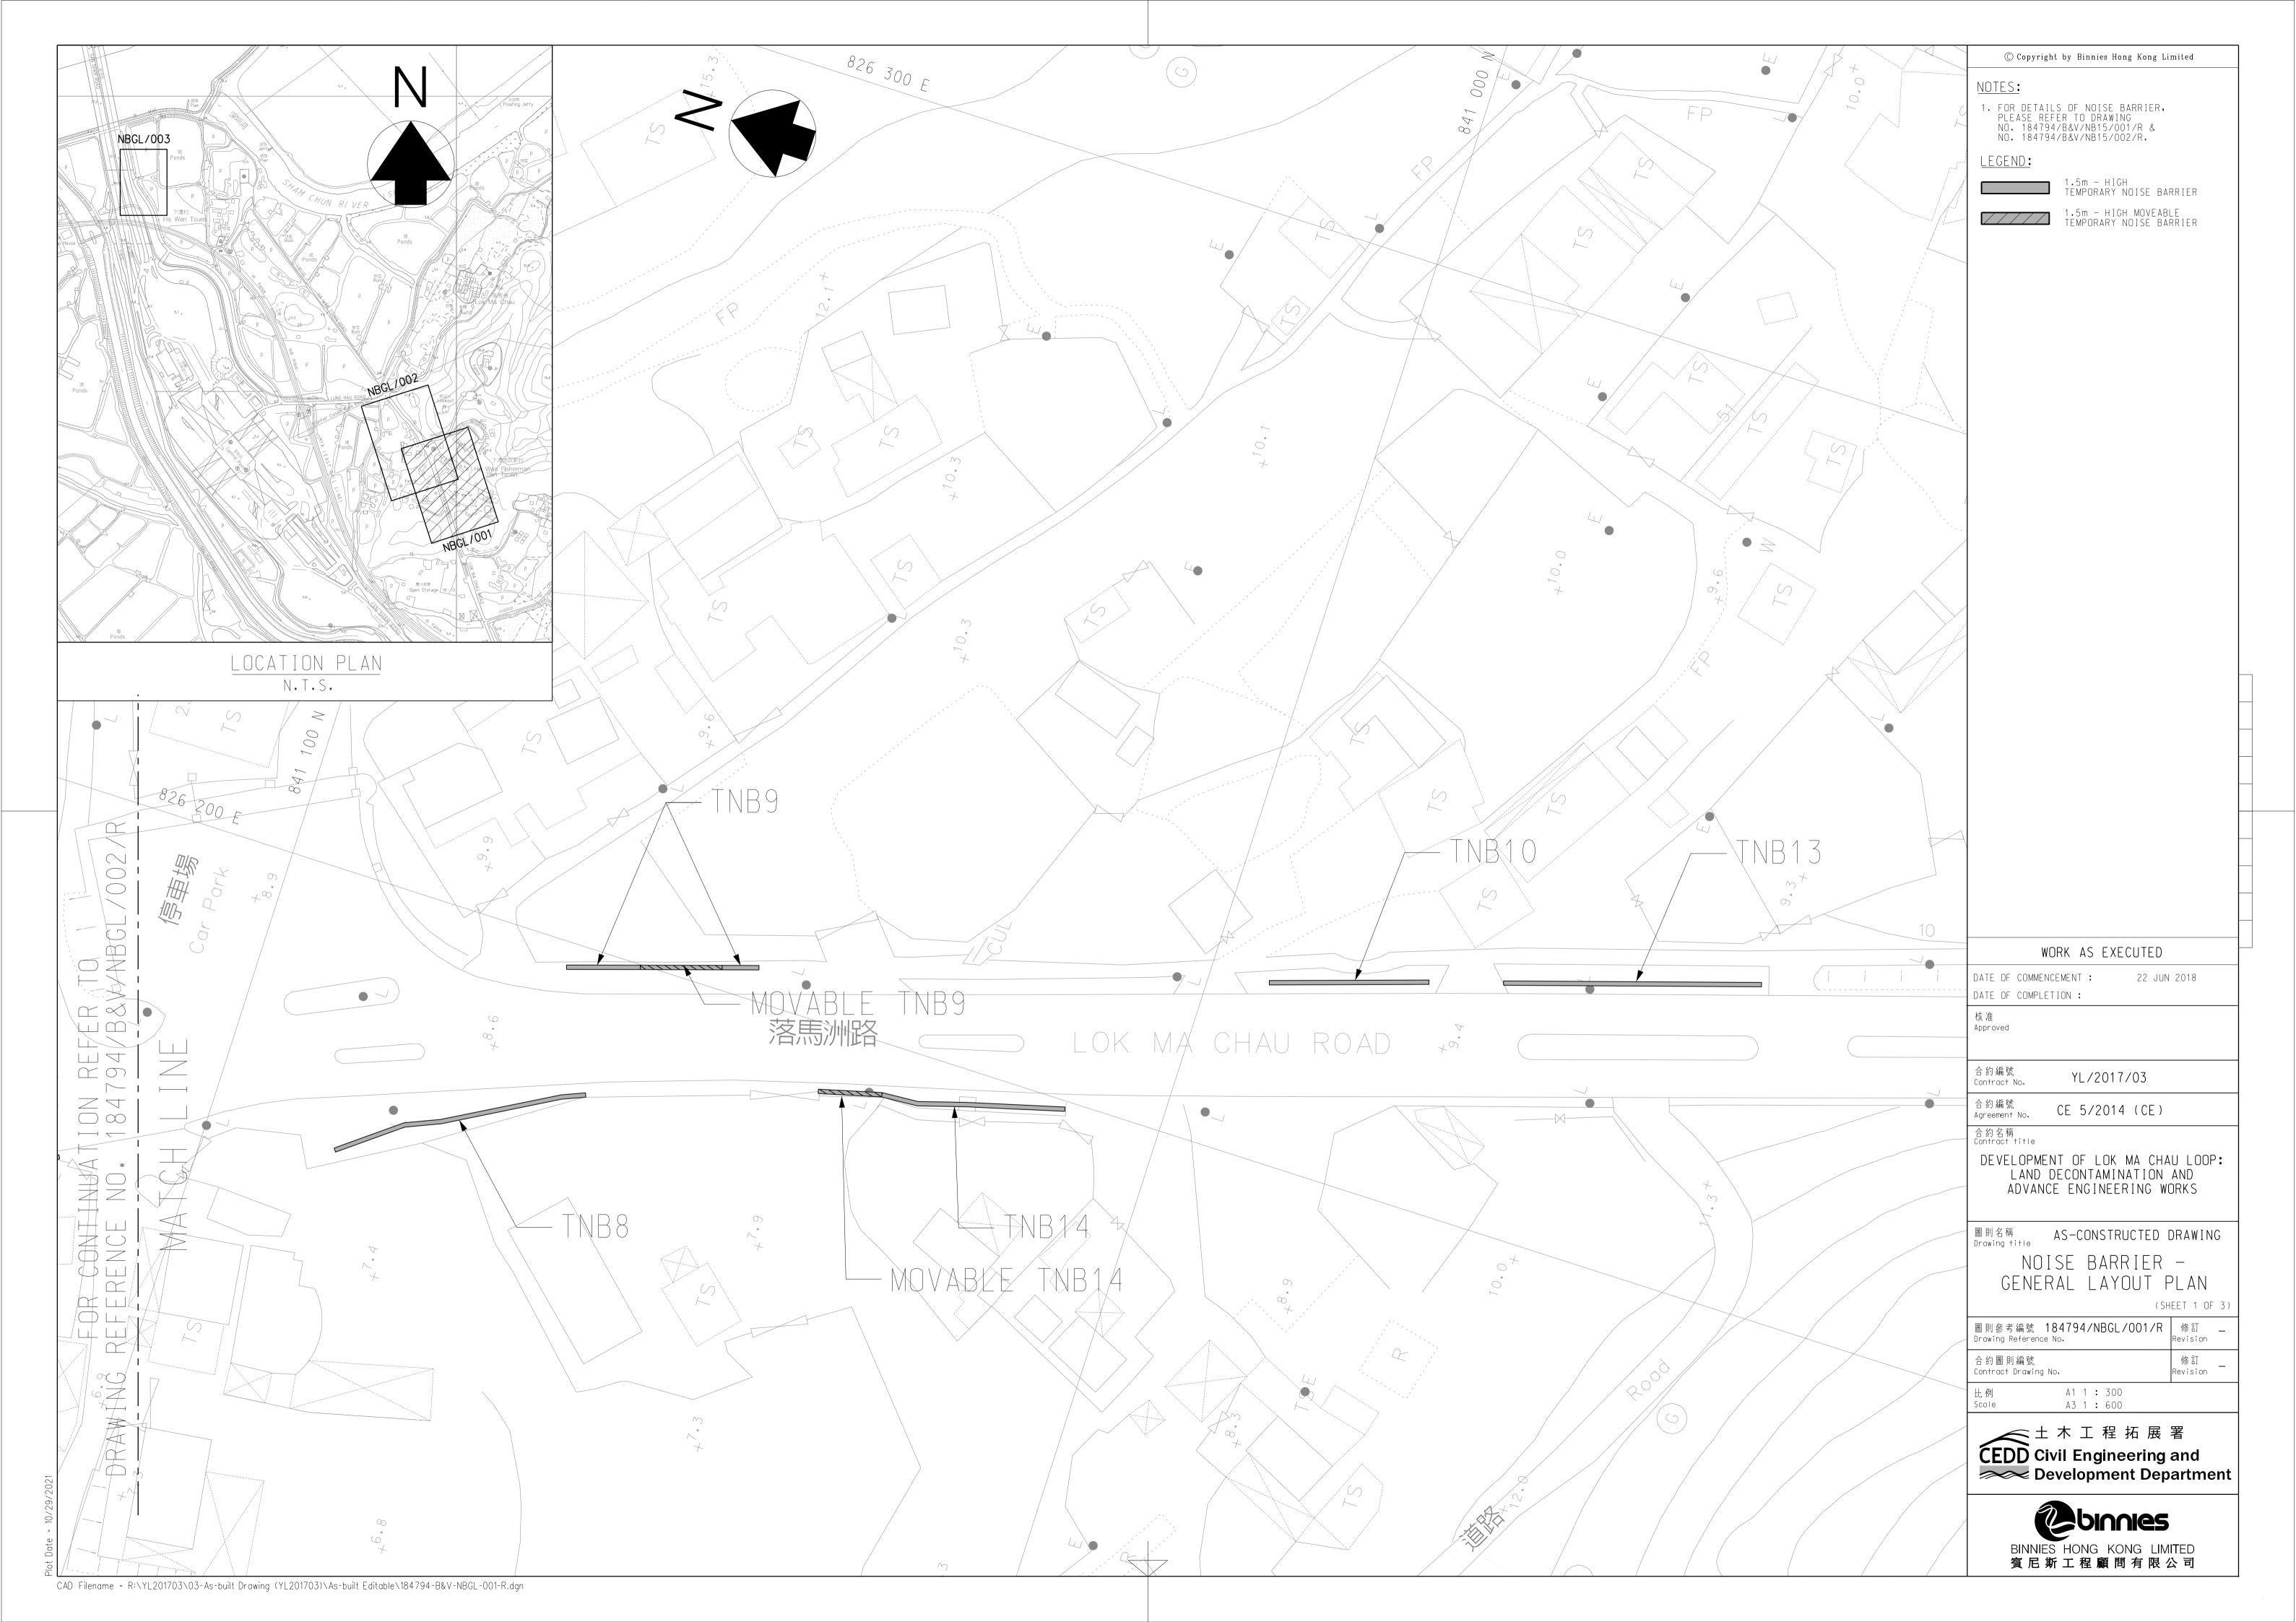
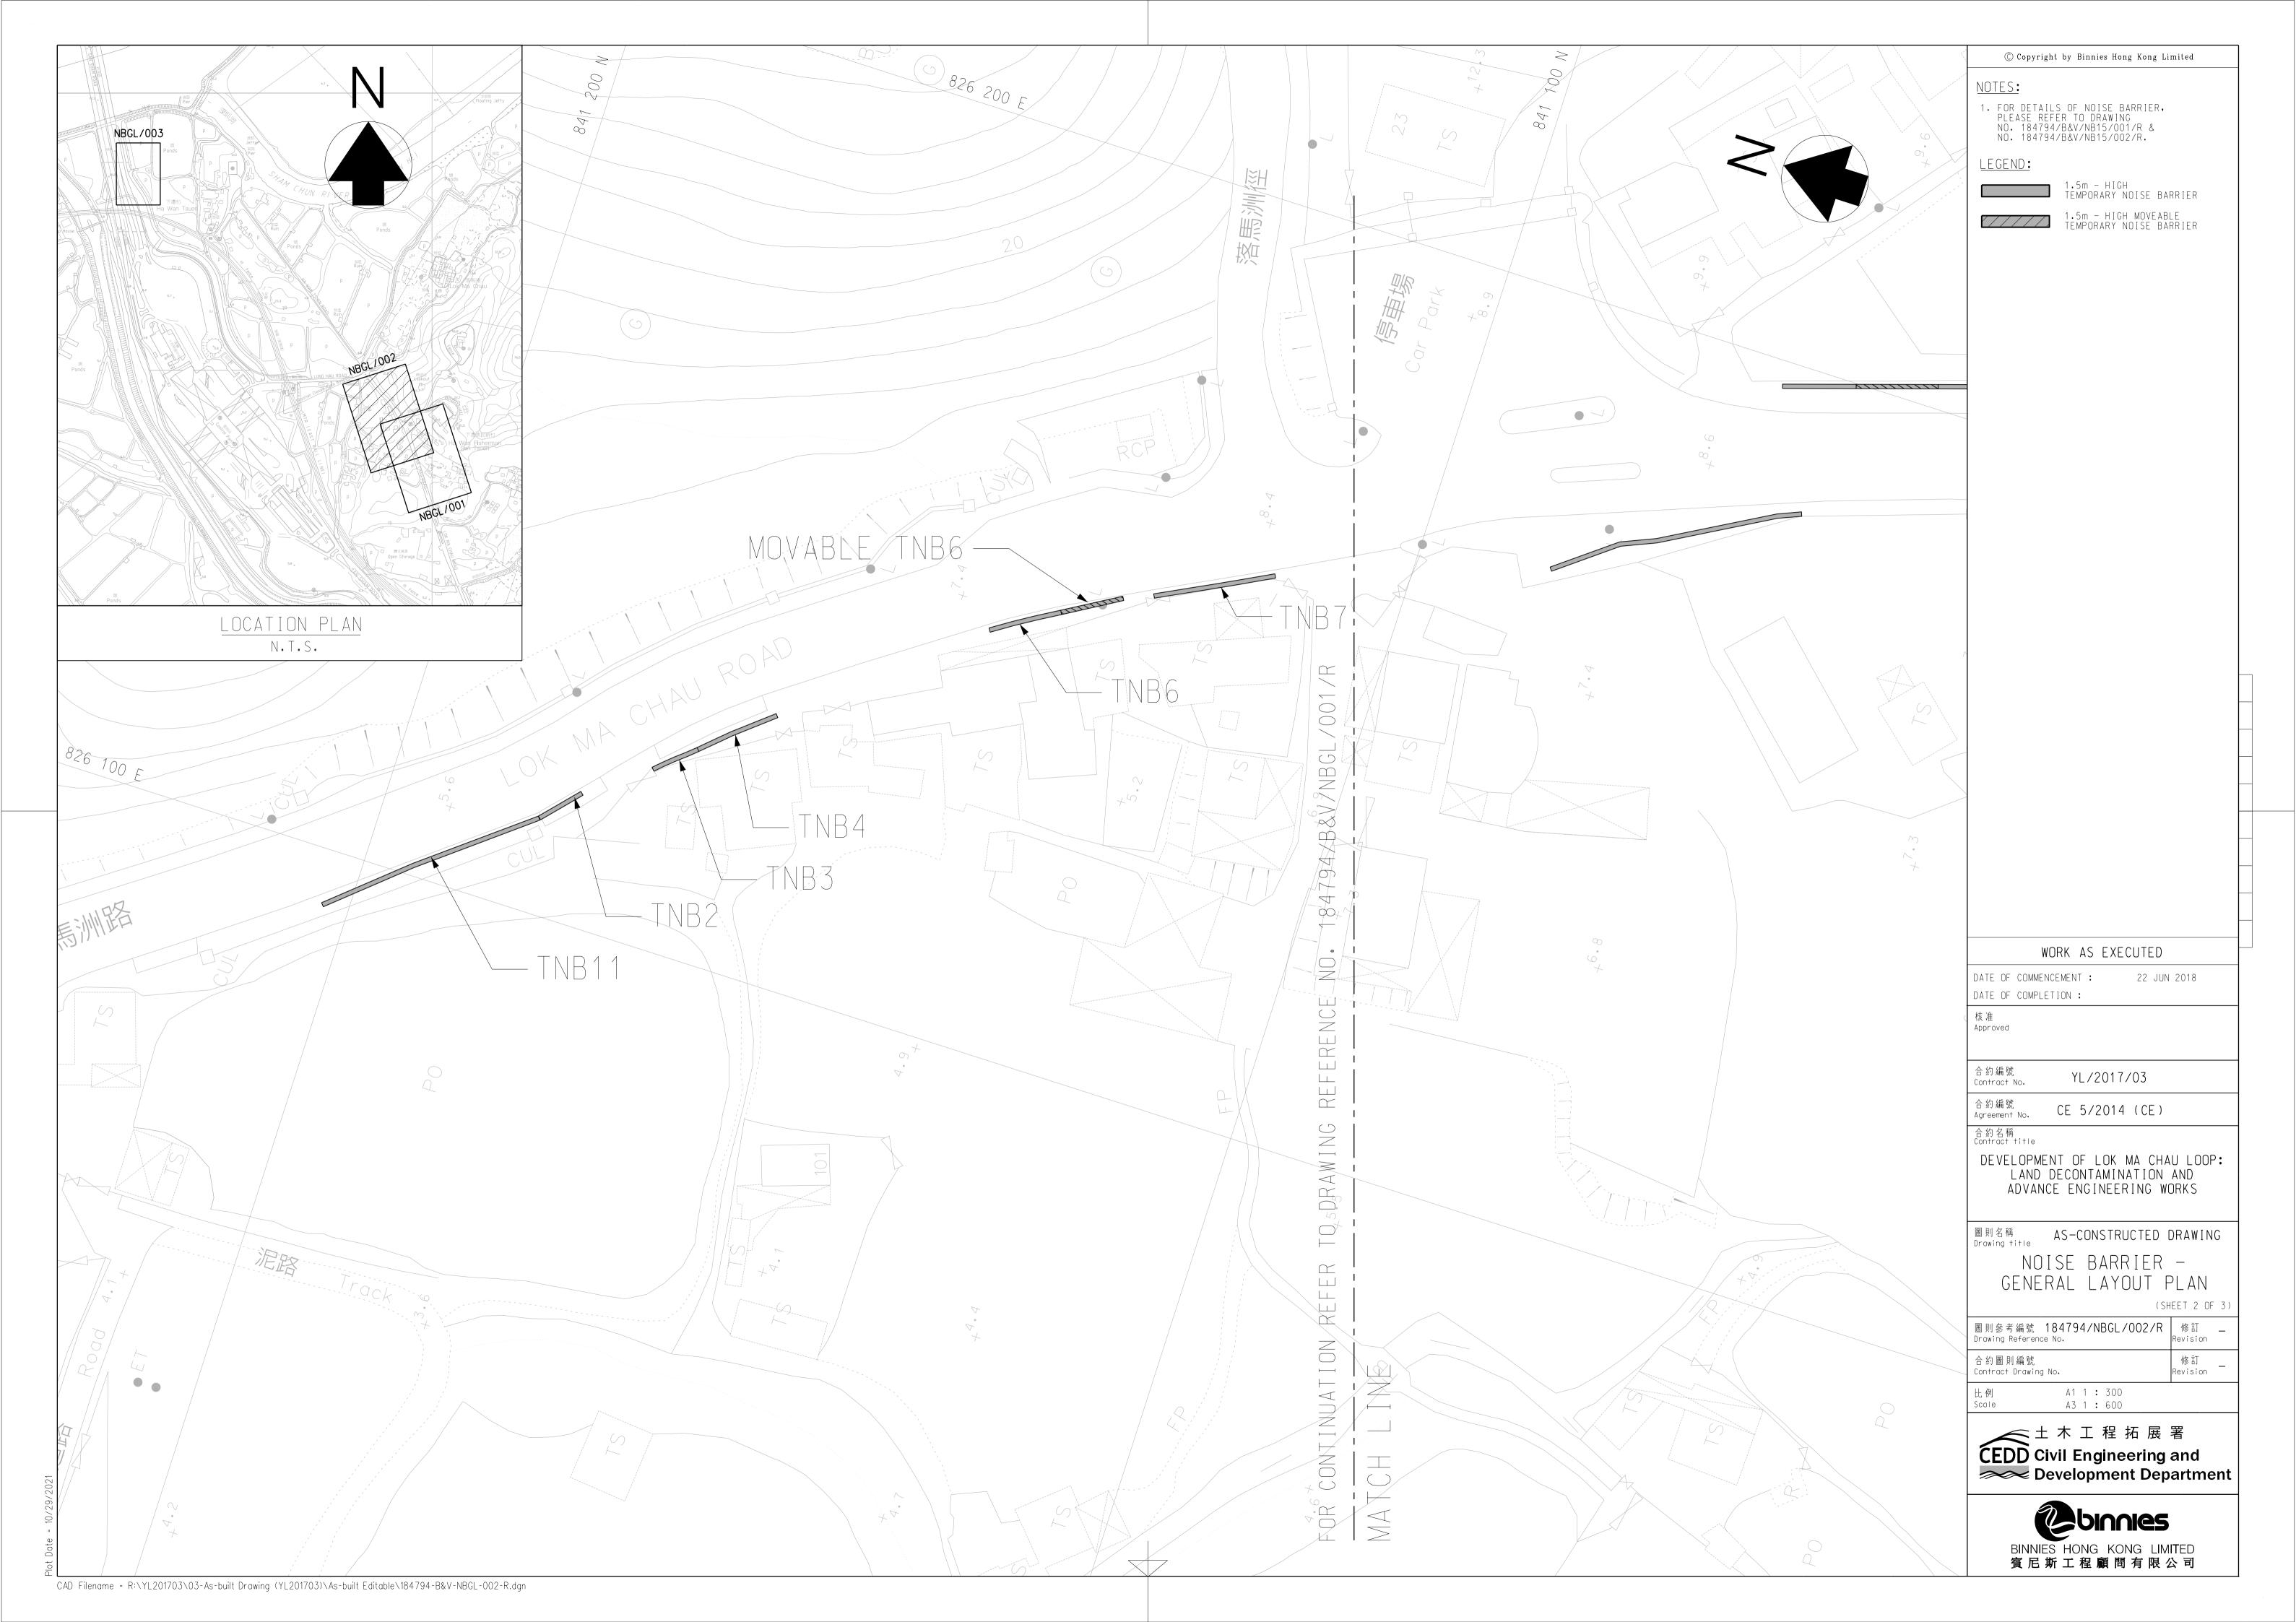
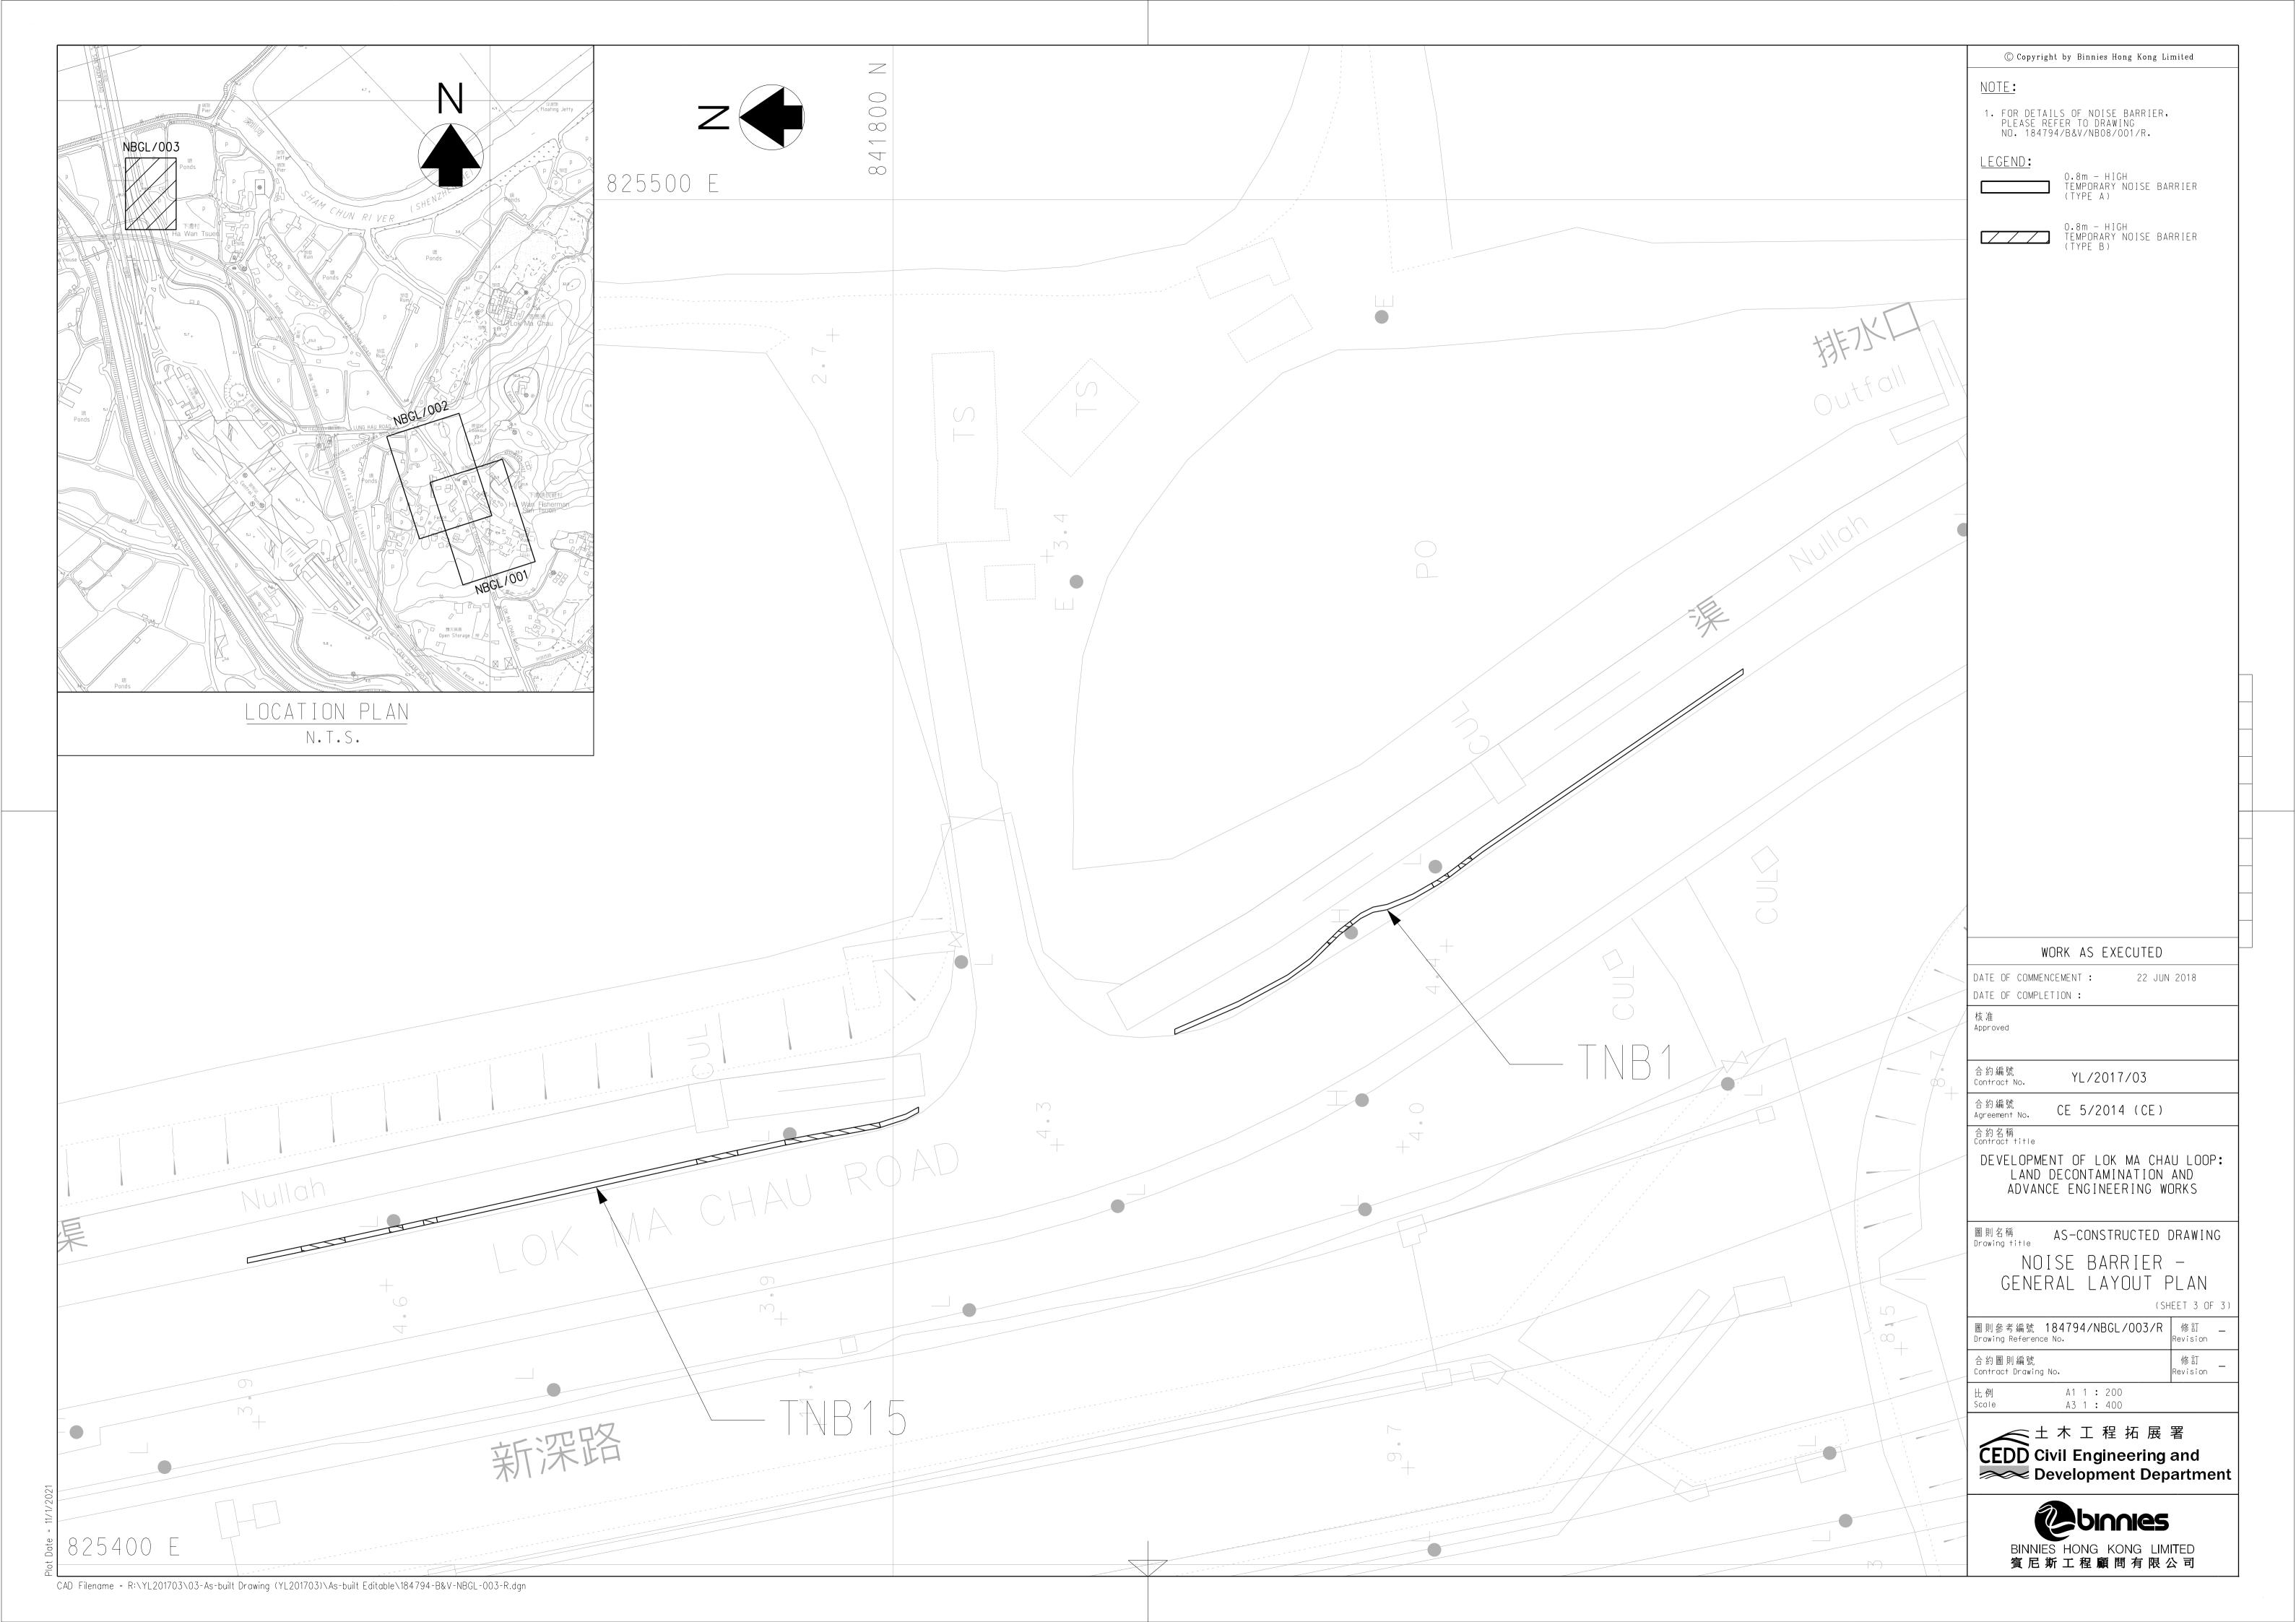
APPENDIX N TEMPORARY NOISE BARRIERS

YL/2017/03 Development of Lok Ma Chau Loop – Land Decontamination and Advance Engineering Works Record Photographs for Temporary Noise Barriers at Lok Ma Chau Road

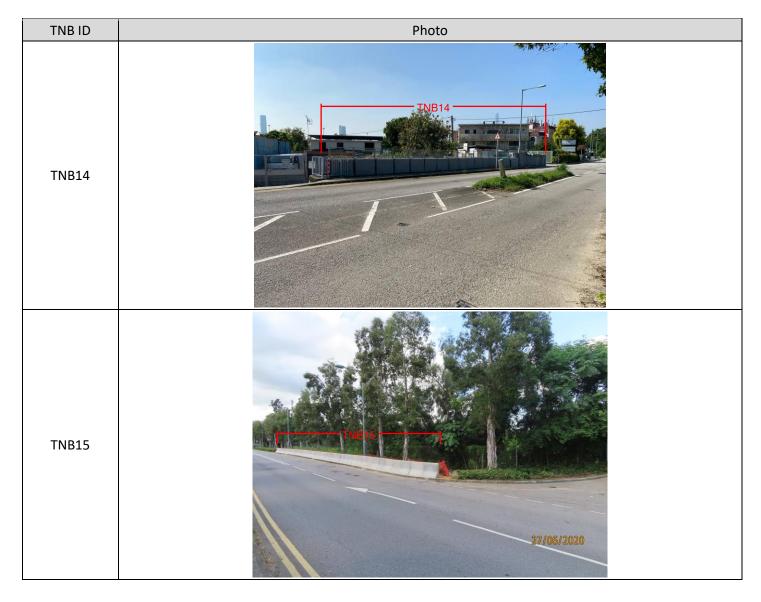
Development of Lok Ma Chau Loop – Land Decontamination and Advance Engineering Works
Record Photographs for Temporary Noise Barriers at Lok Ma Chau Road

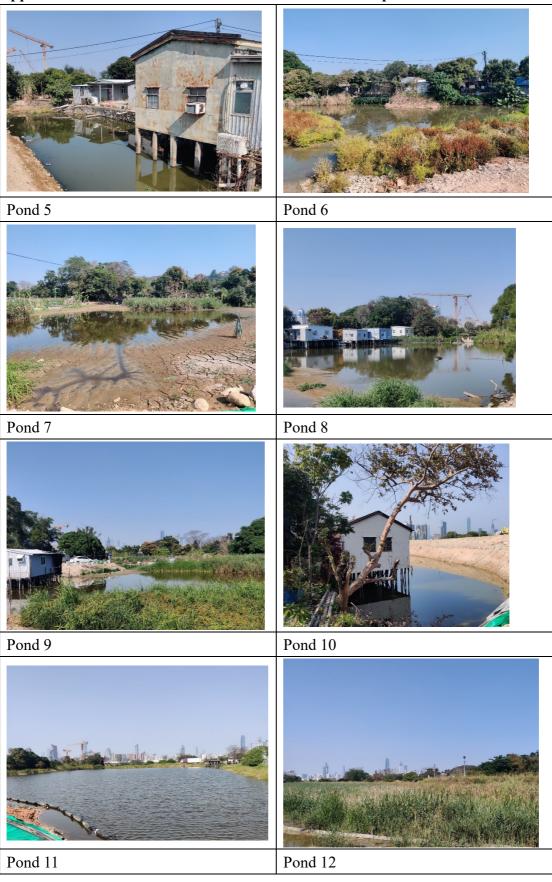
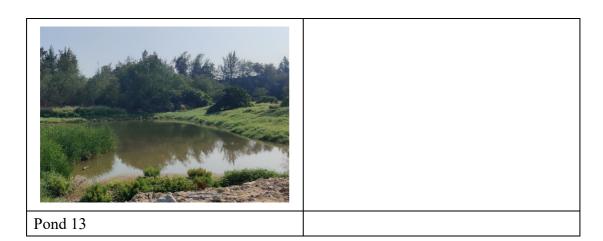
APPENDIX S PHOTO RECORDS OF THE STATUS OF PONDS IN APRIL 2023

$Appendix \ S-Photo \ Records \ of \ The \ status \ of \ Ponds \ in \ April \ 2023$
