**Service Contract No. WD/04/2020
Development of Lok Ma Chau Loop:
Main Works Package 1 –
Environmental Team**

**Environmental Permit No.:
EP-477/2013/A
- Development of Lok Ma Chau Loop**

**Monthly Environmental Monitoring and
Audit Report for May 2023**

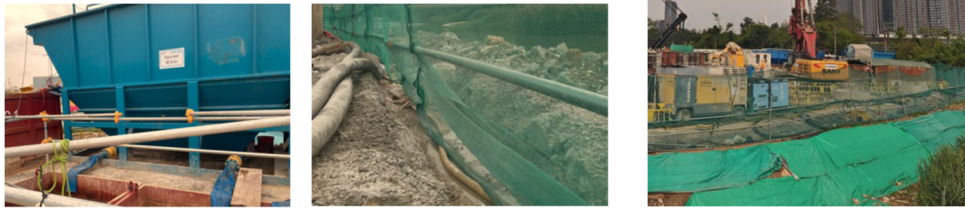
- 3) Water quality mitigation measures as recommended in the EIA Report / EM&A Manual were implemented by the Contractor properly. Silt curtain was deployed to surround the works area and the concrete bund with sump pit and water pump were provided for pumping the collected site runoff to the wetsep for treatment before

discharging out. Exposed slope surface was also covered with tarpaulin sheet to avoid discharge of muddy surface runoff

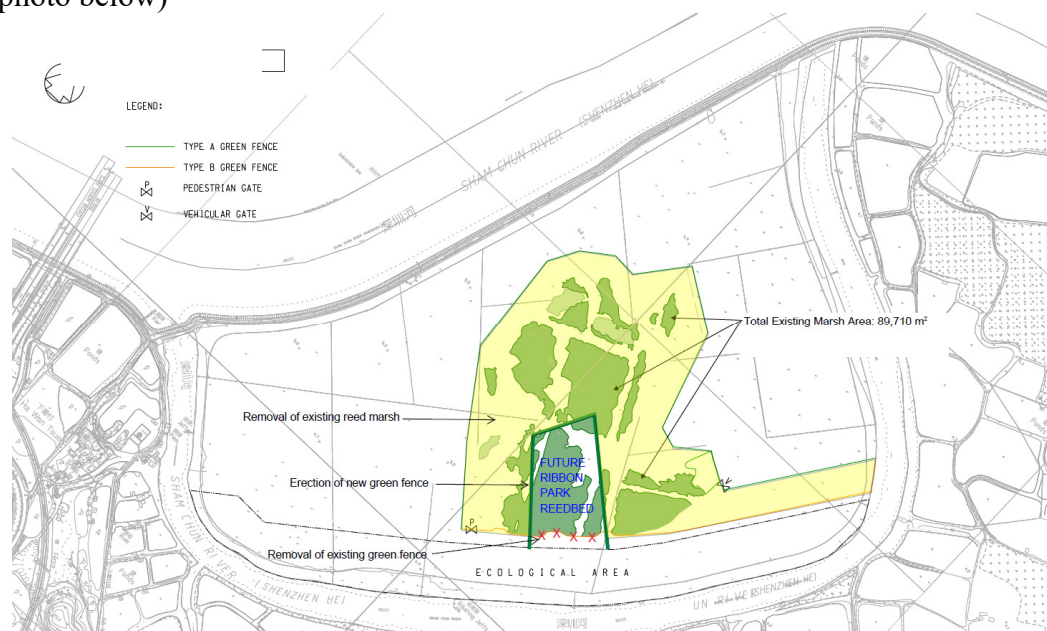
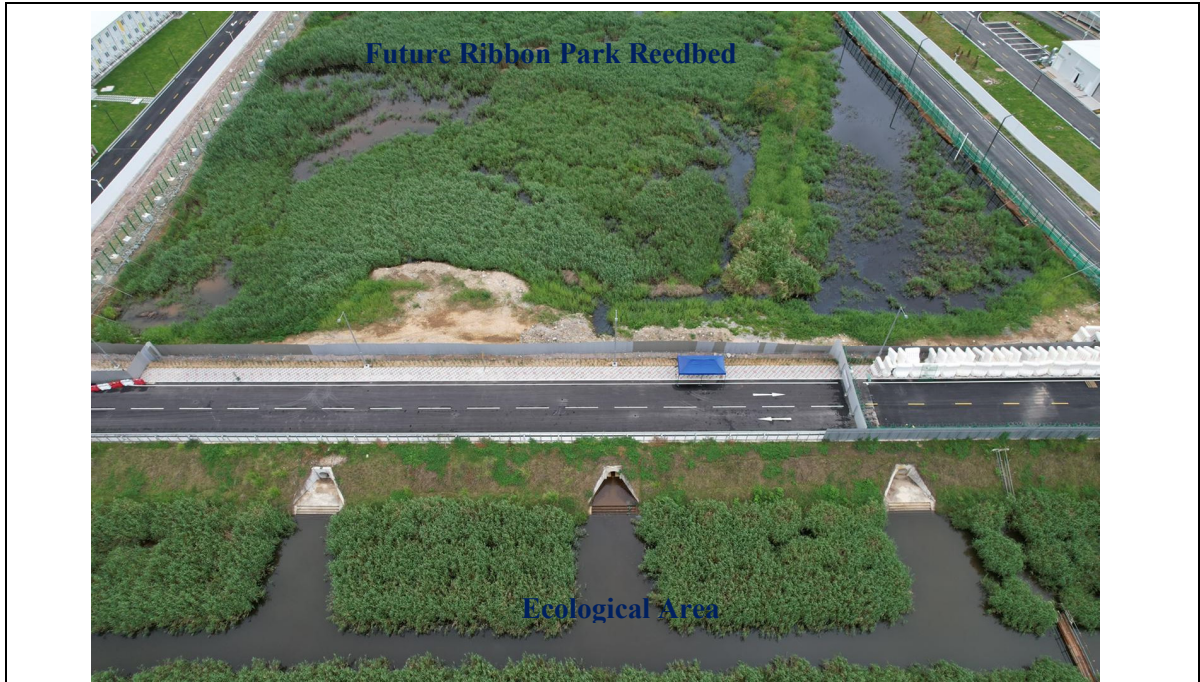
- 10.8 The green fence around the future Ribbon Park Reedbed has been removed and replaced by the hoarding due to the other project's land occupier since March 2022. (See Figure & photo below)

10.10 The Contractor was reminded to maintain the green fence around construction areas and ensure no disturbance to the existing trees and reed marsh habitat subject to the latest situation of LMC Loop.

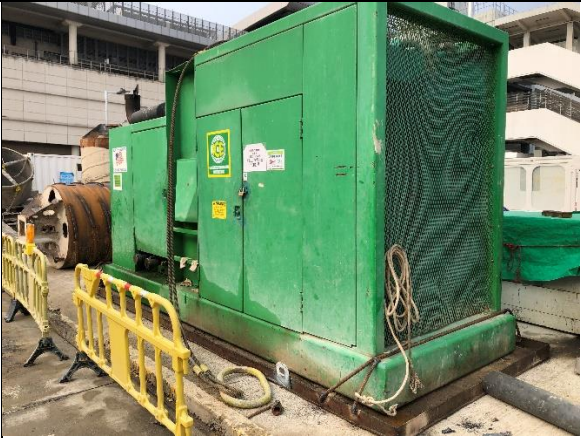
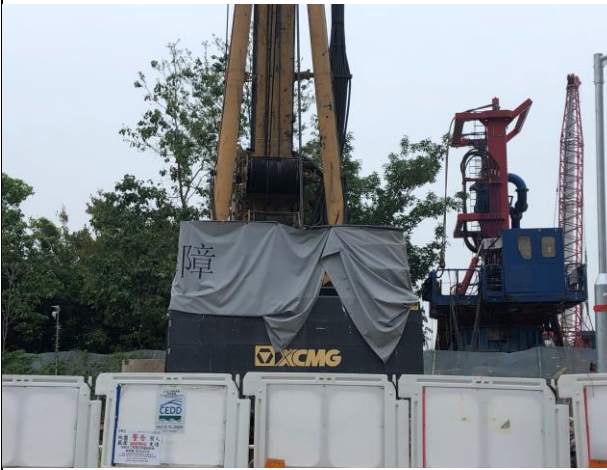
Ref*	Location/ Working Period	Anticipated Major Impacts	Recommended Mitigation Measures	Photo Records (Partial)
EIA S4.8	All site area	Noise impact	<ul style="list-style-type: none"> • Mobile plant should be sited as far away from NSRs as possible and practicable; • Install movable noise barriers and full enclosure, screen the noisy plants including air compressor and generator.

• An acoustic canvas had been deployed along the site boundary facing the resident of Shenzhen City.
