**Service Contract No. WD/04/2020
Development of Lok Ma Chau Loop:
Main Works Package 1 –
Environmental Team**

**Environmental Permit No.:
EP-477/2013/A
- Development of Lok Ma Chau Loop**

**Monthly Environmental Monitoring and
Audit Report for July 2023**

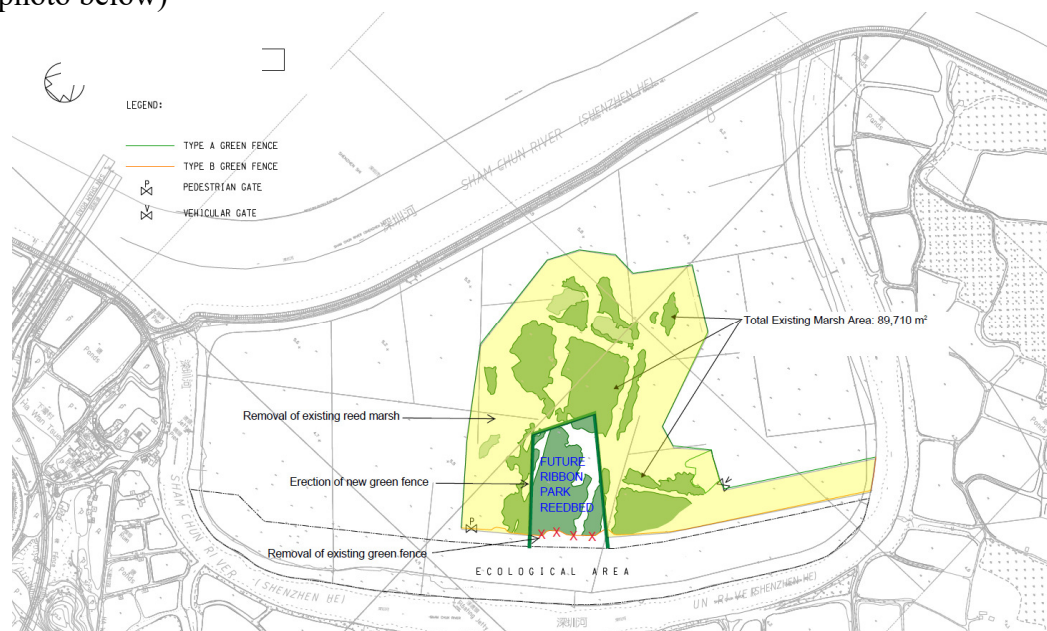
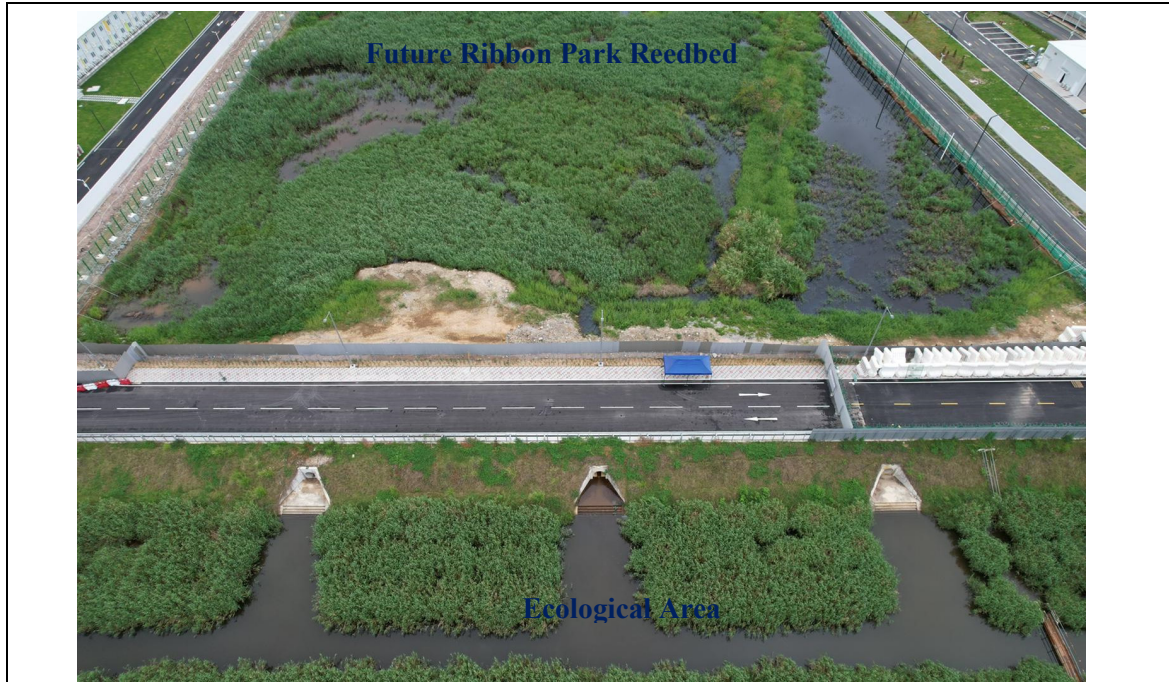
- 10.8 The green fence around the future Ribbon Park Reedbed has been removed and replaced by the hoarding due to the other project's land occupier since March 2022. (See Figure & photo below)

10.10 The Contractor was reminded to maintain the green fence around construction areas and ensure no disturbance to the existing trees and reed marsh habitat subject to the latest situation of LMC Loop.

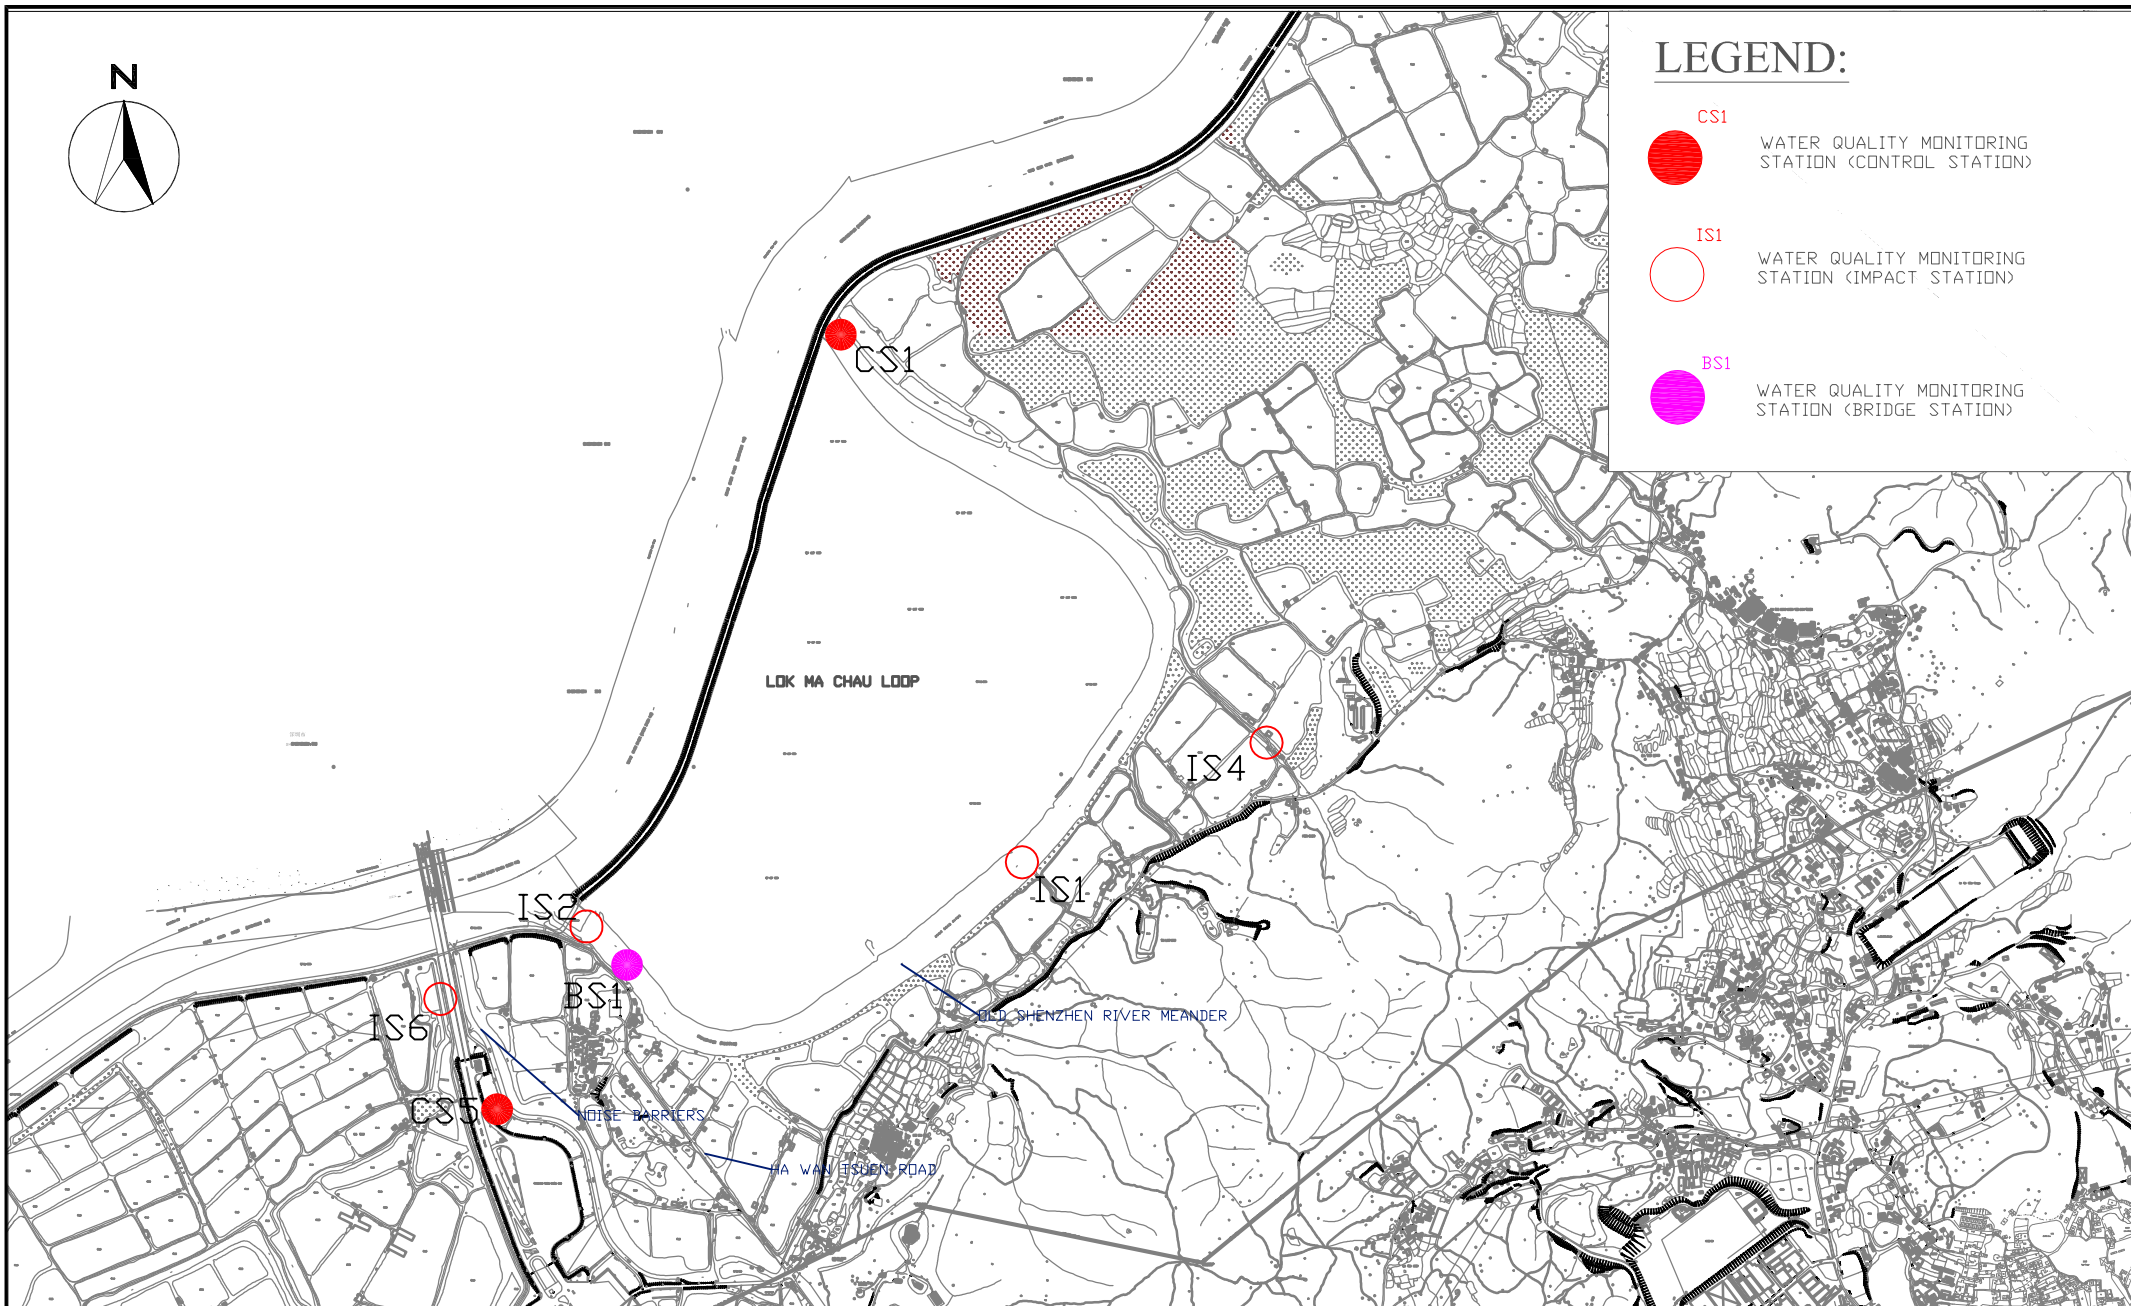
SCALE	1:400 A4	DATE	May 2021
CHECK	PC	DRAWN	IT
JOB No.	WMA 21009	FIGURE NO.	Fig 4
		REV	-

- CS1 WATER QUALITY MONITORING STATION (CONTROL STATION)
- IS1 WATER QUALITY MONITORING STATION (IMPACT STATION)
- BS1 WATER QUALITY MONITORING STATION (BRIDGE STATION)

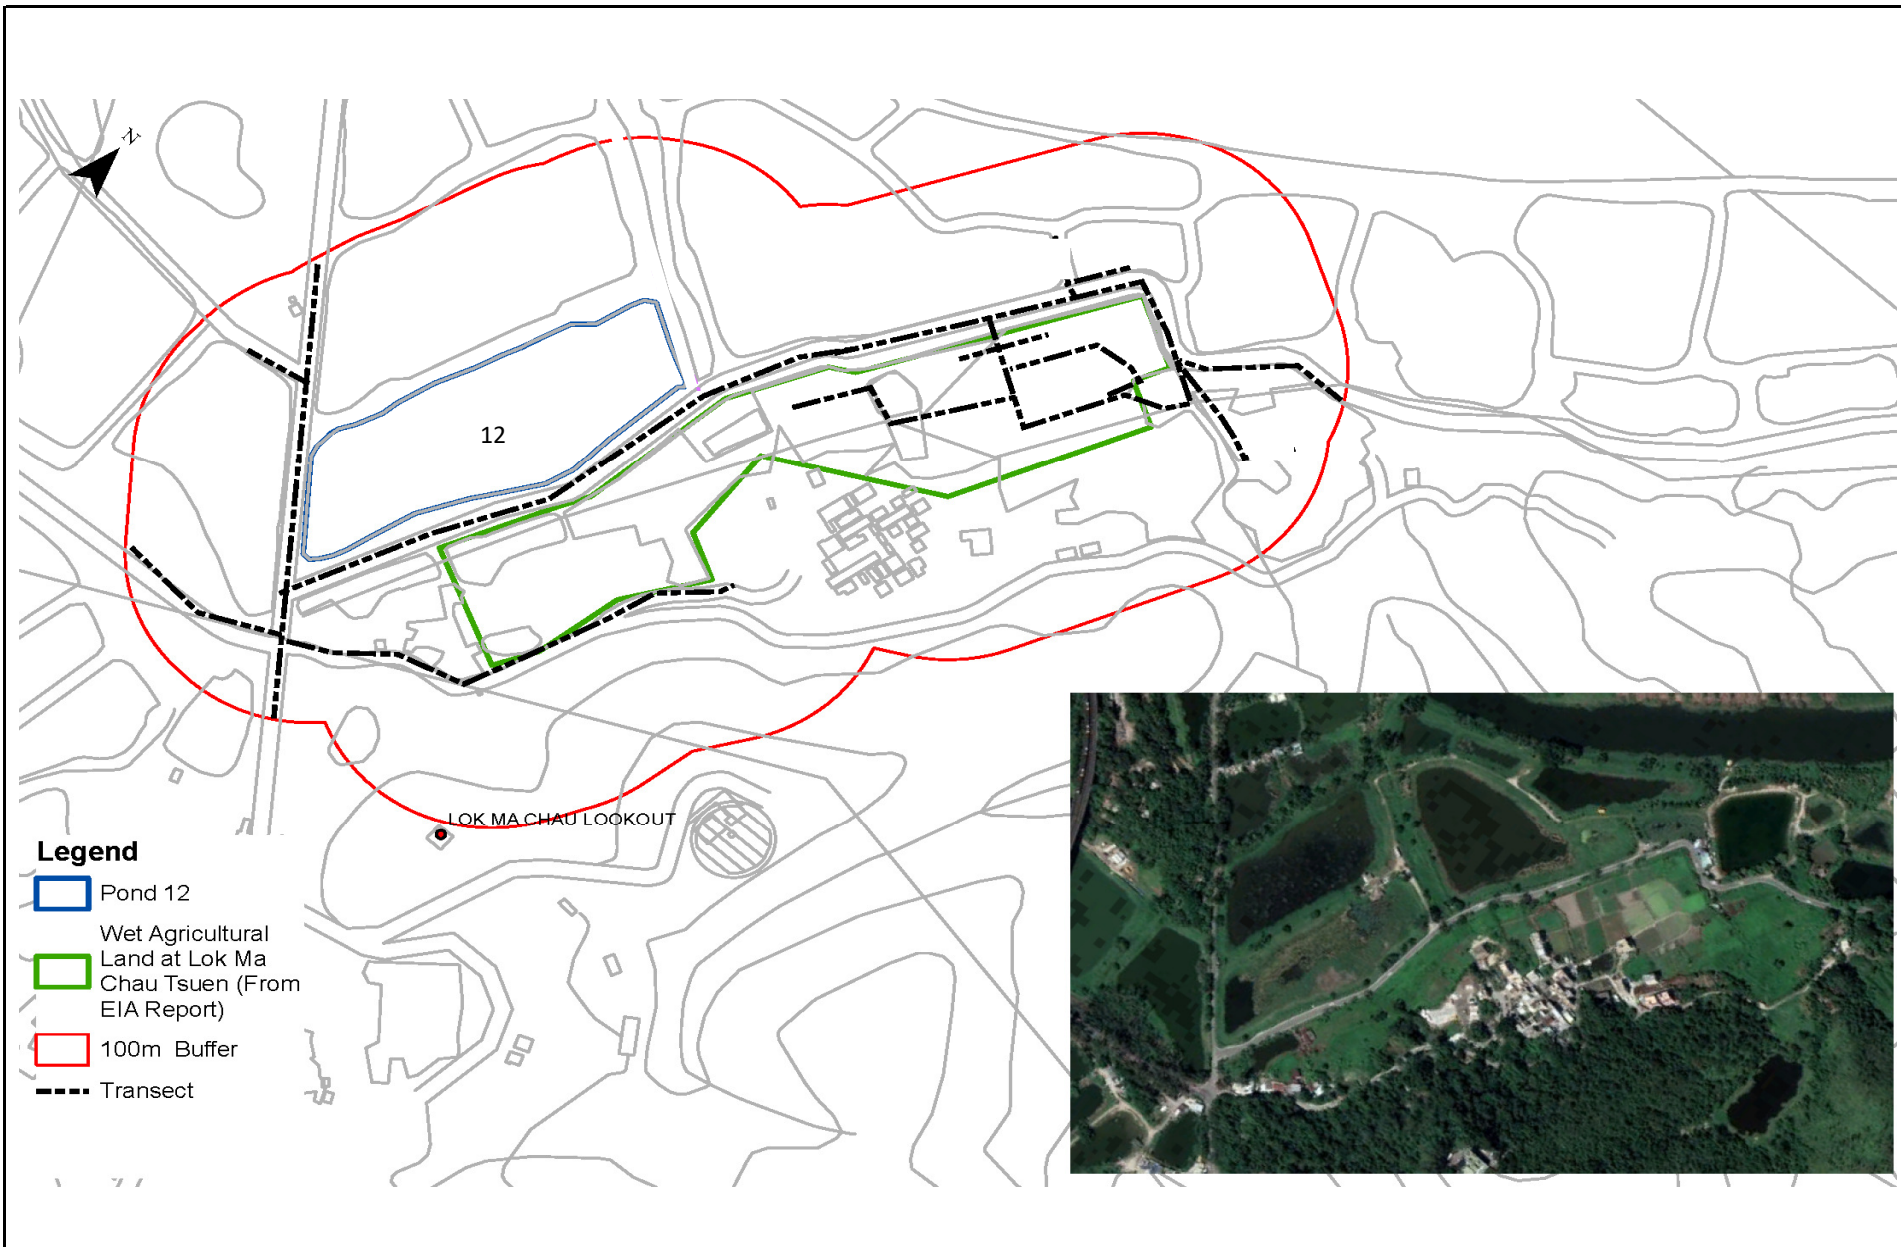
Scale	N.T.S	Project No.	WMA21009
Date	Mar-22	Figure	5b

Service Contract No. WD/04/2020
 Development of Lok Ma Chau Loop Main Work Package 1 - Environmental Team
 Locations of Transect for Monitoring of Chinese Bull Frog

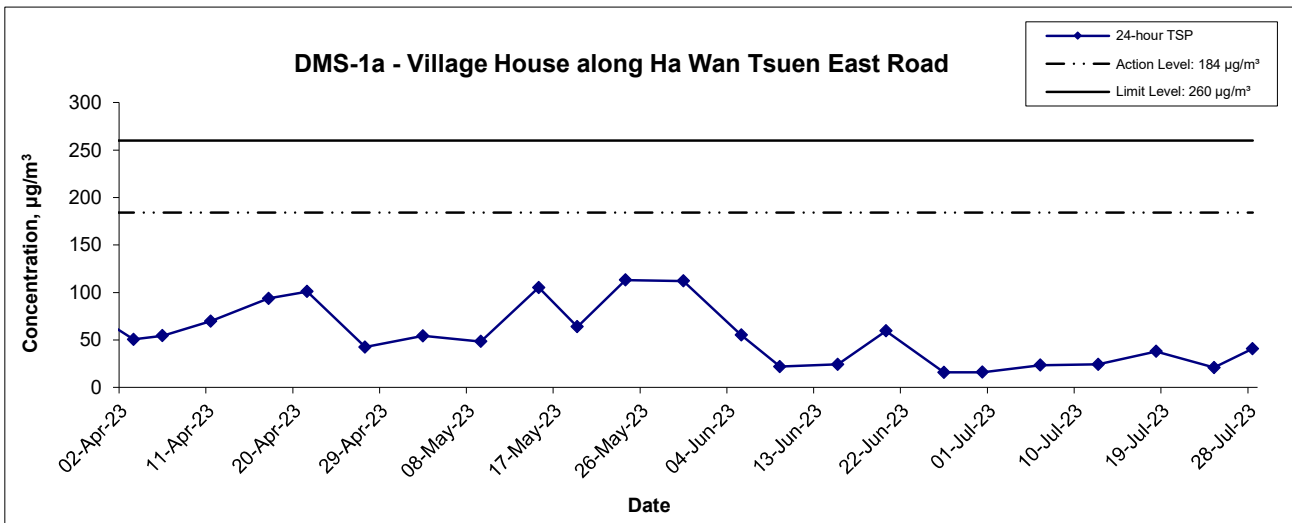
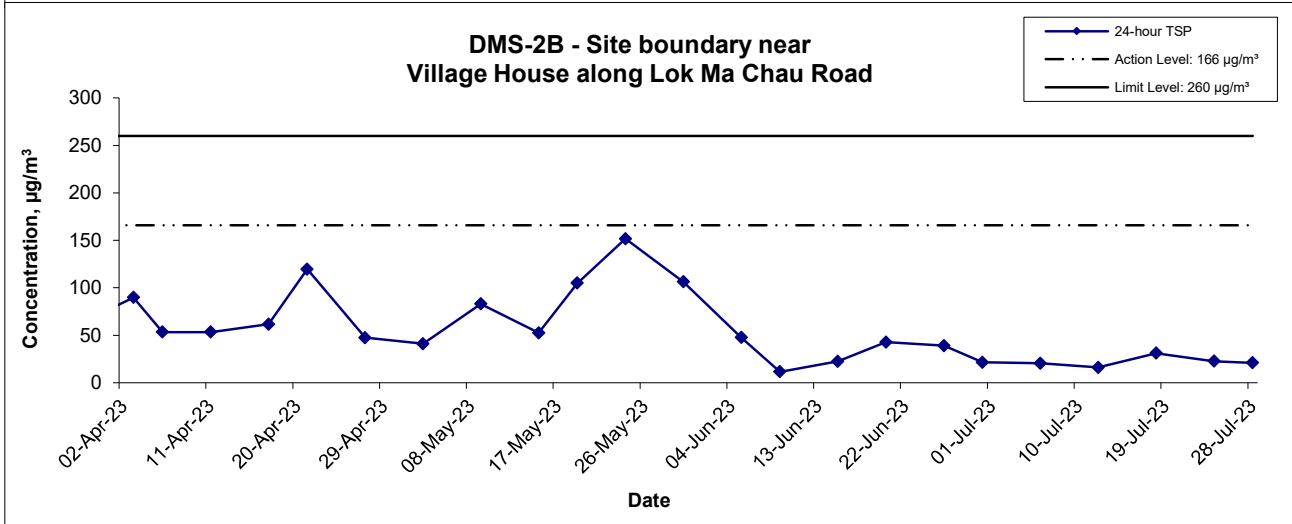
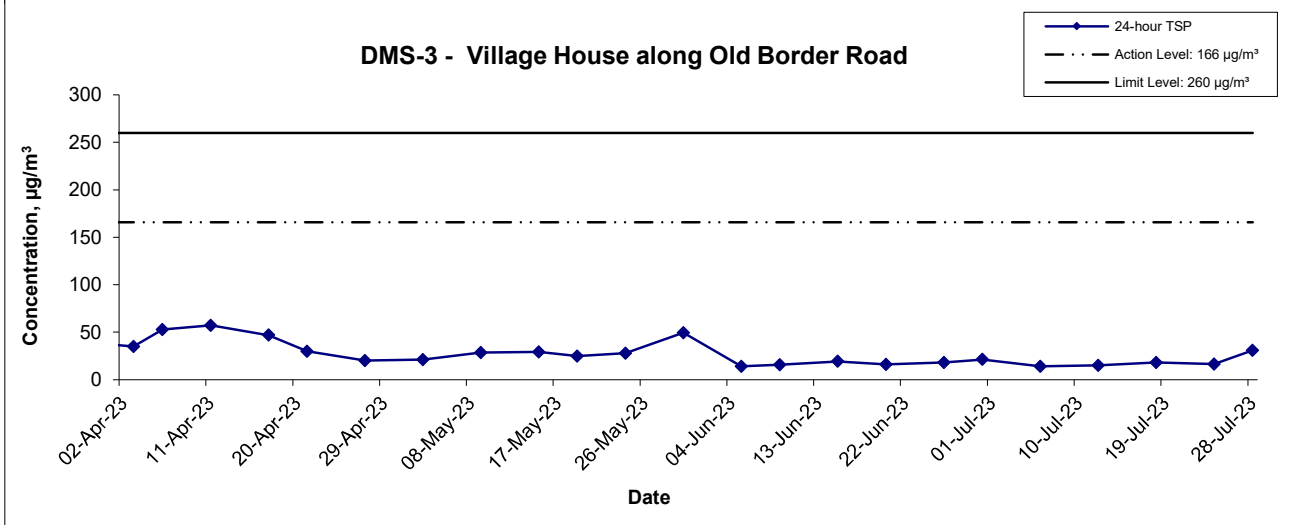
24-hour TSP Concentration Levels

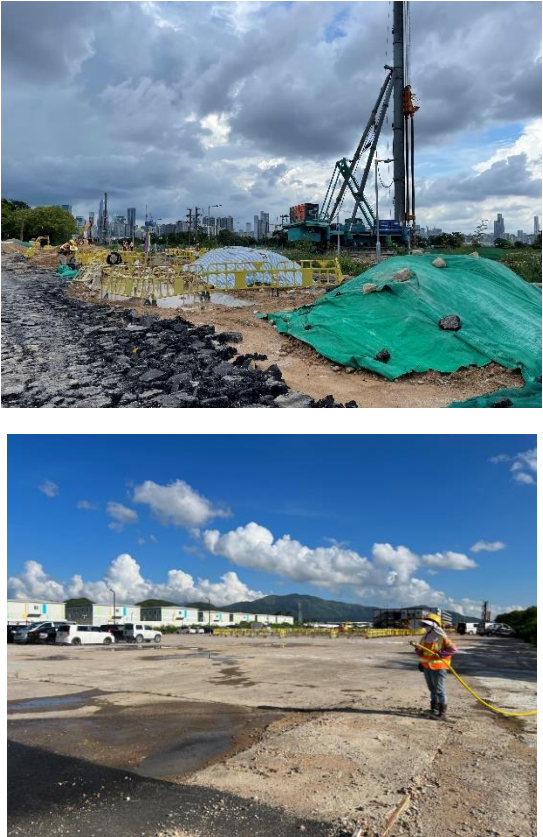
Ref	Location/ Working Period	Anticipated Major Impacts	Recommended Mitigation Measures	Photo Records (Partial)
EIA S3.8	All site area	Dust impact	<ul style="list-style-type: none"> Any excavated or stockpile of dusty material should be covered entirely by impervious sheeting or sprayed with water to maintain the entire surface wet and then removed or backfilled or reinstated where practicable within 24 hours of the excavation or unloading; Any dusty materials remaining after a stockpile is removed should be wetted with water and cleared from the surface of roads;

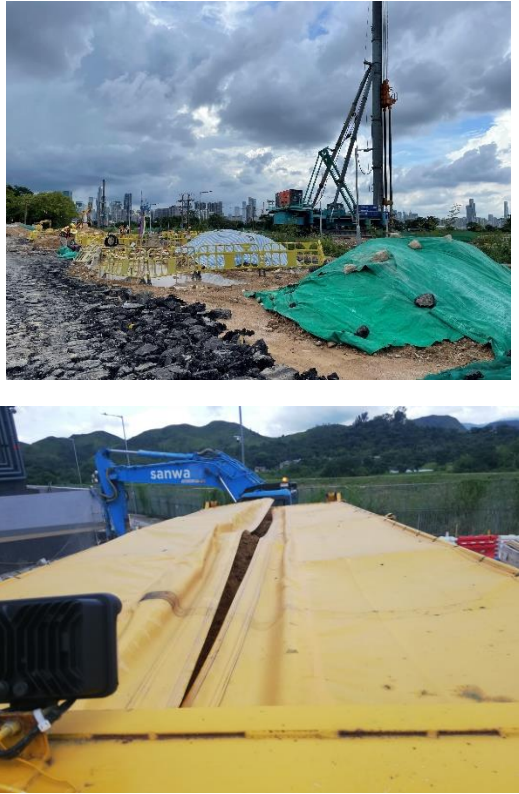
Ref	Location/ Working Period	Anticipated Major Impacts	Recommended Mitigation Measures	Photo Records (Partial)
EIA S3.8	All site area	Dust impact	<ul style="list-style-type: none"> • A stockpile of dusty material should not be extended beyond the pedestrian barriers, fencing or traffic cones; • The load of dusty materials on a vehicle leaving a construction site should be covered entirely by impervious sheeting to ensure that the dusty materials do not leak from the vehicle;

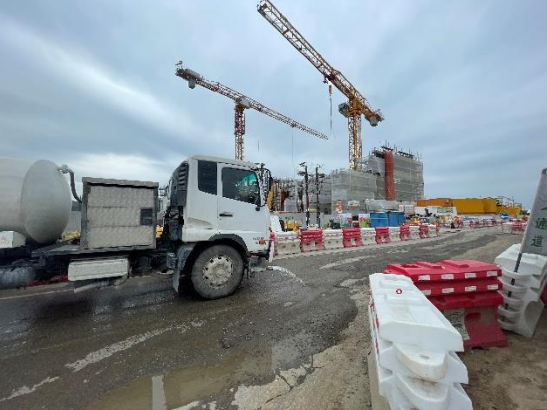
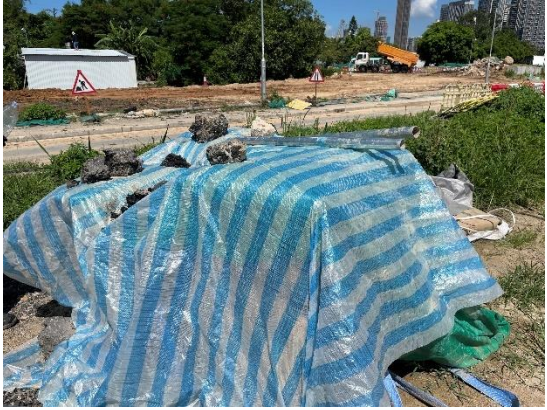
Ref	Location/ Working Period	Anticipated Major Impacts	Recommended Mitigation Measures	Photo Records (Partial)
EIA S3.8	All site area	Dust impact	<ul style="list-style-type: none"> • The portion of any road leading only to construction site that is within 30m of a vehicle entrance or exit should be kept clear of dusty materials; • Every stock of more than 20 bags of cement or dry pulverised fuel ash (PFA) should be covered entirely by impervious sheeting or placed in an area sheltered on the top and the 3 sides;

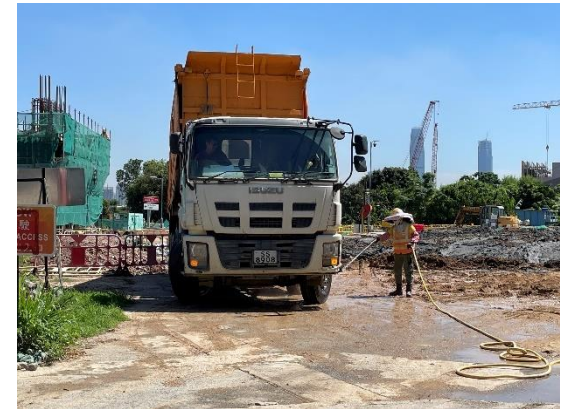
- Where practicable, vehicle washing facilities with high pressure water jet should be provided at every discernible or designated vehicle exit point. The area where vehicle washing takes place and the road section between the washing facilities and the exit point should be paved with concrete, bituminous materials or hardcores.

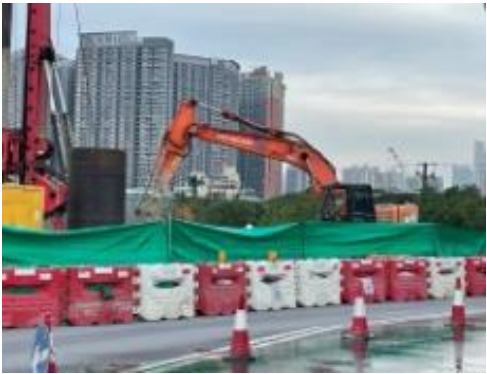
Ref	Location/ Working Period	Anticipated Major Impacts	Recommended Mitigation Measures	Photo Records (Partial)
EIA S4.8	All site area	Noise impact	<ul style="list-style-type: none"> • Mobile plant should be sited as far away from NSRs as possible and practicable; All generator used onsite are Quality Powered Mechanical Equipment (QPME) registered with EPD. • Install movable noise barriers and full enclosure, screen the noisy plants including air compressor and generator.

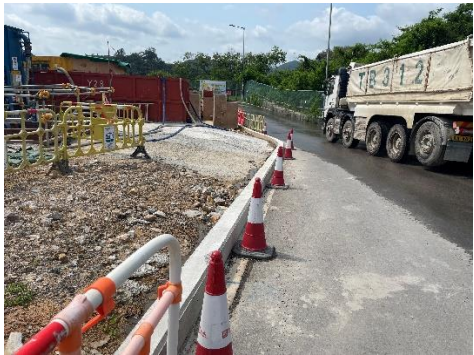
Ref	Location/ Working Period	Anticipated Major Impacts	Recommended Mitigation Measures	Photo Records (Partial)
EIA S5.7	All site area	Water Pollution Control	<ul style="list-style-type: none"> Update and implementation of Stormwater Pollution Control Plan. At the start of site establishment, perimeter cut-off drains to direct off-site water around the site should be constructed with internal drainage works and erosion and sedimentation control facilities implemented. Channels (both temporary and permanent drainage pipes and culverts), earth bunds or sand bag barriers should be provided on site to direct stormwater to silt removal facilities. The design of the temporary on-site

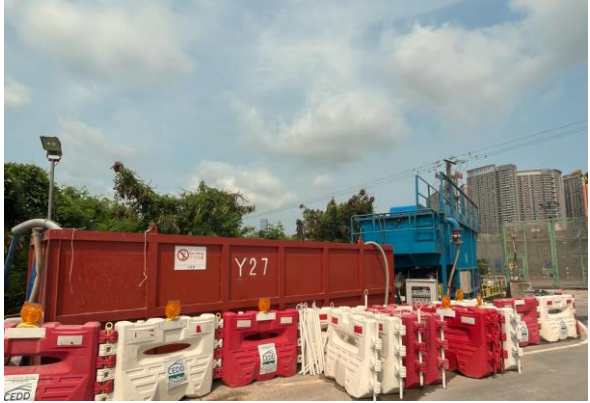
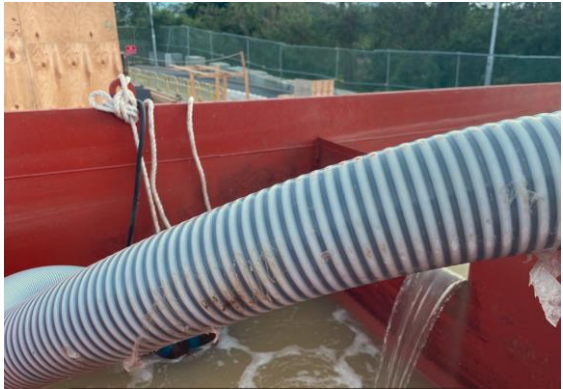
Ref	Location/ Working Period	Anticipated Major Impacts	Recommended Mitigation Measures	Photo Records (Partial)
			<p>drainage system will be undertaken by the contractor prior to the commencement of construction.</p> <ul style="list-style-type: none"> • Diversion of natural stormwater should be provided as far as possible. <p>The design of temporary on-site drainage should prevent runoff going through site surface, construction machinery and equipments in order to avoid or minimize polluted runoff.</p> <p>Sedimentation tanks with sufficient capacity, constructed from pre-formed individual cells of approximately 6 to 8 m3 capacities, are recommended as a general mitigation measure which can be used for settling surface runoff prior to disposal. The system capacity shall be flexible and able to handle multiple inputs from a variety of sources and suited to applications where the influent is pumped.</p>

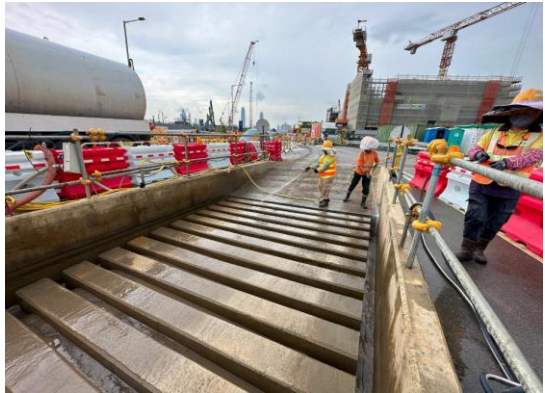
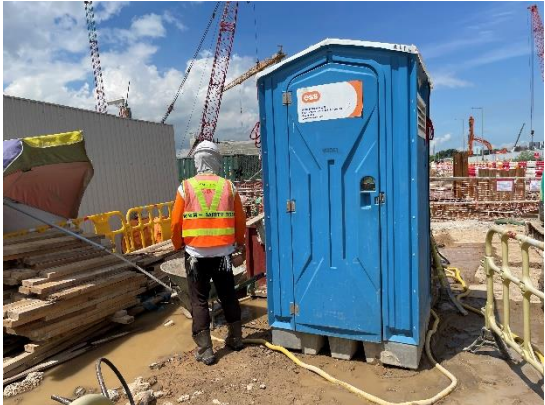
Ref	Location/ Working Period	Anticipated Major Impacts	Recommended Mitigation Measures	Photo Records (Partial)
			<ul style="list-style-type: none"> The design of efficient silt removal facilities should be based on the guidelines in Appendix A1 of ProPECC PN 1/94. The detailed design of the sand/silt traps should be undertaken by the contractor prior to the commencement of construction. <p>All drainage facilities and erosion and sediment control structures should be regularly inspected and maintained to ensure proper and efficient operation at all times and particularly following rainstorms.</p> <ul style="list-style-type: none"> Portable chemical toilets and sewage holding tanks should be provided for handling the construction sewage generated by the workforce. A licensed contractor should be employed to provide appropriate and adequate portable toilets to cater 0.15m³/day/employed populations and be responsible for appropriate disposal and maintenance.

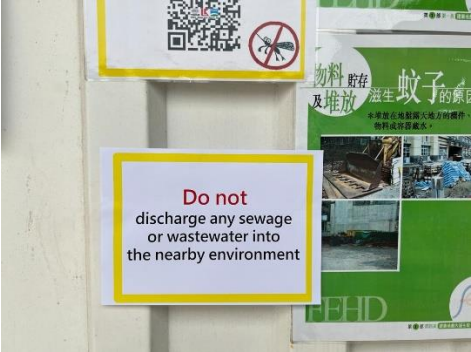
Ref	Location/ Working Period	Anticipated Major Impacts	Recommended Mitigation Measures	Photo Records (Partial)
			<ul style="list-style-type: none"> • Notices should be posted at conspicuous locations to remind the workers not to discharge any sewage or wastewater into the nearby environment during the construction phase of the Project. Regular environmental audit on the construction site should be conducted in order to provide an effective control of any malpractices and achieve continual improvement of environmental performance on site.

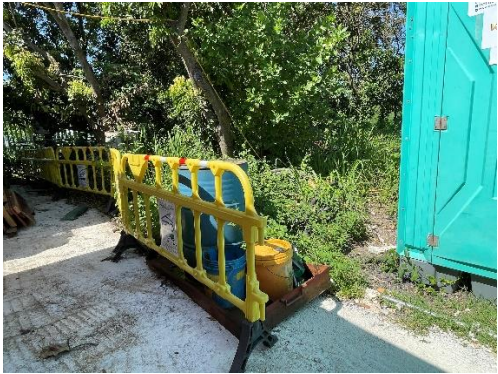
Ref	Location/ Working Period	Anticipated Major Impacts	Recommended Mitigation Measures	Photo Records (Partial)
EIA S7.6	All site area	Waste Generation	<ul style="list-style-type: none"> • Segregate and store different types of waste in different containers, skip or stockpiles to enhance reuse or recycling of materials and their proper disposal; • Proper storage and site practices to minimize the potential for damage and contamination of construction materials;

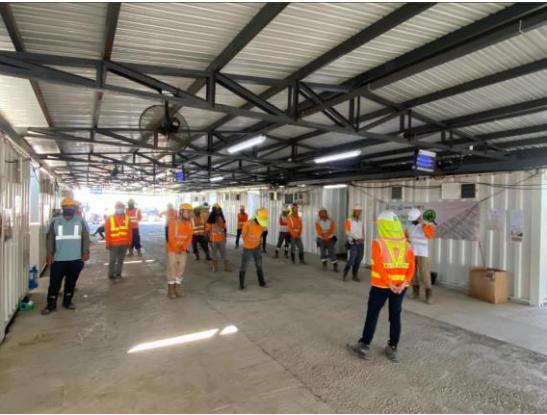
Ref	Location/ Working Period	Anticipated Major Impacts	Recommended Mitigation Measures	Photo Records (Partial)
			<ul style="list-style-type: none"> • Provide training to workers on the importance of appropriate waste management procedures, including waste reduction, reuse and recycling.

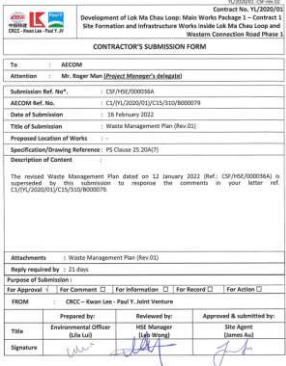
Ref	Location/ Working Period	Anticipated Major Impacts	Recommended Mitigation Measures	Photo Records (Partial)
			<ul style="list-style-type: none"> • Prepare Waste Management Plan and submit to the Engineer for approval • Proper storage and sorting of excavated inert materials to maximize on site reuse for backfilling

<p>The screenshot shows a 'CONTRACTOR'S SUBMISSION FORM' for a Waste Management Plan. It includes fields for 'To: AECOM', 'Attention: Mr. Roger Man', 'Submission Ref. No.', 'AECOM Ref. No.', 'Date of Submission: 16 February 2022', 'Title of Submission: Waste Management Plan (Rev.02)', 'Prepared Location of Works', 'Specification/Drawing Reference: PS Clause 25.20(47)', and 'Description of Content'. A table at the bottom shows the 'Prepared by', 'Reviewed by', and 'Approved & submitted by' with their respective titles and signatures. Below the form is a photograph of a construction site where excavated materials are covered with blue tarpaulin.</p>

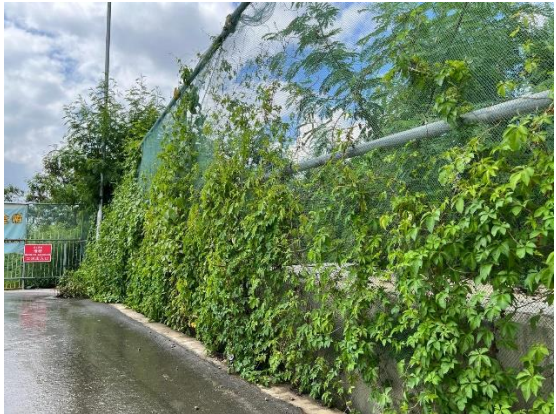
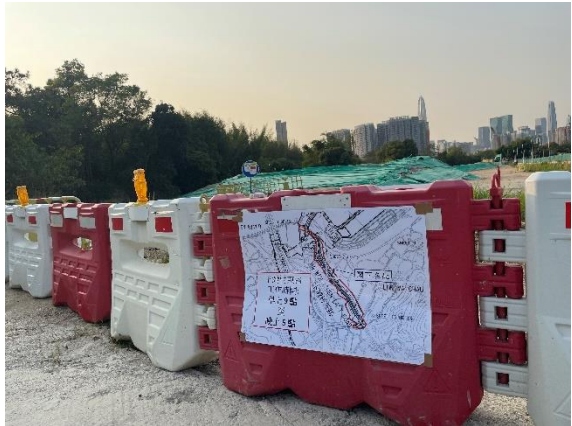
Ref	Location/ Working Period	Anticipated Major Impacts	Recommended Mitigation Measures	Photo Records (Partial)
EIA 12.7 EP 2.7	<p>Constructi on site within the project</p> <p>Pond habitat along alignment (mainly Ha Wan Tsuen Road)</p>	Ecology	<p>Installing 3m high olive-green fence around construction areas to allow or deter different animal passages where appropriate;</p> <p>Carrying out outside dry-season (from November to February next year), the construction works associated with the site formation in the Ecological Area, stabilization of the bank of the old Shenzhen River meander, Western Connection Road along Ha Wan Tsuen Road, to minimise disturbances to migratory birds/water birds;</p>

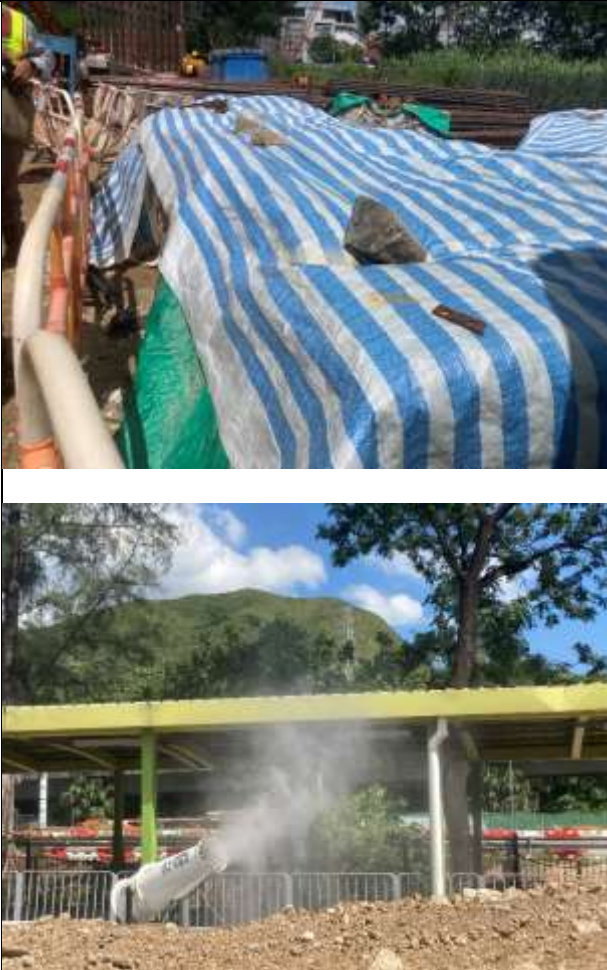
Ref*	Location/Working Period	Anticipated Major Impacts	Recommended Mitigation Measures	Photo Records (Partial)
EIA S3.8	All site area	Dust impact	<ul style="list-style-type: none"> Any excavated or stockpile of dusty material should be covered entirely by impervious sheeting or sprayed with water to maintain the entire surface wet and then removed or backfilled or reinstated where practicable within 24 hours of the excavation or unloading; Any dusty materials remaining after a stockpile is removed should be wetted with water and cleared from the surface of roads;

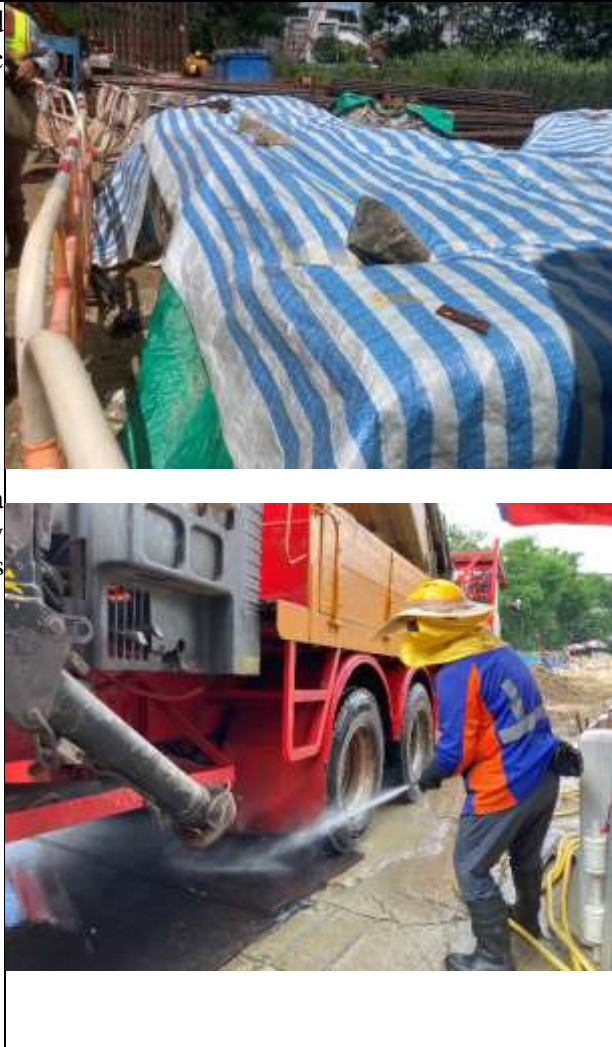
Ref*	Location/ Working Period	Anticipated Major Impacts	Recommended Mitigation Measures	Photo Records (Partial)
EIA S3.8	All site area	Dust impact	<ul style="list-style-type: none"> • A stockpile of dusty material should not be extend beyond the pedestrian barriers, fencing or traffic cones; • The load of dusty materials on a vehicle leaving a construction site should be covered entirely by impervious sheeting to ensure that the dusty materials do not leak from the vehicle;

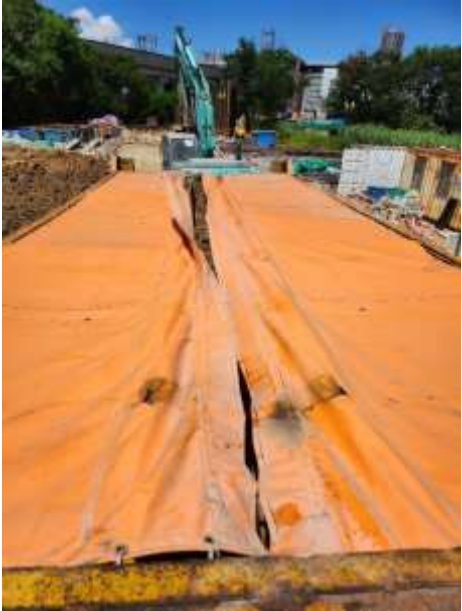
<ul style="list-style-type: none">• The portion of any road leading only to construction site that is within 30m of a vehicle entrance or exit should be kept clear of dusty materials;

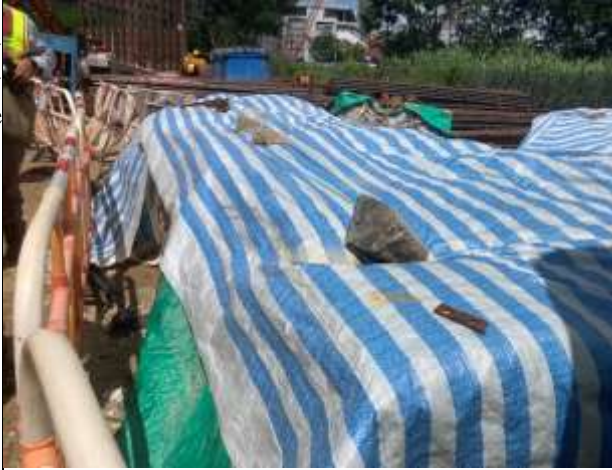
<ul style="list-style-type: none">• Every stock of more than 20 bags of cement or dry pulverised fuel ash (PFA) should be covered entirely by impervious sheeting or placed in an area sheltered on the top and the 3 sides;

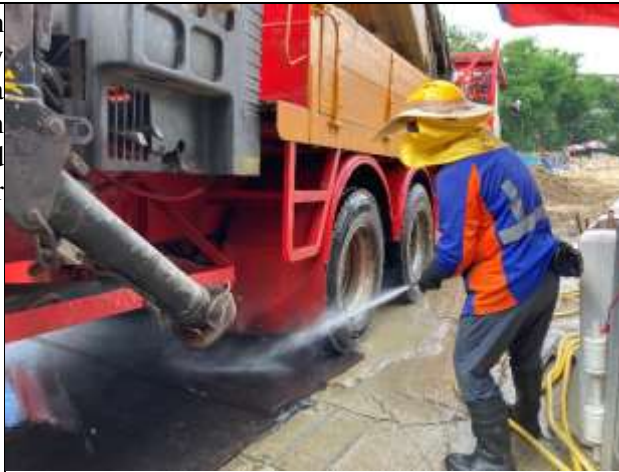
<ul style="list-style-type: none">• Where practicable, vehicle washing facilities with high pressure water jet should be provided at every discernible or designated vehicle exit point. The area where vehicle washing takes place and the road section between the washing facilities and the exit point should be paved with concrete, bituminous materials or hardcores.

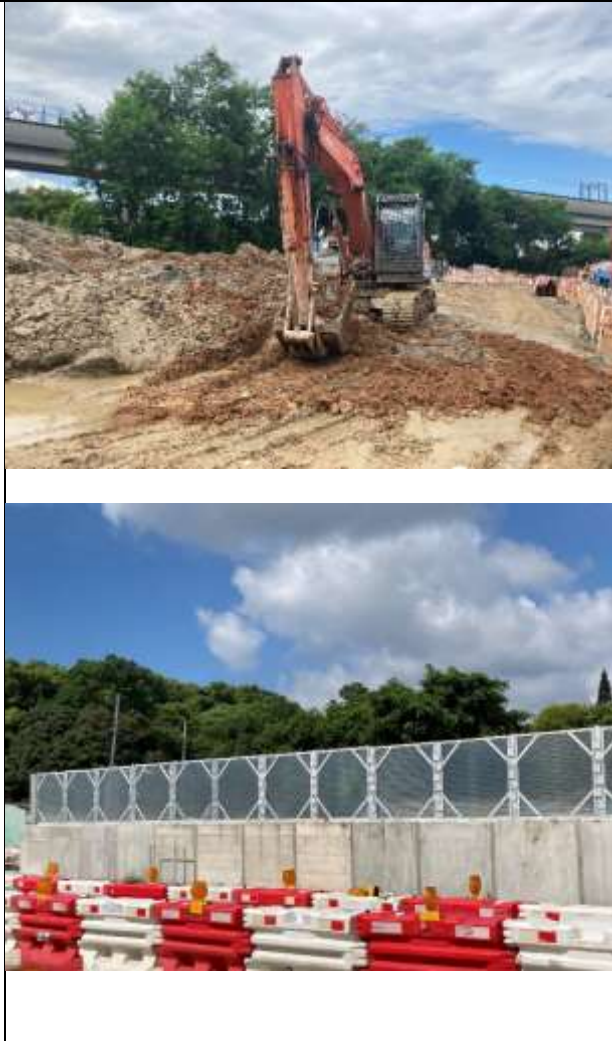
Ref*	Location/ Working Period	Anticipated Major Impacts	Recommended Mitigation Measures	Photo Records (Partial)
EIA S4.8	All site area	Noise impact	<ul style="list-style-type: none"> • Mobile plant should be sited as far away from NSRs as possible and practicable; • Install movable noise barriers and full enclosure, screen the noisy plants including air compressor and generator.

<p>The top photograph shows an orange excavator working on a dirt site with a large pile of earth. The bottom photograph shows a concrete noise barrier with a metal mesh screen, with red and white traffic barrels in the foreground.</p>

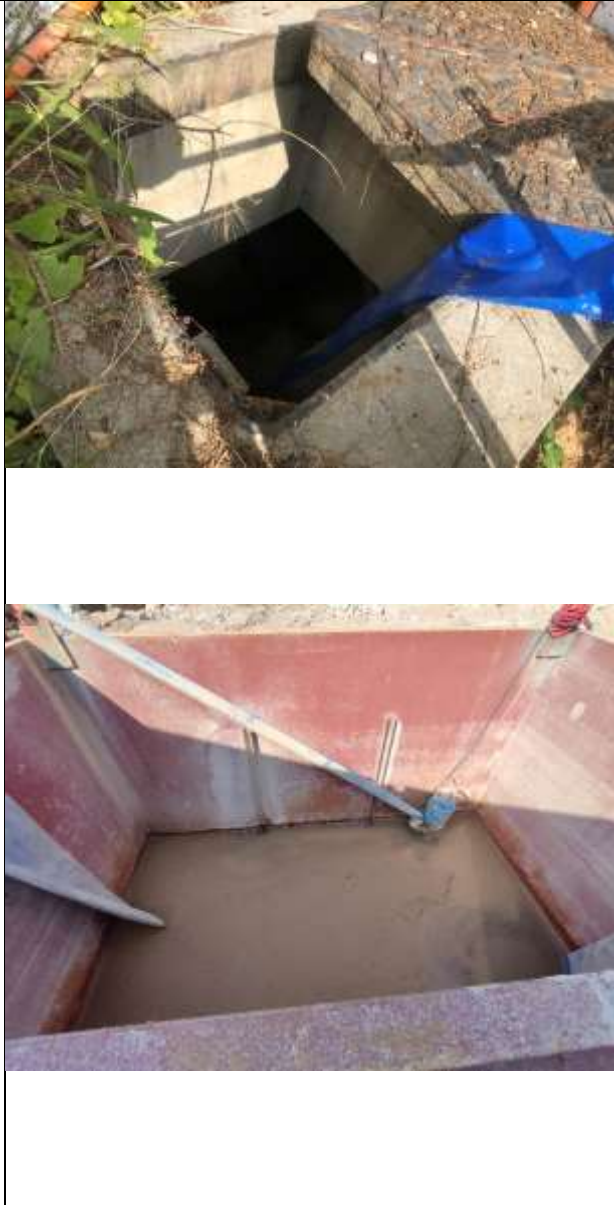
EIA S5.7	All site area	Water Pollution Control	<ul style="list-style-type: none">• At the start of site establishment, perimeter cut-off drains to direct off-site water around the site should be constructed with internal drainage works and erosion and sedimentation control facilities implemented. Channels (both temporary and permanent drainage pipes and culverts), earth bunds or sand bag barriers should be provided on site to direct stormwater to silt removal facilities. The design of the temporary on-site drainage system will be undertaken by the contractor prior to the commencement of construction. • Diversion of natural stormwater should be provided as far as possible. The design of temporary on-site drainage should prevent runoff going through site surface, construction machinery and equipment in order to avoid or minimize polluted runoff.

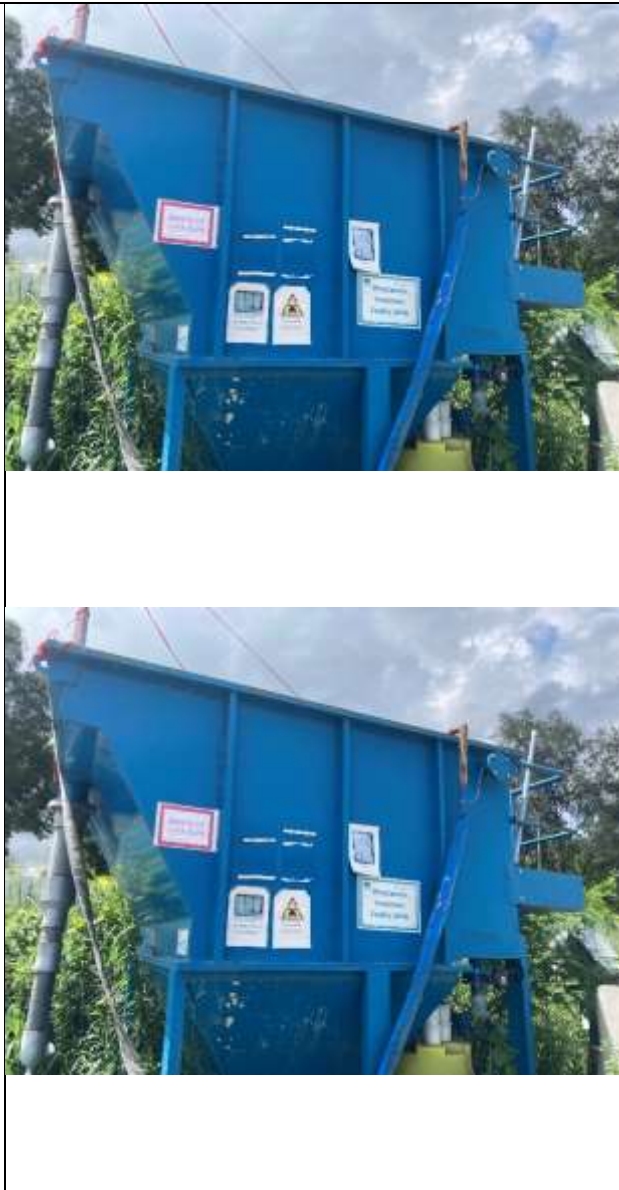
<ul style="list-style-type: none">• Sedimentation tanks with sufficient capacity, constructed from pre-formed individual cells of approximately 6 to 8 m³ capacities, are recommended as a general mitigation measure which can be used for settling surface runoff prior to disposal. The system capacity shall be flexible and able to handle multiple inputs from a variety of sources and suited to applications where the influent is pumped. • The design of efficient silt removal facilities should be based on the guidelines in Appendix A1 of ProPECC PN 1/94. The detailed design of the sand/silt traps should be undertaken by the contractor prior to the commencement of construction.

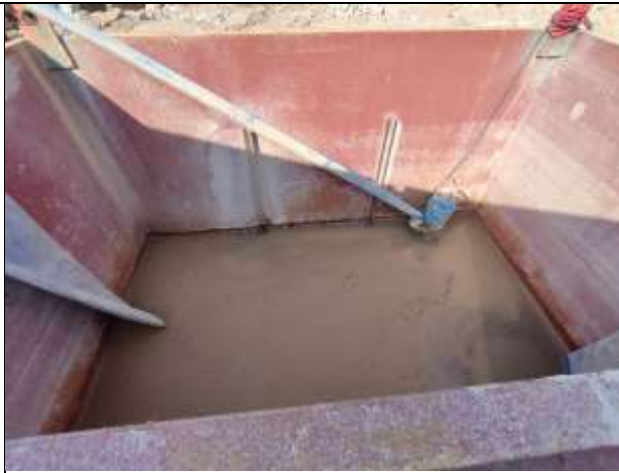
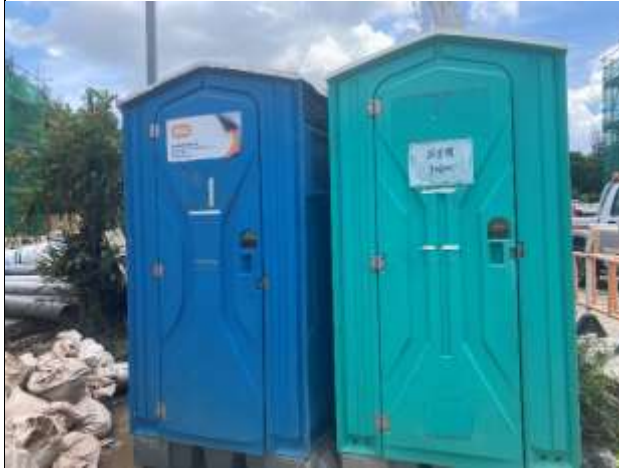
<ul style="list-style-type: none">• All drainage facilities and erosion and sediment control structures should be regularly inspected and maintained to ensure proper and efficient operation at all times and particularly following rainstorms. • Portable chemical toilets and sewage holding tanks should be provided for handling the construction sewage generated by the workforce. A licensed contractor should be employed to provide appropriate and adequate portable toilets to cater 0.15m³/day/employed populations and be responsible for appropriate disposal and maintenance.

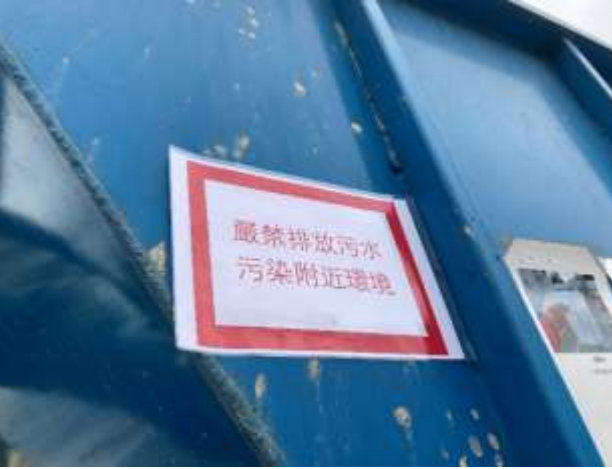
<ul style="list-style-type: none">• Notices should be posted at conspicuous locations to remind the workers not to discharge any sewage or wastewater into the nearby environment during the construction phase of the Project. Regular environmental audit on the construction site should be conducted in order to provide an effective control of any malpractices and achieve continual improvement of environmental performance on site.

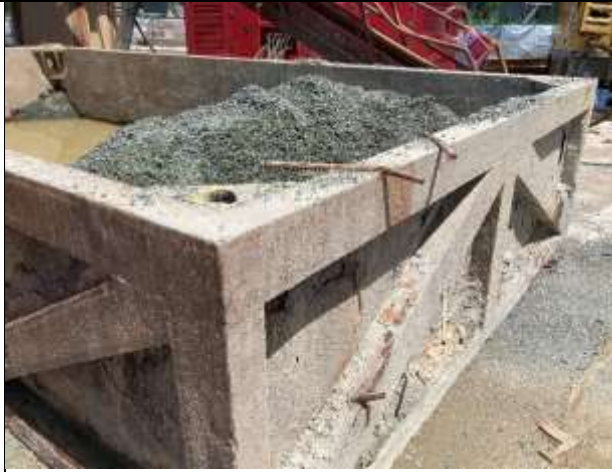
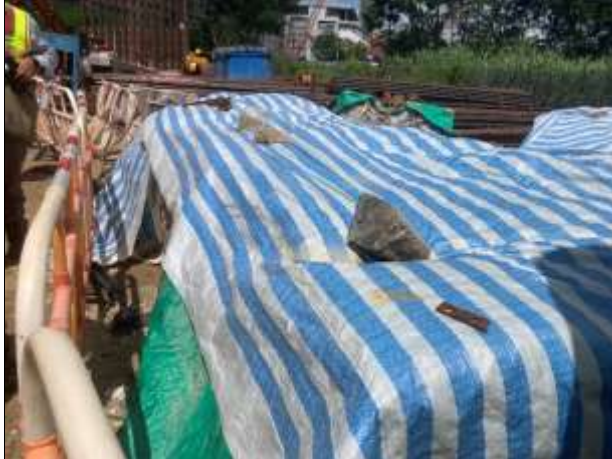
Ref*	Location/ Working Period	Anticipated Major Impacts	Recommended Mitigation Measures	Photo Records (Partial)
EIA S7.6	All site area	Waste Generation	<ul style="list-style-type: none"> • Segregate and store different types of waste in different containers, skip or stockpiles to enhance reuse or recycling of materials and their proper disposal; • Proper storage and site practices to minimize the potential for damage and contamination of construction materials;
