**Service Contract No. WD/04/2020
Development of Lok Ma Chau Loop:
Main Works Package 1 –
Environmental Team**

**Environmental Permit No.:
EP-477/2013/A
- Development of Lok Ma Chau Loop**

**Monthly Environmental Monitoring and
Audit Report for July 2023**

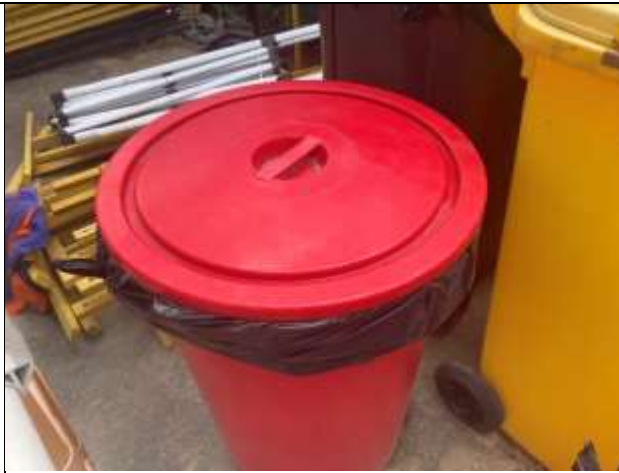
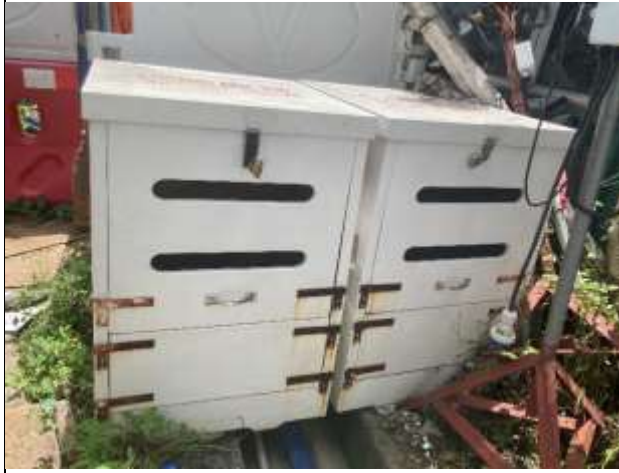
<ul style="list-style-type: none">• Preferably enclosed and covered areas should be provided for general refuse collection and routine cleaning for these areas should also be implemented to keep areas clean. • If chemical wastes are produced at the construction site, the Contractors should register with EPD as chemical waste producers. Chemical wastes should be stored in appropriate containers and collected by a licensed chemical waste contractor. Chemical wastes (e.g. spent lubricant oil) should be recycled at an appropriate facility as far as possible, while the chemical waste that cannot be recycled should be disposed of at either the Chemical Waste Treatment Centre, or another licensed facility, in accordance with the Waste Disposal (Chemical Waste) (General) Regulation.

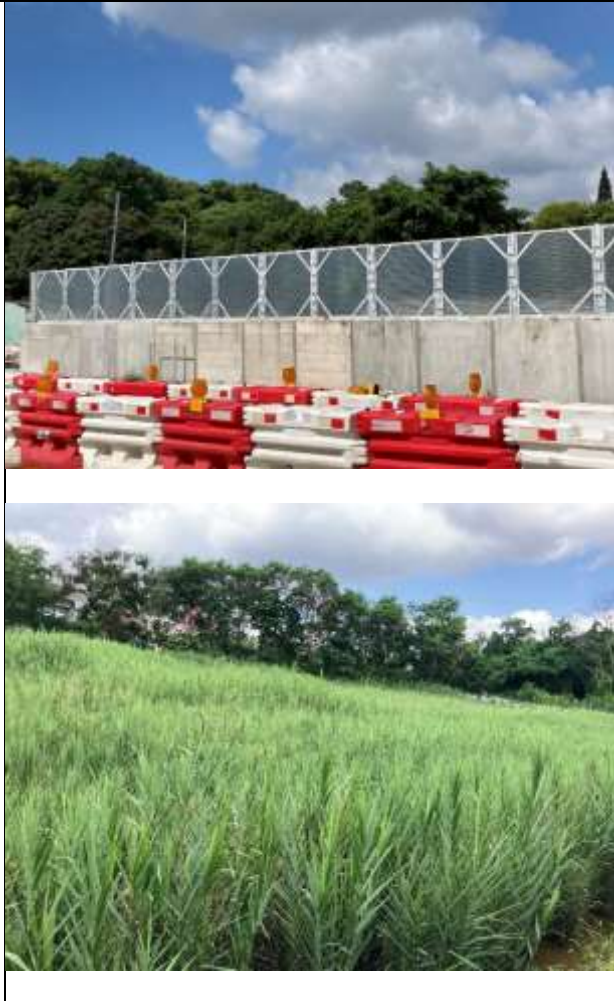
Ref*	Location/ Working Period	Anticipated Major Impacts	Recommended Mitigation Measures	Photo Records (Partial)
EIA S12.7	All site area	Ecology	<ul style="list-style-type: none"> • Use opaque, non-transparent, non-reflective noise barriers for all developments associated with the Project. • On-site compensate the same area of the occupied reedbed

<p>The top photograph shows a construction site with a concrete wall topped with a silver, diamond-patterned noise barrier. In the foreground, there are several rows of red and white plastic water-filled barriers. The background features green trees under a blue sky with white clouds.</p> <p>The bottom photograph shows a lush green reedbed with tall, dense grasses growing on a slight slope. The background consists of a line of trees under a cloudy sky.</p>

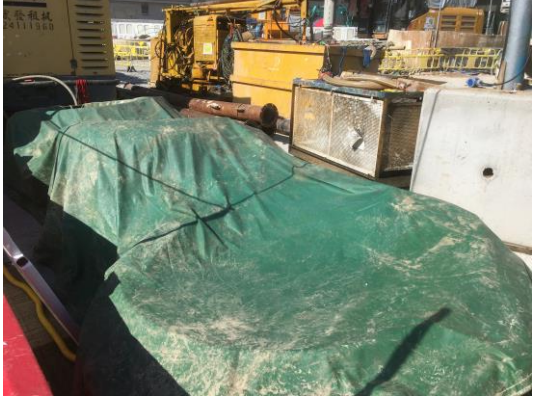
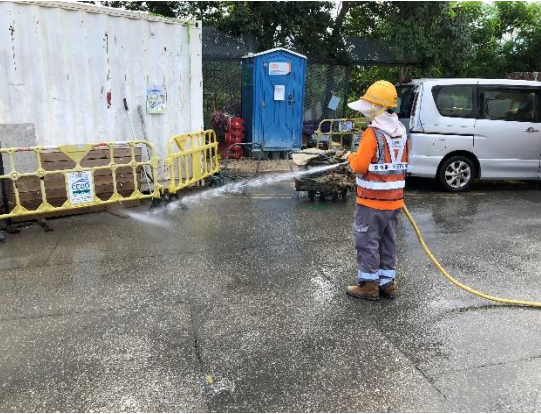
Ref*	Location/ Working Period	Anticipated Major Impacts	Recommended Mitigation Measures	Photo Records (Partial)
EIA S3.8	All site area	Dust impact	<ul style="list-style-type: none"> Any excavated or stockpile of dusty material should be covered entirely by impervious sheeting or sprayed with water to maintain the entire surface wet and then removed or backfilled or reinstated where practicable within 24 hours of the excavation or unloading; Any dusty materials remaining after a stockpile is removed should be wetted with water and cleared from the surface of roads;

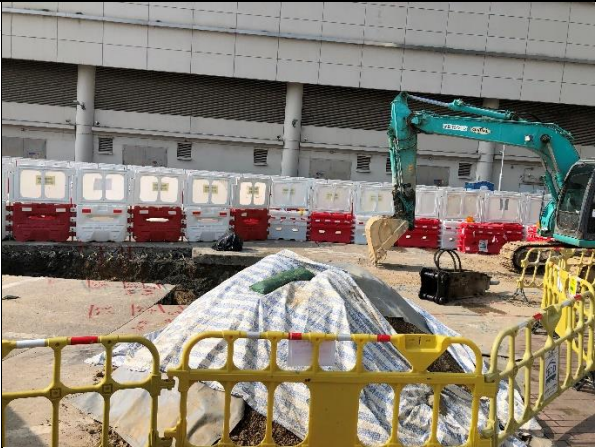
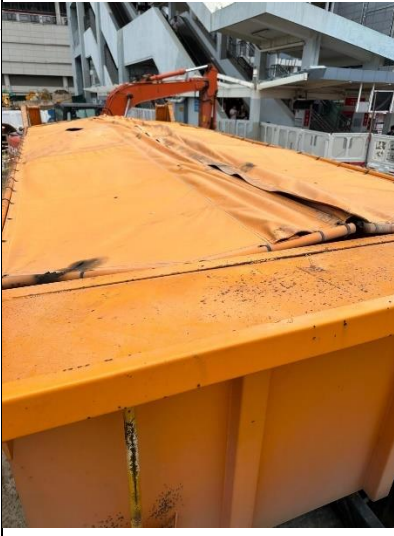
Ref*	Location/ Working Period	Anticipated Major Impacts	Recommended Mitigation Measures	Photo Records (Partial)
EIA S3.8	All site area	Dust impact	<ul style="list-style-type: none"> • A stockpile of dusty material should not be extend beyond the pedestrian barriers, fencing or traffic cones; • The load of dusty materials on a vehicle leaving a construction site should be covered entirely by impervious sheeting to ensure that the dusty materials do not leak from the vehicle;

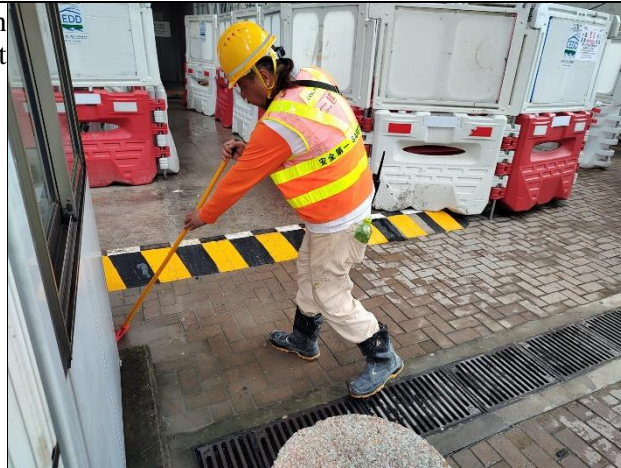
• The portion of any road leading only to construction site that is within 30m of a vehicle entrance or exit should be kept clear of dusty materials;

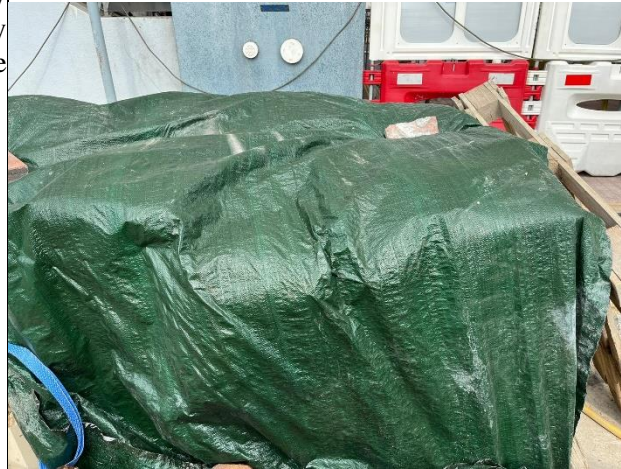
• Every stock of more than 20 bags of cement or dry pulverised fuel ash (PFA) should be covered entirely by impervious sheeting or placed in an area sheltered on the top and the 3 sides;

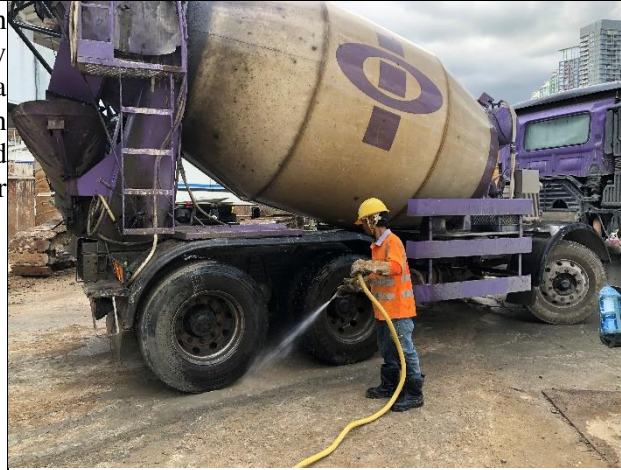
- Where practicable, vehicle washing facilities with high pressure water jet should be provided at every discernible or designated vehicle exit point. The area where vehicle washing takes place and the road section between the washing facilities and the exit point should be paved with concrete, bituminous materials or hardcores.

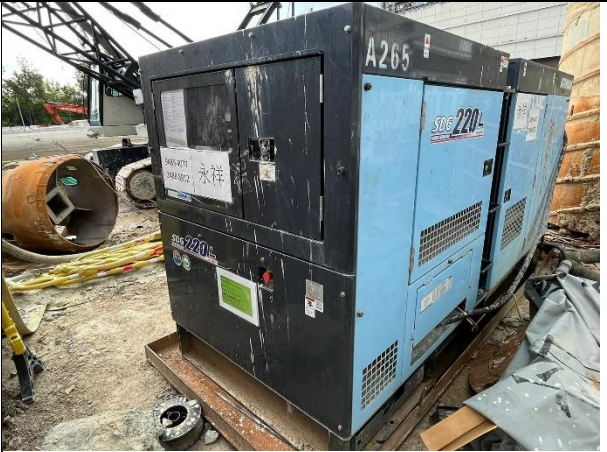
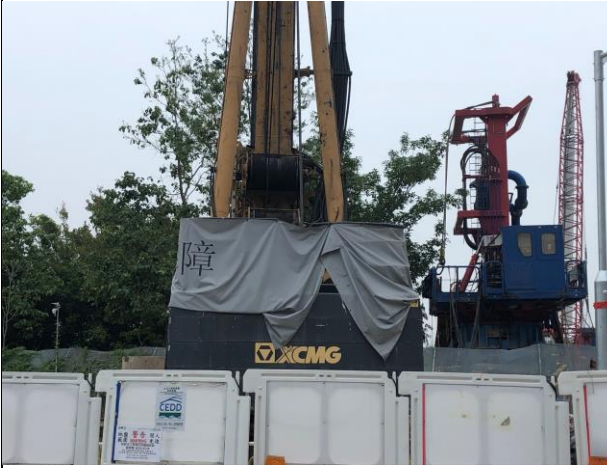
• An acoustic canvas had been deployed along the site boundary facing the resident of Shenzhen City.

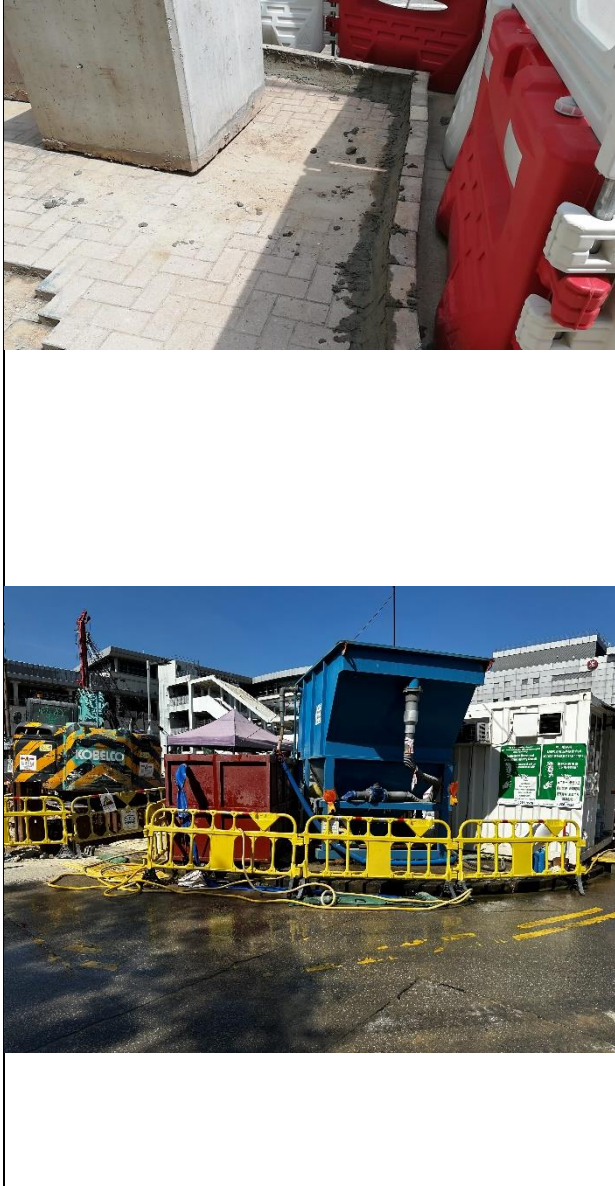
<ul style="list-style-type: none">• Diversion of natural stormwater should be provided as far as possible. The design of temporary on-site drainage should prevent runoff going through site surface, construction machinery and equipment in order to avoid or minimize polluted runoff. • Sedimentation tanks with sufficient capacity, constructed from pre-formed individual cells of approximately 6 to 8 m³ capacities, are recommended as a general mitigation measure which can be used for settling surface runoff prior to disposal. The system capacity shall be flexible and able to handle multiple inputs from a variety of sources and suited to applications where the influent is pumped.

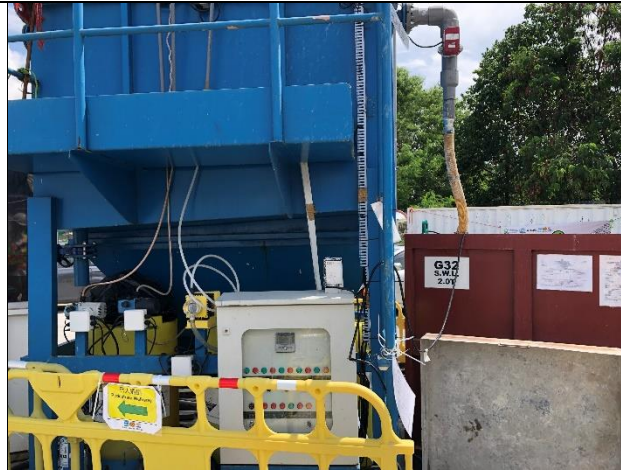
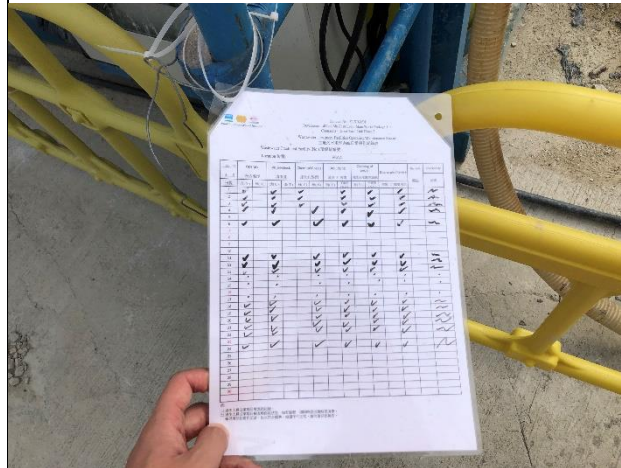
• The design of efficient silt removal facilities should be based on the guidelines in Appendix A1 of ProPECC PN 1/94. The detailed design of the sand/silt traps should be undertaken by the contractor prior to the commencement of construction.

• All drainage facilities and erosion and sediment control structures should be regularly inspected and maintained to ensure proper and efficient operation at all times and particularly following rainstorms.

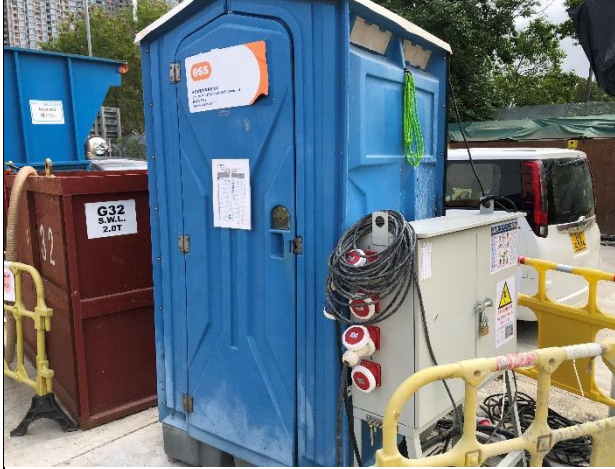
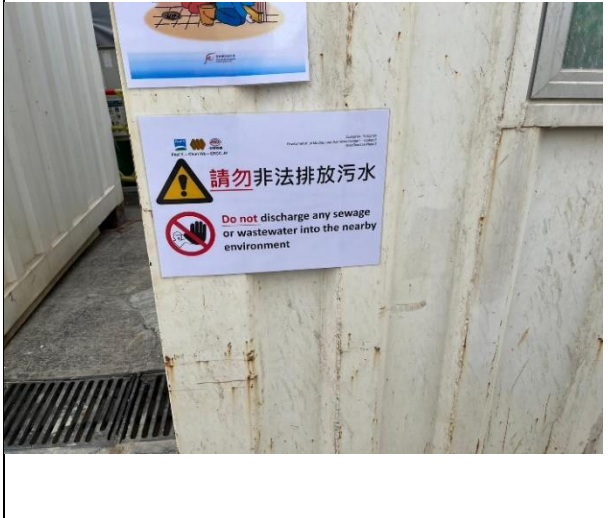
<ul style="list-style-type: none">• Portable chemical toilets and sewage holding tanks should be provided for handling the construction sewage generated by the workforce. A licensed contractor should be employed to provide appropriate and adequate portable toilets to cater 0.15m³/day/employed populations and be responsible for appropriate disposal and maintenance. • Notices should be posted at conspicuous locations to remind the workers not to discharge any sewage or wastewater into the nearby environment during the construction phase of the Project. Regular environmental audit on the construction site should be conducted in order to provide an effective control of any malpractices and achieve continual improvement of environmental performance on site.

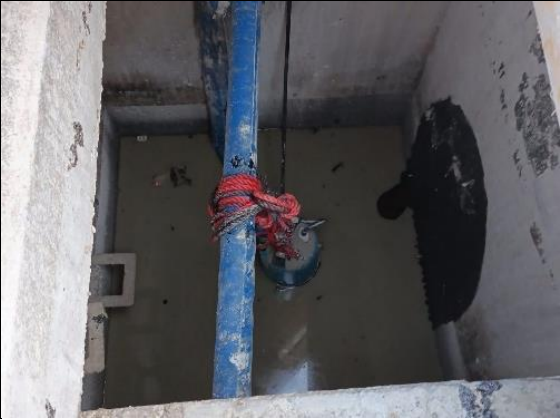
<ul style="list-style-type: none">•An additional water pump had been set up and the concerned outlet have been sealed up with concrete

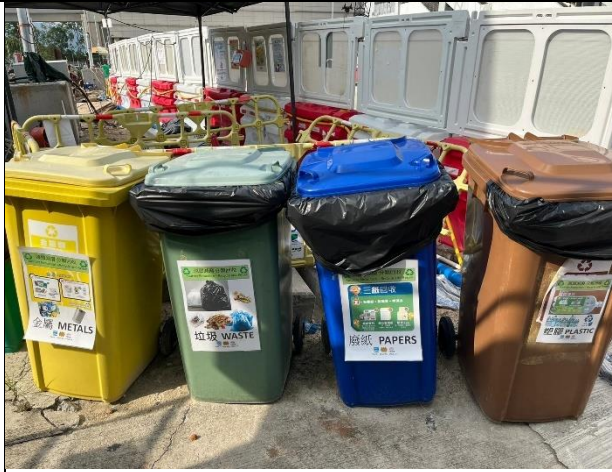
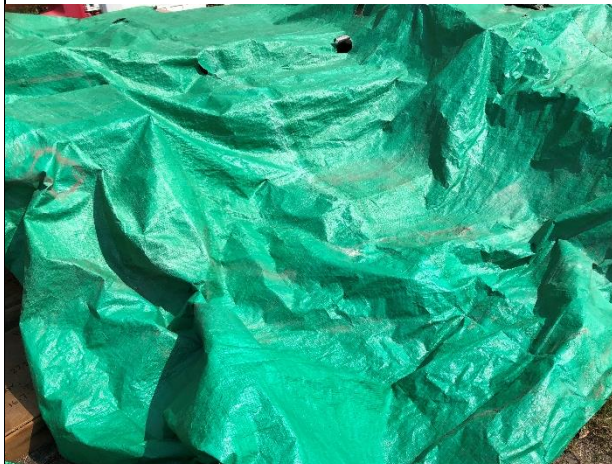
Ref*	Location/ Working Period	Anticipated Major Impacts	Recommended Mitigation Measures	Photo Records (Partial)
EIA S7.6	All site area	Waste Generation	<ul style="list-style-type: none"> • Segregate and store different types of waste in different containers, skip or stockpiles to enhance reuse or recycling of materials and their proper disposal; • Proper storage and site practices to minimize the potential for damage and contamination of construction materials;

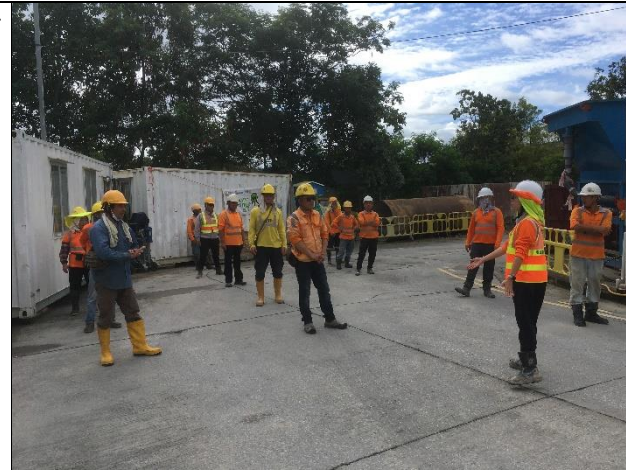
- Provide training to workers on the importance of appropriate waste management procedures, including waste reduction, reuse and recycling.

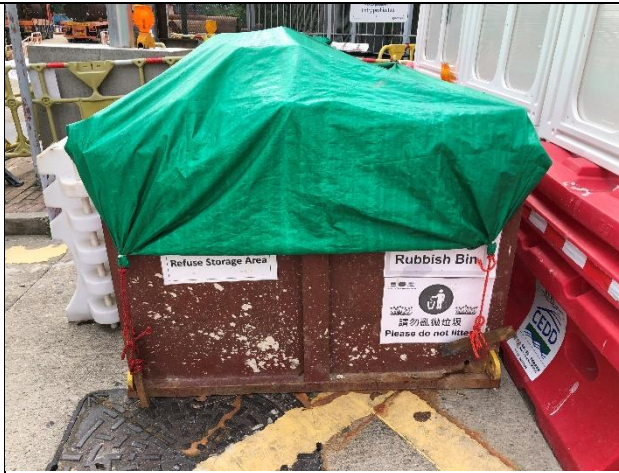
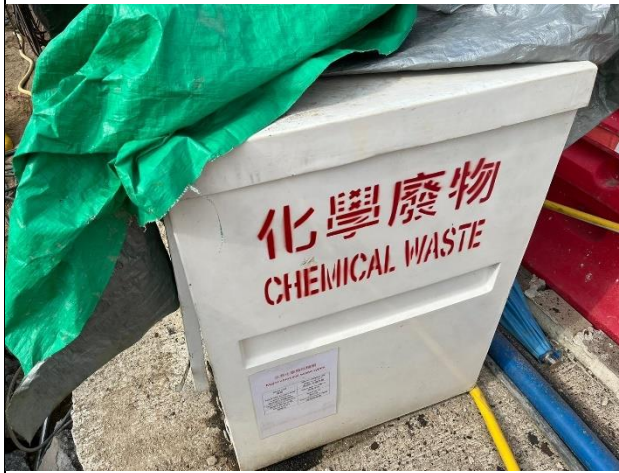
<ul style="list-style-type: none">• Preferably enclosed and covered areas should be provided for general refuse collection and routine cleaning for these areas should also be implemented to keep areas clean. • If chemical wastes are produced at the construction site, the Contractors should register with EPD as chemical waste producers. Chemical wastes should be stored in appropriate containers and collected by a licensed chemical waste contractor. Chemical wastes (e.g. spent lubricant oil) should be recycled at an appropriate facility as far as possible, while the chemical waste that cannot be recycled should be disposed of at either the Chemical Waste Treatment Centre, or another licensed facility, in accordance with the Waste Disposal (Chemical Waste) (General) Regulation.

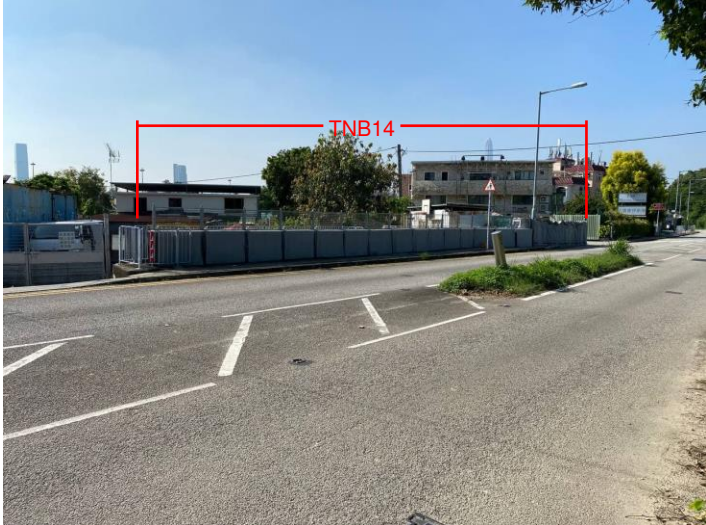
TNB ID	Photo
TNB14

A photograph showing a temporary noise barrier (TNB14) along a road. The barrier is a grey metal fence. In the background, there are buildings and trees. A red rectangle highlights the barrier, with the text "TNB14" written above it. The road is paved and has white lane markings.
TNB15

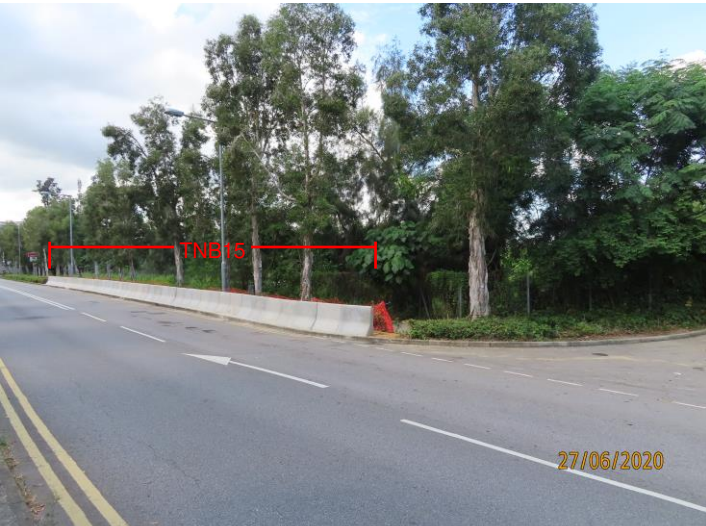
A photograph showing a temporary noise barrier (TNB15) along a road. The barrier is a concrete wall. In the background, there are trees and a cloudy sky. A red rectangle highlights the barrier, with the text "TNB15" written above it. The road is paved and has white lane markings. A date stamp "27/06/2020" is visible in the bottom right corner of the photo.

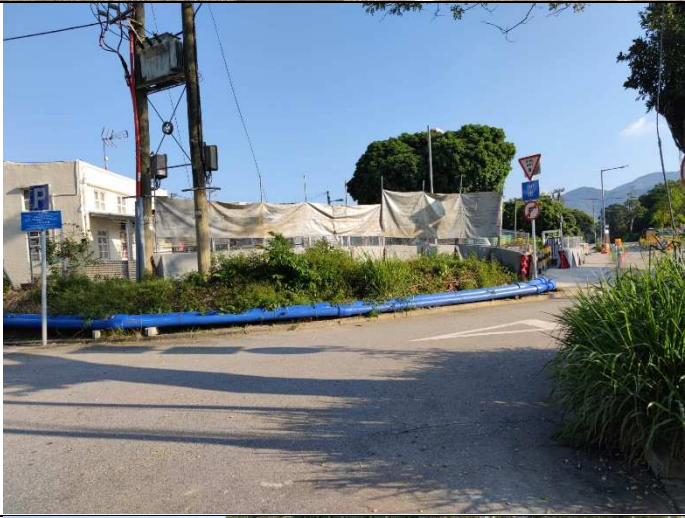
Completed
11

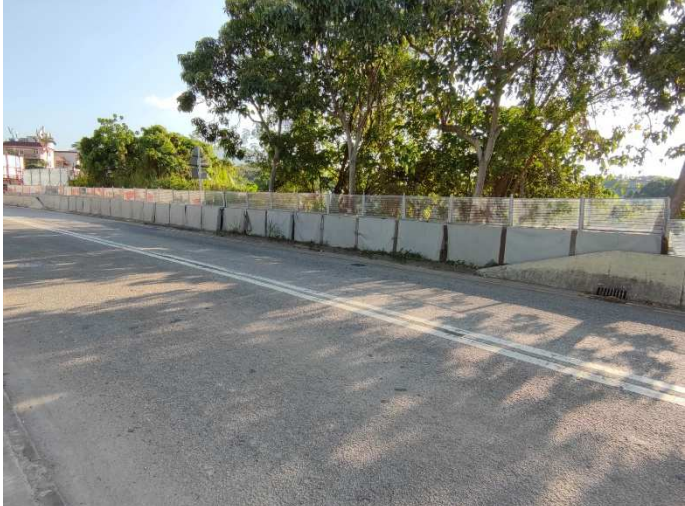
Completed
