**Service Contract No. WD/04/2020
Development of Lok Ma Chau Loop:
Main Works Package 1 –
Environmental Team**

**Environmental Permit No.:
EP-477/2013/A
- Development of Lok Ma Chau Loop**

**Monthly Environmental Monitoring and
Audit Report for August 2023**

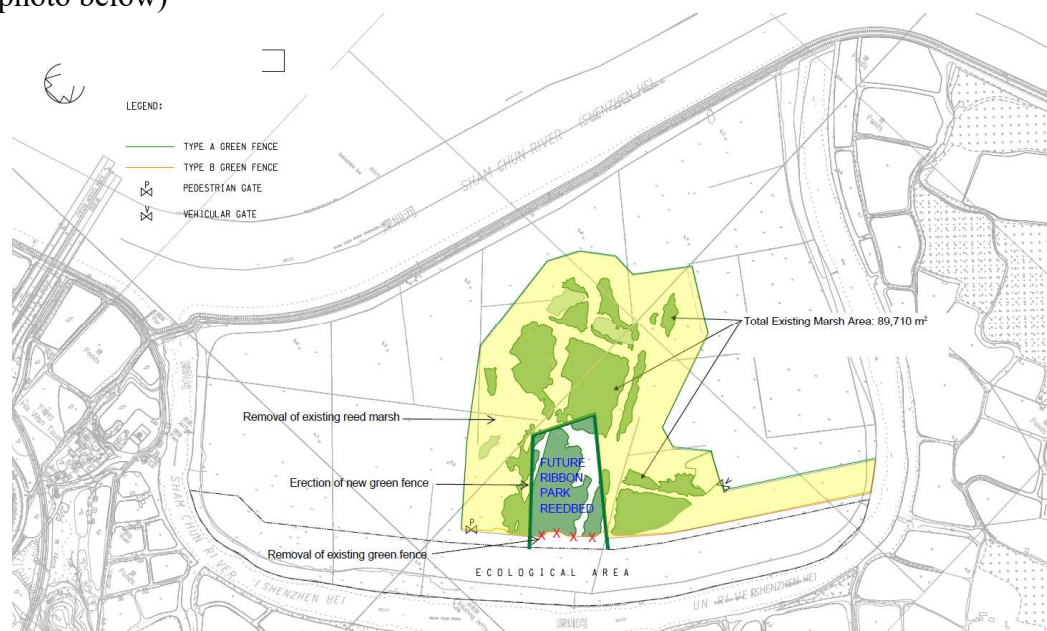
- 10.8 The green fence around the future Ribbon Park Reedbed has been removed and replaced by the hoarding due to the other project's land occupier since March 2022. (See Figure & photo below)

10.10 The Contractor was reminded to maintain the green fence around construction areas and ensure no disturbance to the existing trees and reed marsh habitat subject to the latest situation of LMC Loop.
