**Service Contract No. WD/04/2020
Development of Lok Ma Chau Loop:
Main Works Package 1 –
Environmental Team**

**Environmental Permit No.:
EP-477/2013/A
- Development of Lok Ma Chau Loop**

**Monthly Environmental Monitoring and
Audit Report for October 2023**

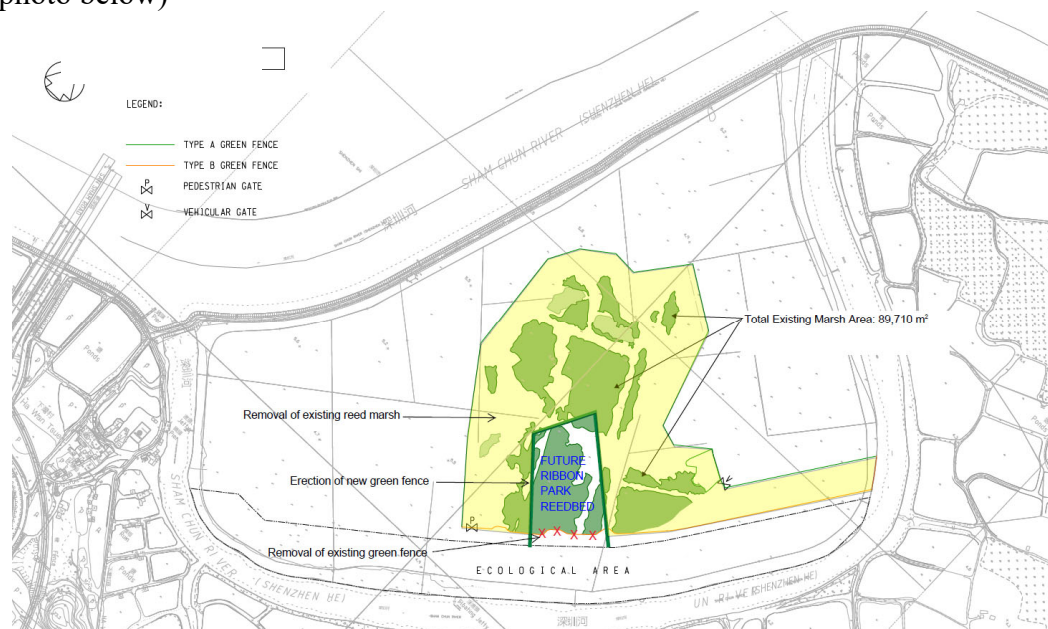
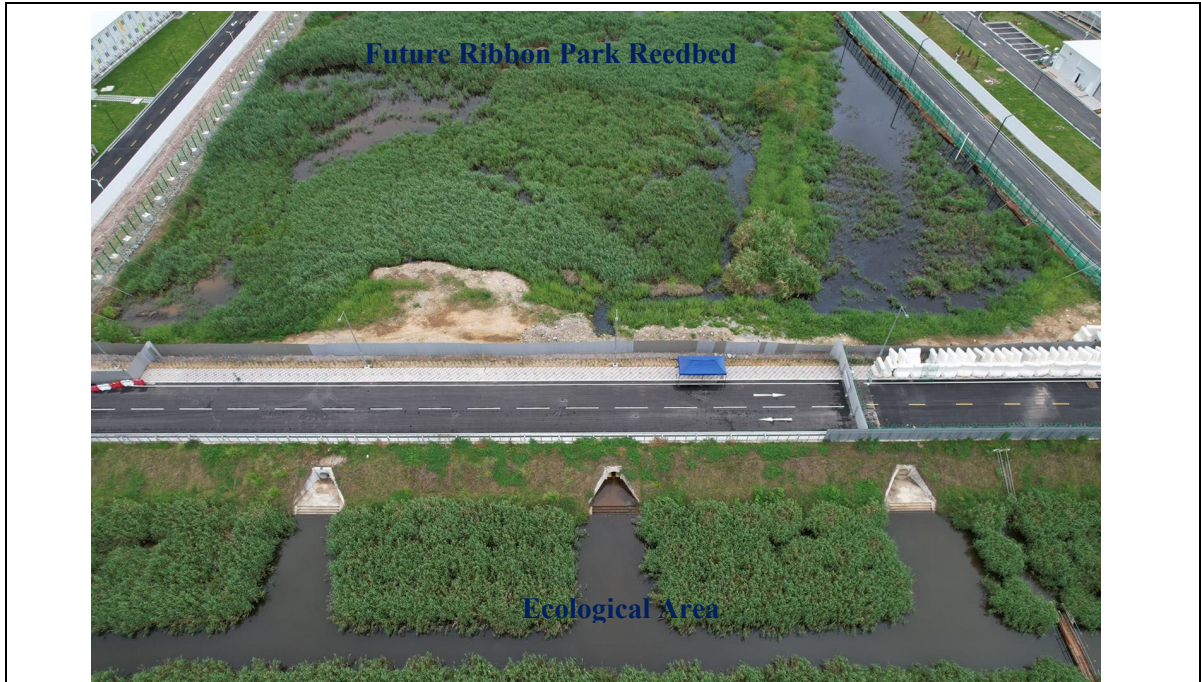
- 10.8 The green fence around the future Ribbon Park Reedbed has been removed and replaced by the hoarding due to the other project's land occupier since March 2022. (See Figure & photo below)

10.10 The Contractor was reminded to maintain the green fence around construction areas and ensure no disturbance to the existing trees and reed marsh habitat subject to the latest situation of LMC Loop.

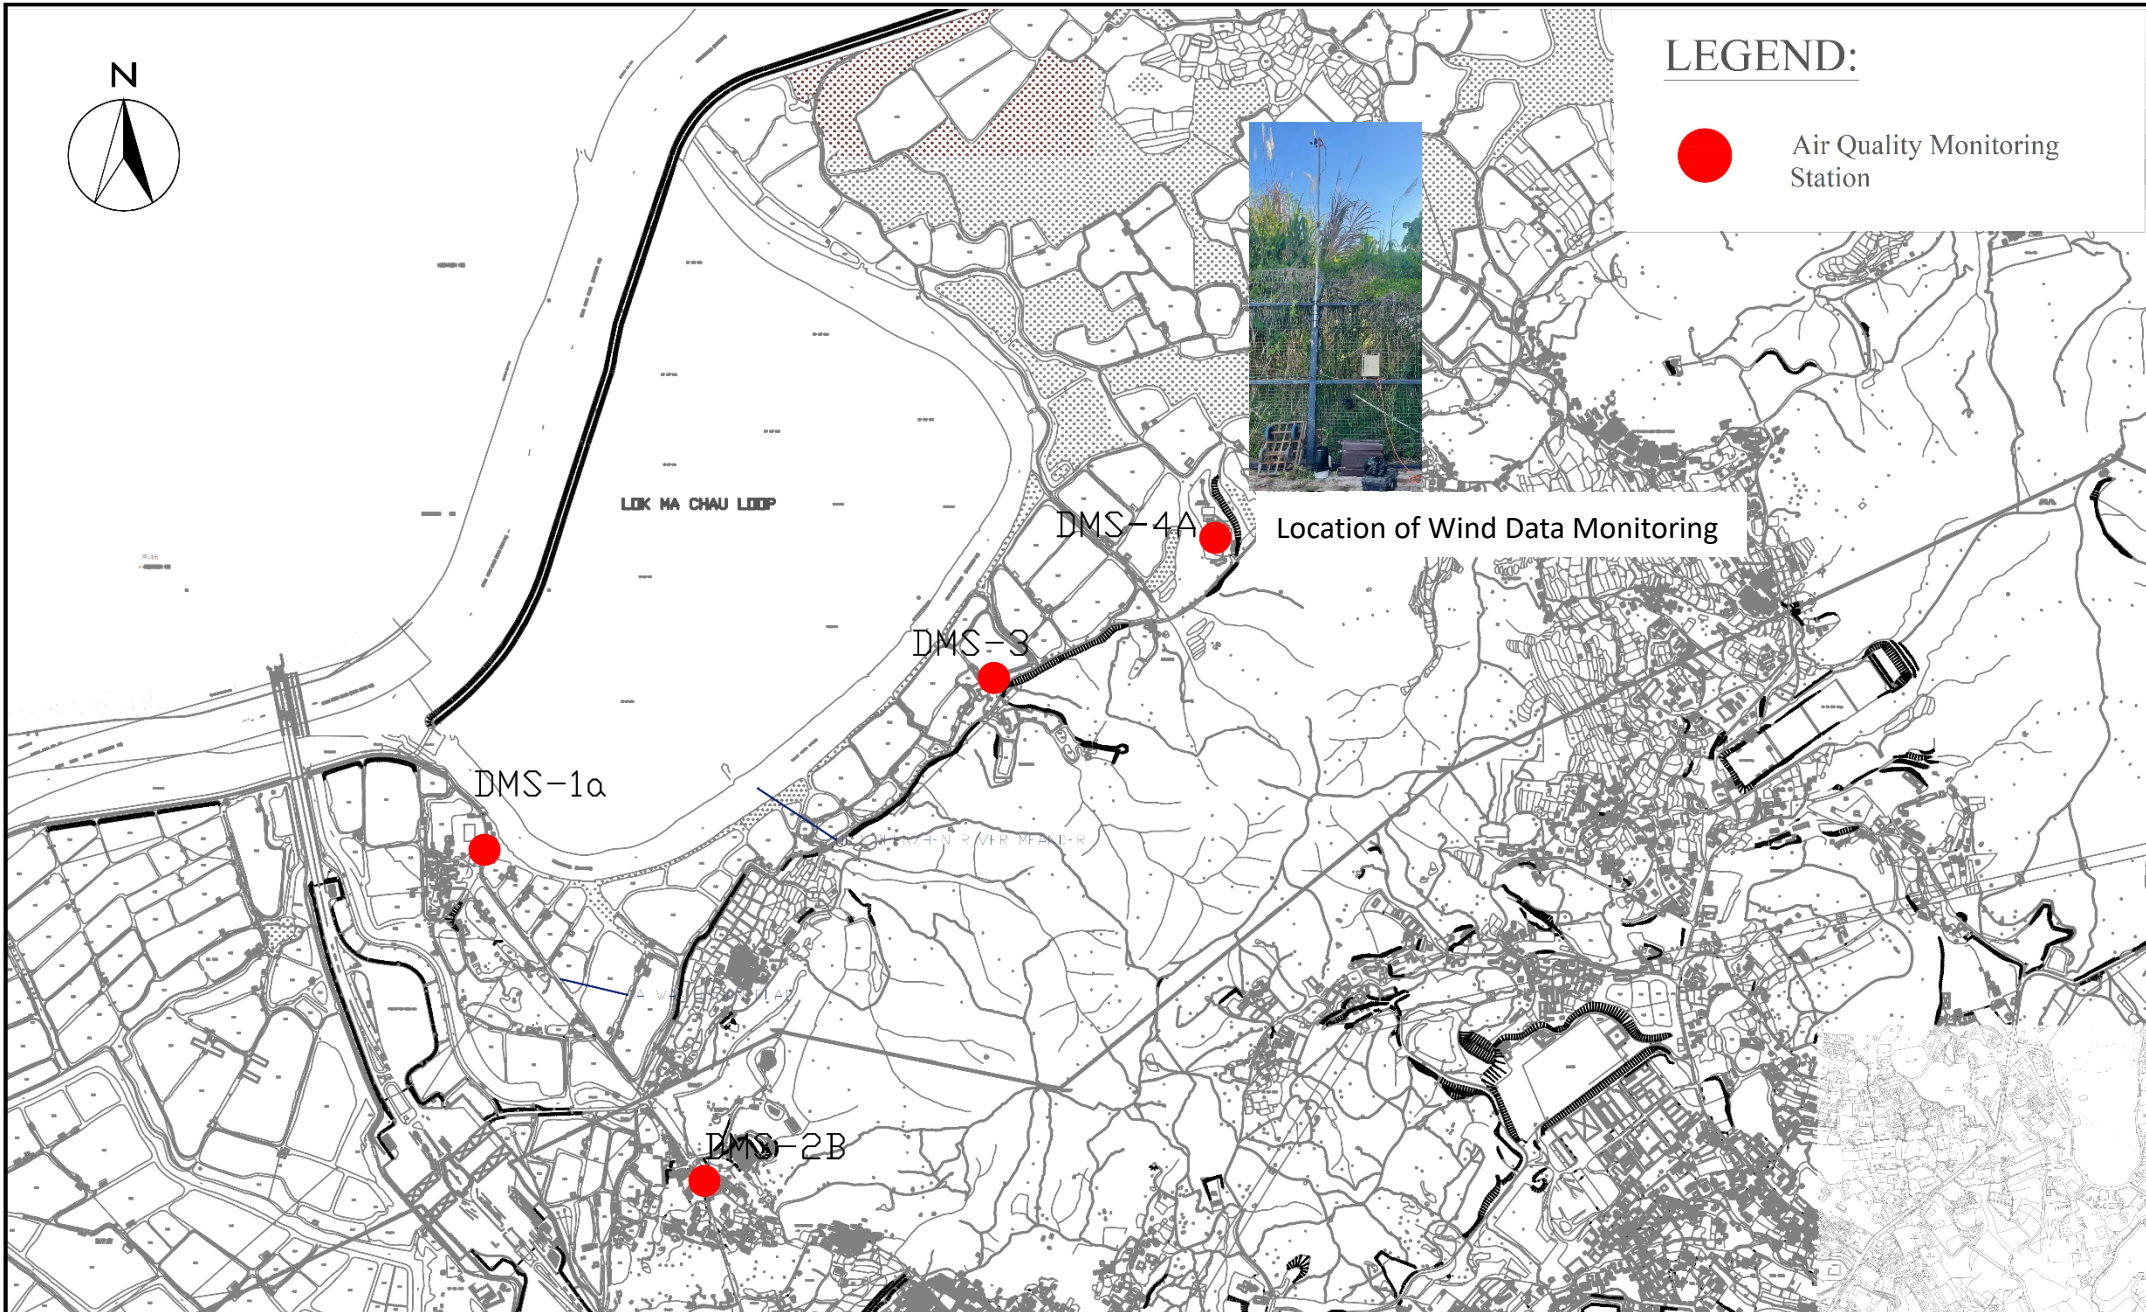
SCALE	1:400 A4	DATE	FEB 2023
CHECK	PC	DRAWN	IT
JOB No.	WMA21009	FIGURE NO.	Fig 2
		REV	-

Location of Wind Data Monitoring

- 3.19 The wind speed and wind direction were recorded by the installed Wind Anemometer set at DMS-4A. The location is shown in **Figure 2**.
- 3.20 The general weather condition and the wind data for the reporting month are summarised in **Appendix I**.

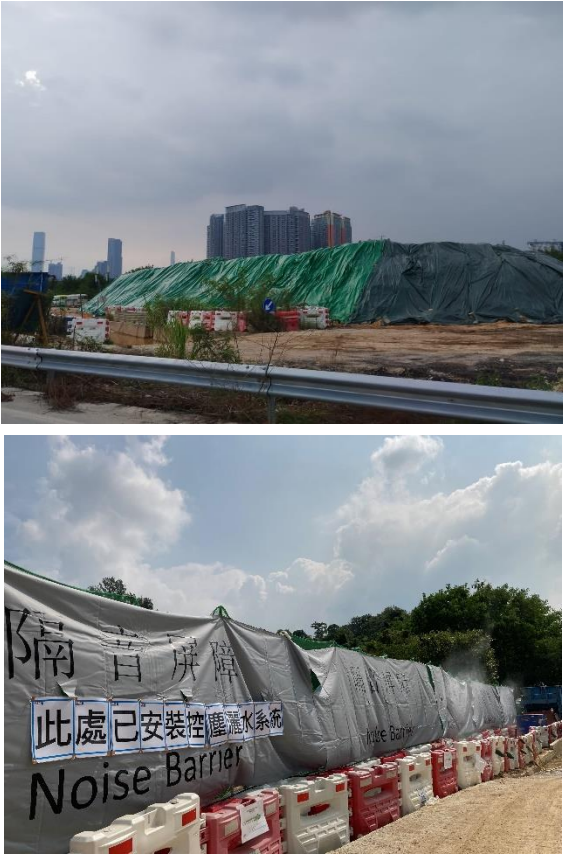
Ref	Location/ Working Period	Anticipated Major Impacts	Recommended Mitigation Measures	Photo Records (Partial)
EIA S3.8	All site area	Dust impact	<ul style="list-style-type: none"> Any excavated or stockpile of dusty material should be covered entirely by impervious sheeting or sprayed with water to maintain the entire surface wet and then removed or backfilled or reinstated where practicable within 24 hours of the excavation or unloading; Any dusty materials remaining after a stockpile is removed should be wetted with water and cleared from the surface of roads;

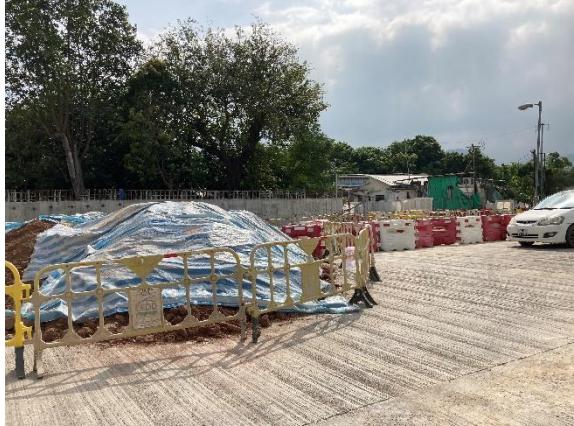
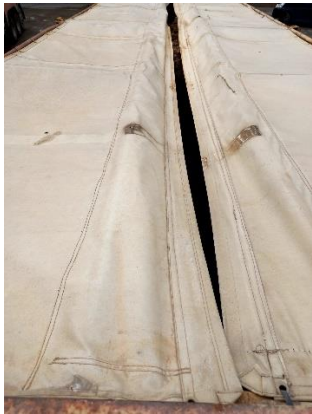
Ref	Location/ Working Period	Anticipated Major Impacts	Recommended Mitigation Measures	Photo Records (Partial)
EIA S3.8	All site area	Dust impact	<ul style="list-style-type: none"> • A stockpile of dusty material should not be extended beyond the pedestrian barriers, fencing or traffic cones; • The load of dusty materials on a vehicle leaving a construction site should be covered entirely by impervious sheeting to ensure that the dusty materials do not leak from the vehicle;

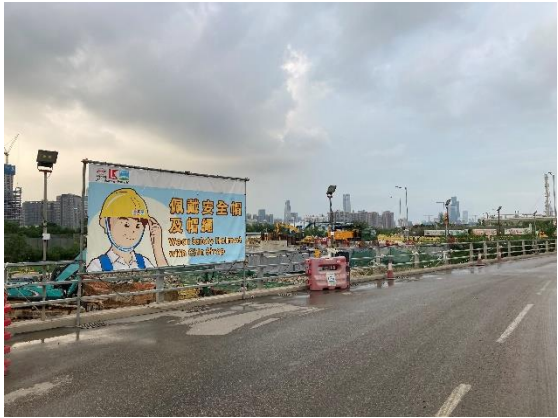
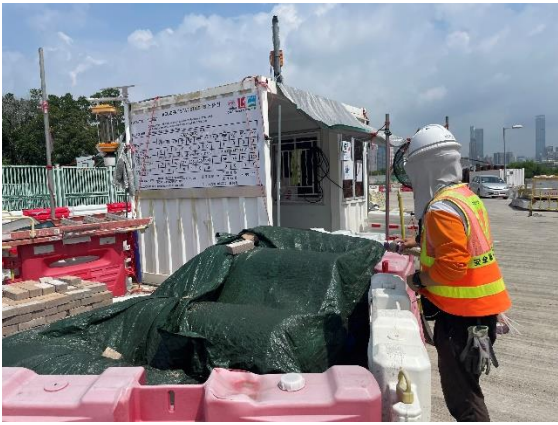
Ref	Location/ Working Period	Anticipated Major Impacts	Recommended Mitigation Measures	Photo Records (Partial)
EIA S3.8	All site area	Dust impact	<ul style="list-style-type: none"> • The portion of any road leading only to construction site that is within 30m of a vehicle entrance or exit should be kept clear of dusty materials; • Every stock of more than 20 bags of cement or dry pulverised fuel ash (PFA) should be covered entirely by impervious sheeting or placed in an area sheltered on the top and the 3 sides;

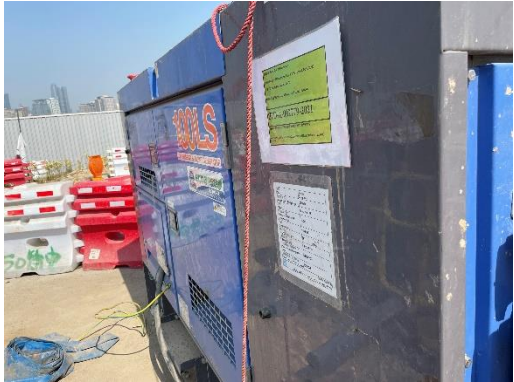
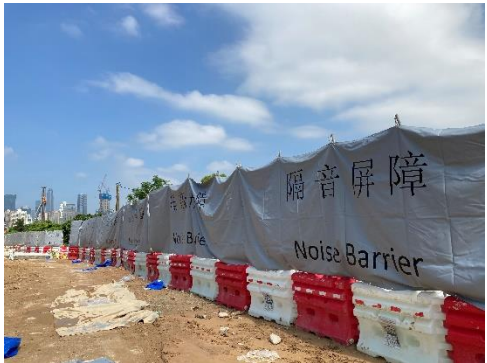
Ref	Location/ Working Period	Anticipated Major Impacts	Recommended Mitigation Measures	Photo Records (Partial)
EIA S4.8	All site area	Noise impact	<ul style="list-style-type: none"> Mobile plant should be sited as far away from NSRs as possible and practicable; All generator used onsite are Quality Powered Mechanical Equipment (QPME) registered with EPD. Install movable noise barriers and full enclosure, screen the noisy plants including air compressor and generator.

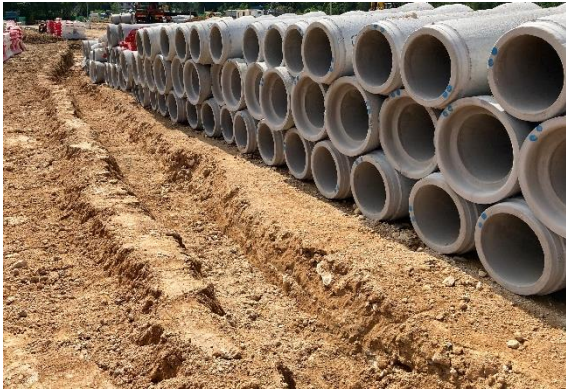
Ref	Location/ Working Period	Anticipated Major Impacts	Recommended Mitigation Measures	Photo Records (Partial)
EIA S5.7	All site area	Water Pollution Control	<ul style="list-style-type: none"> Update and implementation of Stormwater Pollution Control Plan. At the start of site establishment, perimeter cut-off drains to direct off-site water around the site should be constructed with internal drainage works and erosion and sedimentation control facilities implemented. Channels (both temporary and permanent drainage pipes and culverts), earth bunds or sand bag barriers should be provided on site to direct stormwater to silt removal facilities. The design of the temporary on-site

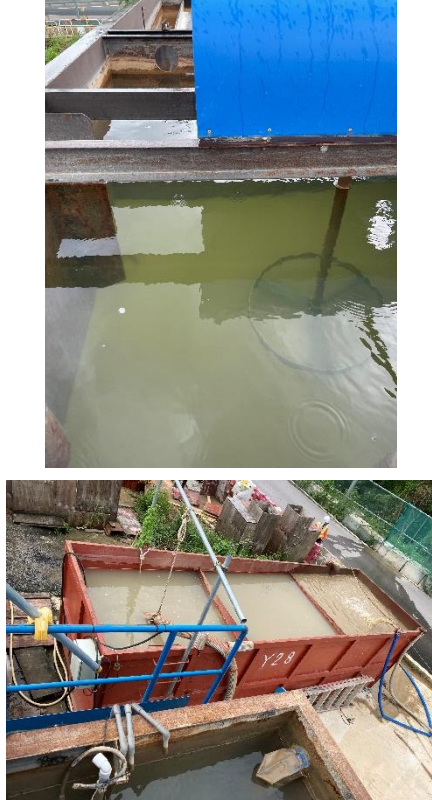
<p>The top photograph shows a concrete drainage channel with a blue tarp covering the end, situated next to a body of greenish water. The bottom photograph shows a large, rectangular, pre-formed metal sedimentation tank with blue railings, containing murky water, with a concrete structure below it.</p>

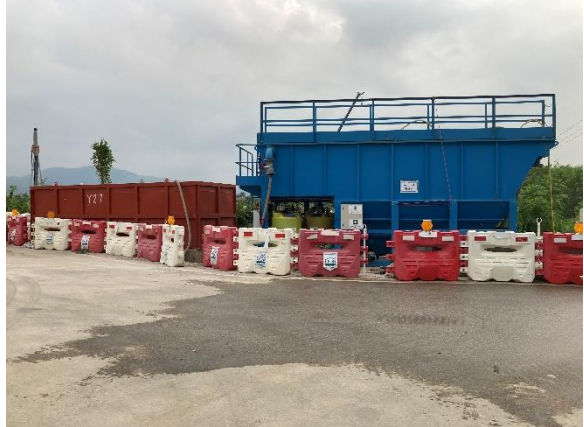
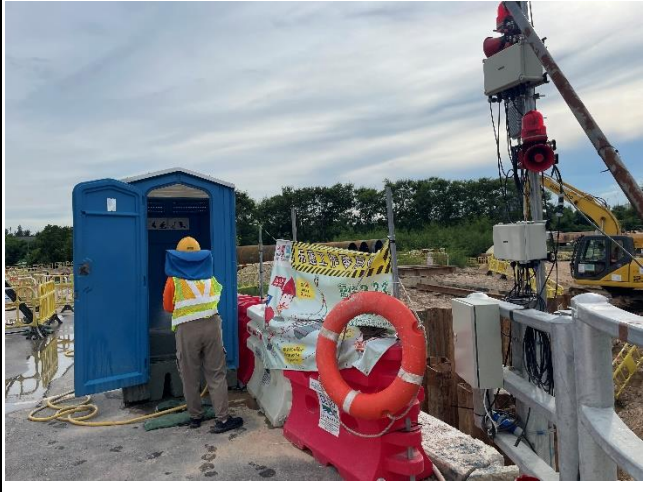
Ref	Location/ Working Period	Anticipated Major Impacts	Recommended Mitigation Measures	Photo Records (Partial)
			<ul style="list-style-type: none"> The design of efficient silt removal facilities should be based on the guidelines in Appendix A1 of ProPECC PN 1/94. The detailed design of the sand/silt traps should be undertaken by the contractor prior to the commencement of construction. <p>All drainage facilities and erosion and sediment control structures should be regularly inspected and maintained to ensure proper and efficient operation at all times and particularly following rainstorms.</p> <ul style="list-style-type: none"> Portable chemical toilets and sewage holding tanks should be provided for handling the construction sewage generated by the workforce. A licensed contractor should be employed to provide appropriate and adequate portable toilets to cater 0.15m³/day/employed populations and be responsible for appropriate disposal and maintenance.

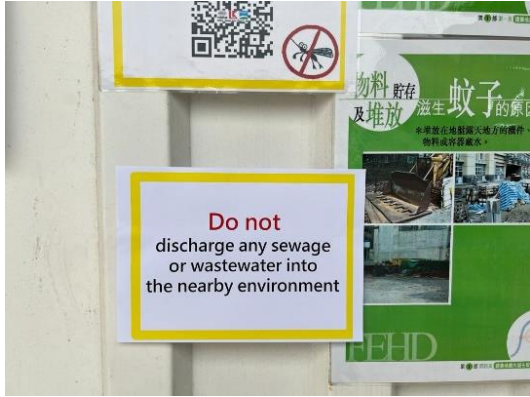
Ref	Location/ Working Period	Anticipated Major Impacts	Recommended Mitigation Measures	Photo Records (Partial)
			<ul style="list-style-type: none"> • Notices should be posted at conspicuous locations to remind the workers not to discharge any sewage or wastewater into the nearby environment during the construction phase of the Project. Regular environmental audit on the construction site should be conducted in order to provide an effective control of any malpractices and achieve continual improvement of environmental performance on site.

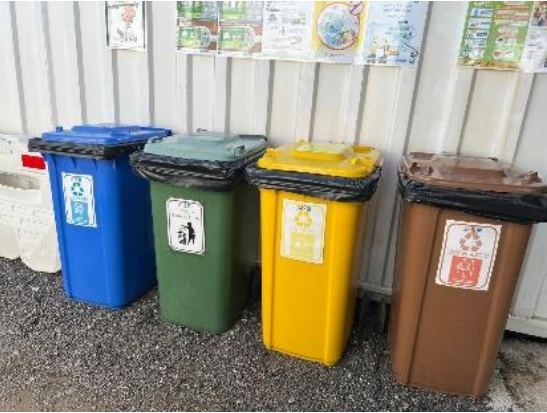
Ref	Location/ Working Period	Anticipated Major Impacts	Recommended Mitigation Measures	Photo Records (Partial)
EIA S7.6	All site area	Waste Generation	<ul style="list-style-type: none"> • Segregate and store different types of waste in different containers, skip or stockpiles to enhance reuse or recycling of materials and their proper disposal; • Proper storage and site practices to minimize the potential for damage and contamination of construction materials;

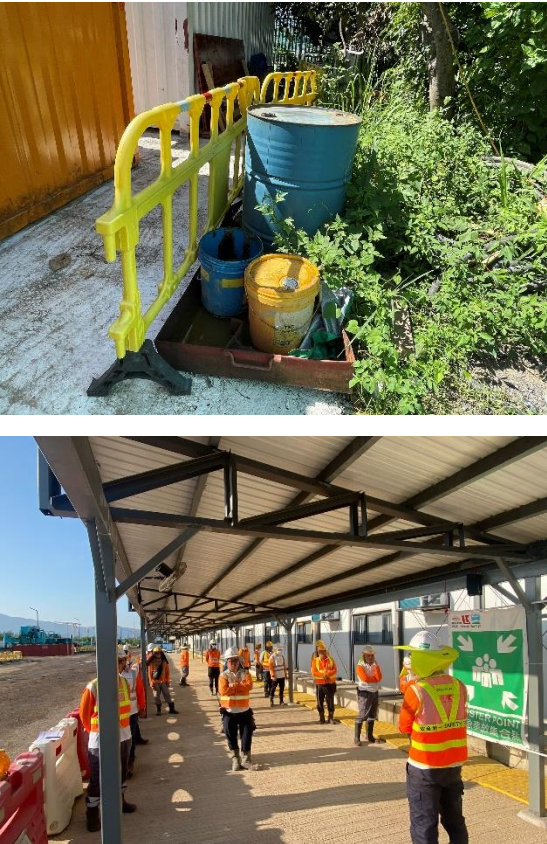
Ref	Location/ Working Period	Anticipated Major Impacts	Recommended Mitigation Measures	Photo Records (Partial)
			<ul style="list-style-type: none"> • Provide training to workers on the importance of appropriate waste management procedures, including waste reduction, reuse and recycling.

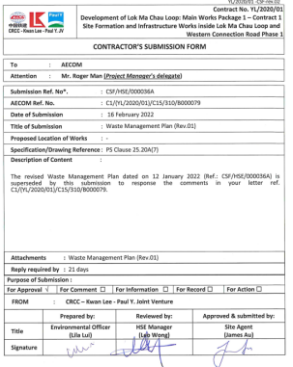
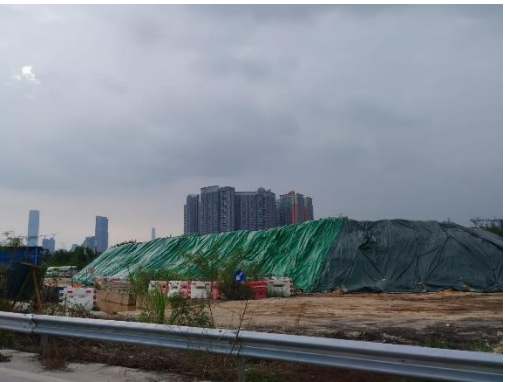
Ref	Location/ Working Period	Anticipated Major Impacts	Recommended Mitigation Measures	Photo Records (Partial)
			<ul style="list-style-type: none"> • Prepare Waste Management Plan and submit to the Engineer for approval • Proper storage and sorting of excavated inert materials to maximize on site reuse for backfilling

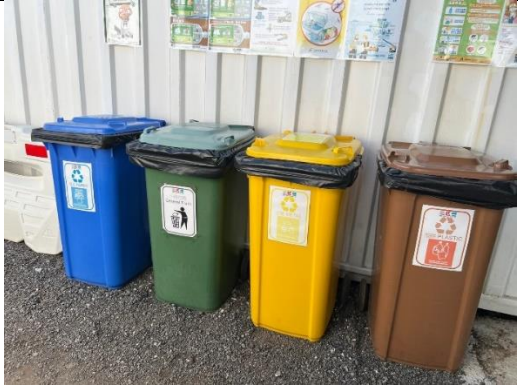
Ref	Location/ Working Period	Anticipated Major Impacts	Recommended Mitigation Measures	Photo Records (Partial)
			<ul style="list-style-type: none"> • General refuse should be stored in enclosed bins separately from construction and chemical wastes. Recycling bins should also be placed to encourage recycling.

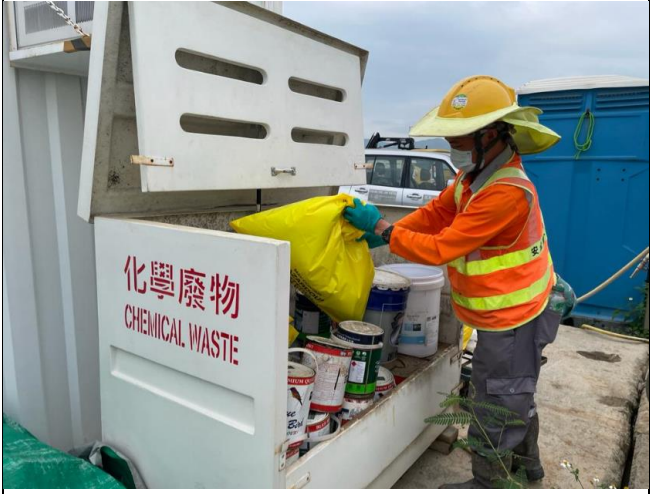
Ref	Location/ Working Period	Anticipated Major Impacts	Recommended Mitigation Measures	Photo Records (Partial)
			<ul style="list-style-type: none"> If chemical wastes are produced at the construction site, the Contractors should register with EPD as chemical waste producers. Chemical wastes should be stored in appropriate containers and collected by a licensed chemical waste contractor. Chemical wastes (e.g. spent lubricant oil) should be recycled at an appropriate facility as far as possible, while the chemical waste that cannot be recycled should be disposed of at either the Chemical Waste Treatment Centre, or another licensed facility, in accordance with the Waste Disposal (Chemical Waste) (General) Regulation.

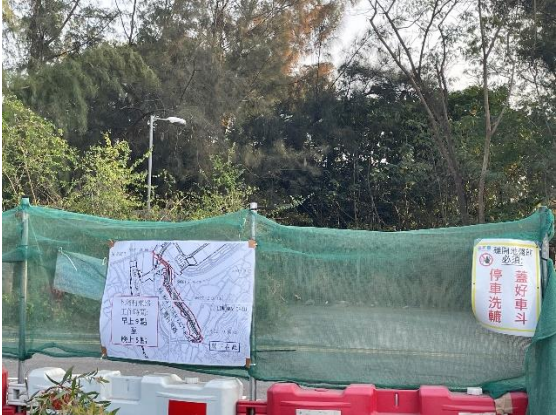
Ref	Location/ Working Period	Anticipated Major Impacts	Recommended Mitigation Measures	Photo Records (Partial)
	Old Shenzhen River meander and other identified important ecologically sensitive areas,		Using powered mechanical equipment for construction works only during the period 9am to 5pm at and near the old Shenzhen River meander and other identified important ecologically sensitive areas, if any;

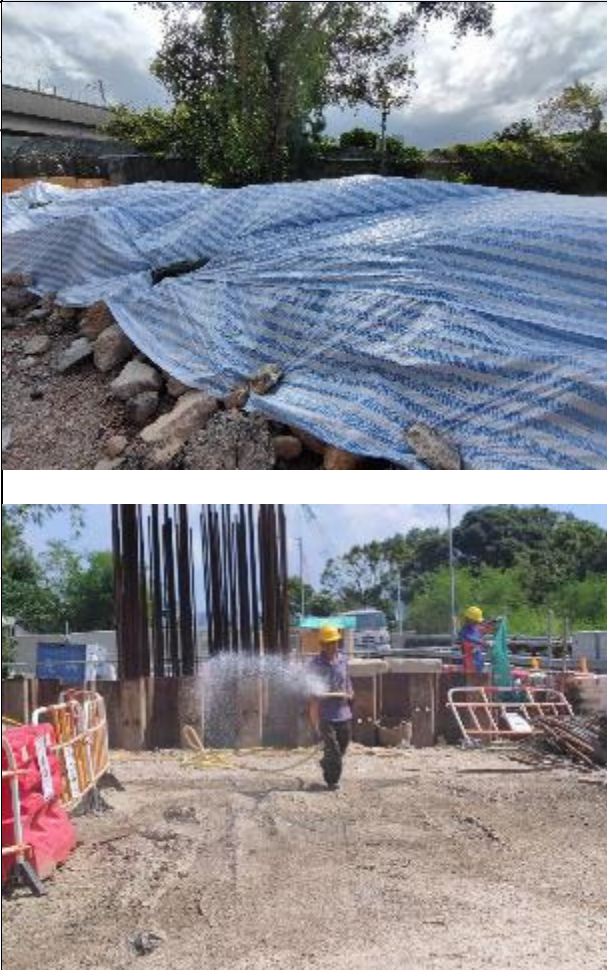
Ref*	Location/Working Period	Anticipated Major Impacts	Recommended Mitigation Measures	Photo Records (Partial)
EIA S3.8	All site area	Dust impact	<ul style="list-style-type: none"> Any excavated or stockpile of dusty material should be covered entirely by impervious sheeting or sprayed with water to maintain the entire surface wet and then removed or backfilled or reinstated where practicable within 24 hours of the excavation or unloading; Any dusty materials remaining after a stockpile is removed should be wetted with water and cleared from the surface of roads;

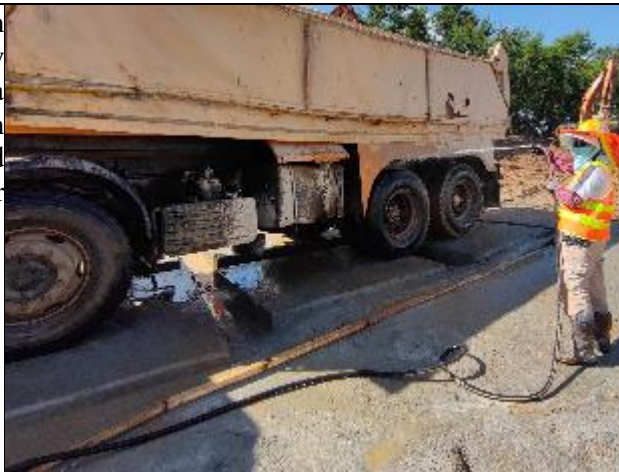
<ul style="list-style-type: none">• Where practicable, vehicle washing facilities with high pressure water jet should be provided at every discernible or designated vehicle exit point. The area where vehicle washing takes place and the road section between the washing facilities and the exit point should be paved with concrete, bituminous materials or hardcores.

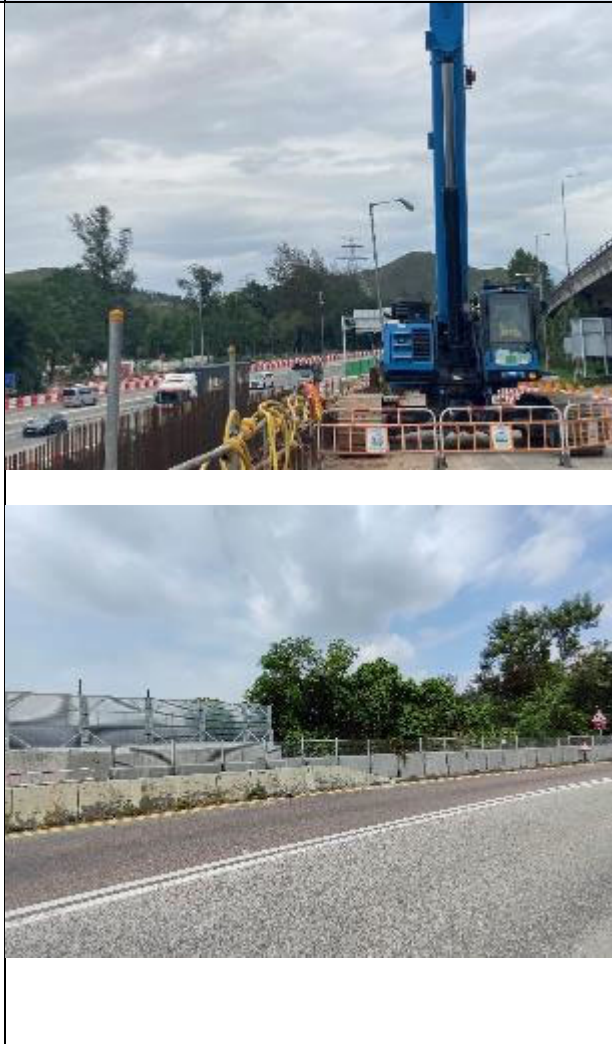
<p>The top photograph shows a blue excavator at a construction site with orange safety barriers and a road in the background. The bottom photograph shows a road with a noise barrier and a large structure covered in a grey mesh enclosure.</p>

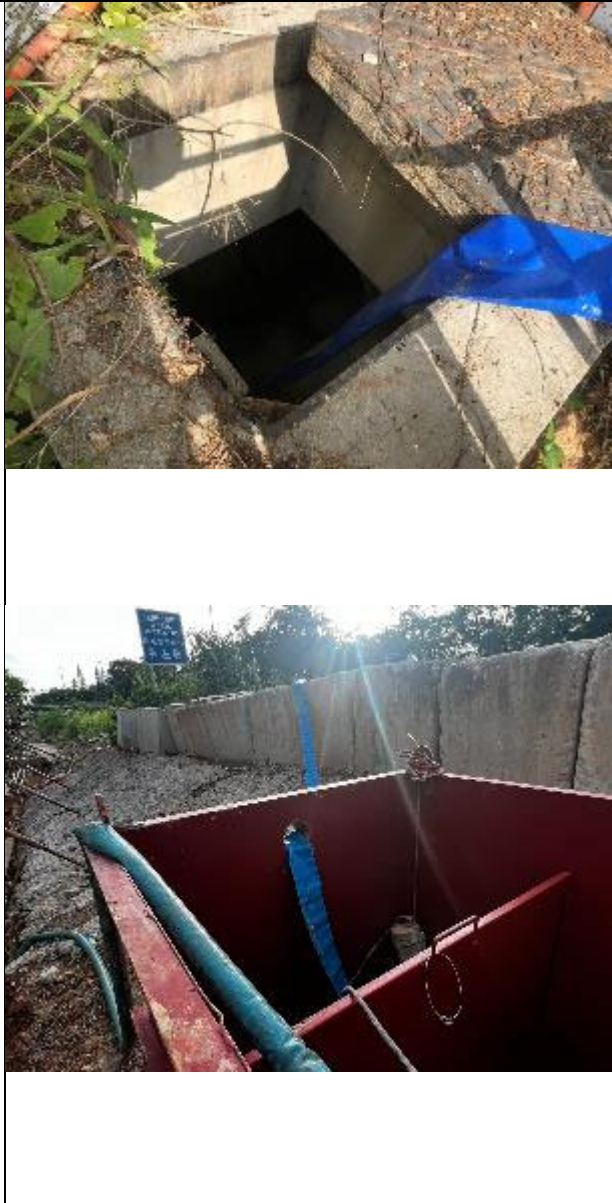
EIA S5.7	All site area	Water Pollution Control	<ul style="list-style-type: none">• At the start of site establishment, perimeter cut-off drains to direct off-site water around the site should be constructed with internal drainage works and erosion and sedimentation control facilities implemented. Channels (both temporary and permanent drainage pipes and culverts), earth bunds or sand bag barriers should be provided on site to direct stormwater to silt removal facilities. The design of the temporary on-site drainage system will be undertaken by the contractor prior to the commencement of construction. • Diversion of natural stormwater should be provided as far as possible. The design of temporary on-site drainage should prevent runoff going through site surface, construction machinery and equipment in order to avoid or minimize polluted runoff.

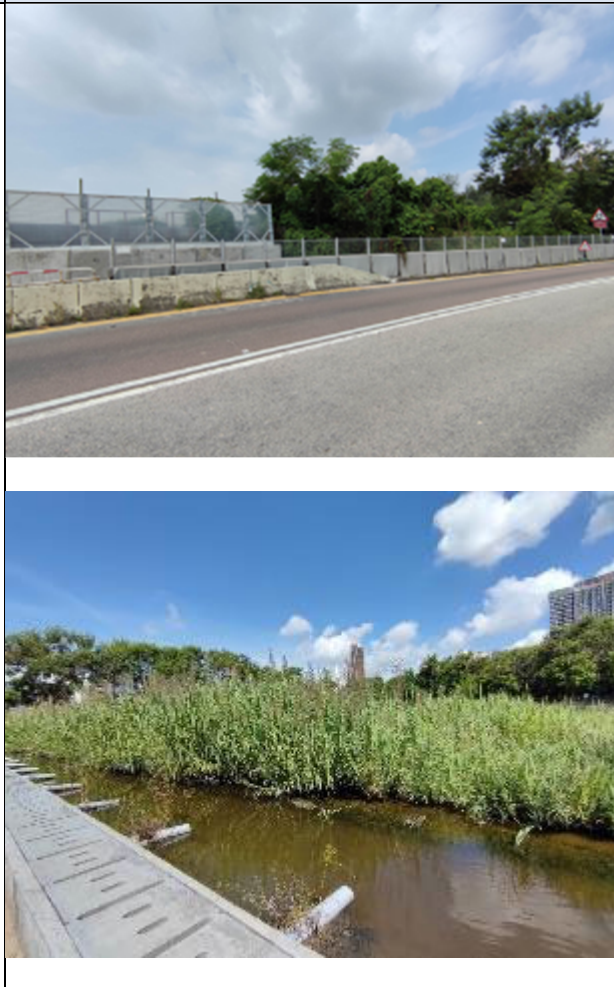
<p>The 'Photo Records (Partial)' column contains two photographs. The top photograph shows a paved road with a white double line, a concrete curb, and a grey noise barrier with a mesh screen. The bottom photograph shows a reedbed area with a concrete walkway, a small stream of water, and dense green reeds under a blue sky with clouds.</p>

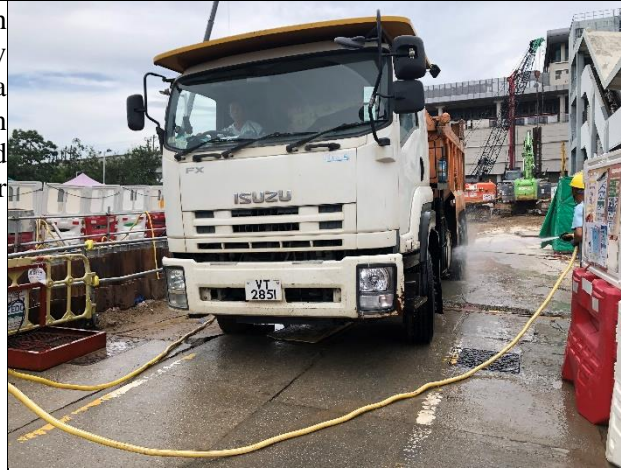
- Where practicable, vehicle washing facilities with high pressure water jet should be provided at every discernible or designated vehicle exit point. The area where vehicle washing takes place and the road section between the washing facilities and the exit point should be paved with concrete, bituminous materials or hardcores.

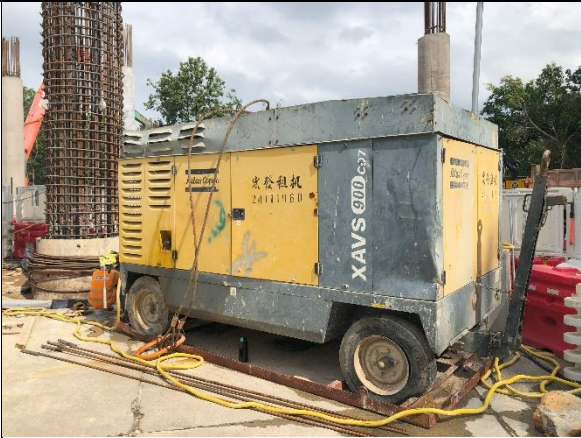
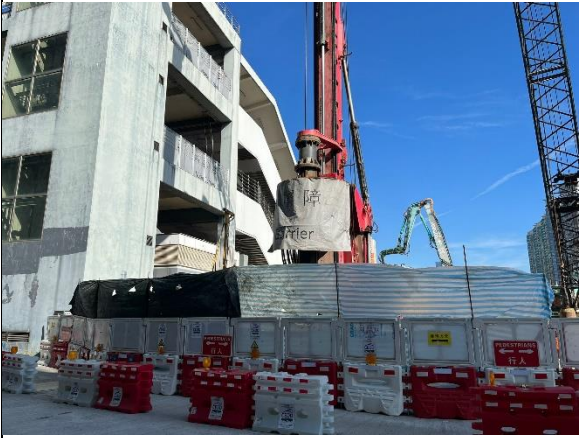
• An acoustic canvas had been deployed along the site boundary facing the public.

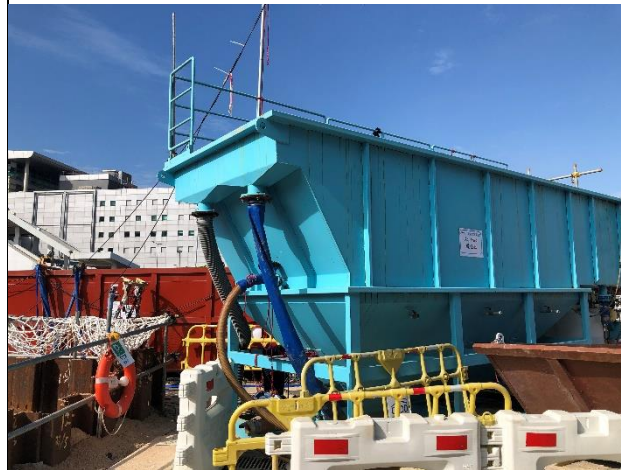
• Sedimentation tanks with sufficient capacity, constructed from pre-formed individual cells of approximately 6 to 8 m³ capacities, are recommended as a general mitigation measure which can be used for settling surface runoff prior to disposal. The system capacity shall be flexible and able to handle multiple inputs from a variety of sources and suited to applications where the influent is pumped.

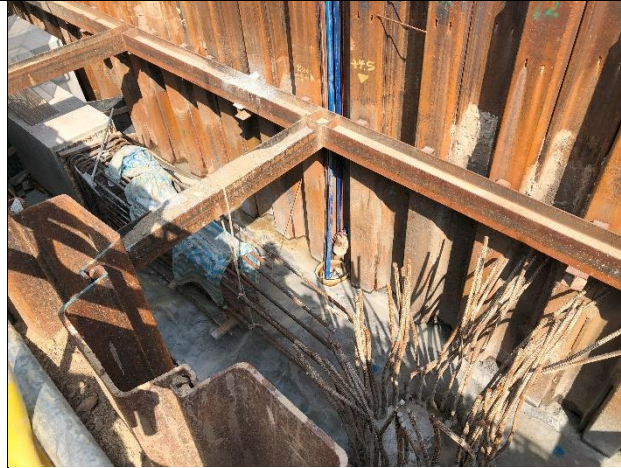
•An additional water pump had been set up and the concerned outlet have been sealed up with concrete

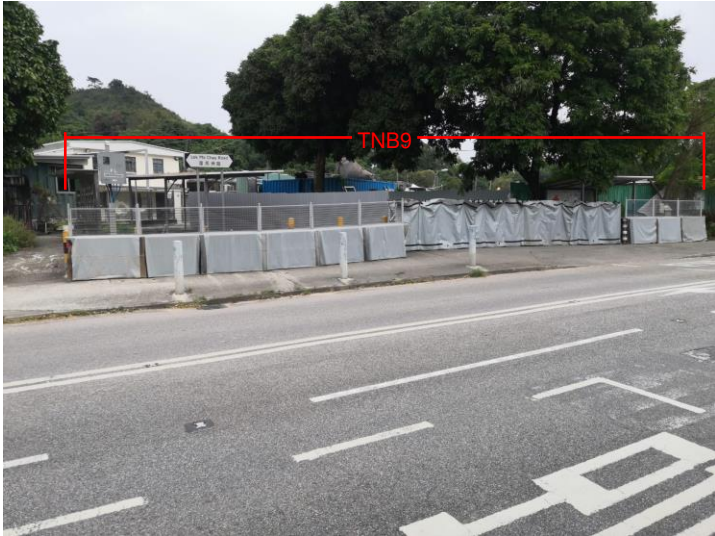
TNB ID	Photo
TNB9

A photograph showing a temporary noise barrier (TNB9) along a road. The barrier consists of grey concrete blocks with a chain-link fence on top. In the background, there are trees and a building. A red box highlights the barrier, with the label 'TNB9' in red text above it.
TNB10

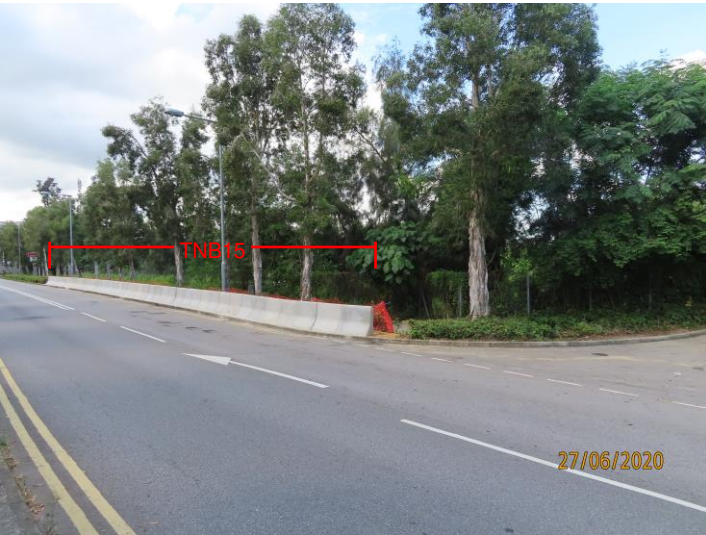
A photograph showing a temporary noise barrier (TNB15) along a road. The barrier is a concrete wall. In the background, there are trees. A red rectangle highlights the barrier, with the label 'TNB15' in red text above it. A date stamp '27/06/2020' is visible in the bottom right corner of the photo.
