**Service Contract No. WD/04/2020  
Development of Lok Ma Chau Loop:  
Main Works Package 1 –  
Environmental Team**

**Environmental Permit No.:  
EP-477/2013/B  
- Development of Lok Ma Chau Loop**

**Monthly Environmental Monitoring and  
Audit Report for December 2023**

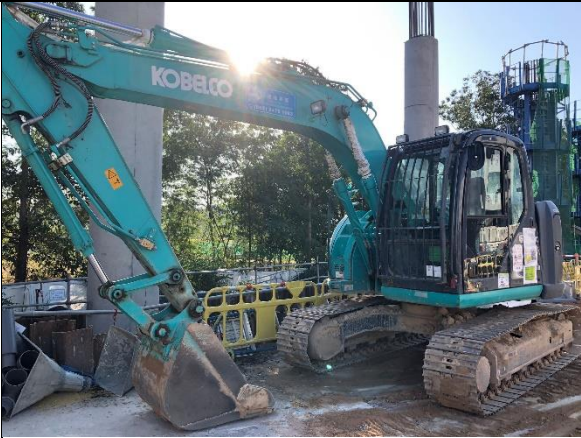
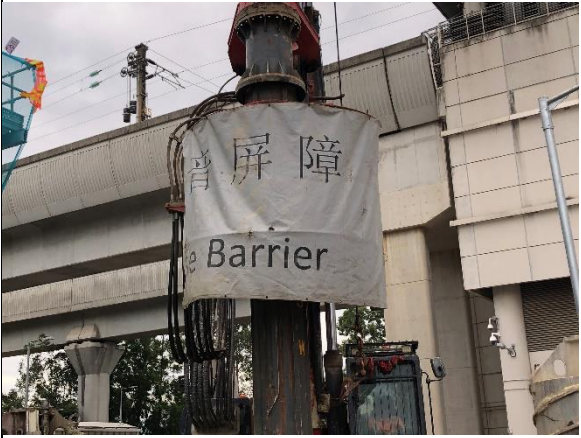
Ref*	Location/ Working Period	Anticipated Major Impacts	Recommended Mitigation Measures	Photo Records (Partial)
EIA S4.8	All site area	Noise impact	<ul style="list-style-type: none"> <li>• Mobile plant should be sited as far away from NSRs as possible and practicable;</li> <li>• Install movable noise barriers and full enclosure, screen the noisy plants including air compressor and generator.</li> </ul>

• An acoustic canvas had been deployed along the site boundary facing the public.
