**Service Contract No. WD/04/2020
Development of Lok Ma Chau Loop:
Main Works Package 1 –
Environmental Team**

**Environmental Permit No.:
EP-477/2013/B
- Development of Lok Ma Chau Loop**

**Monthly Environmental Monitoring and
Audit Report for January 2024**

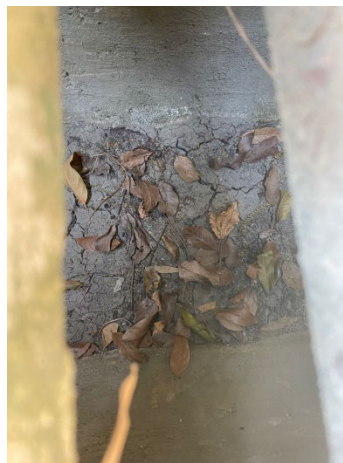
**IS6**

5.36 No water quality monitoring was conducted at IS6 in the reporting month since the channel was dry. Water quality monitoring station, IS6 will be further reviewed and a proposal for any alternative monitoring location including justification will be submitted for approval from IEC and EPD (if necessary).

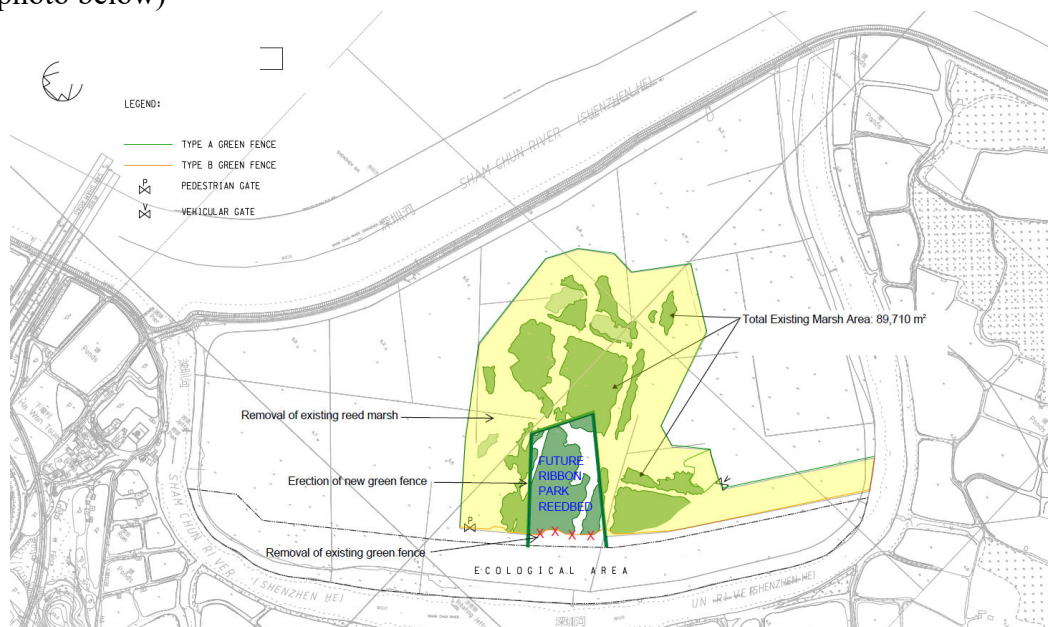
- 10.8 The green fence around the future Ribbon Park Reedbed has been removed and replaced by the hoarding due to the other project’s land occupier since March 2022. (See Figure & photo below)

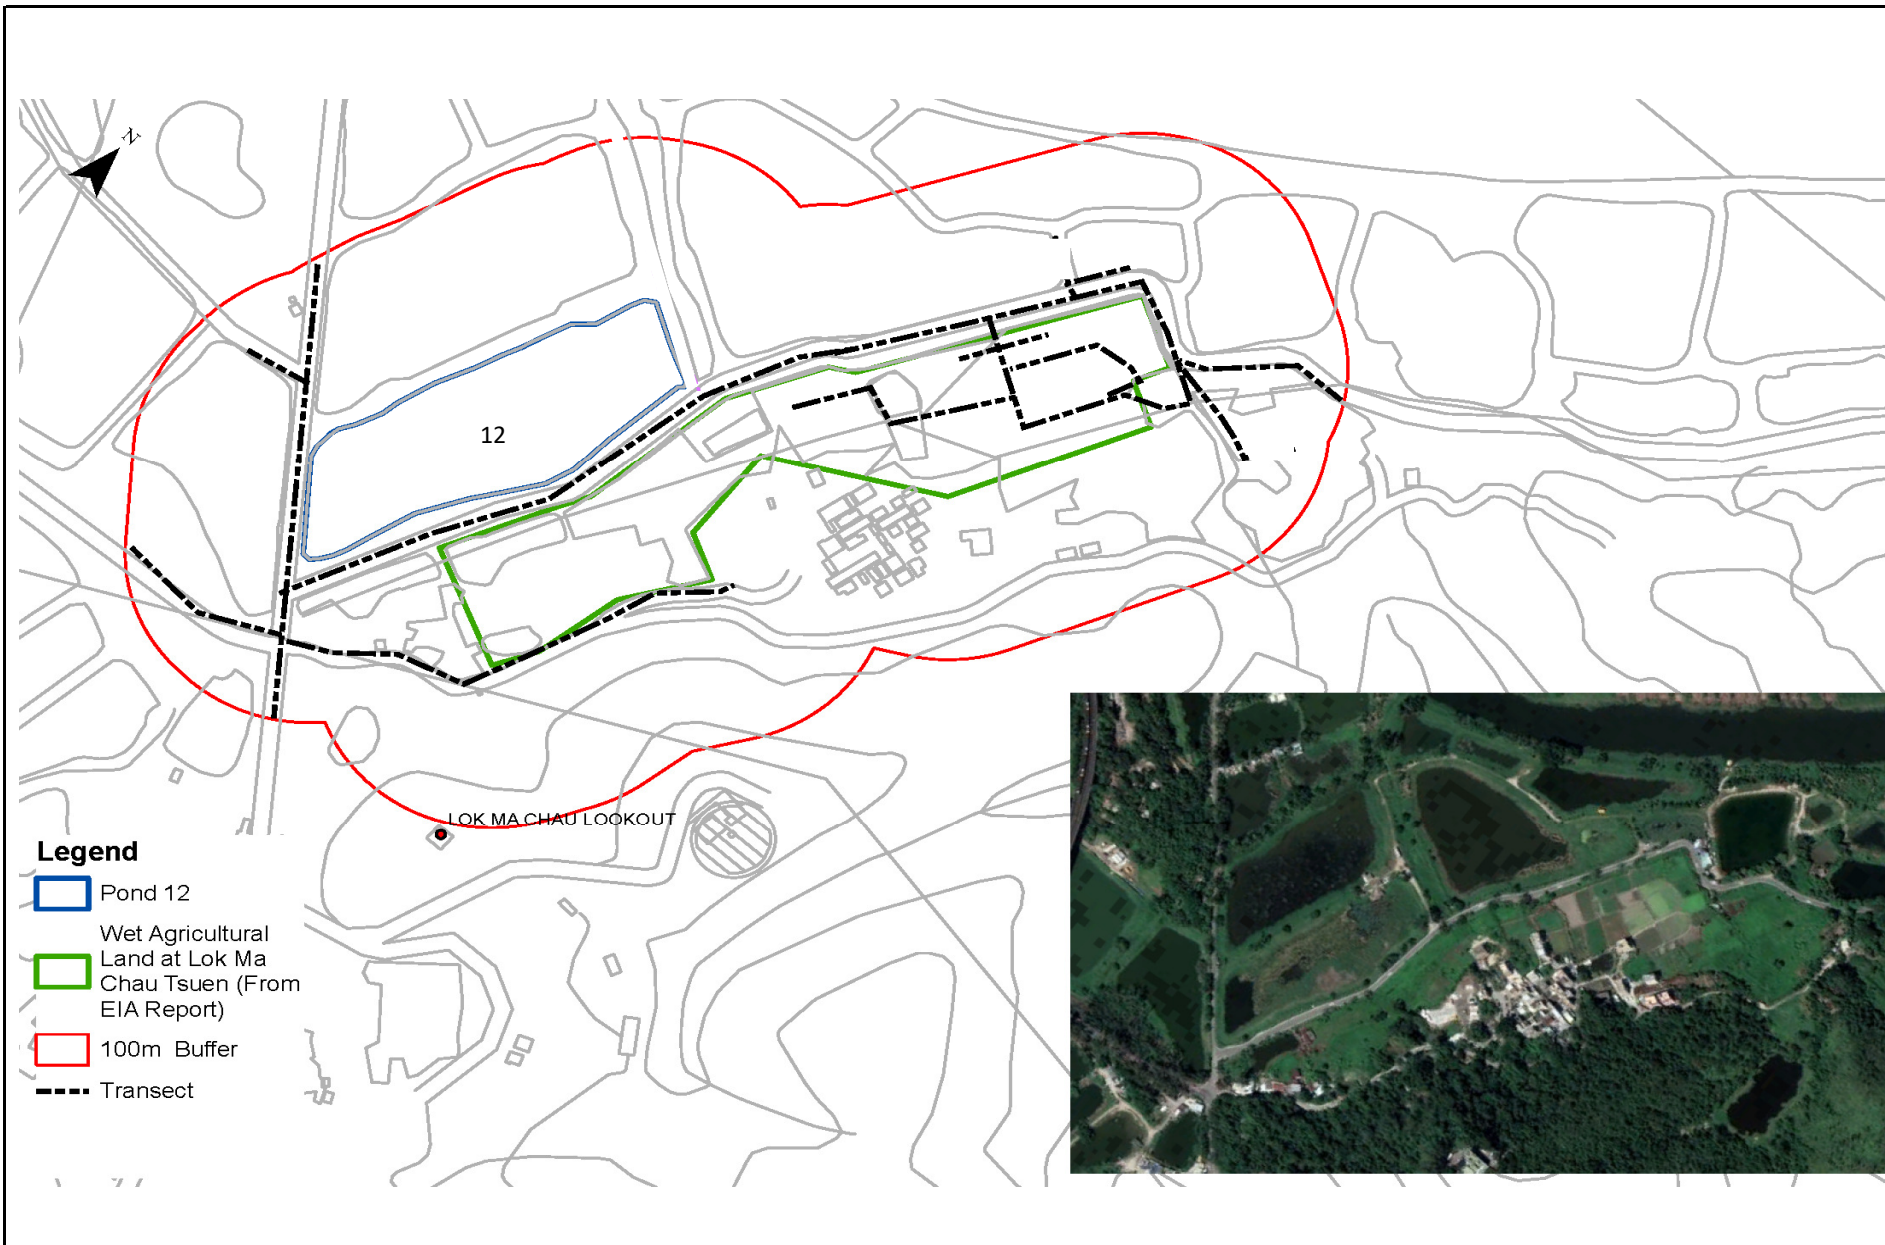
Service Contract No. WD/04/2020 Development of Lok Ma Chau Loop Main Work Package 1 - Environmental Team Locations of Transect for Monitoring of Chinese Bull Frog		Scale	Project No.	WELLAB 匯力 consulting . testing . research
		N.T.S	WMA21009	
		Date	Figure	
		Mar-22	5b

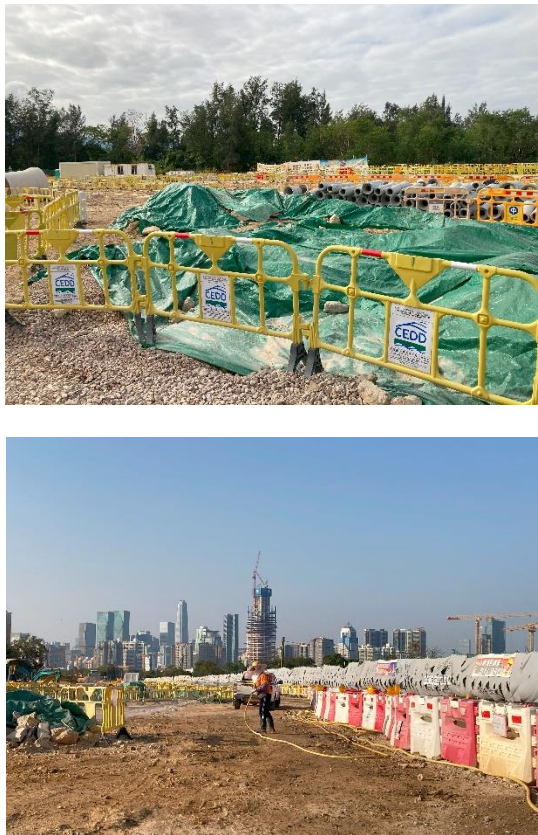
Ref	Location/ Working Period	Anticipated Major Impacts	Recommended Mitigation Measures	Photo Records (Partial)
EIA S3.8	All site area	Dust impact	<ul style="list-style-type: none"> Any excavated or stockpile of dusty material should be covered entirely by impervious sheeting or sprayed with water to maintain the entire surface wet and then removed or backfilled or reinstated where practicable within 24 hours of the excavation or unloading; Any dusty materials remaining after a stockpile is removed should be wetted with water and cleared from the surface of roads;

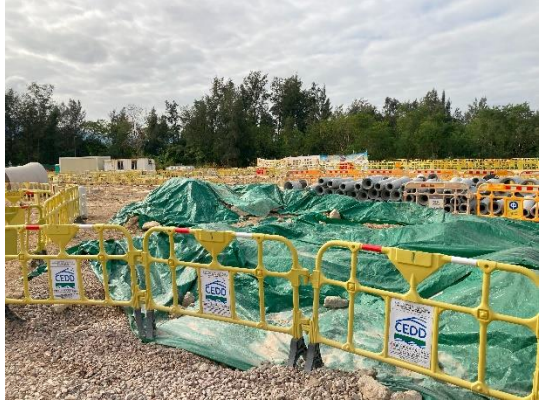
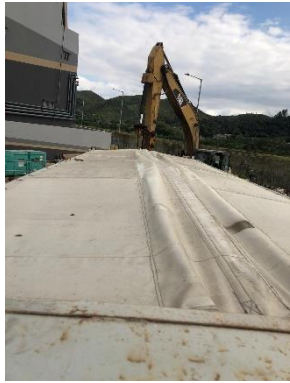
Ref	Location/ Working Period	Anticipated Major Impacts	Recommended Mitigation Measures	Photo Records (Partial)
EIA S3.8	All site area	Dust impact	<ul style="list-style-type: none"> • A stockpile of dusty material should not be extended beyond the pedestrian barriers, fencing or traffic cones; • The load of dusty materials on a vehicle leaving a construction site should be covered entirely by impervious sheeting to ensure that the dusty materials do not leak from the vehicle;

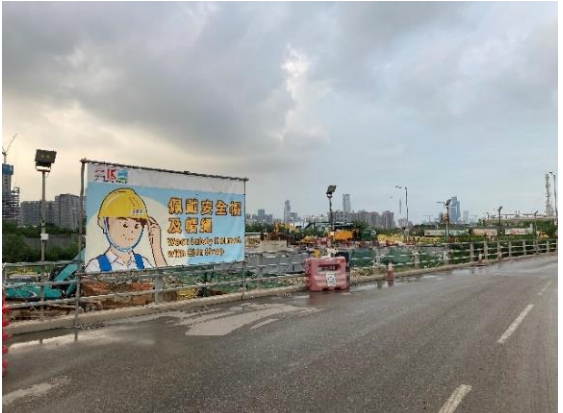
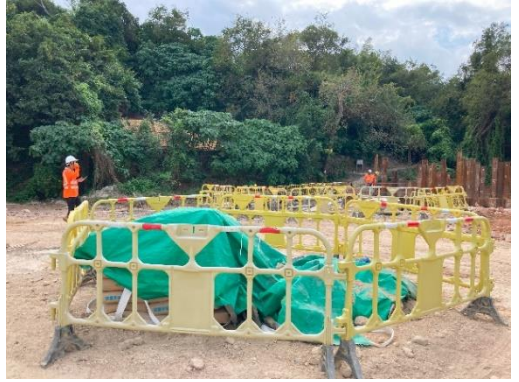
Ref	Location/ Working Period	Anticipated Major Impacts	Recommended Mitigation Measures	Photo Records (Partial)
EIA S3.8	All site area	Dust impact	<ul style="list-style-type: none"> • The portion of any road leading only to construction site that is within 30m of a vehicle entrance or exit should be kept clear of dusty materials; • Every stock of more than 20 bags of cement or dry pulverised fuel ash (PFA) should be covered entirely by impervious sheeting or placed in an area sheltered on the top and the 3 sides;

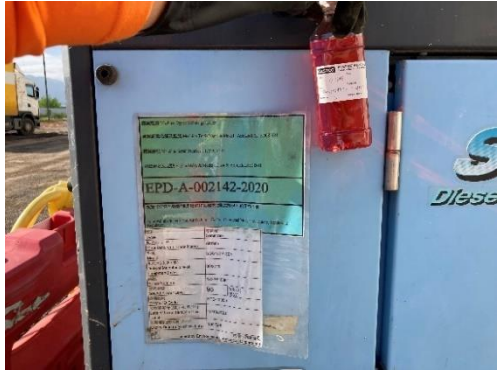
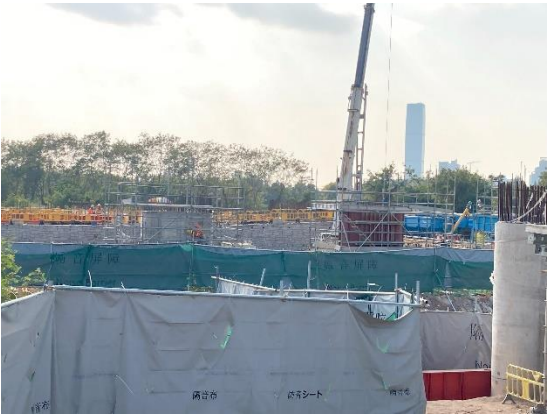
Ref	Location/ Working Period	Anticipated Major Impacts	Recommended Mitigation Measures	Photo Records (Partial)
EIA S4.8	All site area	Noise impact	<ul style="list-style-type: none"> Mobile plant should be sited as far away from NSRs as possible and practicable; All generator used onsite are Quality Powered Mechanical Equipment (QPME) registered with EPD. Install movable noise barriers and full enclosure, screen the noisy plants including air compressor and generator.

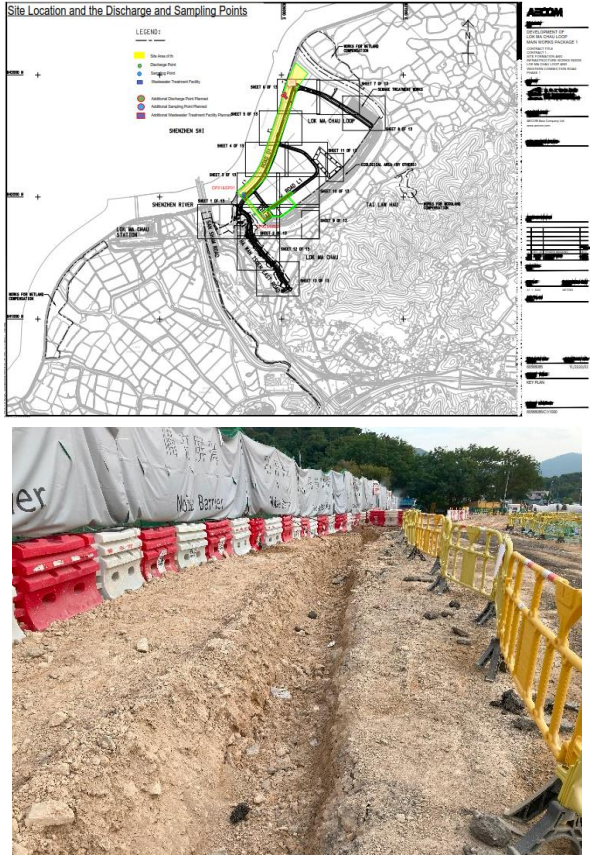
Ref	Location/ Working Period	Anticipated Major Impacts	Recommended Mitigation Measures	Photo Records (Partial)
EIA S5.7	All site area	Water Pollution Control	<ul style="list-style-type: none"> Update and implementation of Stormwater Pollution Control Plan. At the start of site establishment, perimeter cut-off drains to direct off-site water around the site should be constructed with internal drainage works and erosion and sedimentation control facilities implemented. Channels (both temporary and permanent drainage pipes and culverts), earth bunds or sand bag barriers should be provided on site to direct stormwater to silt removal facilities. The design of the temporary on-site drainage system will be undertaken by the contractor prior to the commencement of construction.

<p>The figure consists of two parts. The top part is a map titled 'Site Location and the Discharge and Sampling Points'. It shows a detailed site plan with various colored zones and points. A legend on the left identifies symbols for 'Site Boundary', 'Discharge Point', 'Sampling Point', 'Perimeter Protection Facility', 'Artificial Drainage Pipe/Channel', 'Artificial Stormwater Storage Pond/Retention Pond', and 'Artificial Stormwater Treatment Facility'. The map shows the site's location relative to surrounding roads and infrastructure. The bottom part is a photograph showing a long, narrow trench dug into the ground at a construction site. The trench is lined with red and white plastic sheeting. Yellow plastic safety barriers are placed along the right side of the trench. The ground is dirt and gravel.</p>

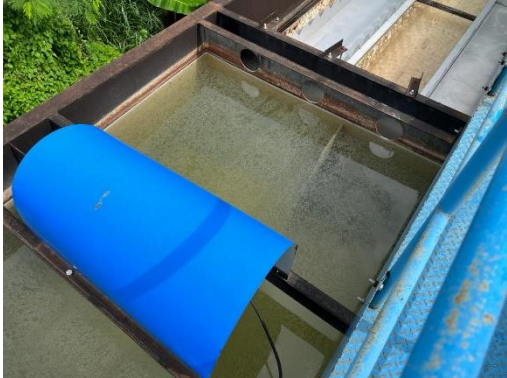
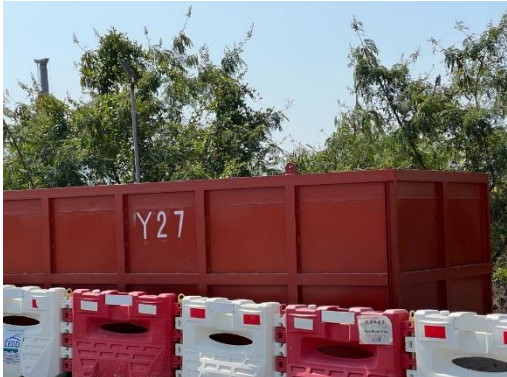
Ref	Location/ Working Period	Anticipated Major Impacts	Recommended Mitigation Measures	Photo Records (Partial)
			<ul style="list-style-type: none"> • Diversion of natural stormwater should be provided as far as possible. The design of temporary on-site drainage should prevent runoff going through site surface, construction machinery and equipments in order to avoid or minimize polluted runoff. <p>Sedimentation tanks with sufficient capacity, constructed from pre-formed individual cells of approximately 6 to 8 m³ capacities, are recommended as a general mitigation measure which can be used for settling surface runoff prior to disposal. The system capacity shall be flexible and able to handle multiple inputs from a variety of sources and suited to applications where the influent is pumped.</p>

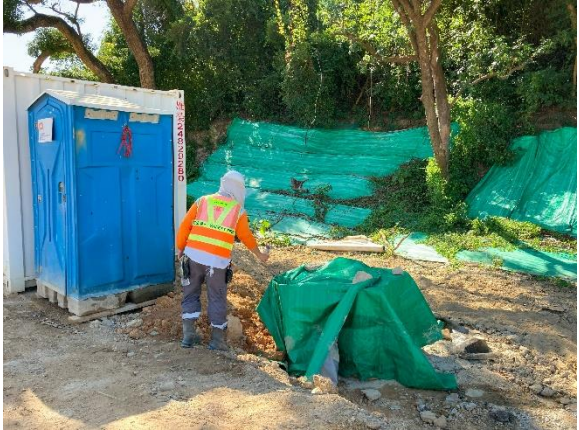
Ref	Location/ Working Period	Anticipated Major Impacts	Recommended Mitigation Measures	Photo Records (Partial)
			<ul style="list-style-type: none"> The design of efficient silt removal facilities should be based on the guidelines in Appendix A1 of ProPECC PN 1/94. The detailed design of the sand/silt traps should be undertaken by the contractor prior to the commencement of construction. <p>All drainage facilities and erosion and sediment control structures should be regularly inspected and maintained to ensure proper and efficient operation at all times and particularly following rainstorms.</p> <ul style="list-style-type: none"> Portable chemical toilets and sewage holding tanks should be provided for handling the construction sewage generated by the workforce. A licensed contractor should be employed to provide appropriate and adequate portable toilets to cater 0.15m³/day/employed populations and be responsible for appropriate disposal and maintenance.

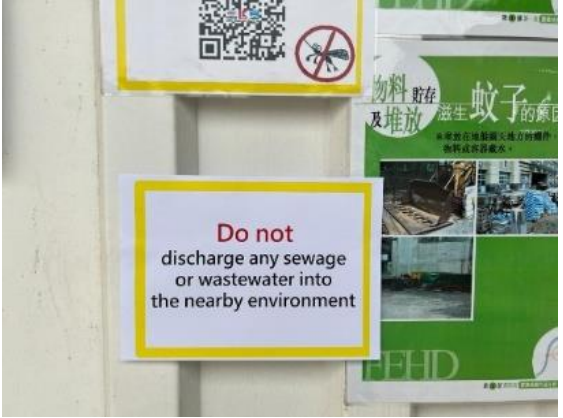
Ref	Location/ Working Period	Anticipated Major Impacts	Recommended Mitigation Measures	Photo Records (Partial)
			<ul style="list-style-type: none"> • Notices should be posted at conspicuous locations to remind the workers not to discharge any sewage or wastewater into the nearby environment during the construction phase of the Project. Regular environmental audit on the construction site should be conducted in order to provide an effective control of any malpractices and achieve continual improvement of environmental performance on site.

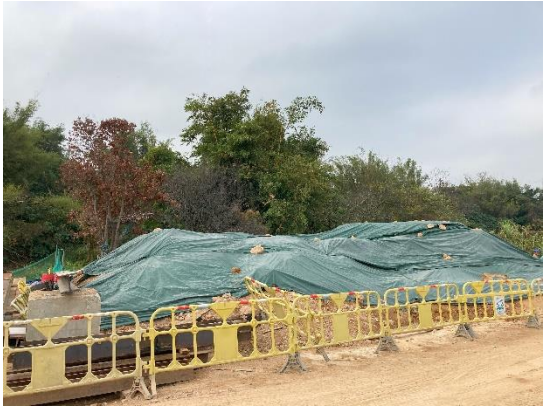
Ref	Location/ Working Period	Anticipated Major Impacts	Recommended Mitigation Measures	Photo Records (Partial)
			<ul style="list-style-type: none"> • Prepare Waste Management Plan and submit to the Engineer for approval • Proper storage and sorting of excavated inert materials to maximize on site reuse for backfilling

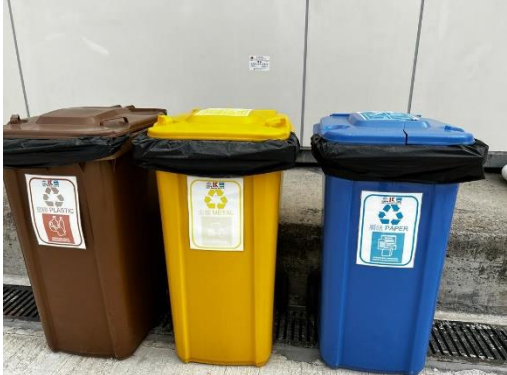
Ref	Location/ Working Period	Anticipated Major Impacts	Recommended Mitigation Measures	Photo Records (Partial)
			<ul style="list-style-type: none">• General refuse should be stored in enclosed bins separately from construction and chemical wastes. Recycling bins should also be placed to encourage recycling.

A photograph showing three recycling bins lined up against a wall. From left to right: a brown bin with a red recycling symbol, a yellow bin with a yellow recycling symbol, and a blue bin with a blue recycling symbol. Each bin has a black lid and a white label with a recycling symbol and text.

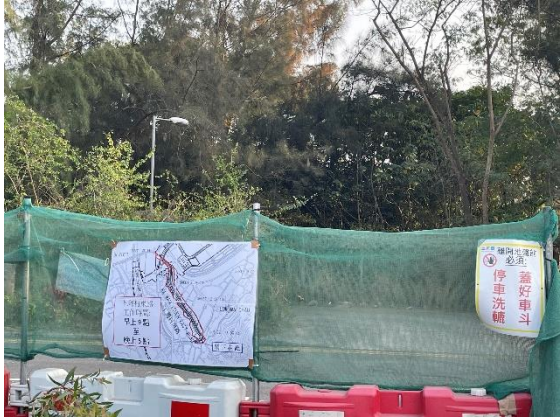
Ref	Location/ Working Period	Anticipated Major Impacts	Recommended Mitigation Measures	Photo Records (Partial)
	Old Shenzhen River meander and other identified important ecologically sensitive areas,		Using powered mechanical equipment for construction works only during the period 9am to 5pm at and near the old Shenzhen River meander and other identified important ecologically sensitive areas, if any;

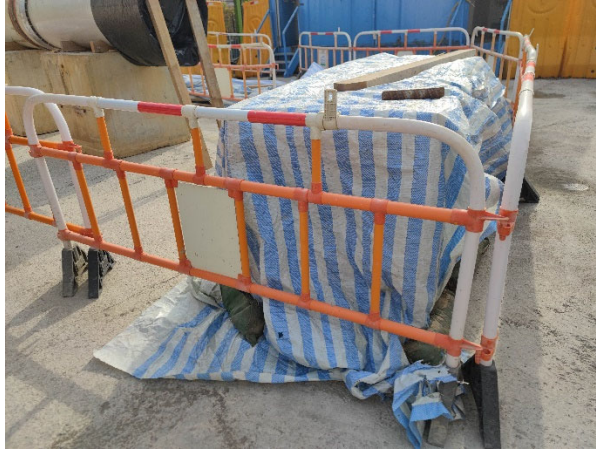
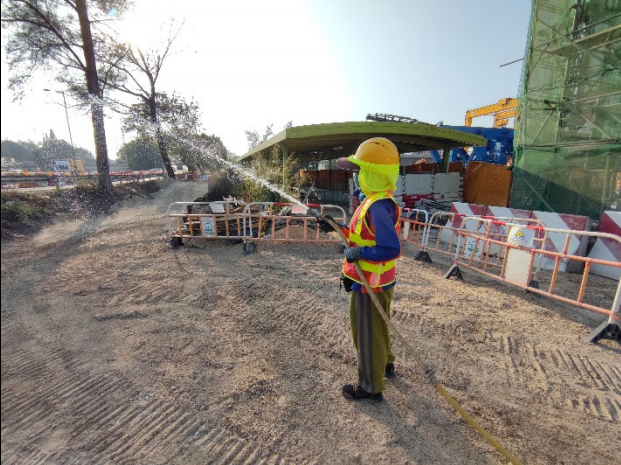
Ref*	Location/Working Period	Anticipated Major Impacts	Recommended Mitigation Measures	Photo Records (Partial)
EIA S3.8	All site area	Dust impact	<ul style="list-style-type: none"> Any excavated or stockpile of dusty material should be covered entirely by impervious sheeting or sprayed with water to maintain the entire surface wet and then removed or backfilled or reinstated where practicable within 24 hours of the excavation or unloading; Any dusty materials remaining after a stockpile is removed should be wetted with water and cleared from the surface of roads;

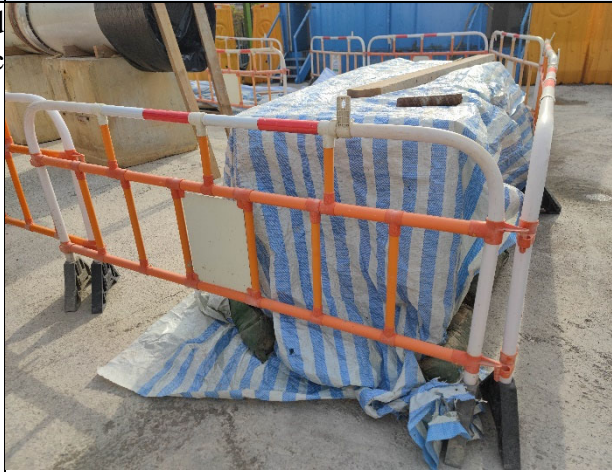
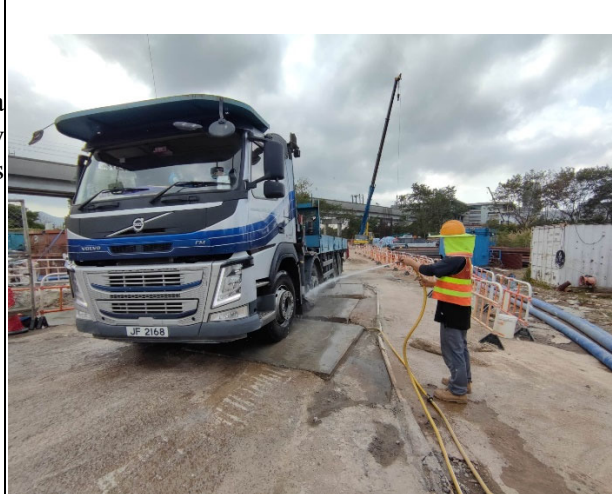
Ref*	Location/ Working Period	Anticipated Major Impacts	Recommended Mitigation Measures	Photo Records (Partial)
EIA S3.8	All site area	Dust impact	<ul style="list-style-type: none"> • A stockpile of dusty material should not be extend beyond the pedestrian barriers, fencing or traffic cones; • The load of dusty materials on a vehicle leaving a construction site should be covered entirely by impervious sheeting to ensure that the dusty materials do not leak from the vehicle;

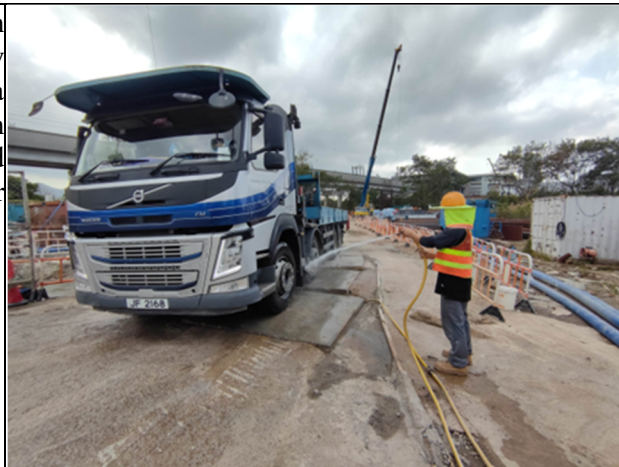
<ul style="list-style-type: none">• Where practicable, vehicle washing facilities with high pressure water jet should be provided at every discernible or designated vehicle exit point. The area where vehicle washing takes place and the road section between the washing facilities and the exit point should be paved with concrete, bituminous materials or hardcores.

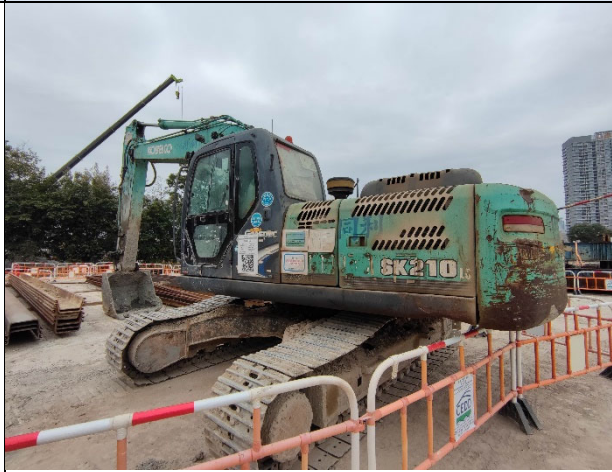
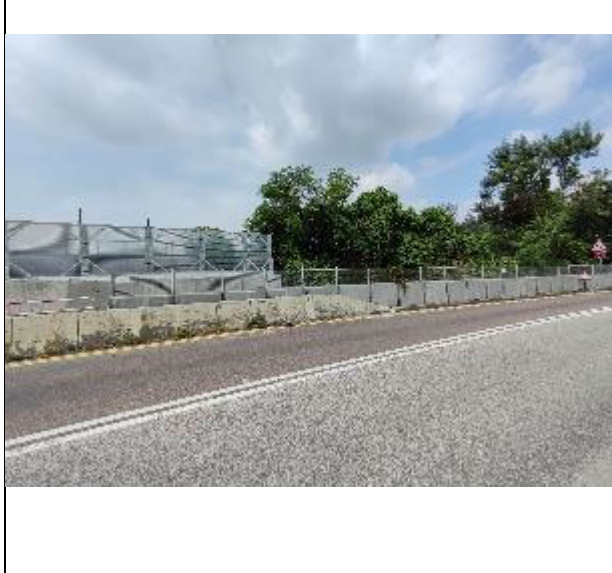
Ref*	Location/ Working Period	Anticipated Major Impacts	Recommended Mitigation Measures	Photo Records (Partial)
EIA S4.8	All site area	Noise impact	<ul style="list-style-type: none"> • Mobile plant should be sited as far away from NSRs as possible and practicable; • Install movable noise barriers and full enclosure, screen the noisy plants including air compressor and generator.

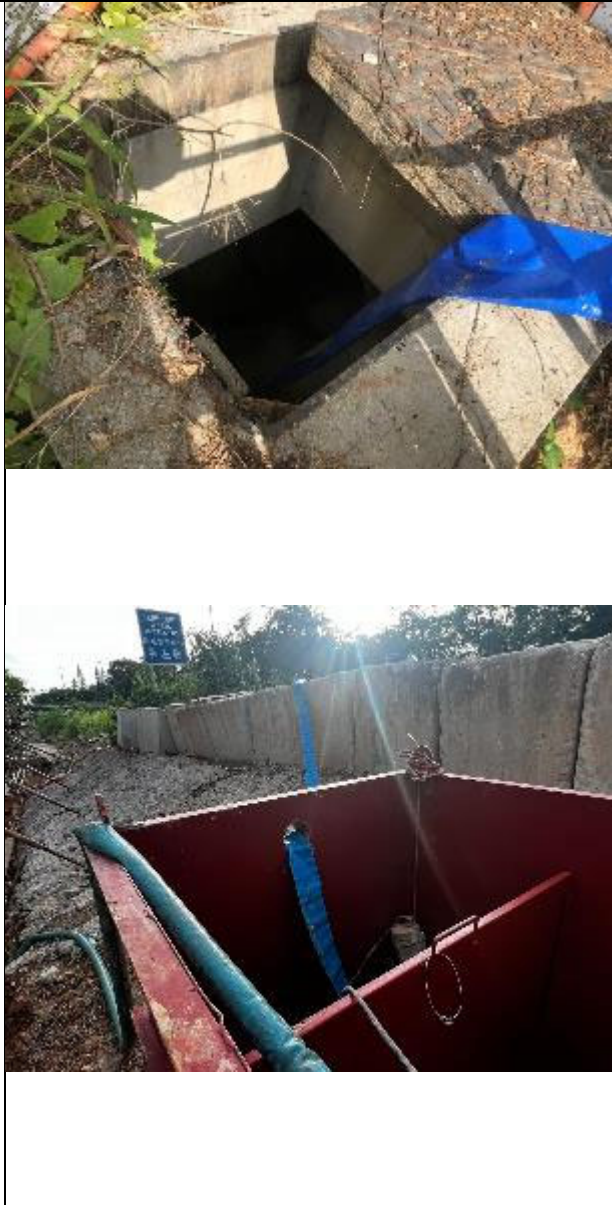
EIA S5.7	All site area	Water Pollution Control	<ul style="list-style-type: none">• At the start of site establishment, perimeter cut-off drains to direct off-site water around the site should be constructed with internal drainage works and erosion and sedimentation control facilities implemented. Channels (both temporary and permanent drainage pipes and culverts), earth bunds or sand bag barriers should be provided on site to direct stormwater to silt removal facilities. The design of the temporary on-site drainage system will be undertaken by the contractor prior to the commencement of construction. • Diversion of natural stormwater should be provided as far as possible. The design of temporary on-site drainage should prevent runoff going through site surface, construction machinery and equipment in order to avoid or minimize polluted runoff.

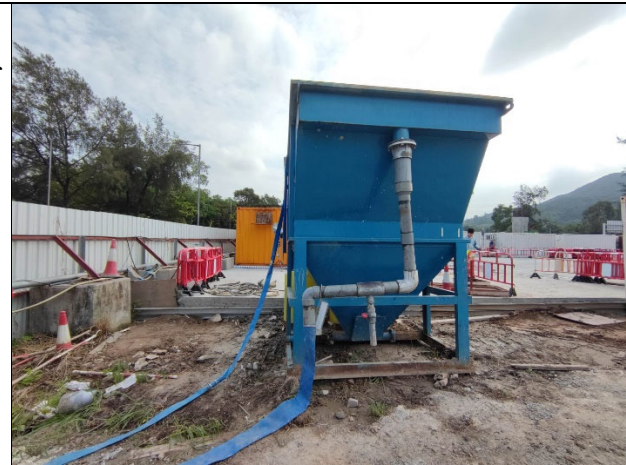
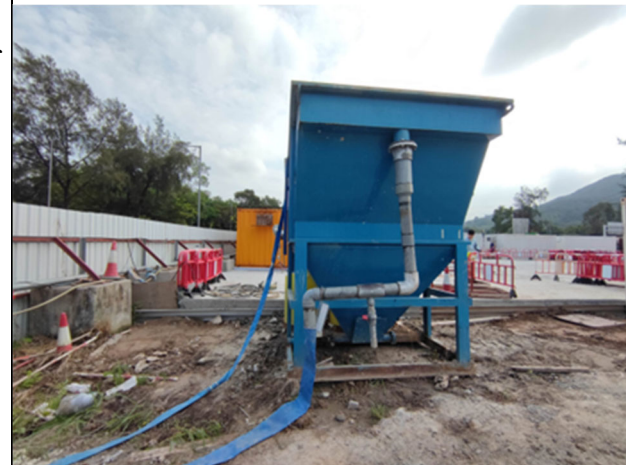
- Sedimentation tanks with sufficient capacity, constructed from pre-formed individual cells of approximately 6 to 8 m³ capacities, are recommended as a general mitigation measure which can be used for settling surface runoff prior to disposal. The system capacity shall be flexible and able to handle multiple inputs from a variety of sources and suited to applications where the influent is pumped.

- The design of efficient silt removal facilities should be based on the guidelines in Appendix A1 of ProPECC PN 1/94. The detailed design of the sand/silt traps should be undertaken by the contractor prior to the commencement of construction.

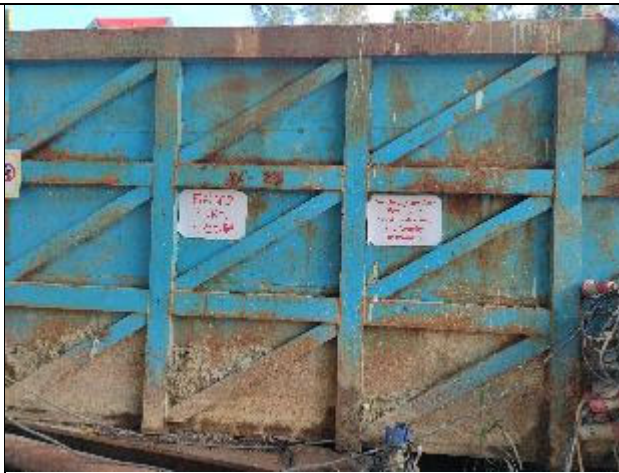
<ul style="list-style-type: none">• Notices should be posted at conspicuous locations to remind the workers not to discharge any sewage or wastewater into the nearby environment during the construction phase of the Project. Regular environmental audit on the construction site should be conducted in order to provide an effective control of any malpractices and achieve continual improvement of environmental performance on site.

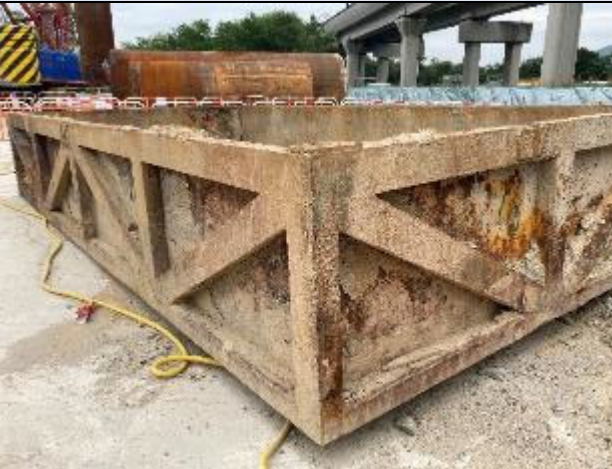
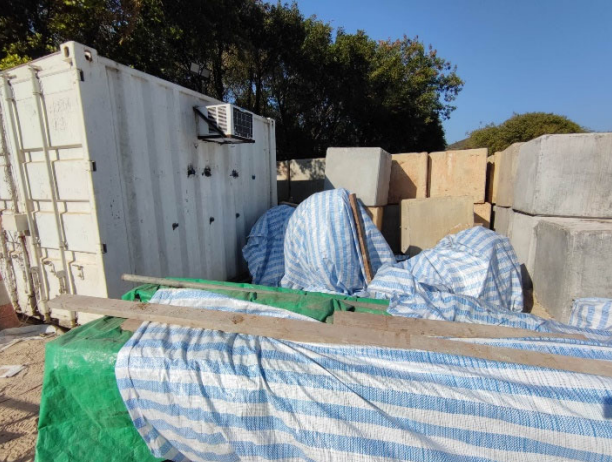
Ref*	Location/ Working Period	Anticipated Major Impacts	Recommended Mitigation Measures	Photo Records (Partial)
EIA S7.6	All site area	Waste Generation	<ul style="list-style-type: none"> • Segregate and store different types of waste in different containers, skip or stockpiles to enhance reuse or recycling of materials and their proper disposal; • Proper storage and site practices to minimize the potential for damage and contamination of construction materials;

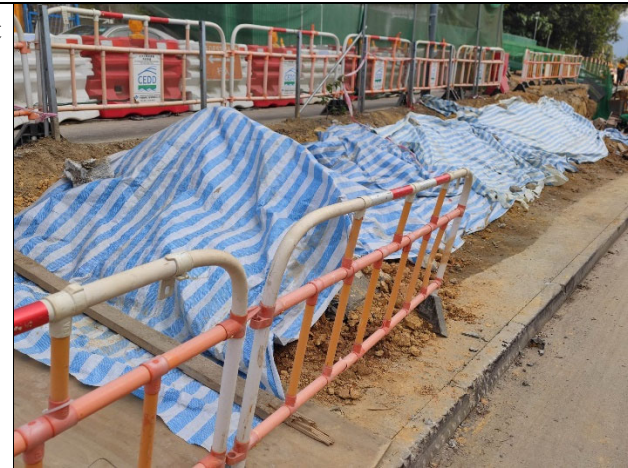
• Proper storage and sorting of excavated inert materials to maximize on site reuse for backfilling

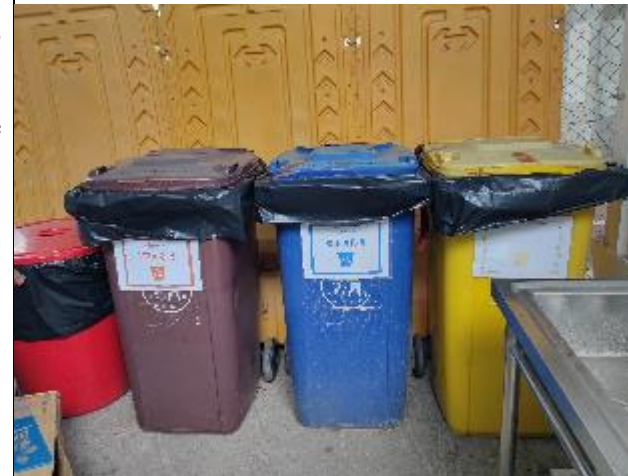
• General refuse should be stored in enclosed bins separately from construction and chemical wastes. Recycling bins should also be placed to encourage recycling.

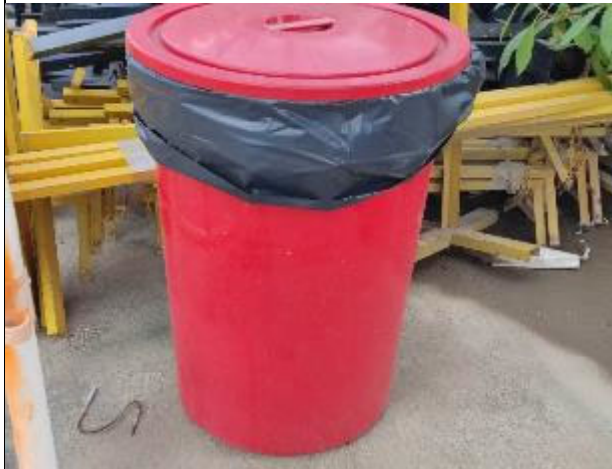
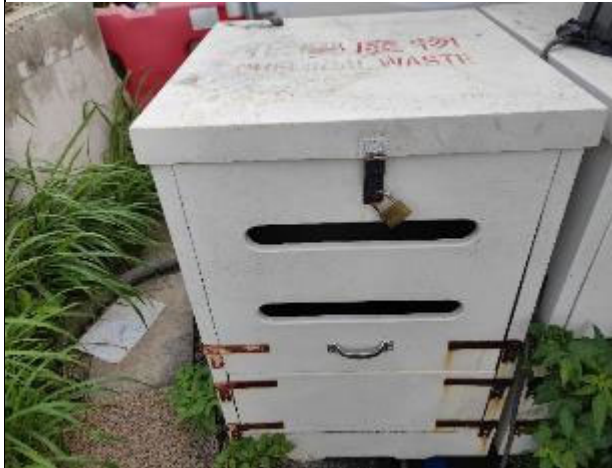
<ul style="list-style-type: none">• Preferably enclosed and covered areas should be provided for general refuse collection and routine cleaning for these areas should also be implemented to keep areas clean. • If chemical wastes are produced at the construction site, the Contractors should register with EPD as chemical waste producers. Chemical wastes should be stored in appropriate containers and collected by a licensed chemical waste contractor. Chemical wastes (e.g. spent lubricant oil) should be recycled at an appropriate facility as far as possible, while the chemical waste that cannot be recycled should be disposed of at either the Chemical Waste Treatment Centre, or another licensed facility, in accordance with the Waste Disposal (Chemical Waste) (General) Regulation.

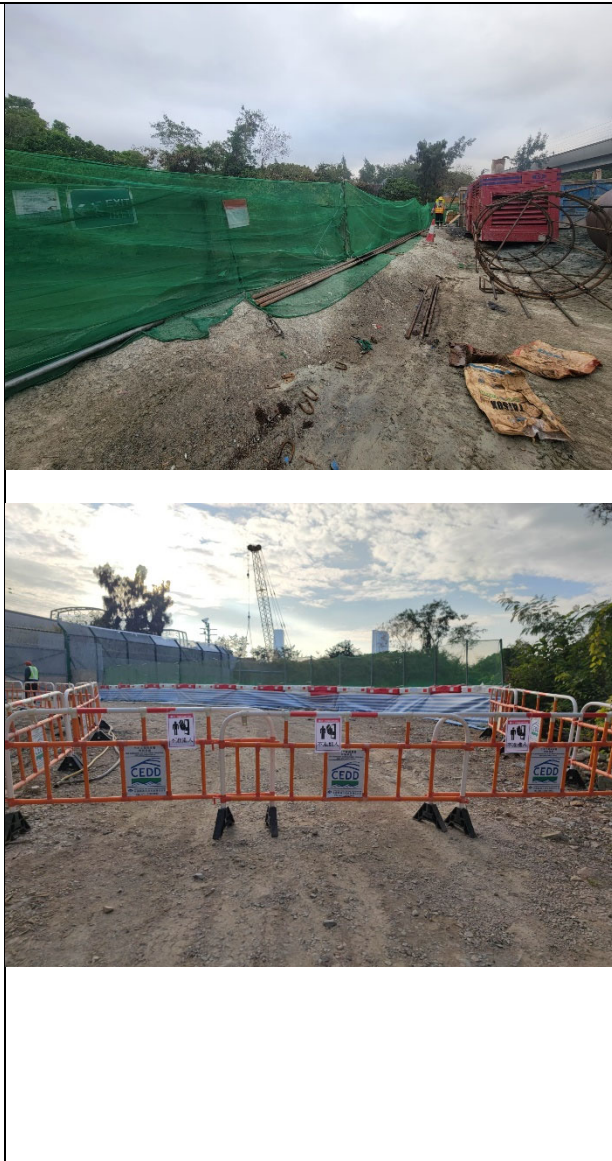
ERR S4.2.2	STEMDC	Ecology	<ul style="list-style-type: none">• Installation of 3m-high olive green fence site hoarding around construction areas to reduce disturbance and such installation should allow passage of animal • Well-defined and fenced work area to prevent intentional or accidental encroachment or trespassing to other part of the mitigation wetland for access, parking, operation of plants/machineries, or stockpiling of construction material/waste nearby

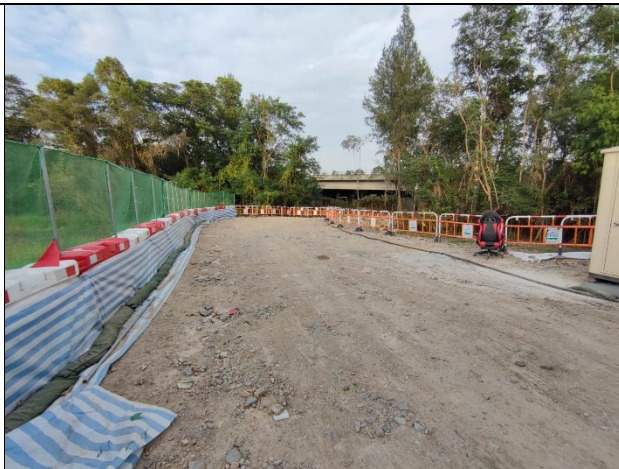
<ul style="list-style-type: none">Measures to avoid any spillage or discharge of untreated runoff from the site to other part of the mitigation wetland should be implemented, including but not limited to provision of sandbags barrier and perimeter channels at site boundaries,

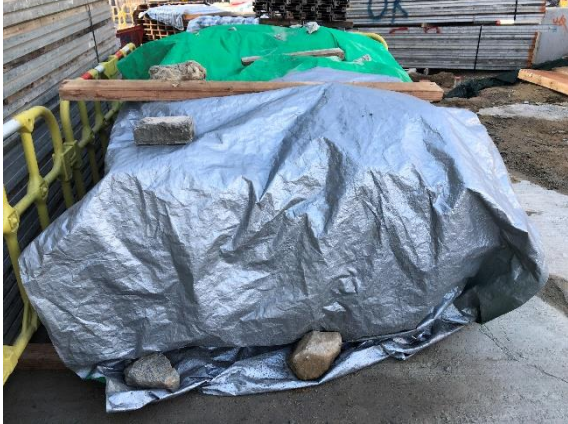
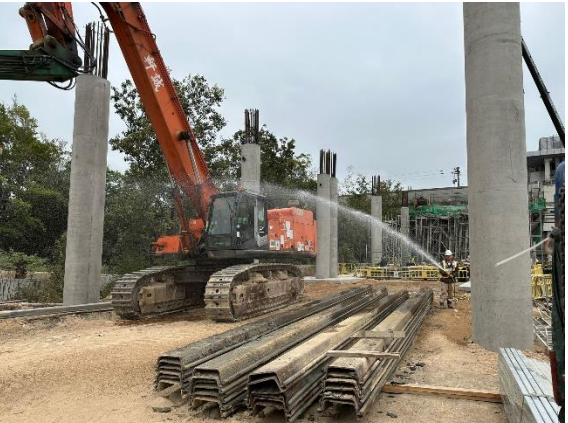
Ref*	Location/ Working Period	Anticipated Major Impacts	Recommended Mitigation Measures	Photo Records (Partial)
EIA S3.8	All site area	Dust impact	<ul style="list-style-type: none"> Any excavated or stockpile of dusty material should be covered entirely by impervious sheeting or sprayed with water to maintain the entire surface wet and then removed or backfilled or reinstated where practicable within 24 hours of the excavation or unloading; Any dusty materials remaining after a stockpile is removed should be wetted with water and cleared from the surface of roads;

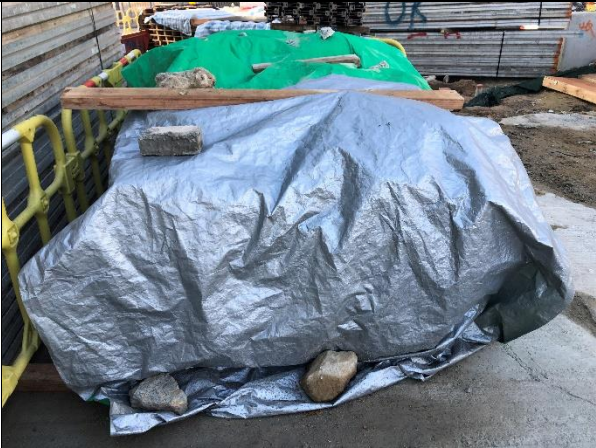
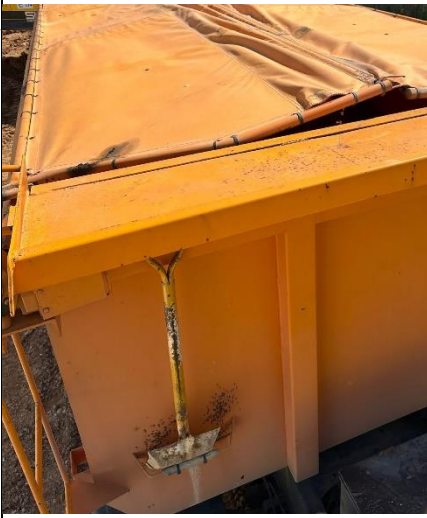
Ref*	Location/ Working Period	Anticipated Major Impacts	Recommended Mitigation Measures	Photo Records (Partial)
EIA S3.8	All site area	Dust impact	<ul style="list-style-type: none"> • A stockpile of dusty material should not be extend beyond the pedestrian barriers, fencing or traffic cones; • The load of dusty materials on a vehicle leaving a construction site should be covered entirely by impervious sheeting to ensure that the dusty materials do not leak from the vehicle;

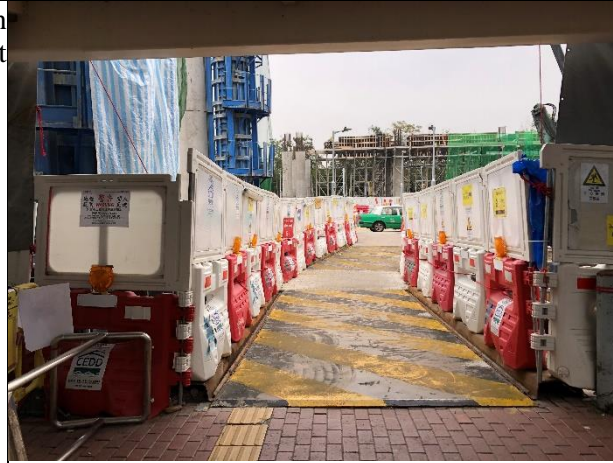
• The portion of any road leading only to construction site that is within 30m of a vehicle entrance or exit should be kept clear of dusty materials;

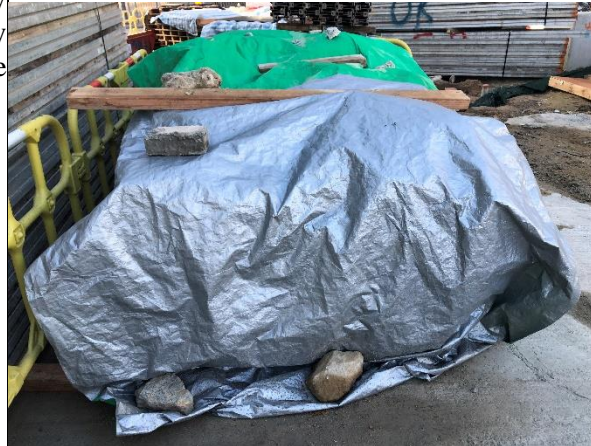
• Every stock of more than 20 bags of cement or dry pulverised fuel ash (PFA) should be covered entirely by impervious sheeting or placed in an area sheltered on the top and the 3 sides;

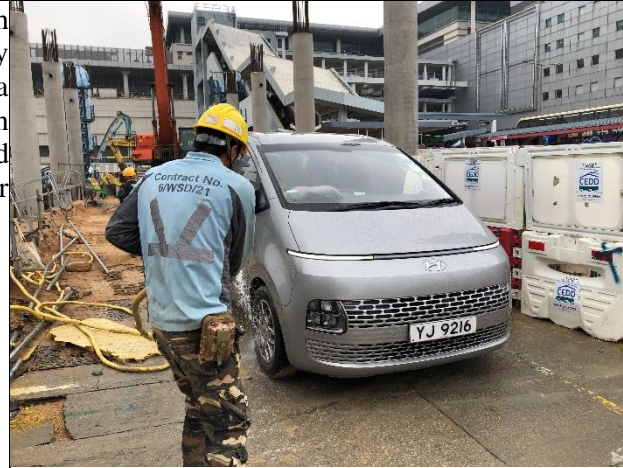
- Where practicable, vehicle washing facilities with high pressure water jet should be provided at every discernible or designated vehicle exit point. The area where vehicle washing takes place and the road section between the washing facilities and the exit point should be paved with concrete, bituminous materials or hardcores.

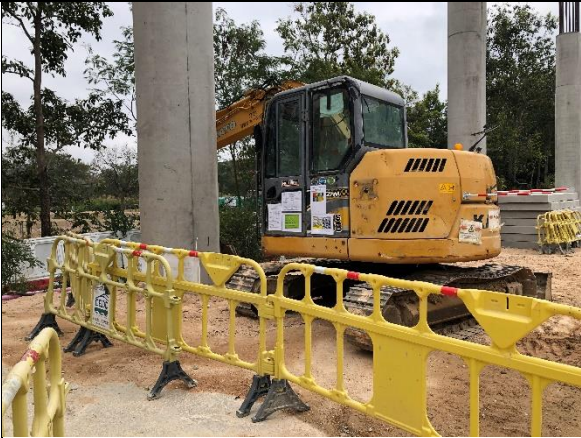
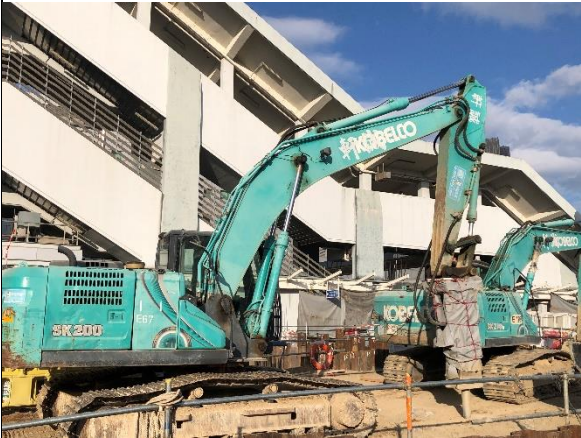
Ref*	Location/ Working Period	Anticipated Major Impacts	Recommended Mitigation Measures	Photo Records (Partial)
EIA S4.8	All site area	Noise impact	<ul style="list-style-type: none"> • Mobile plant should be sited as far away from NSRs as possible and practicable; • Install movable noise barriers and full enclosure, screen the noisy plants including air compressor and generator.

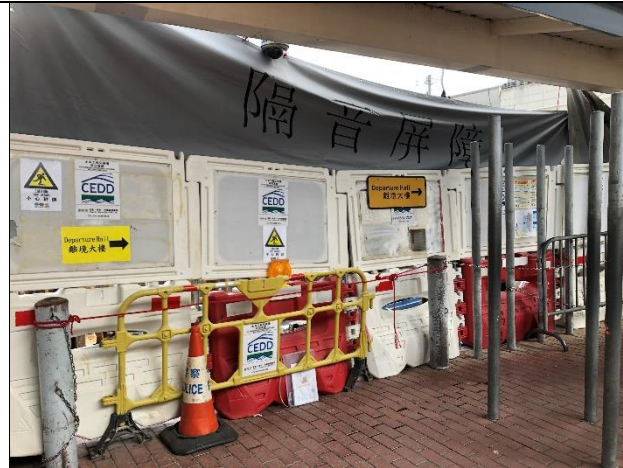
• An acoustic canvas had been deployed along the site boundary facing the public.

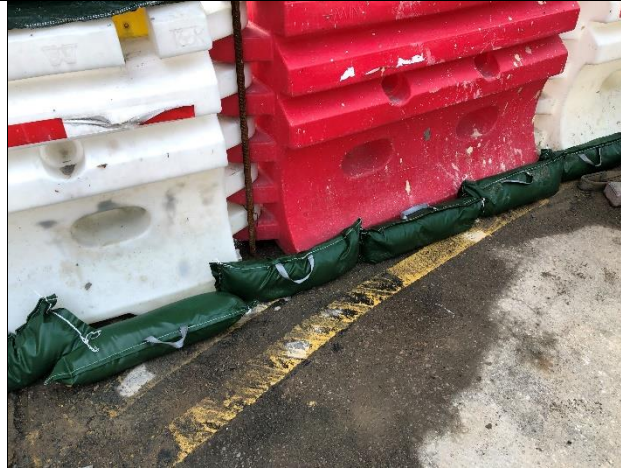
• Diversion of natural stormwater should be provided as far as possible. The design of temporary on-site drainage should prevent runoff going through site surface, construction machinery and equipment in order to avoid or minimize polluted runoff.

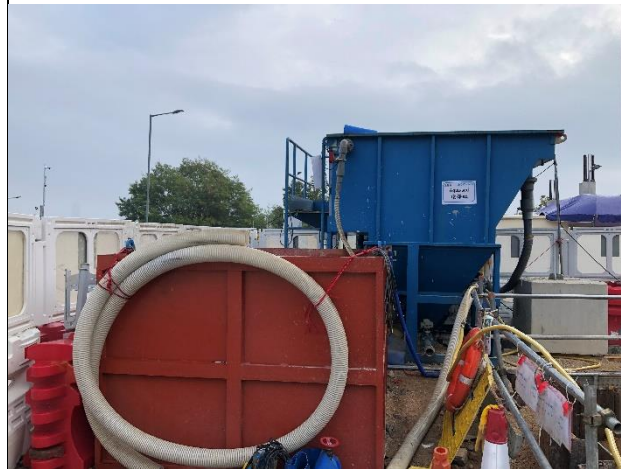
• Sedimentation tanks with sufficient capacity, constructed from pre-formed individual cells of approximately 6 to 8 m³ capacities, are recommended as a general mitigation measure which can be used for settling surface runoff prior to disposal. The system capacity shall be flexible and able to handle multiple inputs from a variety of sources and suited to applications where the influent is pumped.

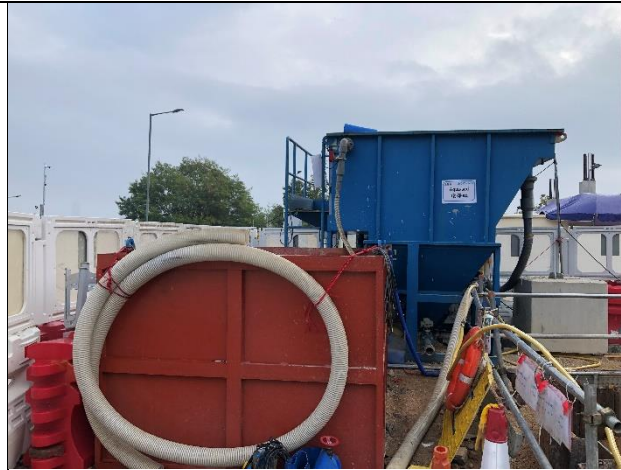
- The design of efficient silt removal facilities should be based on the guidelines in Appendix A1 of ProPECC PN 1/94. The detailed design of the sand/silt traps should be undertaken by the contractor prior to the commencement of construction.

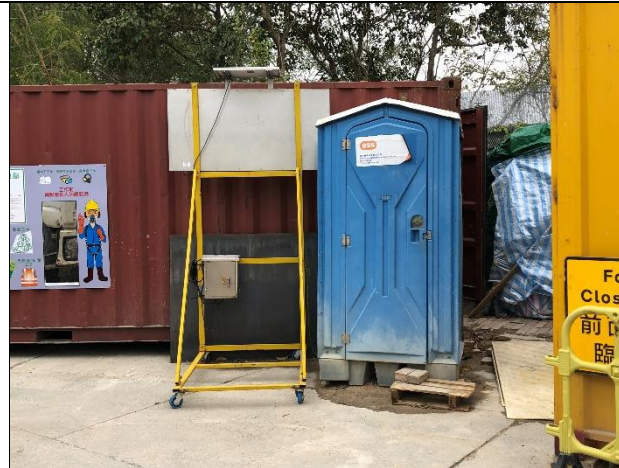
• Portable chemical toilets and sewage holding tanks should be provided for handling the construction sewage generated by the workforce. A licensed contractor should be employed to provide appropriate and adequate portable toilets to cater 0.15m³/day/employed populations and be responsible for appropriate disposal and maintenance.

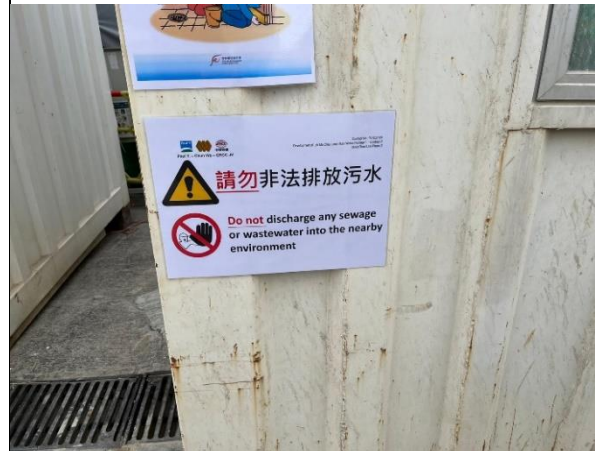
• Notices should be posted at conspicuous locations to remind the workers not to discharge any sewage or wastewater into the nearby environment during the construction phase of the Project. Regular environmental audit on the construction site should be conducted in order to provide an effective control of any malpractices and achieve continual improvement of environmental performance on site.

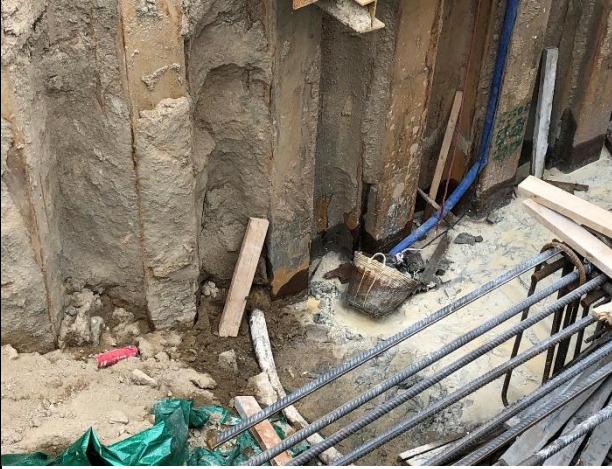
<ul style="list-style-type: none">•An additional water pump had been set up and the concerned outlet have been sealed up with concrete
