**Service Contract No. WD/04/2020
Development of Lok Ma Chau Loop:
Main Works Package 1 –
Environmental Team**

**Environmental Permit No.:
EP-477/2013/B
- Development of Lok Ma Chau Loop**

**Monthly Environmental Monitoring and
Audit Report for January 2024**

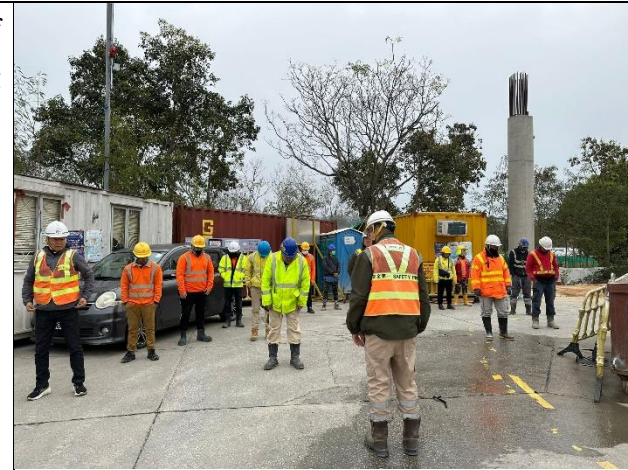
- Provide training to workers on the importance of appropriate waste management procedures, including waste reduction, reuse and recycling.

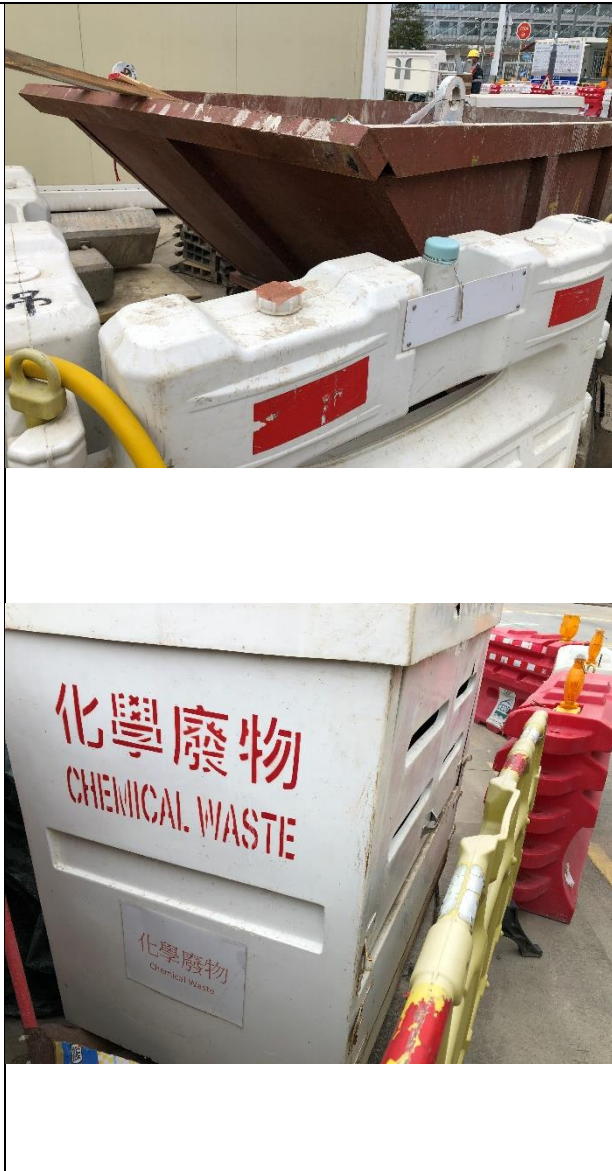
<ul style="list-style-type: none">• Preferably enclosed and covered areas should be provided for general refuse collection and routine cleaning for these areas should also be implemented to keep areas clean. • If chemical wastes are produced at the construction site, the Contractors should register with EPD as chemical waste producers. Chemical wastes should be stored in appropriate containers and collected by a licensed chemical waste contractor. Chemical wastes (e.g. spent lubricant oil) should be recycled at an appropriate facility as far as possible, while the chemical waste that cannot be recycled should be disposed of at either the Chemical Waste Treatment Centre, or another licensed facility, in accordance with the Waste Disposal (Chemical Waste) (General) Regulation.

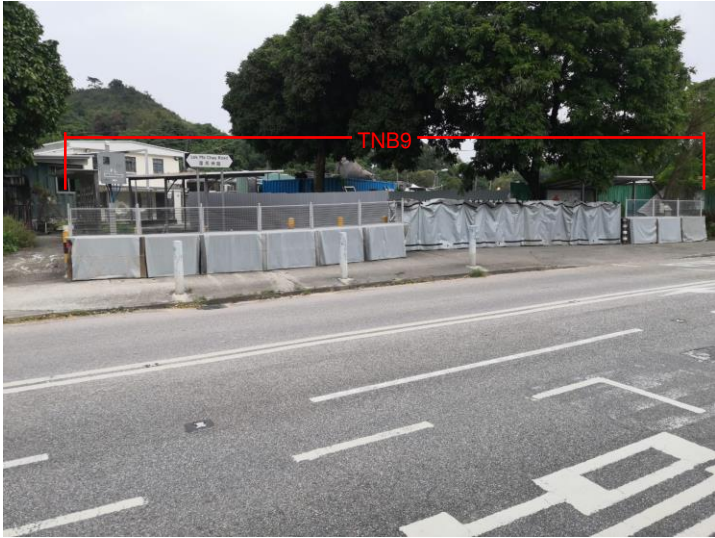
TNB ID	Photo
TNB9

A photograph showing a temporary noise barrier (TNB9) along a road. The barrier consists of grey concrete blocks topped with a chain-link fence. In the background, there are trees and a building. A red rectangular box highlights the barrier, with the label 'TNB9' in red text above it.
TNB10

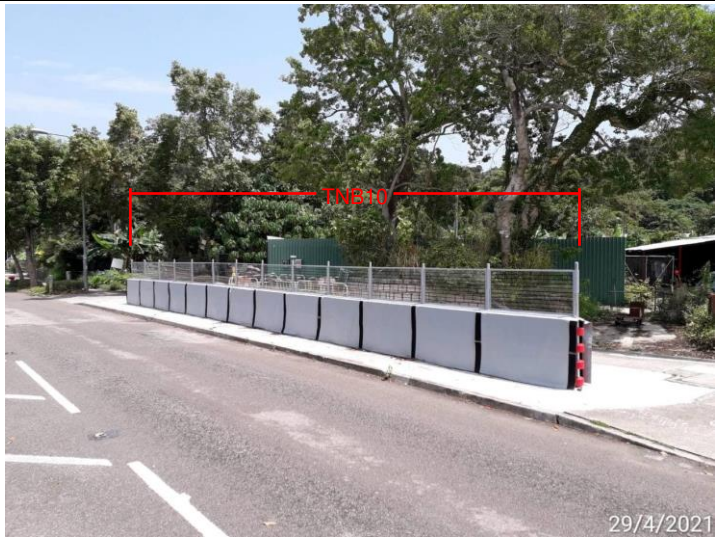
A photograph showing a temporary noise barrier (TNB10) along a road. The barrier consists of grey concrete blocks topped with a chain-link fence. The background shows lush green trees. A red rectangular box highlights the barrier, with the label 'TNB10' in red text above it. The date '29/4/2021' is visible in the bottom right corner.
TNB13

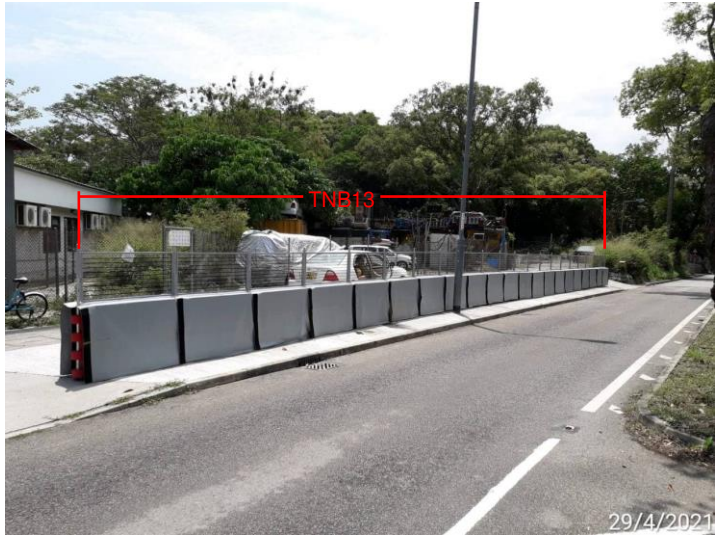
A photograph showing a temporary noise barrier (TNB13) along a road. The barrier consists of grey concrete blocks topped with a chain-link fence. In the background, there are trees and a building. A red rectangular box highlights the barrier, with the label 'TNB13' in red text above it. The date '29/4/2021' is visible in the bottom right corner.

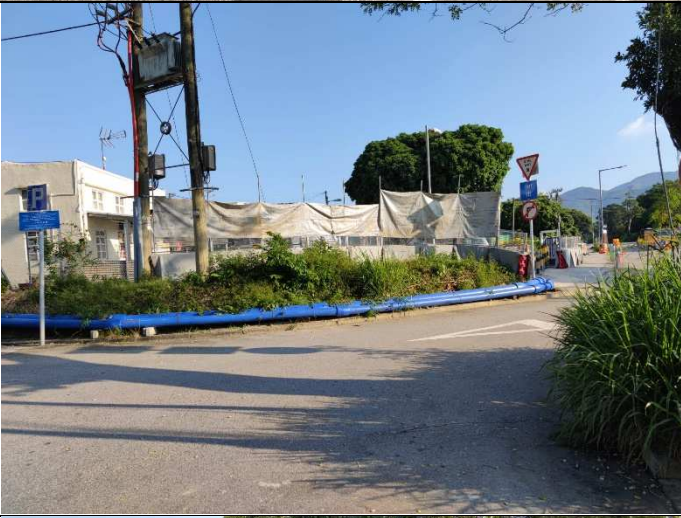
Completed
10

Completed
11

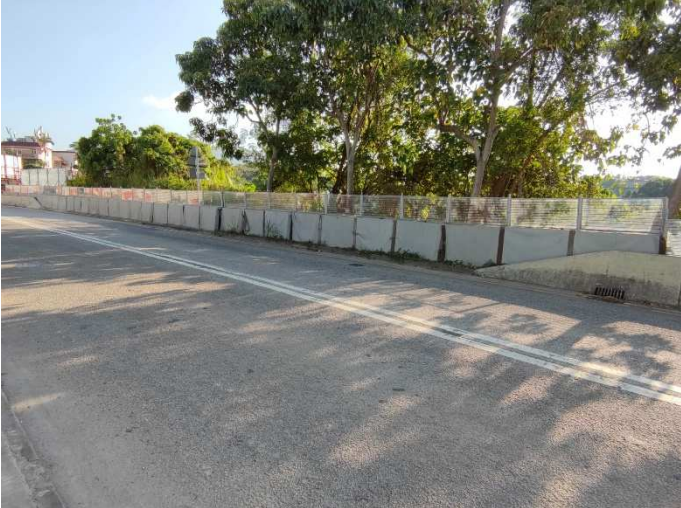
Completed
