Service Contract No. WD/04/2020 Development of Lok Ma Chau Loop: Main Works Package 1 – Environmental Team

Environmental Permit No.: EP-477/2013/B - Development of Lok Ma Chau Loop

Monthly Environmental Monitoring and Audit Report for February 2024

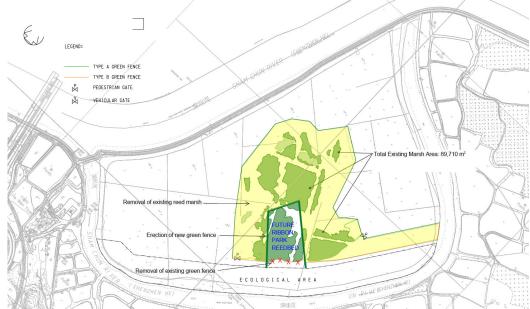
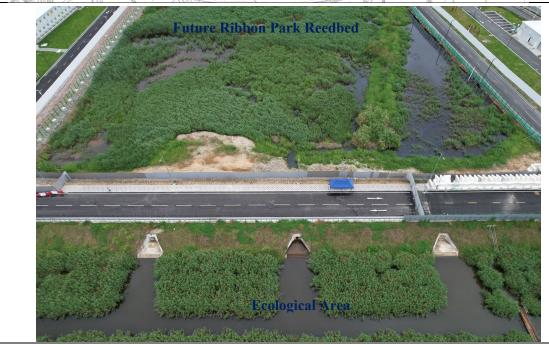
10.8 The green fence around the future Ribbon Park Reedbed has been removed and replaced by the hoarding due to the other project's land occupier since March 2022. (See Figure & photo below)

10.10 The Contractor was reminded to maintain the green fence around construction areas and ensure no disturbance to the exiting trees and reed marsh habitat subject to the latest situation of LMC Loop.

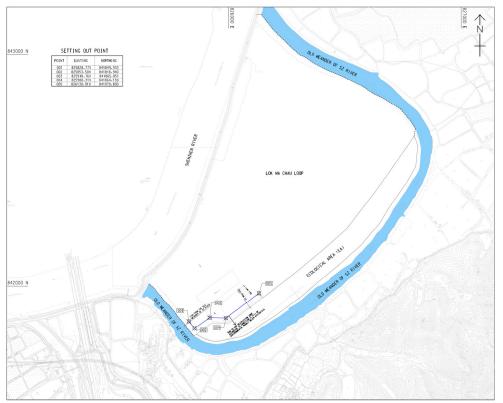
10.9 Installation of the green fence alongside the Ecological Area and the Meander was

proposed and completed on $20^{\rm th}$ May 2022. The layout plan of the green fence installation is shown below: -

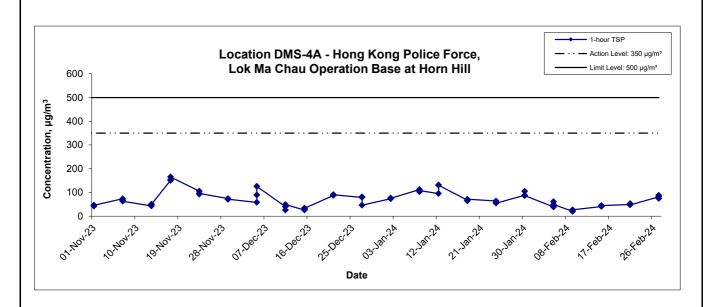
1-hour TSP Concentration Levels

Service Contract No. WD/04/2020
Development of Lok Ma Chau Loop:
Main Works Package 1 - Environmental Team
Graphical Presentation of 1-hour TSP Monitoring Results

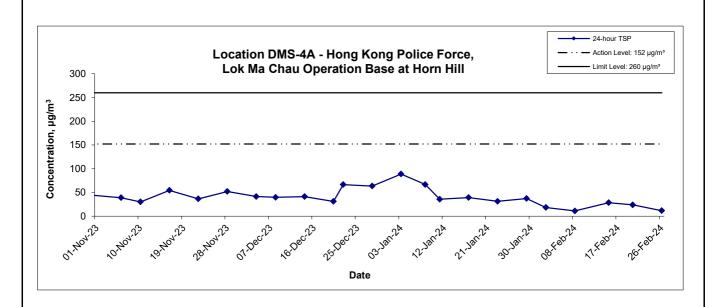
24-hour TSP Concentration Levels

Title Service Contract No. WD/04/2020
Development of Lok Ma Chau Loop:
Main Works Package 1 - Environmental Team
Graphical Presentation of 24-hour TSP Monitoring Results

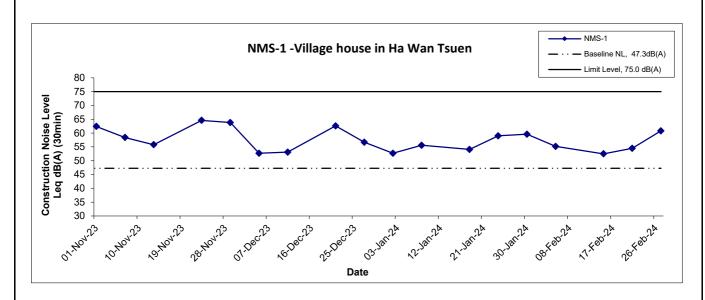
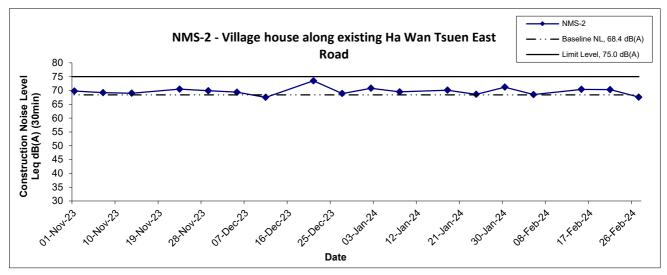
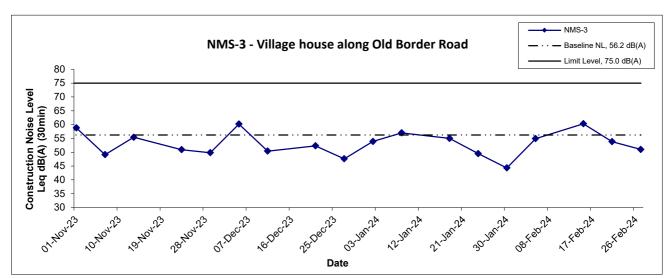
Noise Levels

Title Service Contract No. WD/04/2020
Development of Lok Ma Chau Loop:
Main Works Package 1 - Environmental Team
Graphical Presentation of Construction Noise Monitoring
Results

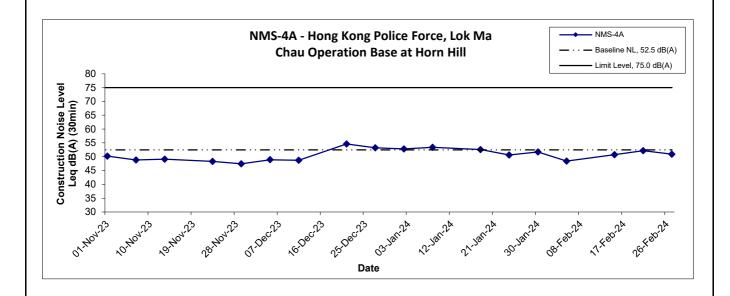
Noise Levels

Title Service Contract No. WD/04/2020
Development of Lok Ma Chau Loop:
Main Works Package 1 - Environmental Team
Graphical Presentation of Construction Noise Monitoring
Results

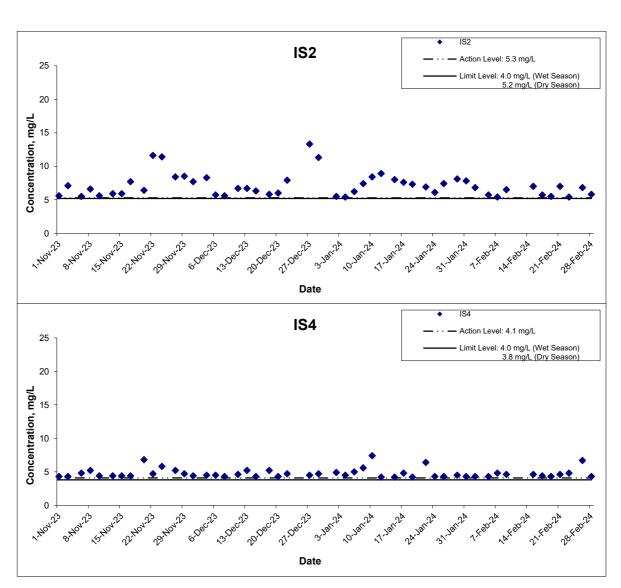
Dissolved Oxygen

Title
Service Contract No. WD/04/2020
Development of Lok Ma Chau Loop:
Main Works Package 1 - Environmental Team
Graphical Presentation of Water Quality Monitoring
Results

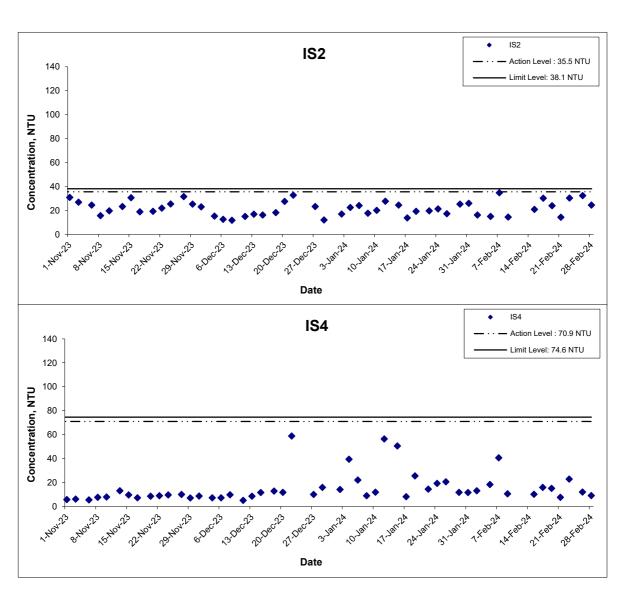
Turbidity

Title Service Contract No. WD/04/2020
Development of Lok Ma Chau Loop:
Main Works Package 1 - Environmental Team
Graphical Presentation of Water Quality Monitoring
Results

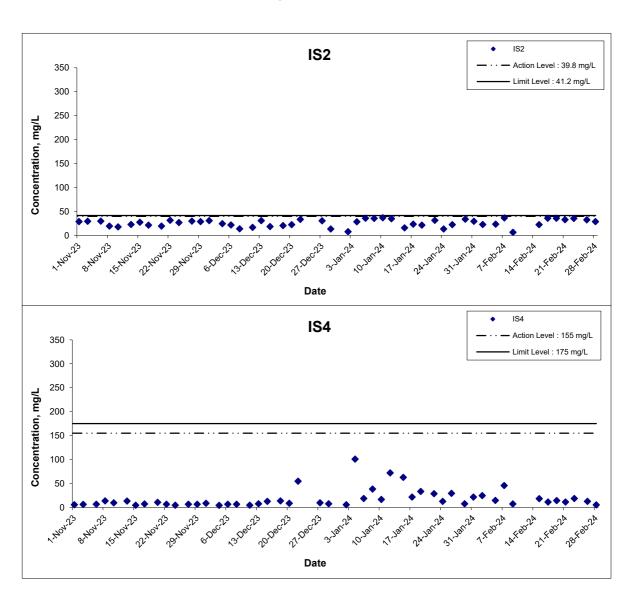
Suspended Solids

Remark: The graphical point at zero concentration is presented as <2.5 mg/L

Title Service Contract No. WD/04/2020
Development of Lok Ma Chau Loop:
Main Works Package 1 - Environmental Team
Graphical Presentation of Water Quality Monitoring
Results

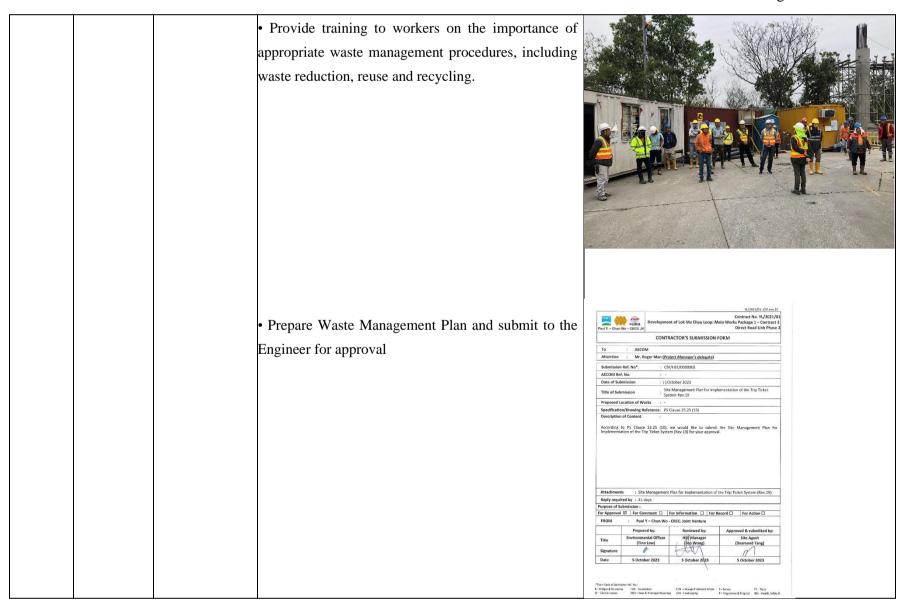
Proper storage and sorting of excavated inert materials to maximize on site reuse for backfilling General refuse should be stored in enclosed bins separately from construction and chemical wastes. Recycling bins should also be placed to encourage recycling.

• Preferably enclosed and covered areas should be provided for general refuse collection and routine cleaning for these areas should also be implemented to keep areas clean.

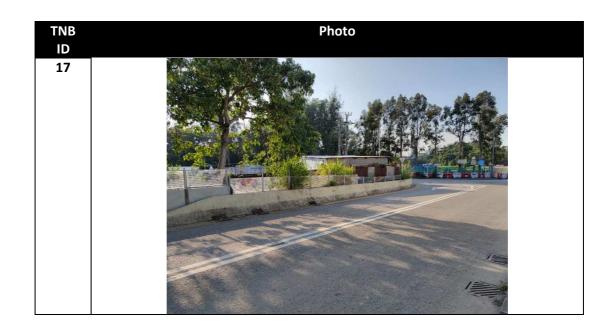
Record Photographs for Temporary Noise Barriers at Lok Ma Chau Road

TNB ID	Photo	Construction Status
9		Completed
10		Completed
11		Completed

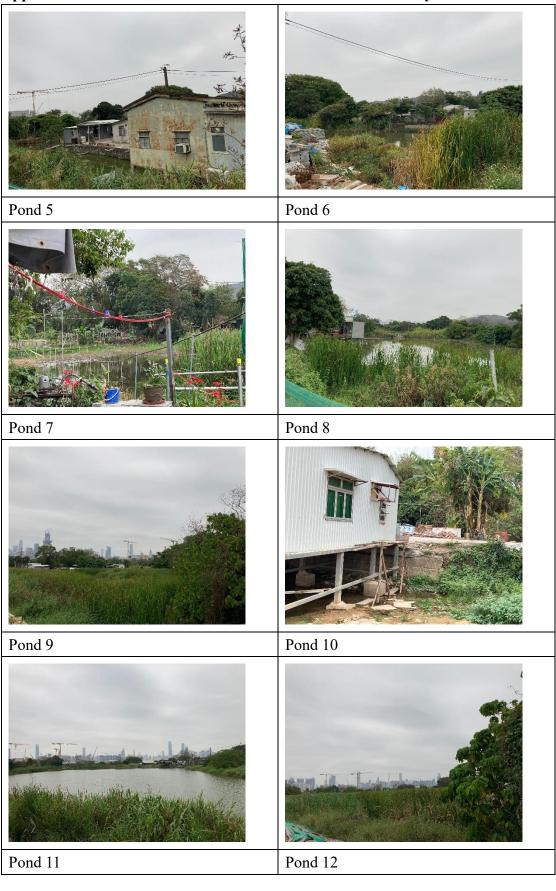
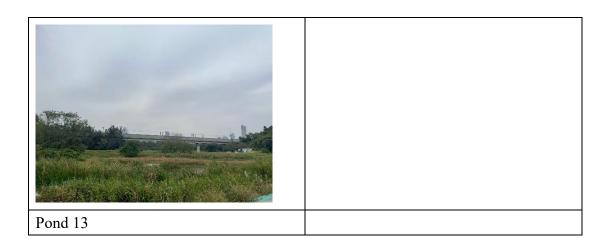
APPENDIX S PHOTO RECORDS OF THE STATUS OF PONDS

Appendix S-Photo Records of the status of Ponds in February 2024
