**Service Contract No. WD/04/2020  
Development of Lok Ma Chau Loop:  
Main Works Package 1 –  
Environmental Team**

**Environmental Permit No.:  
EP-477/2013/A  
- Development of Lok Ma Chau Loop**

**Monthly Environmental Monitoring and  
Audit Report for November 2023**

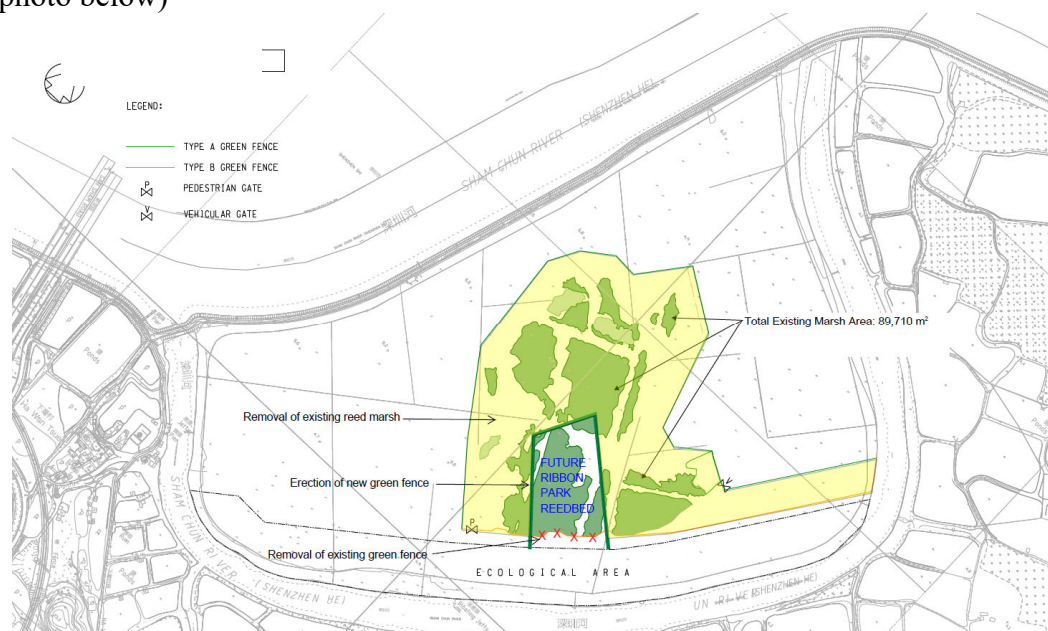
- 10.8 The green fence around the future Ribbon Park Reedbed has been removed and replaced by the hoarding due to the other project's land occupier since March 2022. (See Figure & photo below)

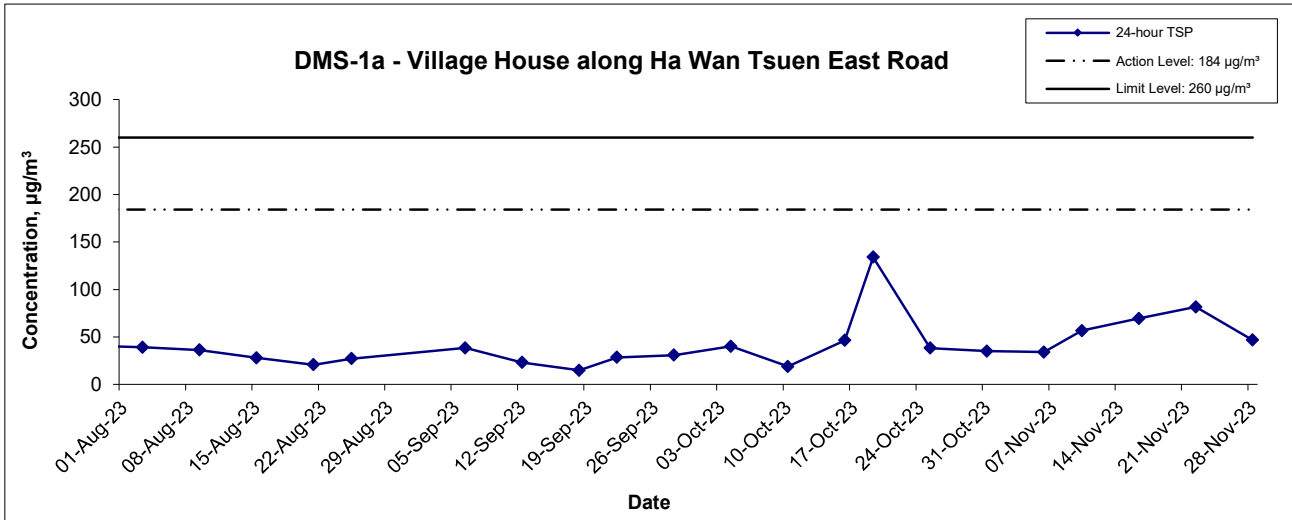
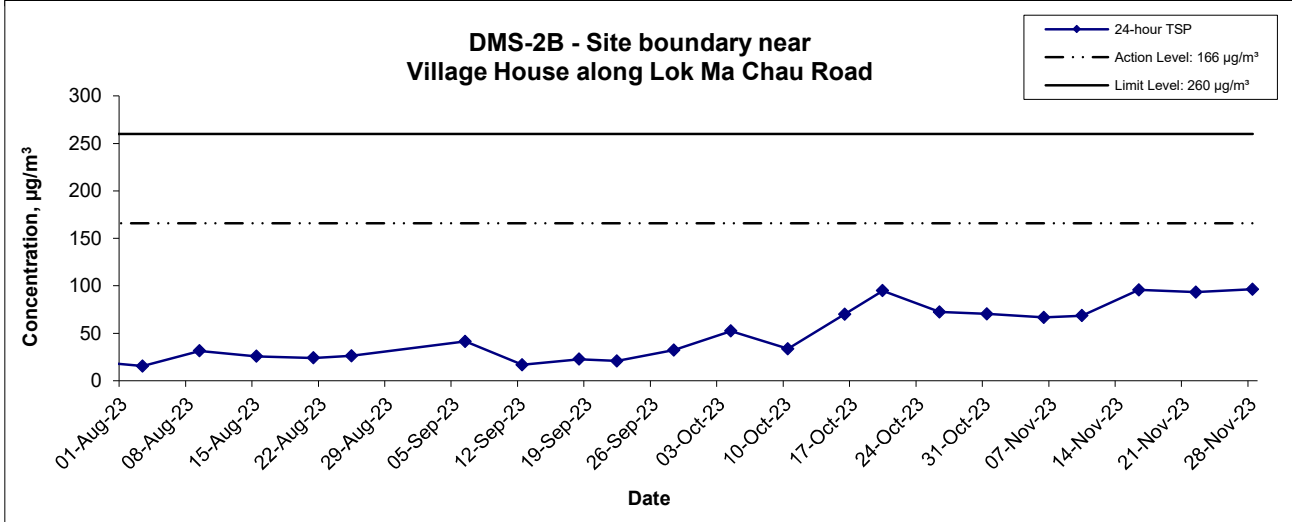
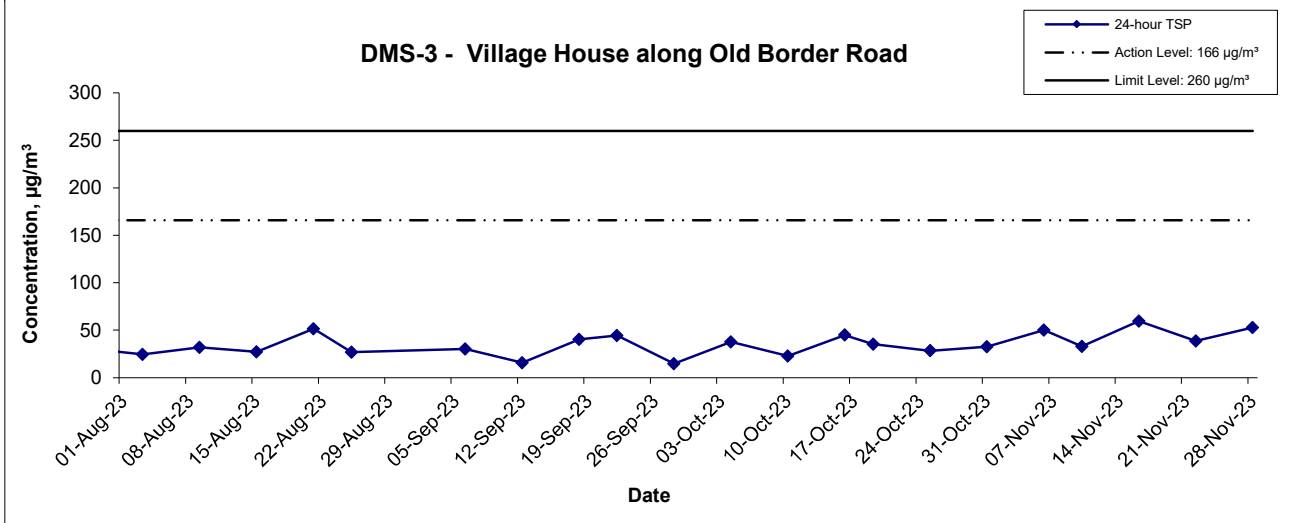
## 24-hour TSP Concentration Levels

Title Service Contract No. WD/04/2020 Development of Lok Ma Chau Loop: Main Works Package 1 - Environmental Team Graphical Presentation of 24-hour TSP Monitoring Results	Scale	N.T.S	Project No.	WMA21009	匯力 consulting . testing . research
	Date	Nov 23	Appendix	F

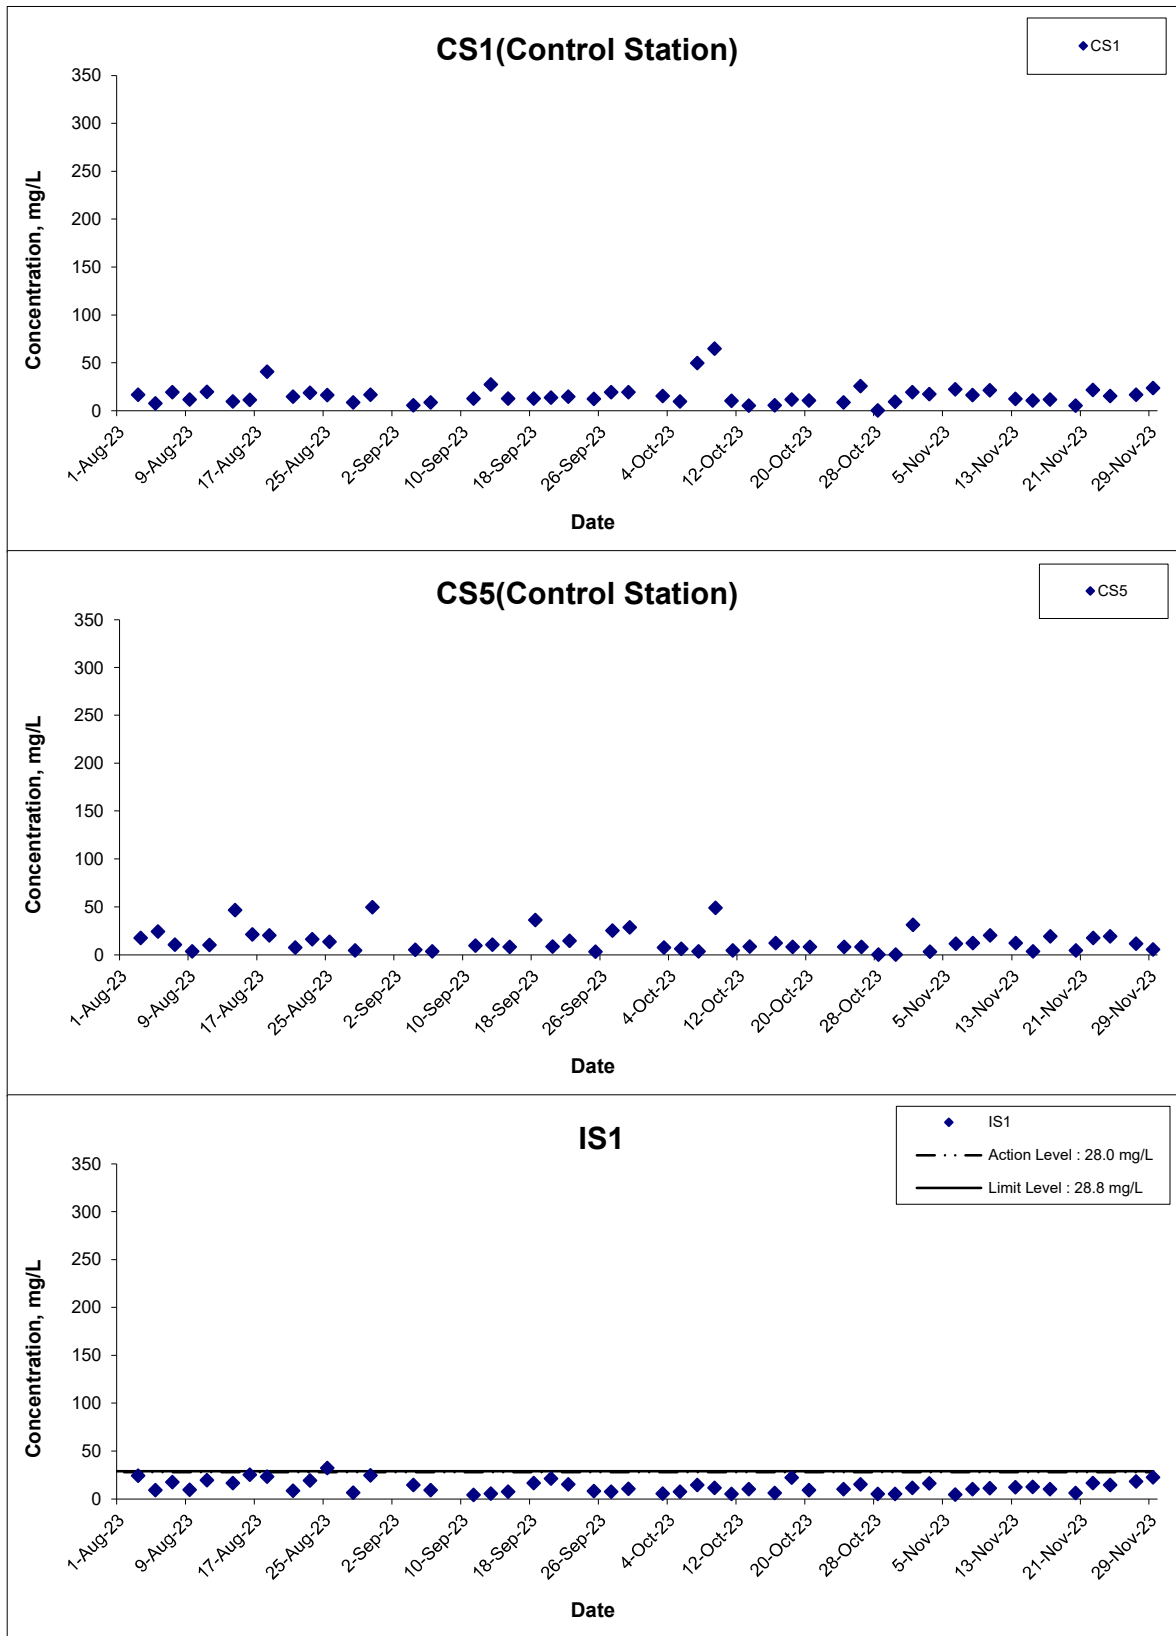
## Suspended Solids

Remark: The graphical point at zero concentration is presented as <2.5 mg/L

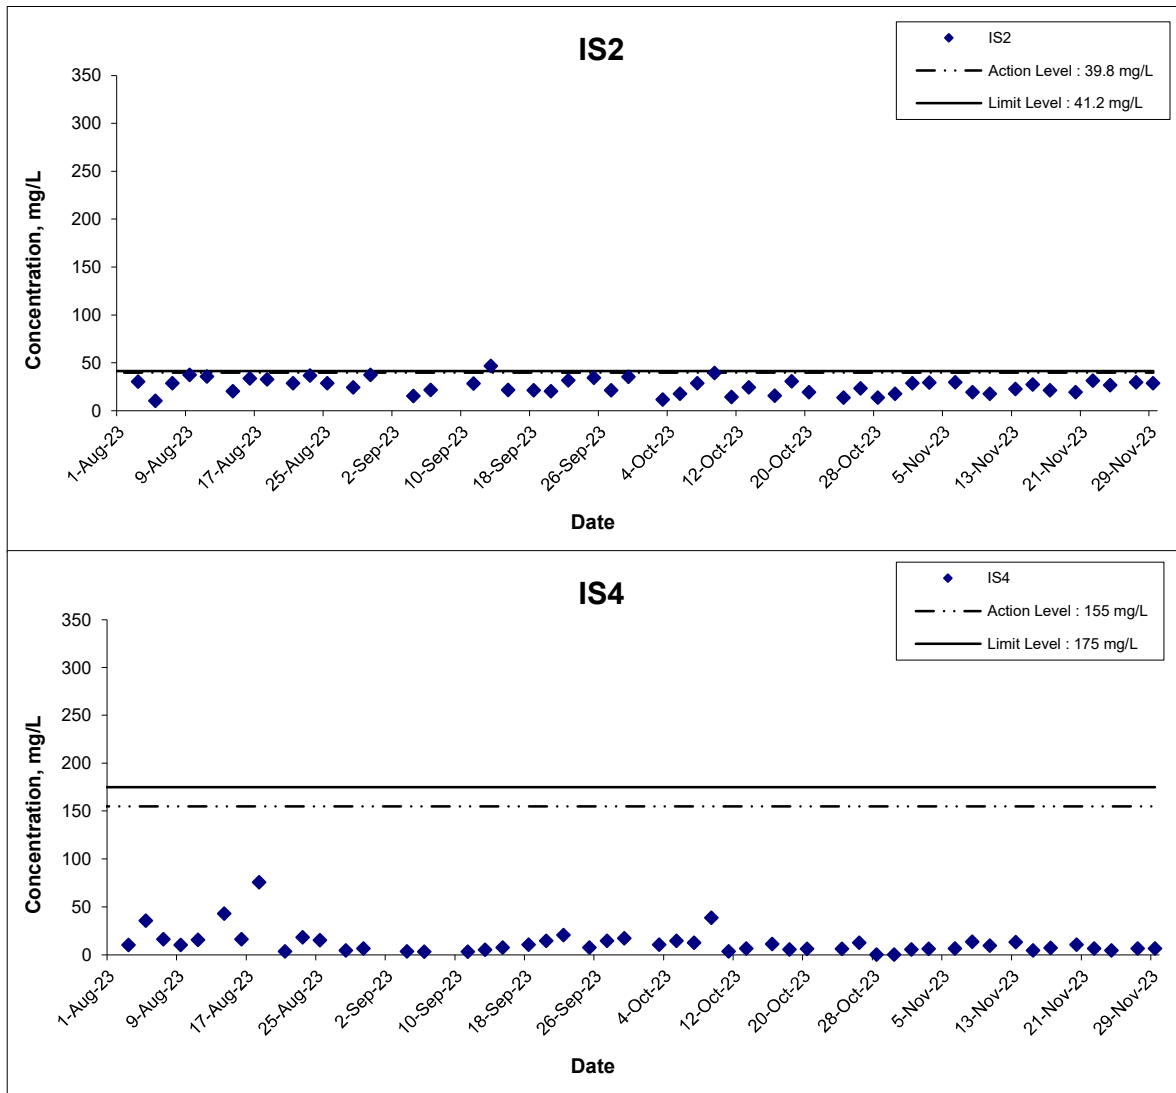
## Suspended Solids

Remark: The graphical point at zero concentration is presented as <2.5 mg/L

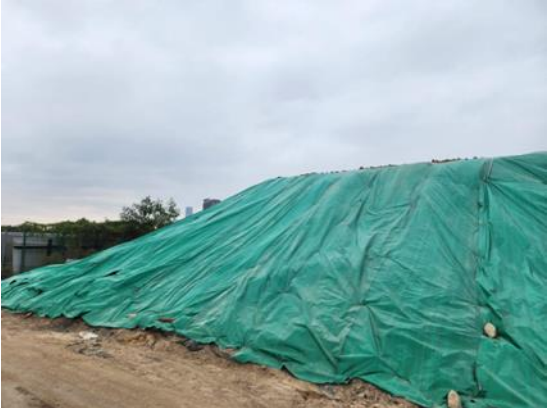
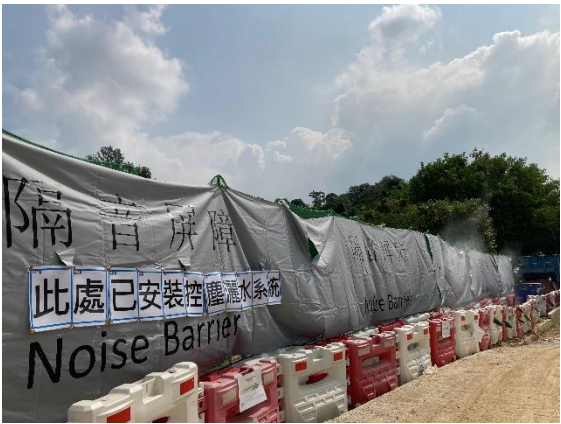
Ref	Location/ Working Period	Anticipated Major Impacts	Recommended Mitigation Measures	Photo Records (Partial)
EIA S3.8	All site area	Dust impact	<ul style="list-style-type: none"> <li>Any excavated or stockpile of dusty material should be covered entirely by impervious sheeting or sprayed with water to maintain the entire surface wet and then removed or backfilled or reinstated where practicable within 24 hours of the excavation or unloading;</li> <li>Any dusty materials remaining after a stockpile is removed should be wetted with water and cleared from the surface of roads;</li> </ul>

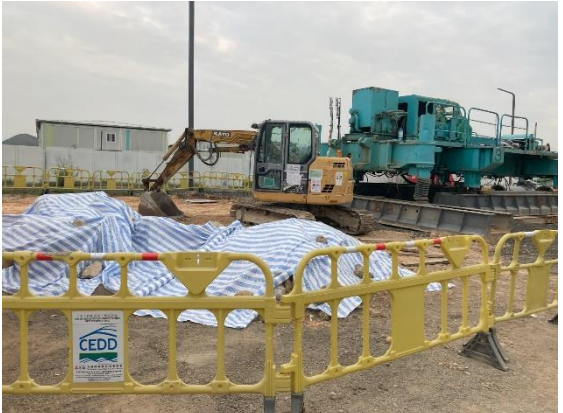
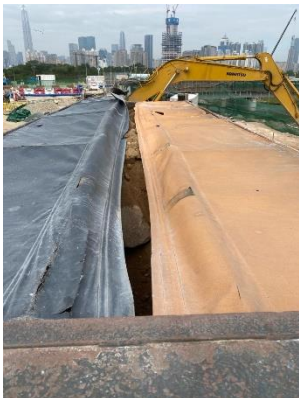
Ref	Location/ Working Period	Anticipated Major Impacts	Recommended Mitigation Measures	Photo Records (Partial)
EIA S3.8	All site area	Dust impact	<ul style="list-style-type: none"> <li>• A stockpile of dusty material should not be extended beyond the pedestrian barriers, fencing or traffic cones;</li> <li>• The load of dusty materials on a vehicle leaving a construction site should be covered entirely by impervious sheeting to ensure that the dusty materials do not leak from the vehicle;</li> </ul>

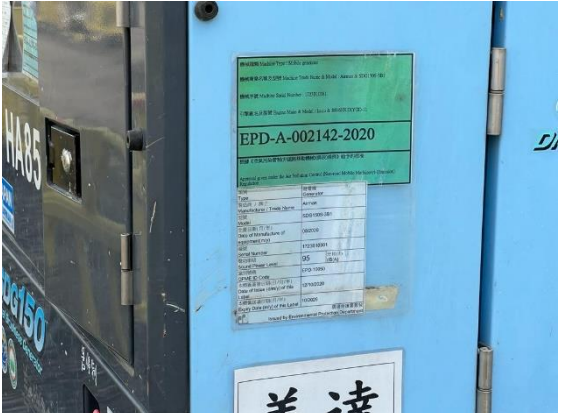
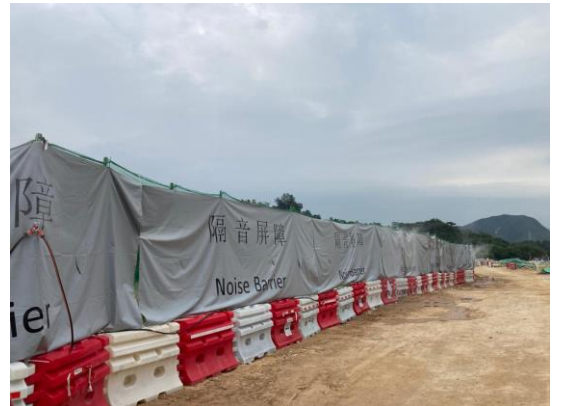
Ref	Location/ Working Period	Anticipated Major Impacts	Recommended Mitigation Measures	Photo Records (Partial)
EIA S4.8	All site area	Noise impact	<ul style="list-style-type: none"> <li>Mobile plant should be sited as far away from NSRs as possible and practicable;</li> <li>All generator used onsite are Quality Powered Mechanical Equipment (QPME) registered with EPD.</li> <li>Install movable noise barriers and full enclosure, screen the noisy plants including air compressor and generator.</li> </ul>

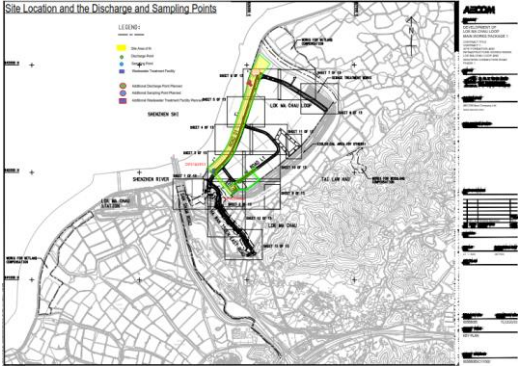
Ref	Location/ Working Period	Anticipated Major Impacts	Recommended Mitigation Measures	Photo Records (Partial)
EIA S5.7	All site area	Water Pollution Control	<ul style="list-style-type: none"> <li>Update and implementation of Stormwater Pollution Control Plan.</li> <li>At the start of site establishment, perimeter cut-off drains to direct off-site water around the site should be constructed with internal drainage works and erosion and sedimentation control facilities implemented. Channels (both temporary and permanent drainage pipes and culverts), earth bunds or sand bag barriers should be provided on site to direct stormwater to silt removal facilities. The design of the temporary on-site</li> </ul>

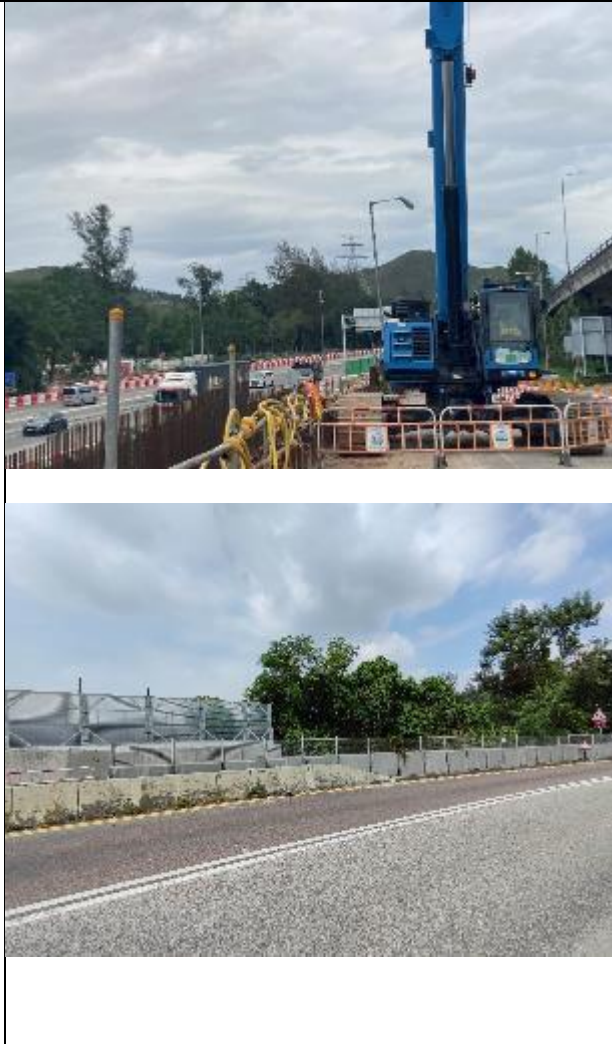
<p>The top photograph shows a blue mobile plant (likely a generator or air compressor) at a construction site, with orange safety barriers and yellow caution tape in the foreground. The bottom photograph shows a road with a white dashed line, a concrete noise barrier, and a full enclosure behind it, with trees in the background.</p>

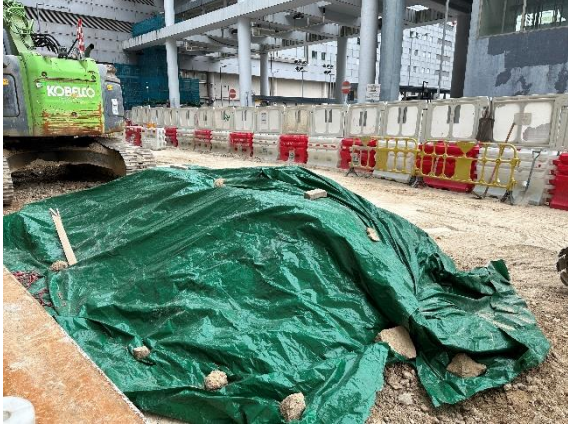
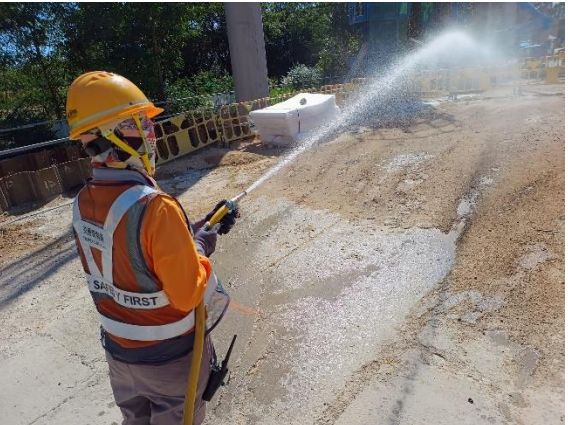
Ref*	Location/ Working Period	Anticipated Major Impacts	Recommended Mitigation Measures	Photo Records (Partial)
EIA S3.8	All site area	Dust impact	<ul style="list-style-type: none"> <li>• A stockpile of dusty material should not be extend beyond the pedestrian barriers, fencing or traffic cones;</li> <li>• The load of dusty materials on a vehicle leaving a construction site should be covered entirely by impervious sheeting to ensure that the dusty materials do not leak from the vehicle;</li> </ul>

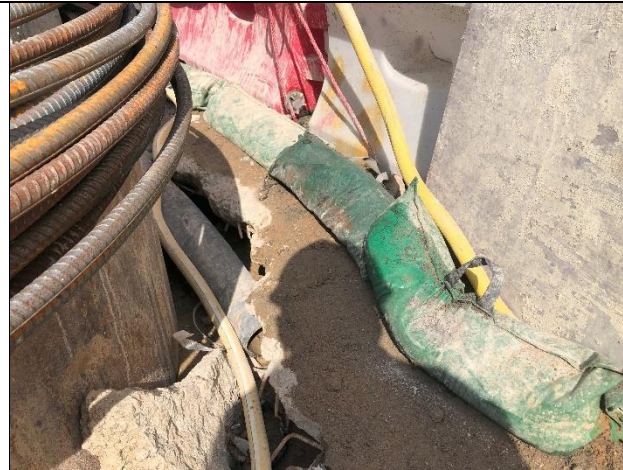
• Sedimentation tanks with sufficient capacity, constructed from pre-formed individual cells of approximately 6 to 8 m<sup>3</sup> capacities, are recommended as a general mitigation measure which can be used for settling surface runoff prior to disposal. The system capacity shall be flexible and able to handle multiple inputs from a variety of sources and suited to applications where the influent is pumped.
