Monthly EM&A Report (April 2022)

Contract Name : Environmental Team for Drainage
Improvement Works at Ngong Ping
(Contract No. DC/2019/06)

Report No. : 0118/20/ED/0471A

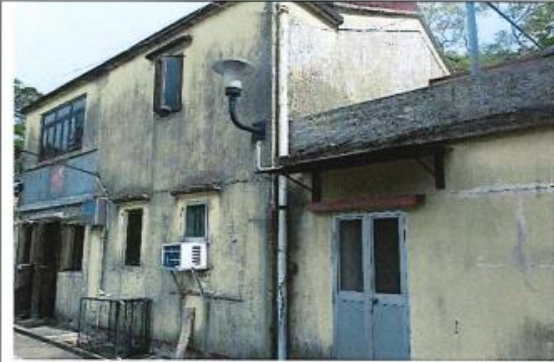
Photo 1: General View of NP-10

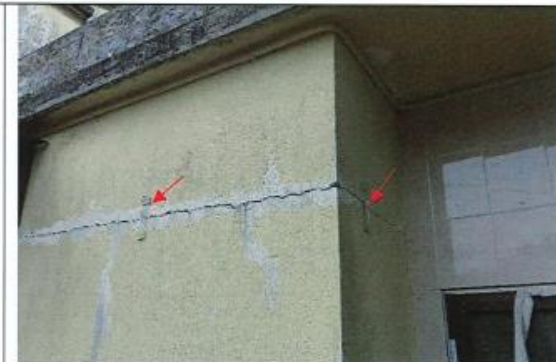
Photo 3: Tell-tales for crack monitoring were installed at NP-10.

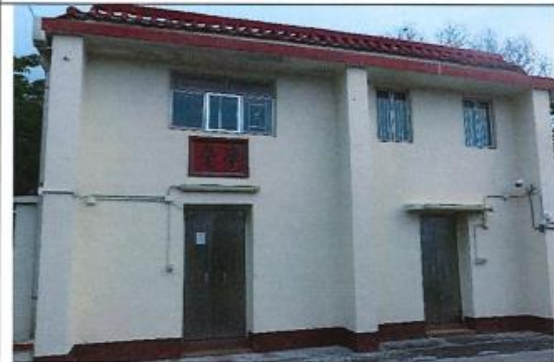
Photo 4: General View of NP-11

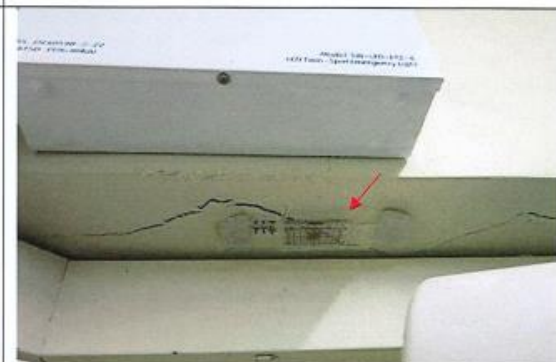
Photo 6: Tell-tale for crack monitoring was installed at NP-11.

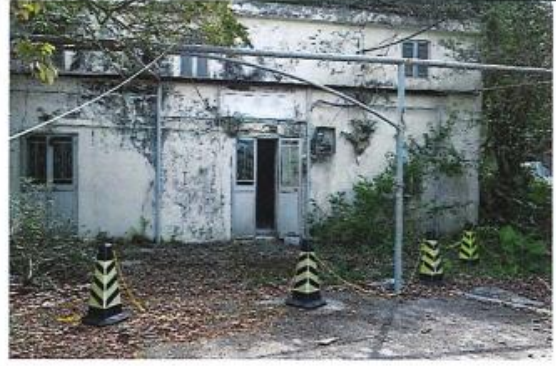
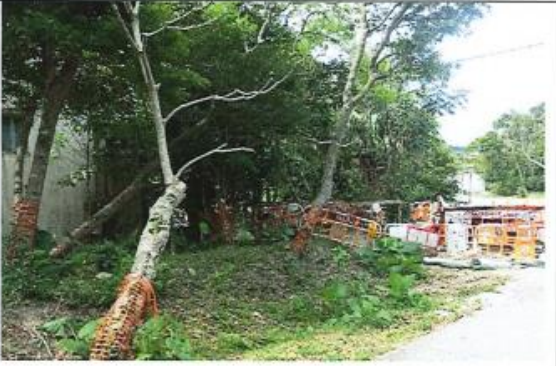
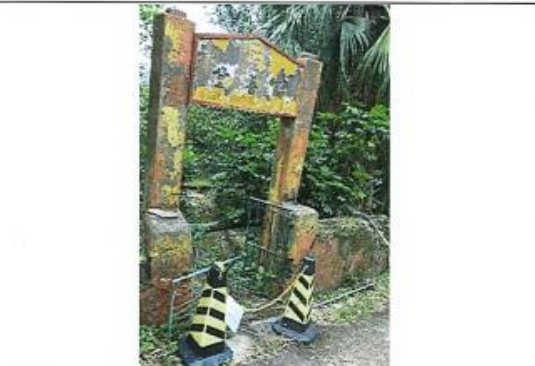
<p>Photo 7: NP-19 has been fenced off in accordance to EM&A Manual.</p>	<p>Photo 8: Construction works in close proximity of NP-19</p>	<p>Photo 9: Access to NP-20 & NP-21 has been fenced off in accordance to EM&A Manual.</p>

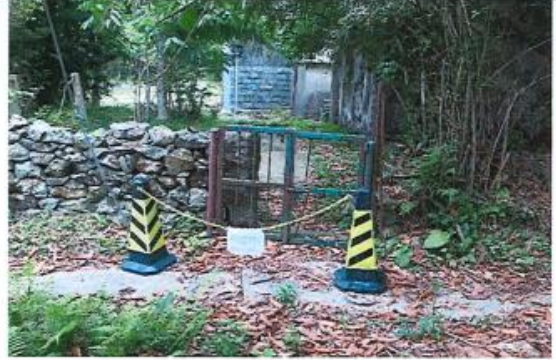
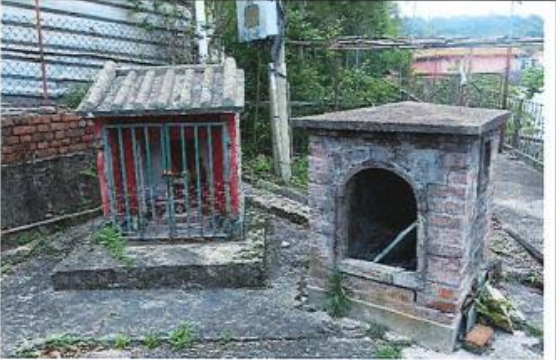
<p>Photo 10: Access to NP-20 & NP-21 has been fenced off in accordance to EM&A Manual.</p>	<p>Photo 11: No temporary fence has been erected around NP-26 in mutual agreement with the villagers.</p>	<p>Photo 12: A new notice was placed near NP-26.</p>
