**Monthly EM&A Report
(December 2022)**

Contract No. : DPW 01/2020
Contract Name : Environmental Team for Drainage
Improvement Works at Ngong Ping
(Contract No. DC/2019/06)
Report No. : 0118/20/ED/0556A
EP No. : EP-456/2013/B

**Drainage Improvement Works at Ngong Ping
Monthly EM&A Report for December 2022**

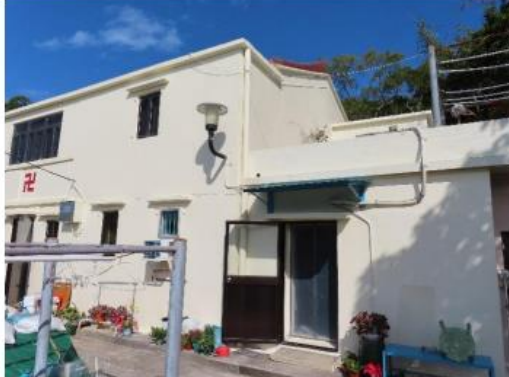
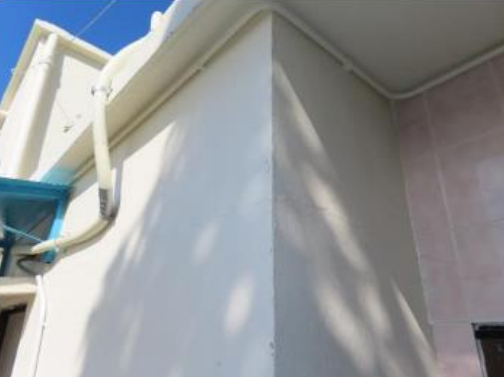
Photo Record (20/12/2022)

<p>Photo 1: General View of NP-10</p>	<p>Photo 2: Reflective targets for settlement monitoring were installed on the fence wall at NP-10.</p>	<p>Photo 3: Tell-tales (TT1 & TT2) for crack monitoring were removed by the owner at NP-10 due to renovation works; Crack was repaired.</p>

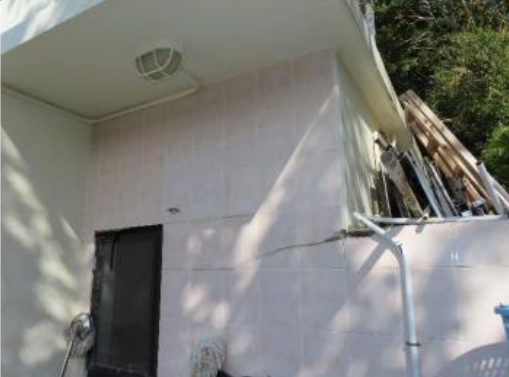
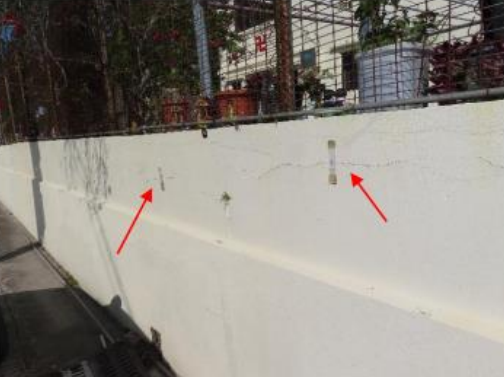
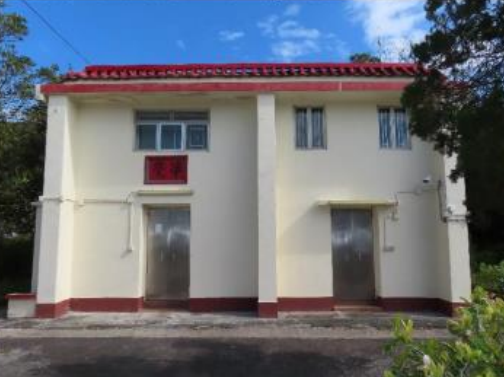
<p>Photo 4: Renovation works were done at NP-10 except for the walls in Kitchen & Lavatory at the time of inspection.</p>	<p>Photo 5: Tell-tales for crack monitoring were installed on the fence wall at NP-10.</p>	<p>Photo 6: General View of NP-11</p>

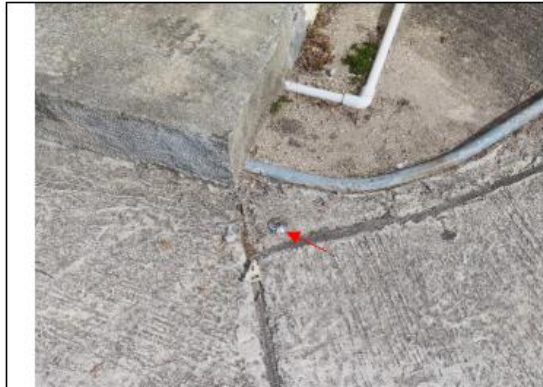
Photo 7: Ground settlement marker for settlement monitoring was installed at the entrance of NP-11.

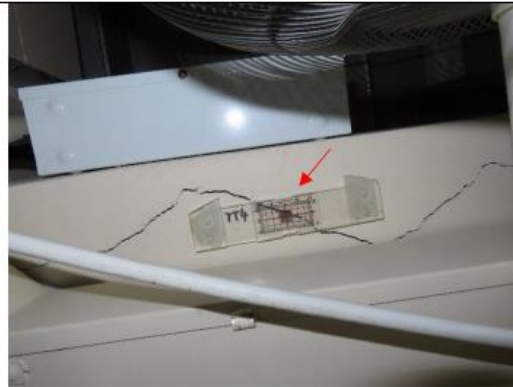
Photo 8: Tell-tale for crack monitoring was installed at NP-11.

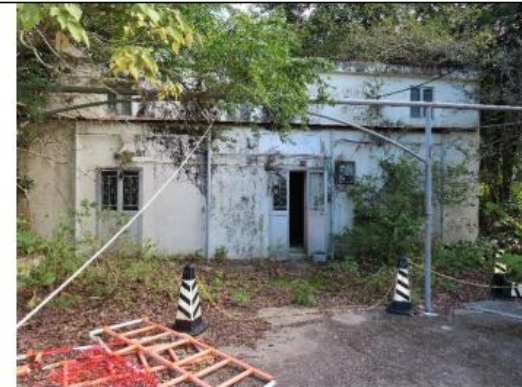
Photo 9: NP-19 has been fenced off in accordance to EM&A Manual.
