**Monthly EM&A Report  
(June 2023)**

**Contract No.** : DPW 01/2020  
**Contract Name** : Environmental Team for Drainage  
Improvement Works at Ngong Ping  
(Contract No. DC/2019/06)  
**Report No.** : 0118/20/ED/0601A  
**EP No.** : EP-456/2013/B

**Drainage Improvement Works at Ngong Ping**  
**Monthly EM&A Report for June 2023**

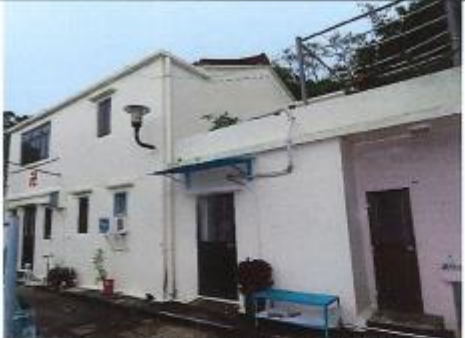
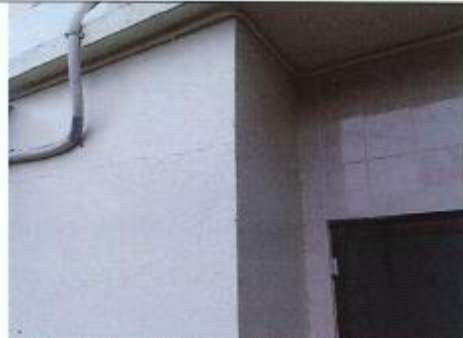
Photo Record (20/06/2023)

<p>Photo 1: General View of NP-10</p>	<p>Photo 2: Reflective targets for settlement monitoring were installed on the fence wall at NP-10.</p>	<p>Photo 3: Tell-tales (TT1 &amp; TT2) for crack monitoring were removed by the owner at NP-10 due to renovation works; Crack was repaired.</p>

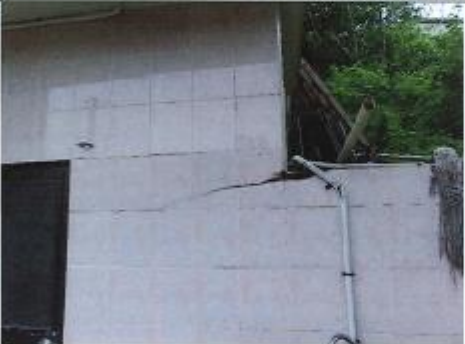
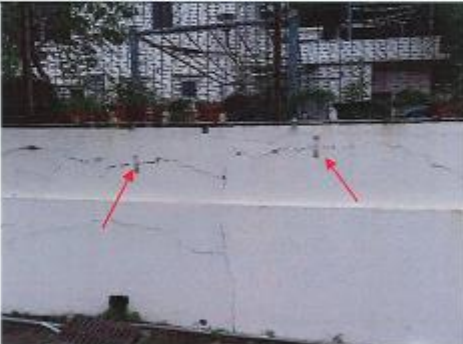
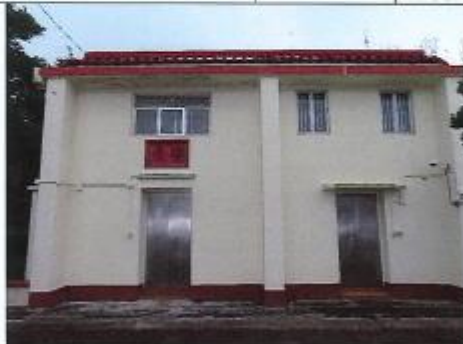
<p>Photo 4: Renovation works were done at NP-10 except for the walls in Kitchen &amp; Lavatory at the time of inspection.</p>	<p>Photo 5: Tell-tales for crack monitoring were installed on the fence wall at NP-10.</p>	<p>Photo 6: General View of NP-11</p>
