**Monthly EM&A Report
(August 2023)**

Contract No. : DPW 01/2020
Contract Name : Environmental Team for Drainage
Improvement Works at Ngong Ping
(Contract No. DC/2019/06)
Report No. : 0118/20/ED/0614A
EP No. : EP-456/2013/B

**Drainage Improvement Works at Ngong Ping
Monthly EM&A Report for August 2023**

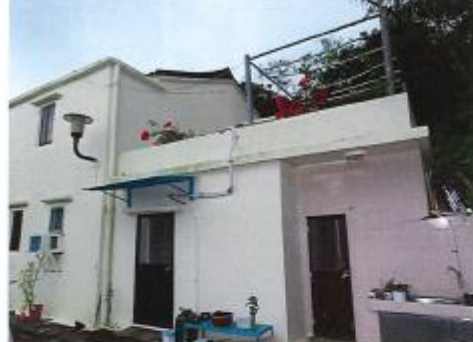
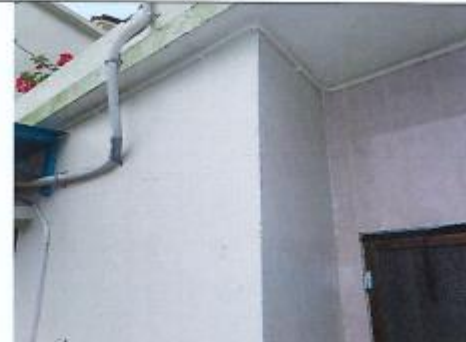
<p>Photo 1: General View of NP-10</p>	<p>Photo 2: Reflective targets for settlement monitoring were installed on the fence wall at NP-10.</p>	<p>Photo 3: Tell-tales (TT1 & TT2) for crack monitoring were removed by the owner at NP-10 due to renovation works; Crack was repaired.</p>

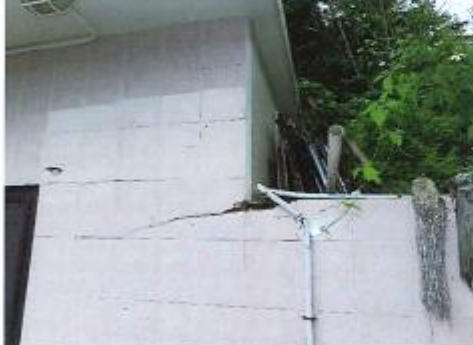
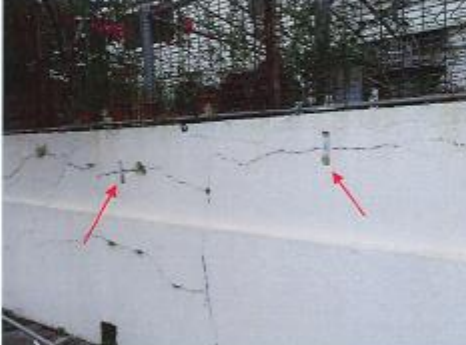
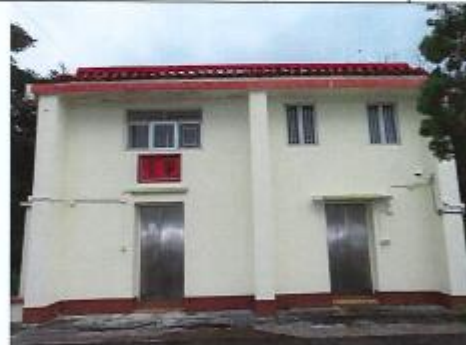
<p>Photo 4: Renovation works were done at NP-10 except for the walls in Kitchen & Lavatory at the time of inspection.</p>	<p>Photo 5: Tell-tales for crack monitoring were installed on the fence wall at NP-10.</p>	<p>Photo 6: General View of NP-11</p>

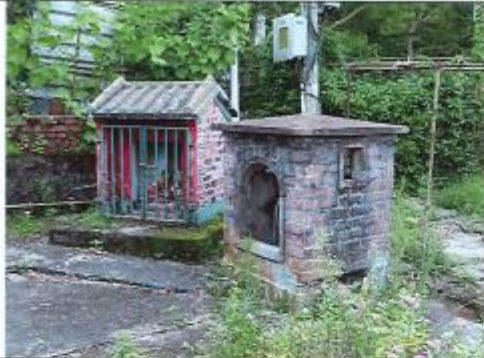
Photo 13: No temporary fence has been erected around NP-26 in mutual agreement with the villagers.
