**Monthly EM&A Report
(September 2023)**

Contract No. : DPW 01/2020
Contract Name : Environmental Team for Drainage
Improvement Works at Ngong Ping
(Contract No. DC/2019/06)
Report No. : 0118/20/ED/0617
EP No. : EP-456/2013/B

**Drainage Improvement Works at Ngong Ping
Monthly EM&A Report for September 2023**

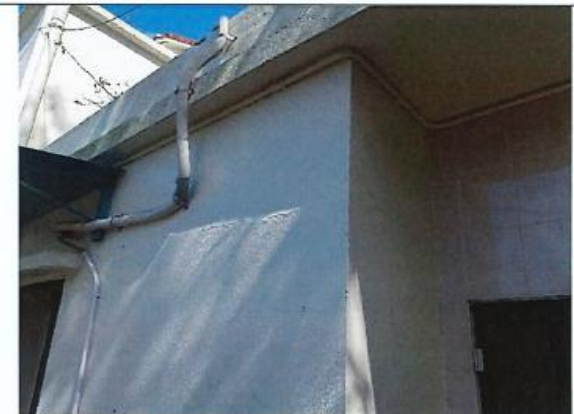
Photo 2: Reflective targets for settlement monitoring were installed on the fence wall at NP-10.

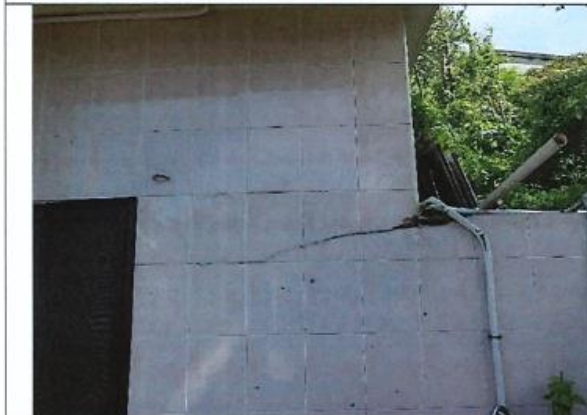
Photo 3: Tell-tales (TT1 & TT2) for crack monitoring were removed by the owner at NP-10 due to renovation works; Crack was repaired.

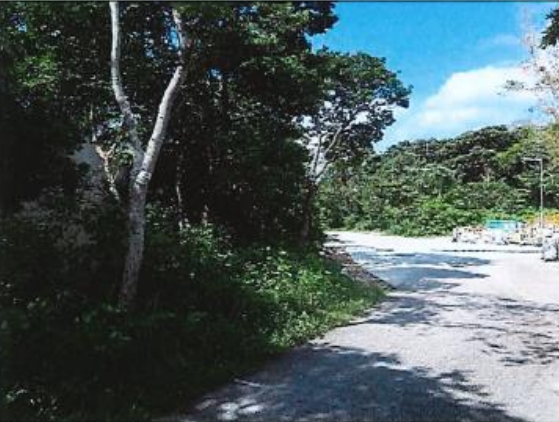
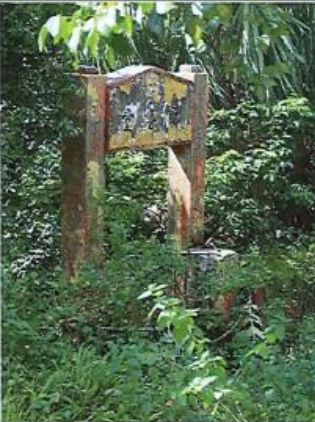
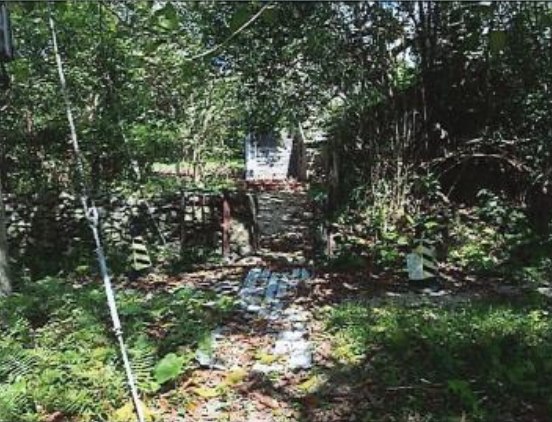
<p>Photo 7: Ground settlement marker for settlement monitoring was installed at the entrance of NP-11.</p>	<p>Photo 8: Tell-tale for crack monitoring was installed at NP-11.</p>	<p>Photo 9: NP-19 has been fenced off in accordance to EM&A Manual.</p>
