**Service Contract No. NDO 04/2019
Environmental Team for Environmental
Monitoring and Audit Works in
Construction Phase for the First Phase
Development of Kwu Tung North and
Fanling North New Development Areas**

**Monthly Environmental Monitoring and
Audit Report for August 2023**

Monthly Environmental Monitoring and Audit Report No. 46 (August 2023)

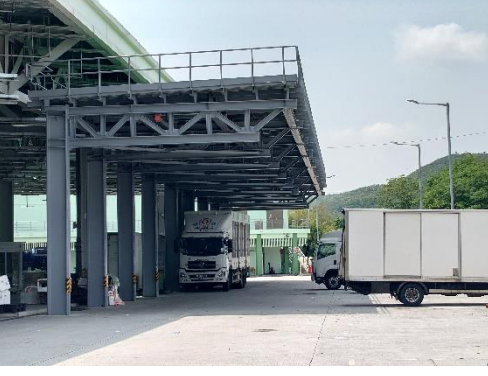
<p>Hard paved exposed haul road</p>	  <p>Hard paved exposed haul road</p>

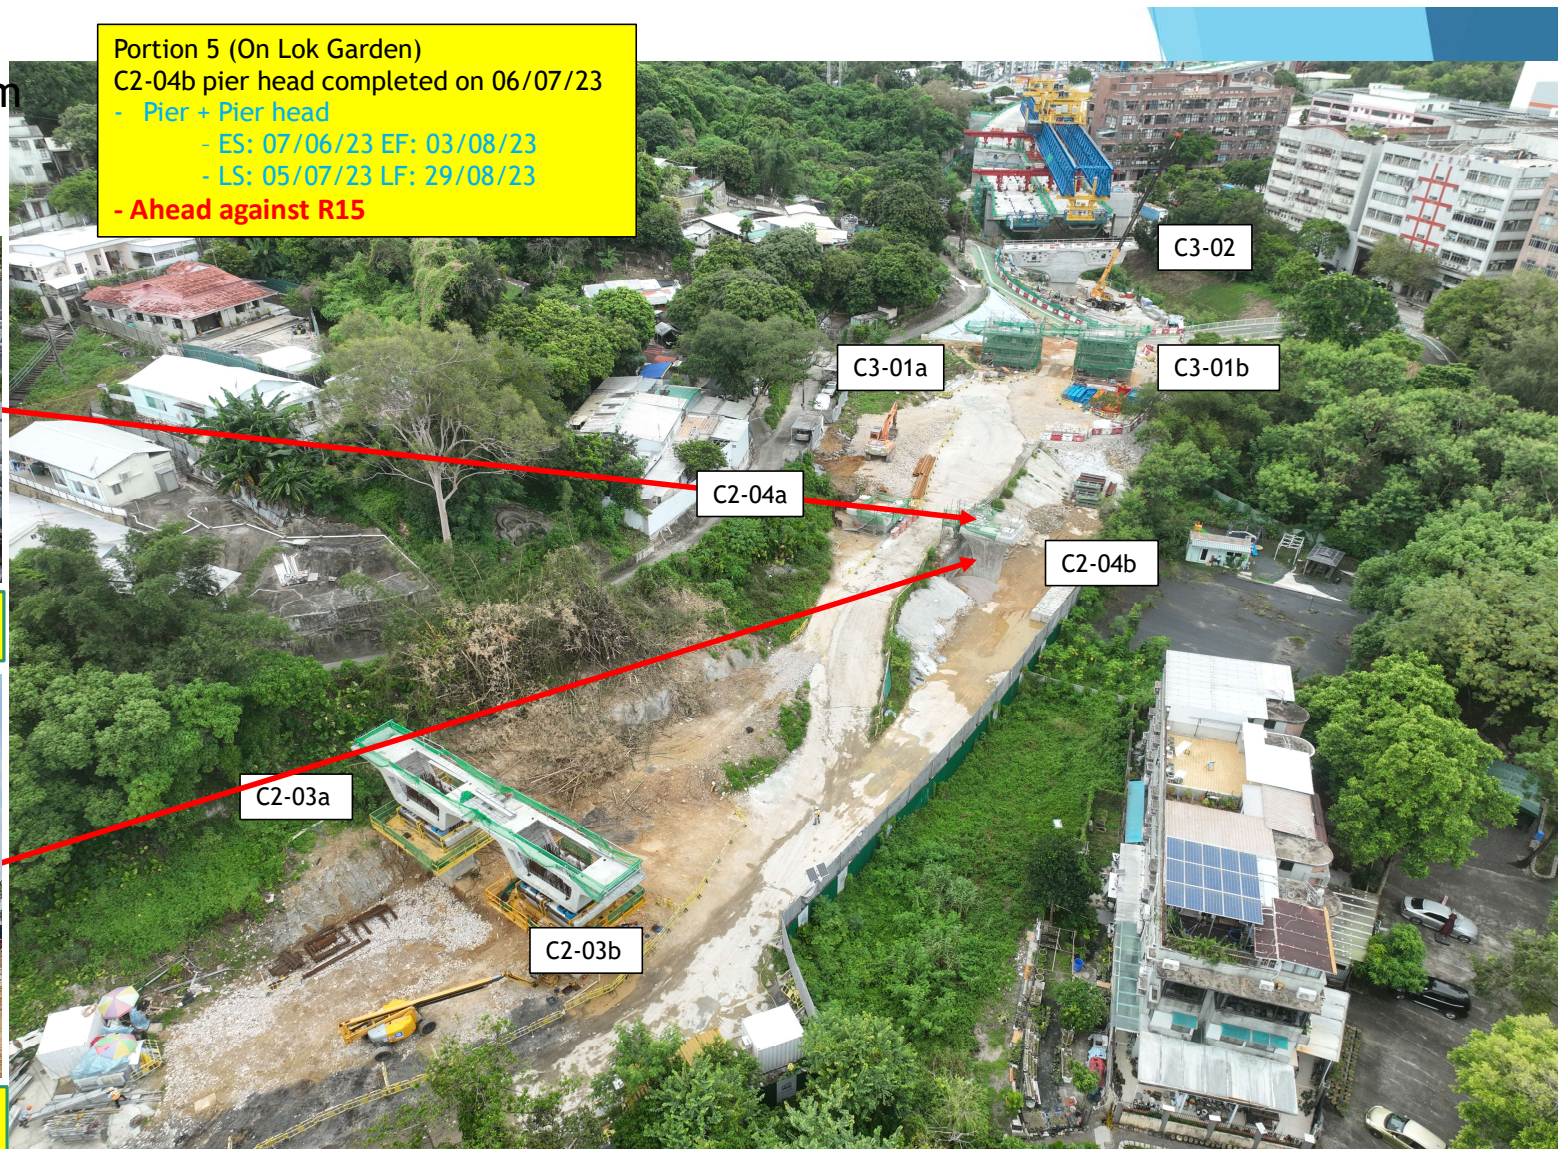
Dismantling of falsework C2-04b pier head completed on 21/07/23

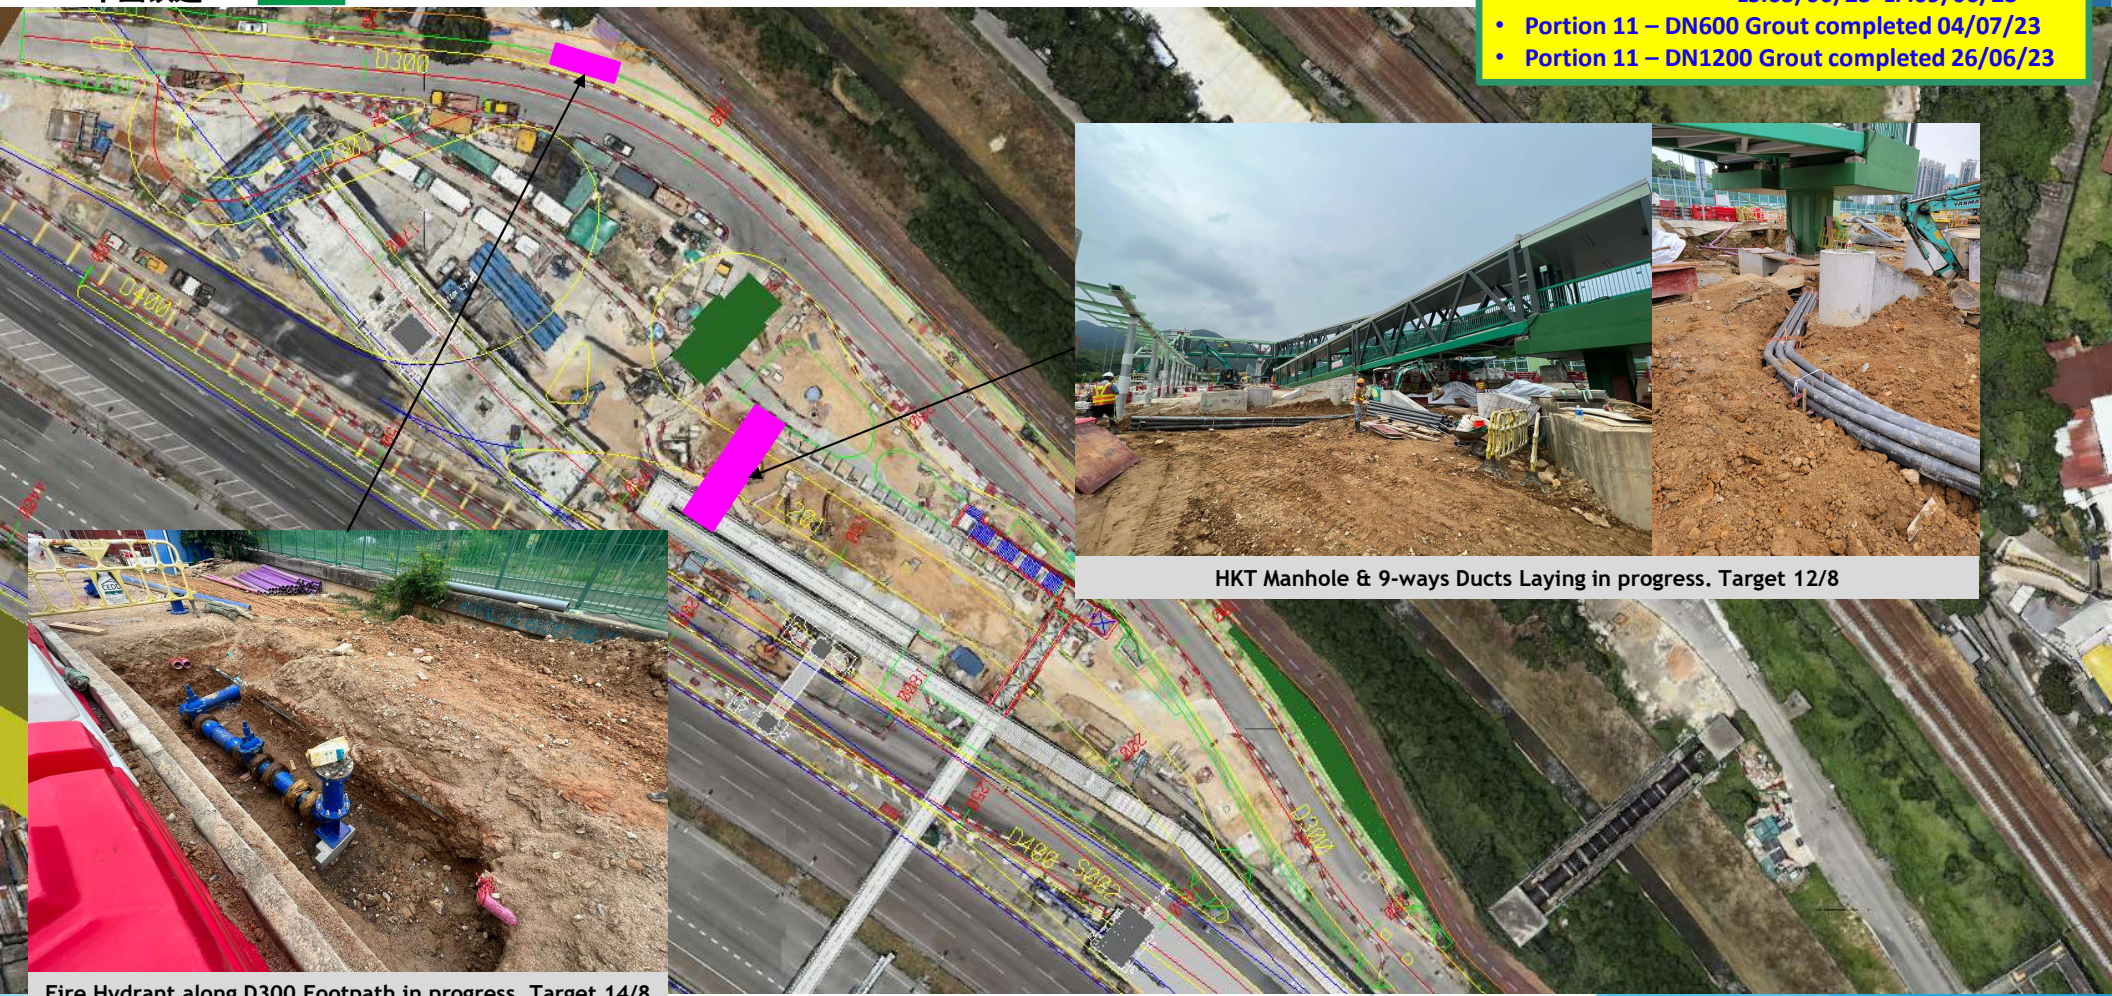
4. TWSRE – Dn600 Watermain within BBI area
PMI 027- 200 (R15) ES:16/02/23 EF:12/04/23
LS:03/06/23 LF:09/06/23
- Portion 11 – DN600 Grout completed 04/07/23
 - Portion 11 – DN1200 Grout completed 26/06/23

HKT Manhole & 9-ways Ducts Laying in progress. Target 12/8

Fire Hydrant along D300 Footpath in progress. Target 14/8
