# **Civil Engineering and Development Department**

## **Service Contract No. NDO 04/2019 Environmental Team for Environmental Monitoring and Audit Works in Construction Phase for the First Phase Development of Kwu Tung North and Fanling North New Development Areas**

### **Monthly Environmental Monitoring and Audit Report for October 2023**

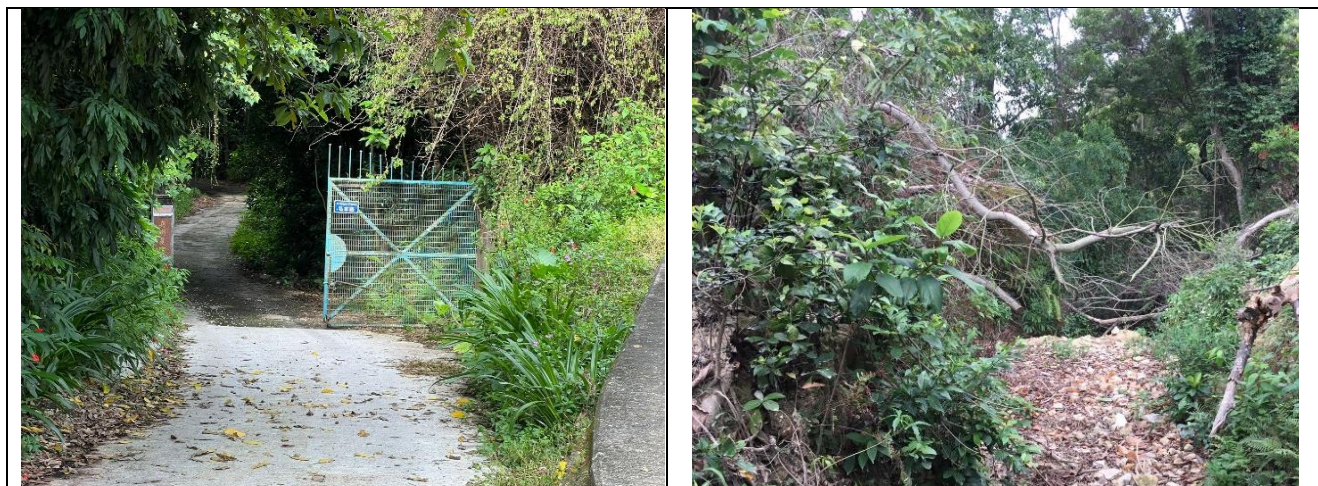
9.59 For the monitoring conducted on 18 October 2023 at Transect T5, a section of the transect route was found located within a private property and hence not accessible. Another section of transect T5 was found blocked by a new accumulation of fallen trees. The inaccessible part are shown in **Photo 1** and **Photo 2** below. The adjusted accessible transect route is shown in **Figure 11**.

Photo 1. Inaccessible part of transect T5 located within a private property.	Photo 2. Inaccessible part of transect T5 blocked by fallen trees.
--	--

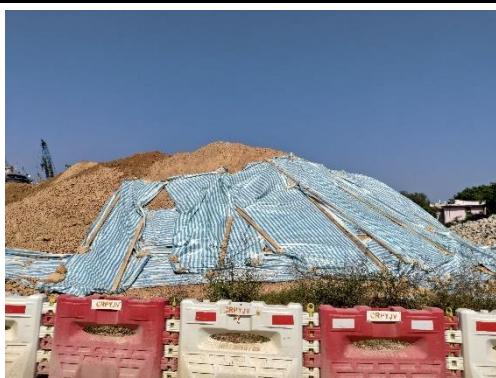
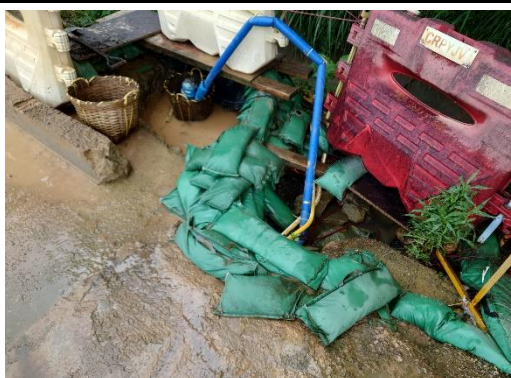
ND/2019/05

Covering dusty stockpile	Provision of sand bags around works area
ND/2019/07	 	 
	Covering exposed slope surface with tarpaulin	De-silting waste water before discharge
<b>Water quality mitigation measures for site(s) in operation phase, remaining defect works</b>		
ND/2019/06	 	 
	Hard paved exposed haul road	Hard paved exposed haul road

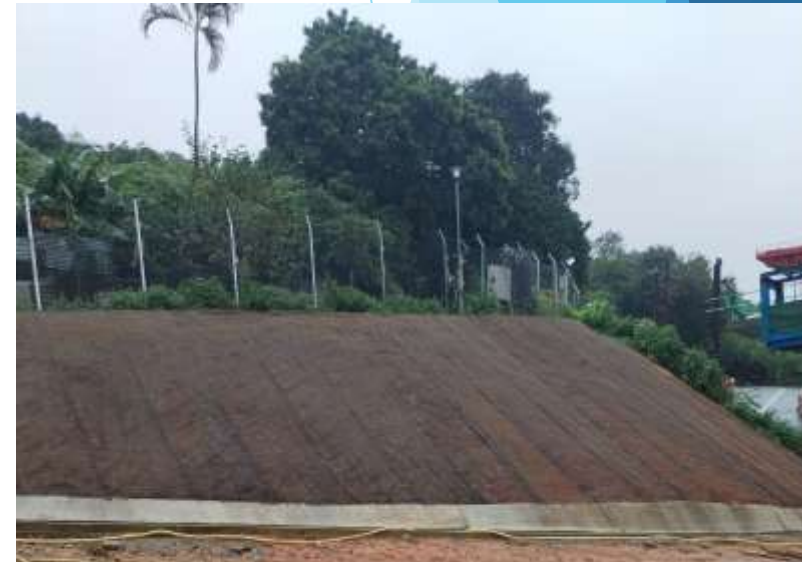
- Revised drainage design approved on 05/10/23
- Setting out for upper u-channel done on 06/10/23
- U-channel construction in progress

Laying biodegradable erosion control mat on slope FS28 completed on 09/10/23

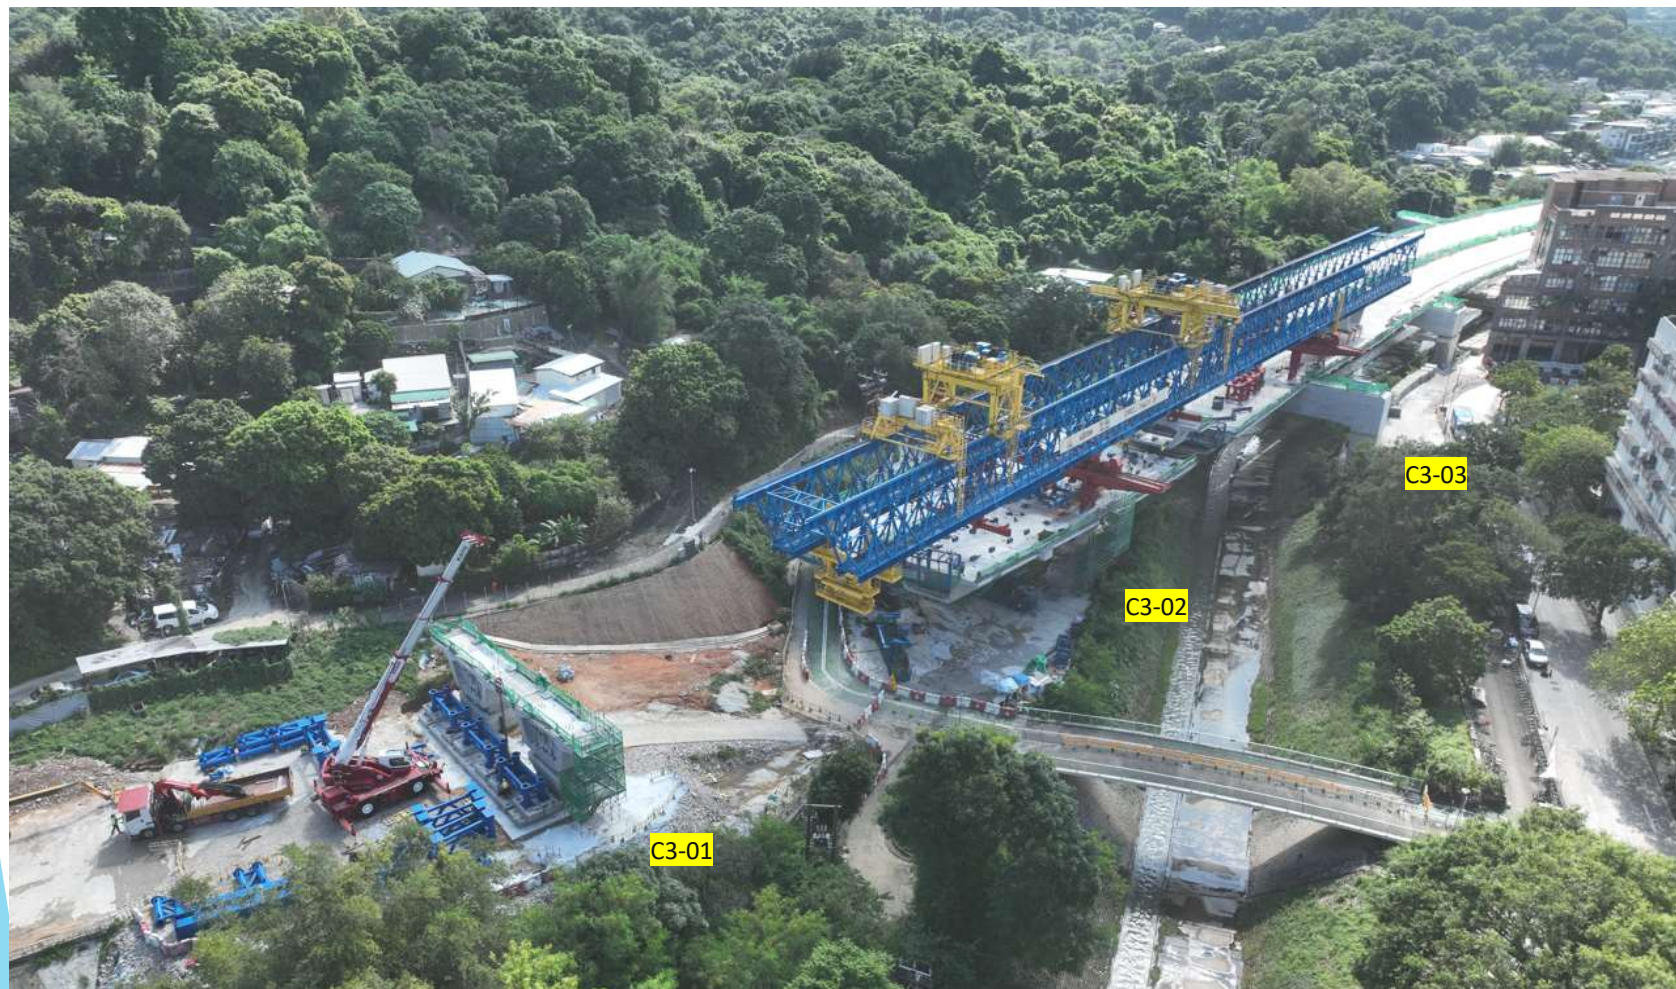
- Total 248 segments erected by LG up to 14 Oct 2023.

Hanger Beam is used for first pair segment erection

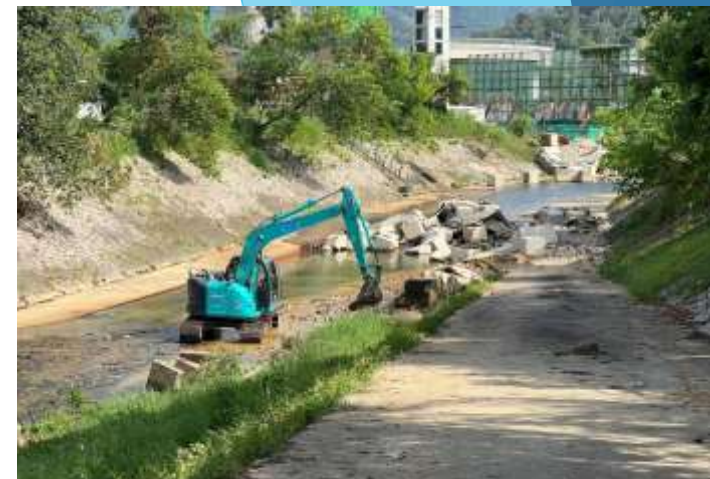
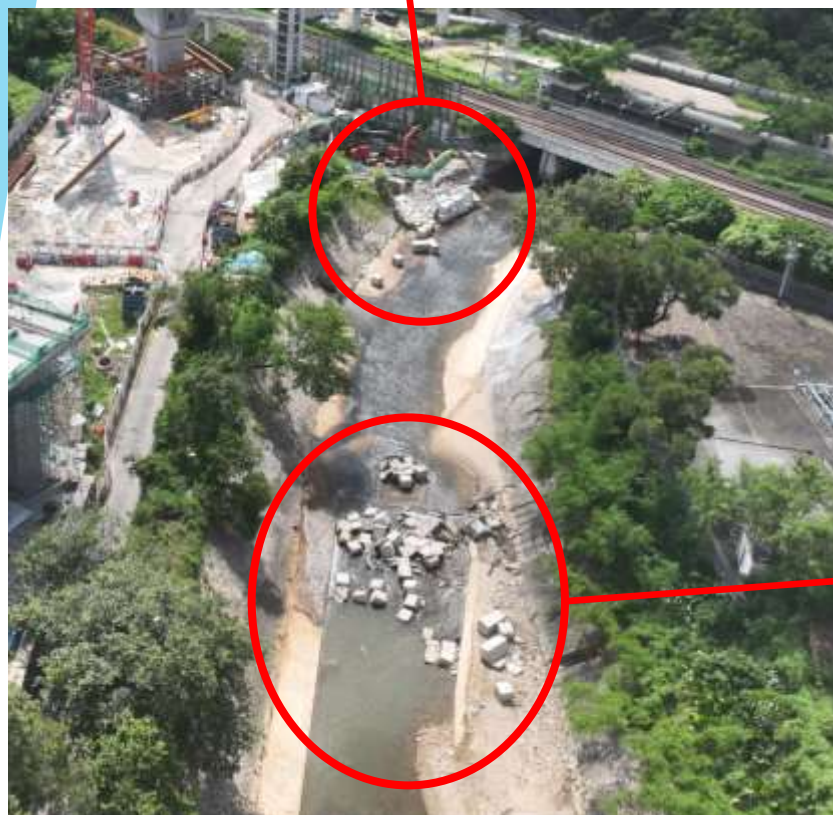
Removal of debris and concrete blocks from Ma Wat River near D2-01 in progress.

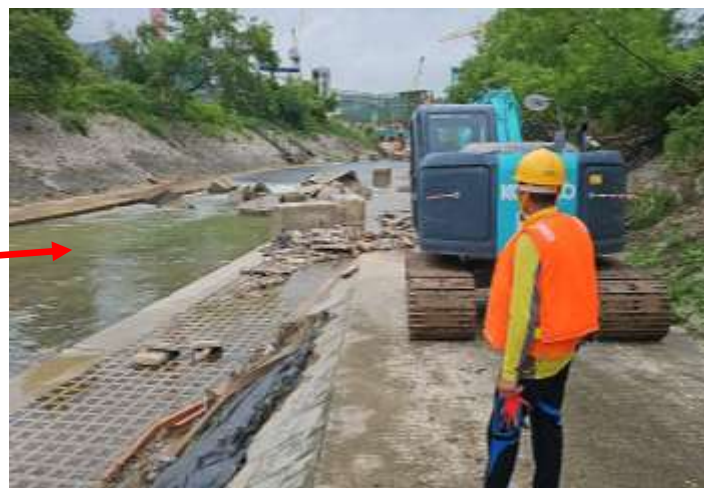
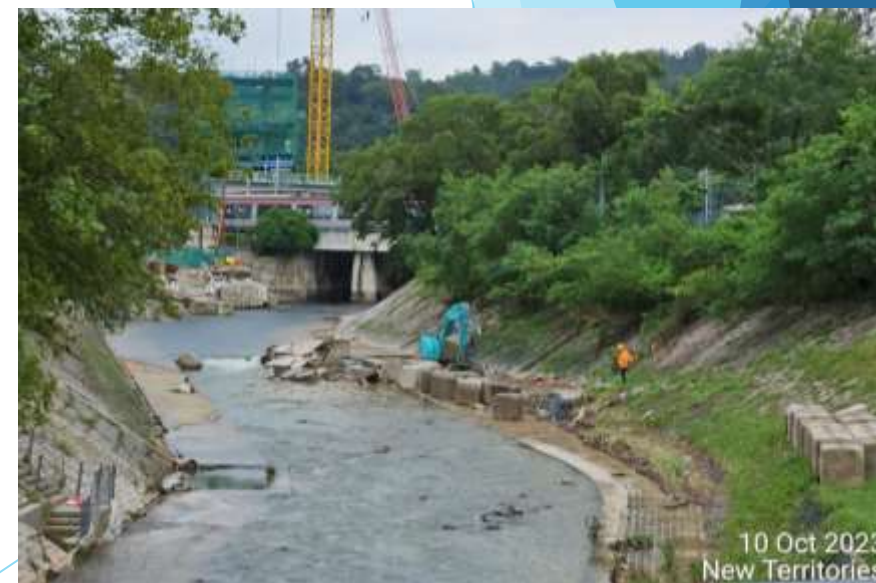
Removal of damaged concrete blocks platform at D2-01

- Works commenced on 05/10/23
