**Service Contract No. NDO 04/2019
Environmental Team for Environmental
Monitoring and Audit Works in
Construction Phase for the First Phase
Development of Kwu Tung North and
Fanling North New Development Areas**

**Monthly Environmental Monitoring and
Audit Report for January 2024**

Monthly Environmental Monitoring and Audit Report No. 51 (January 2024)

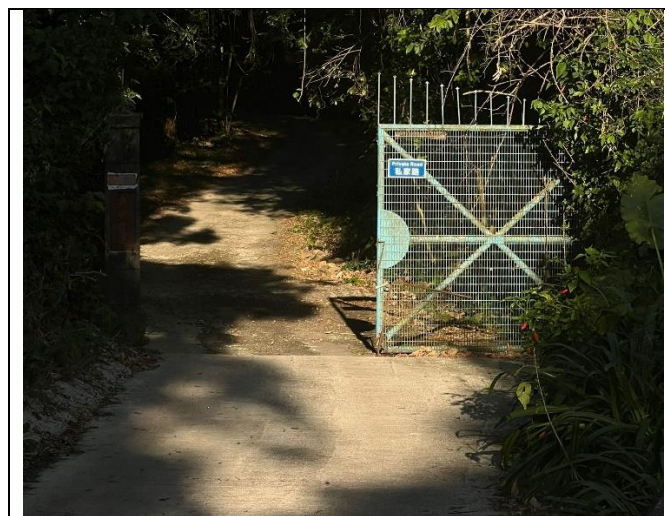
9.54 For the monitoring conducted on 25 January 2024 at Transect T5, a section of the transect route was found located within a private property and hence not accessible. The inaccessible part are shown in **Photo 1** below. The adjusted accessible transect route is shown in **Figure 11**.

Photo 1. Inaccessible part of transect T5 located within a private property.
