Service Contract No. NDO 04/2019 Environmental Team for Environmental Monitoring and Audit Works in Construction Phase for the First Phase Development of Kwu Tung North and Fanling North New Development Areas

Monthly Environmental Monitoring and Audit Report for April 2024

Monthly Environmental Monitoring and Audit Report No. 54 (April 2024)

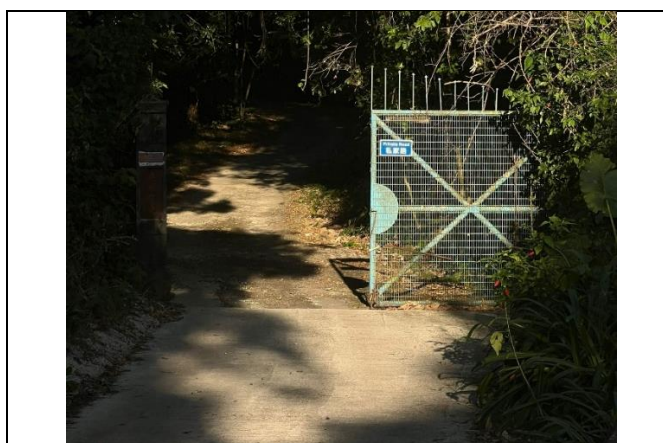
9.59 For the monitoring conducted on 10 April 2024 at Transect T5, a section of the transect route was found located within a private property and hence not accessible. The inaccessible part are shown in **Photo 1** below. The adjusted accessible transect route is shown in **Figure 11**.

Photo 1. Inaccessible part of transect T5 located within a private property.
