# **Civil Engineering and Development Department**

## **Service Contract No. NDO 04/2019 Environmental Team for Environmental Monitoring and Audit Works in Construction Phase for the First Phase Development of Kwu Tung North and Fanling North New Development Areas**

### **Monthly Environmental Monitoring and Audit Report for May 2024**

**Monthly Environmental Monitoring and Audit Report No. 55 (May 2024)**

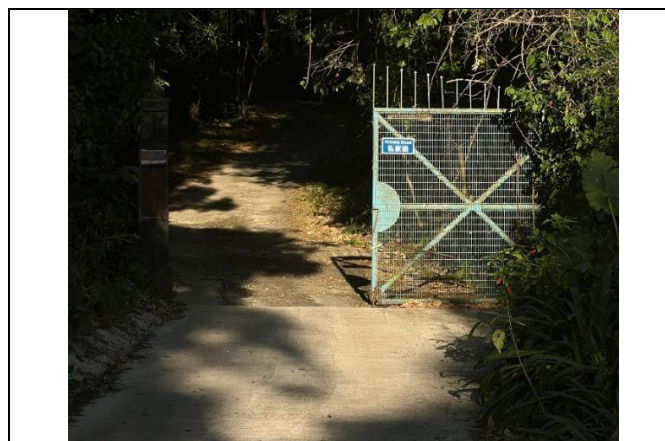
Photo 1. Inaccessible part of transect T5 located within a private property.

9.59 For the monitoring conducted on 22 May 2024 at Transect T5, a section of the transect route was found located within a private property and hence not accessible. The inaccessible part are shown in **Photo 1** below. The adjusted accessible transect route is shown in **Figure 11**.

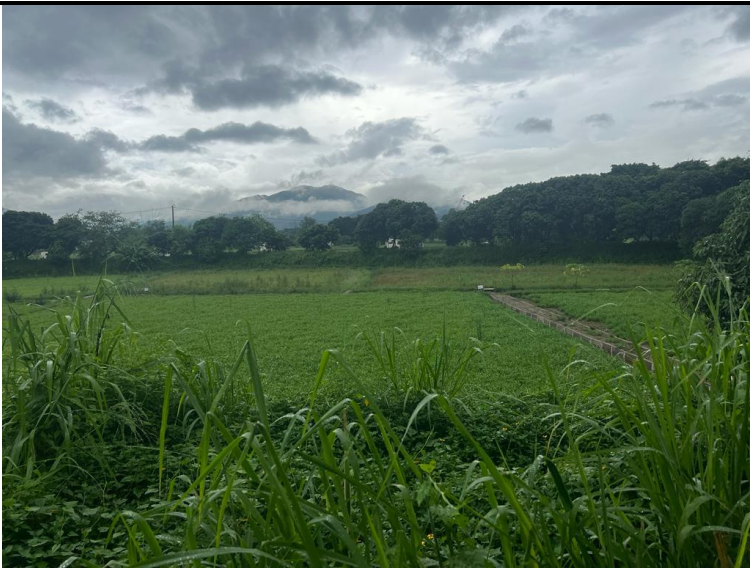
**Table 10.6 Photographic Records of Site Activities in LVNP**

Continuing agricultural practice in existing farmland to maintain habitats in Long Valley

<p><i>Open water Habitat</i>            Creation of wetland with designated habitat for biodiversity conservation</p>
