Project Profile for Stream Improvement at Ta Kwu Ling Associated with the Resite of Chuk Yuen Village

(Report No. 255228/06.119/D)

November 2009
Civil Engineering and Development Department

Civil Engineering Office
Boundary Control Point Division

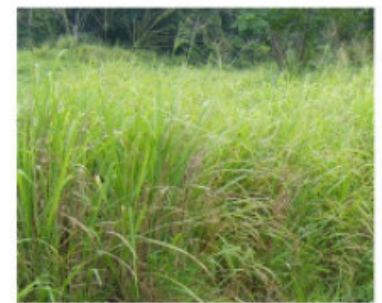
LR 1 Abandoned Agricultural
Land / Low Lying
Grassland

- 7.6.2 Three LRs have been identified, namely, LR 1 Abandoned Agricultural Land / Low Lying Grassland, LR 2 Active Agricultural Land and LR 3 Stream. With the recommended landscape mitigation measures, the residual impacts during both construction and operation are considered to be slight for all three LRs.

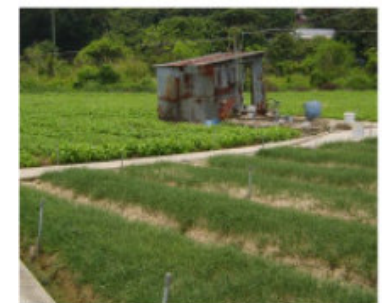
LR 2 Active Agricultural Land

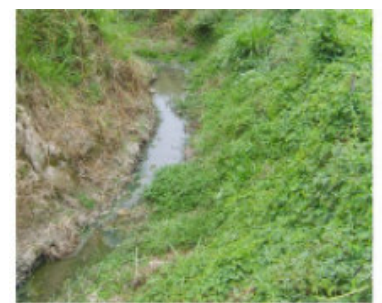
LR 3 Stream

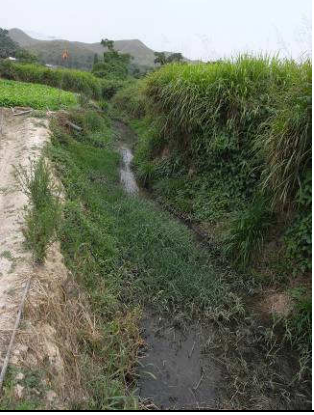
<p>Plate F5 Stream</p>	<p>Plate F6 Developed Area</p>

3.6.5 The stream is situated besides the active agricultural land and abandoned agricultural land / low-lying grassland. It is modified and overgrew with *Panicum maximum* and *Cyperus* spp. along the riparian zone (**Plate F5**). The stream is shallow with medium to slow flow and high turbidity but may flood during heavy rainfall event. Neither fish nor ripple on water surface in response to baiting was observed during the field survey. Only a few common dragonfly species were recorded inhabiting at the riparian zone. A total of two Chinese Pond Herons, one White-breasted Waterhen and one Asiatic Painted Frog *Kaloula pulchra pulchra* were found associated with the watercourse. The ecological value of this stream section is considered to be low due to the low species diversity and abundance with low quality of water and modified watercourse nature with intermittent flow seasonally.
