Project Profile for
Roadside Slope Improvement Works
along Ma On Shan Tsuen Road within Ma On Shan Country Park

**ENVIRON Hong Kong Limited
Hong Kong SAR**

December 2009

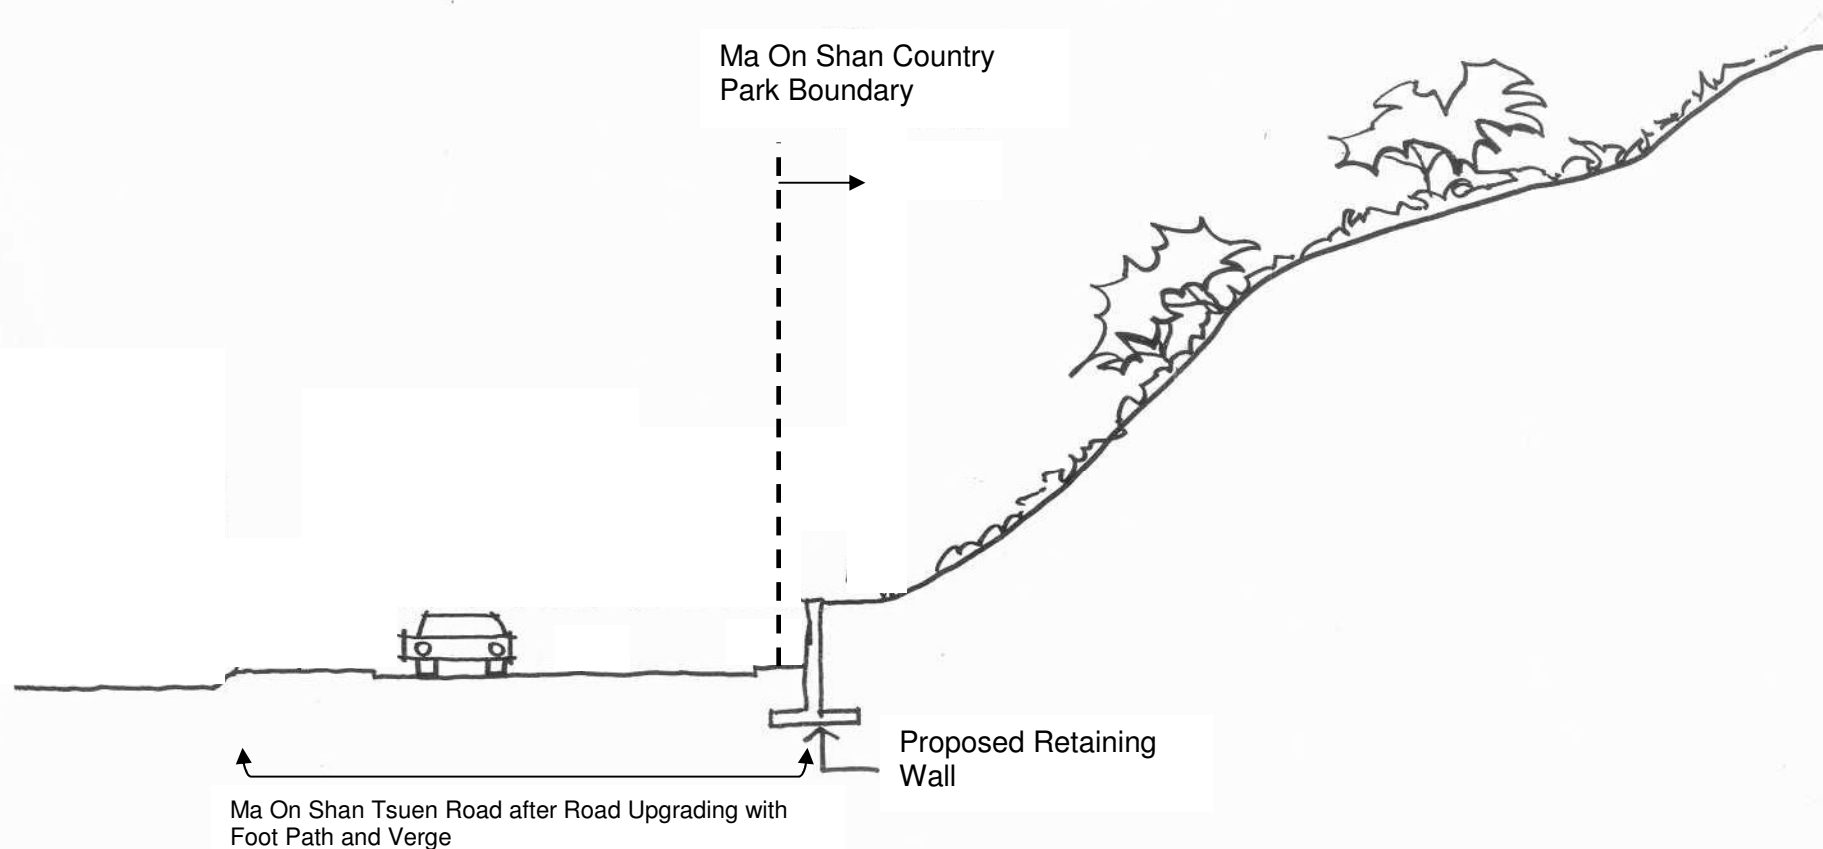
Typical Section for Slope Improvement Works with Retaining Wall Structure

1. Steel casing will be driven into the ground with the underground soil being excavated as the casing advances;
2. Steel H-pile will be placed after the casing reaches the specified founding level;
3. The steel casing will be extracted while the void between the casing and the H-pile will be grouted;

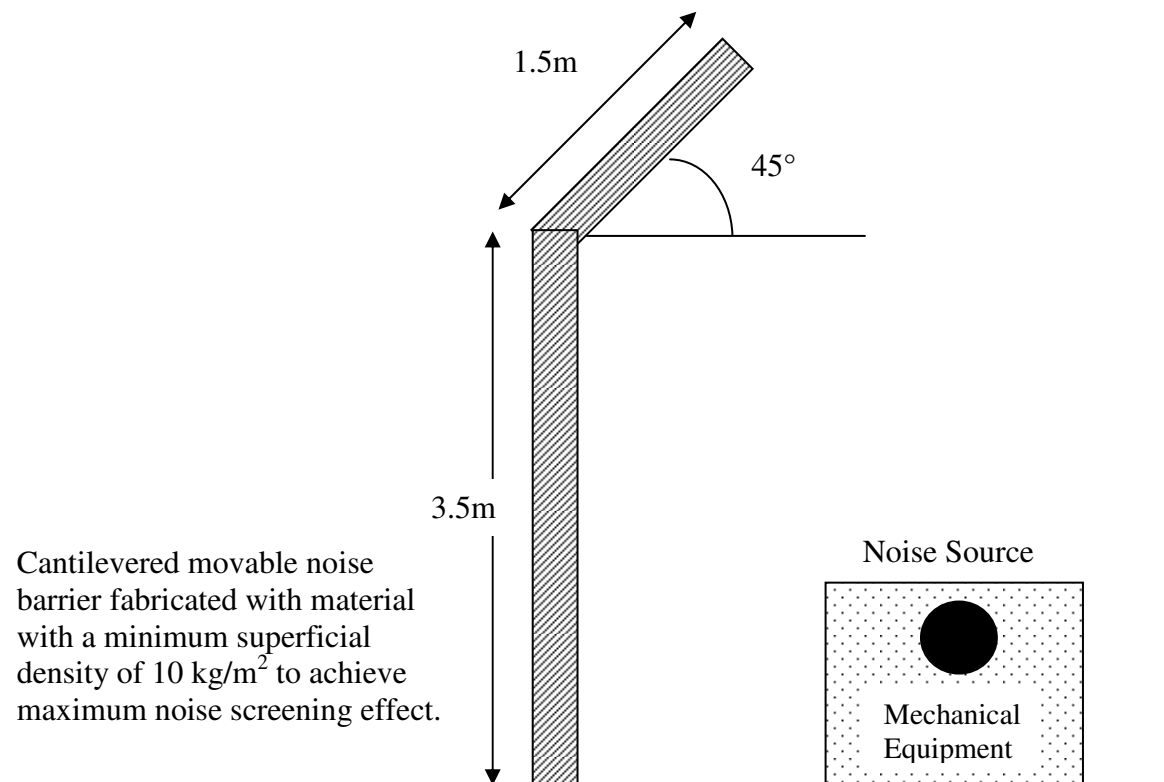
Figure: Annex V	<u>ENVIRON</u>
Title: Typical Section of Movable Noise Barrier	Drawn by: SLam
	Checked by: TC
Project: Project Profile for Roadside Slope Improvement Works along Ma On Shan Tsuen Road within Ma On Shan Country Park	Rev.: 1.2
	Date: July 2009

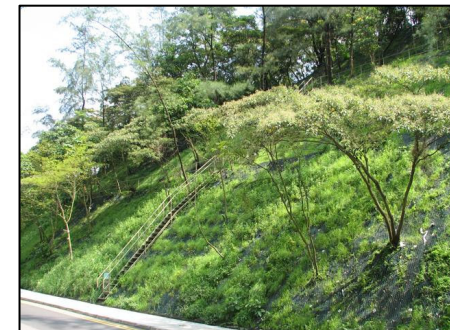
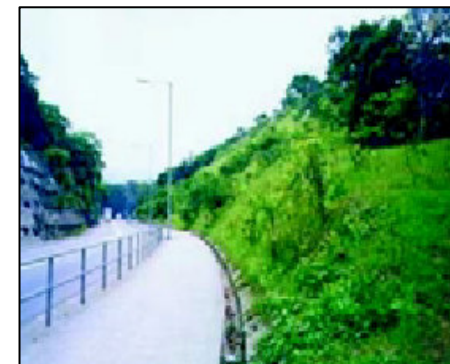
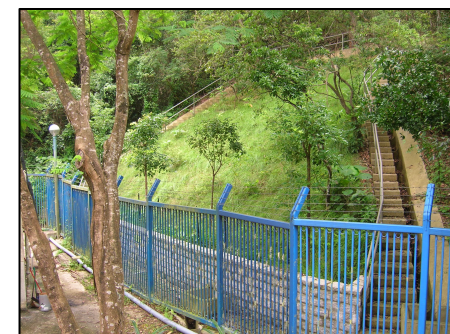
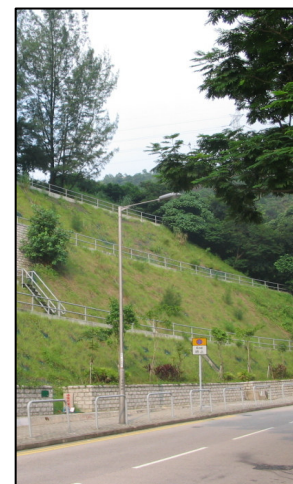
Figure: A8-3

Examples of green slope with soil nail installation and existing tree retained after landscape treatment
