**Major Restoration to
the Residence of Ip Ting-sz,
Lin Ma Hang Tsuen, Sha Tau Kok,
New Territories**

Project Profile

Leisure and Cultural Services Department
The Government of the Hong Kong Special Administrative Region

AUGUST 2010

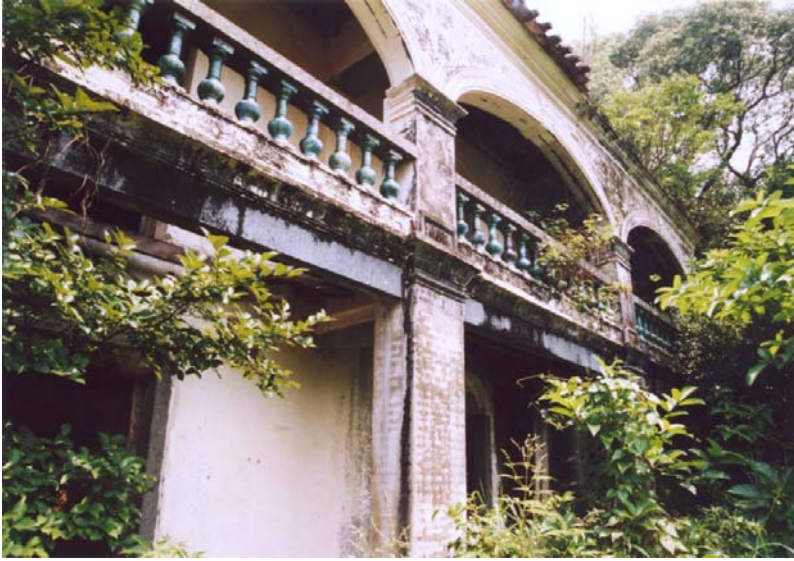
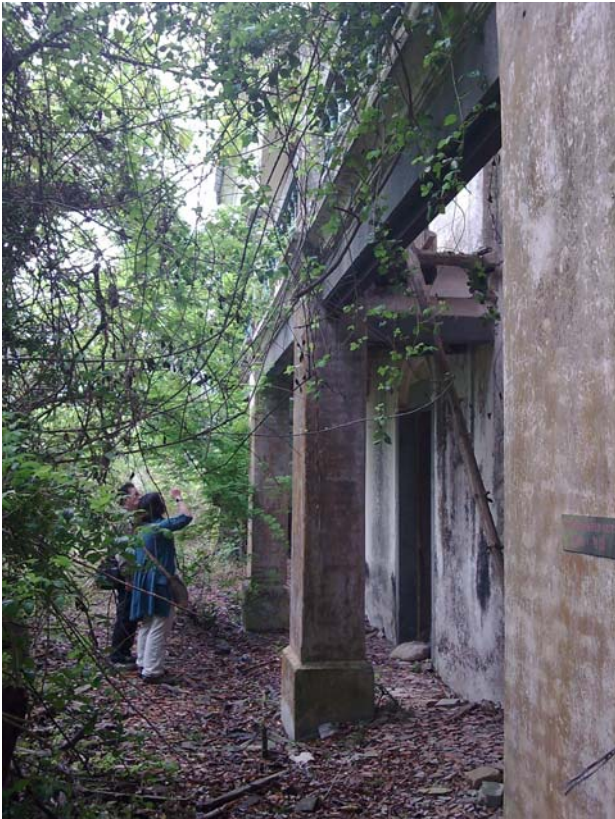
Photo 1 Front Elevation of the Main Building
相片 1 主樓正面

1.2.2 The main roof and structural floor of the Main Building have been extensively and seriously affected by termite infestation. Temporary propping is already in place by the Antiquities and Monuments Office (“AMO”), to prevent it from collapse. (Photos showing the deteriorated components of the Residence are at **Appendix II**). AMO has been allocated Government funding and has been tasked with the job of carrying out a full restoration to the Residence, which was declared as a Monument in November 2009.

- 2.4.1 Most roofing tiles have fallen off and broken; the roof is currently covered by corrugated steel sheets. New tiles of matching size, quality and colour to original will be used for the retiling of the roof. Sample of tiles is to be approved before ordering.

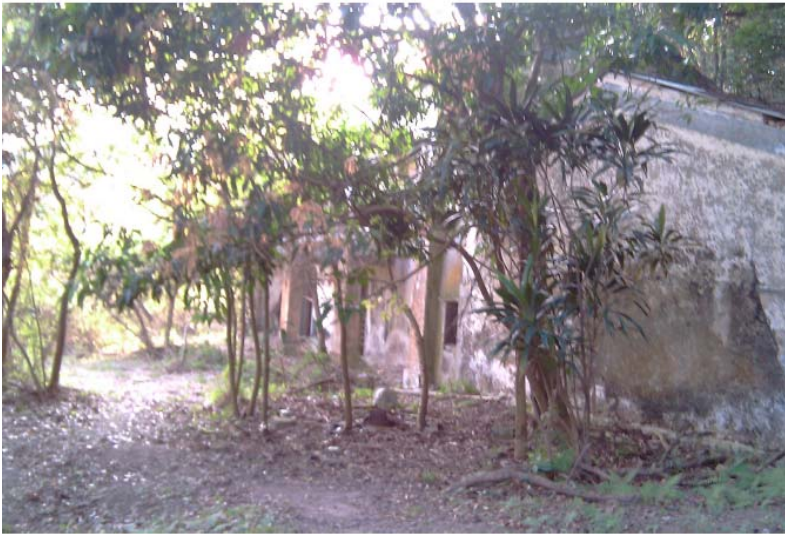
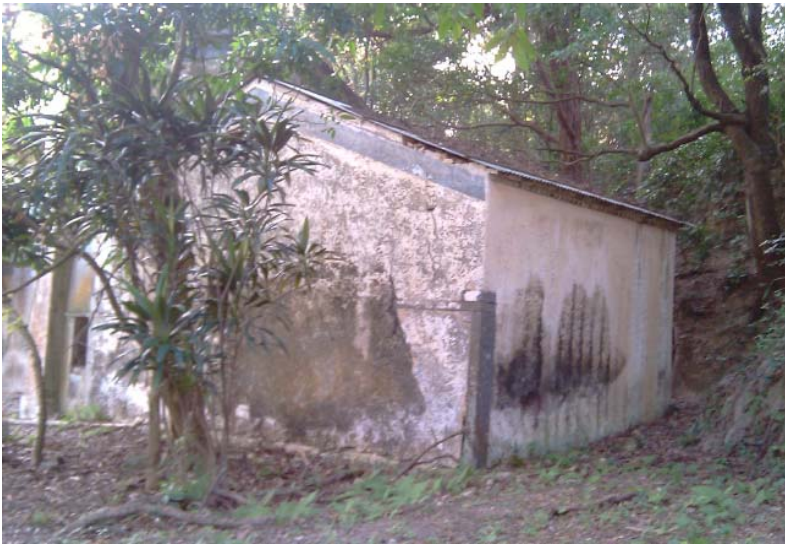
Photo 4 Annex Block (Kitchen Annex)
相片 4 附建物 (附建廚房)

1.2.3 There is a small brick-built Annex attached to the Residence, which was used as a kitchen, it is not within the declared monument boundary. Emergency repair was carried out in 2005 to reconstruct the roof at the Annex and covered it with corrugated sheets, Minimum repair works will be carried out to the Annex, as part of this major renovation project.

- (vii) Minimum repairing works will be carried out at the Kitchen Annex. The demolition of wall connecting the Main Building and the Kitchen Annex will not affect the opening at the Kitchen Annex. Gate with horizontal bars will be installed to control human access to the Kitchen Annex and at the same time

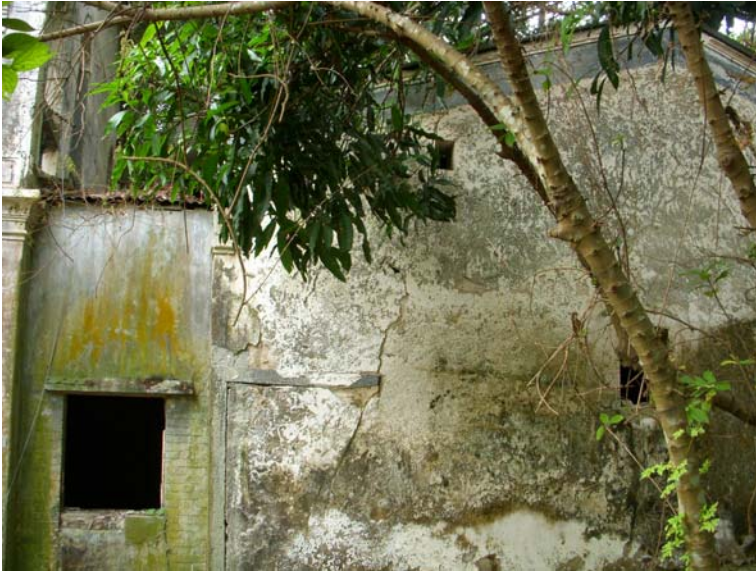
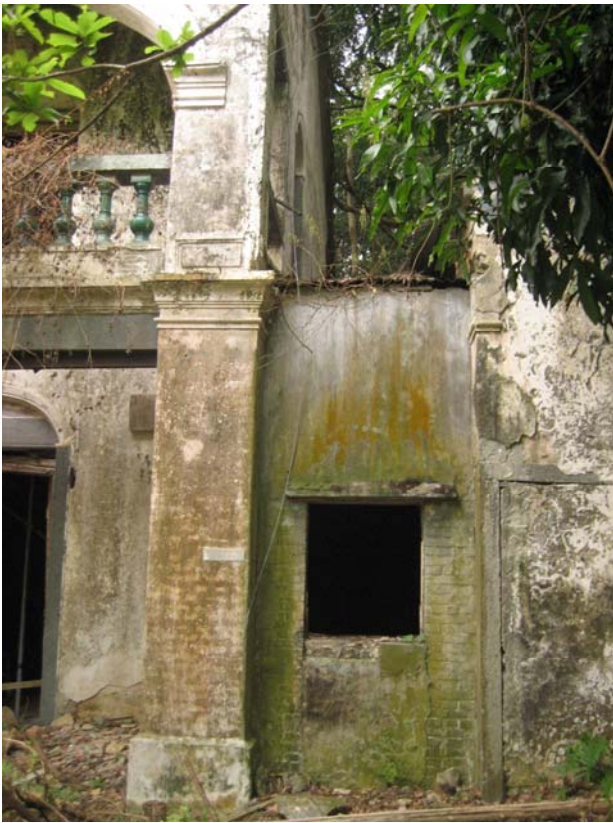
Photo 5 Aisle Connecting the Main Building and the Annex Block
相片 5 連接主樓和附建物之通道

- 2.6.1 The aisle connecting the main building and the annex block is found to be later addition from the conservation study. Its timber roof structure has collapsed and is temporarily covered by corrugated sheets. It has lower heritage value and in order to restore the Residence to its original status, the aisle will be demolished and the opening at the main building will be provided with wooden doors with materials matching the façade of the structures. For the opening at the annex block, it will be provided with a gate with horizontal bars which will control human access to the annex and at the same time to allow bat's flight.

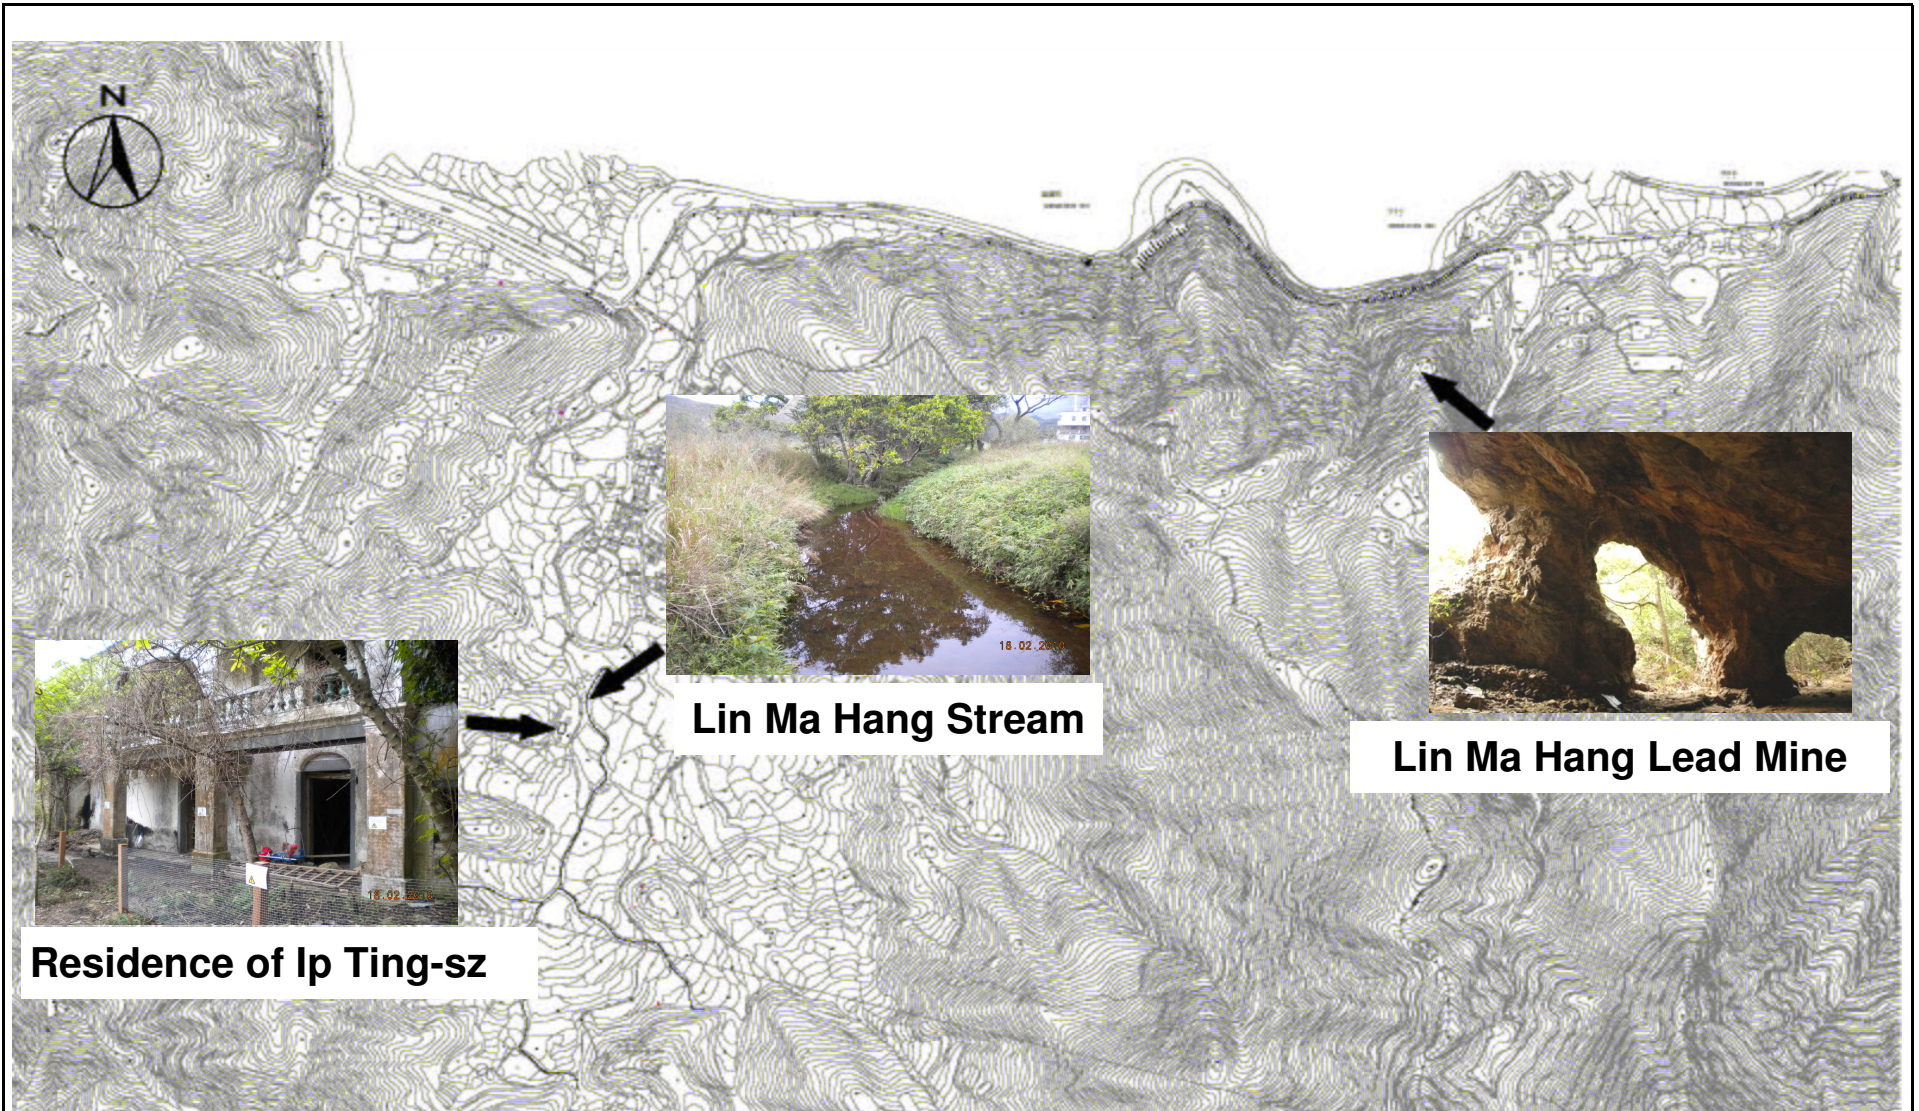
Scale	N.T.S	Project No.	IA0004
Date	Feb 2010	Figure	1

Title
 Quotation Ref.: AMO0911013
 Consultancy for Ecological Study at the Residence of Ip Ting-sz, Lin Ma Hang, Closed Area
 Site Layout Plan

- 2.1 The residence of Ip Ting-sz (hereinafter called “the Residence”) is located at Lin Ma Hang Tsuen, Sha Tau Kok, New Territories, within the Closed Area. The location of the Residence is shown in **Figure 1**.
