**Natural Terrain Hazard Mitigation Works
at
Study Area No. 12NW-C/SA1
Above Leung Fai Tin Along Clear Water Bay Road,
Sai Kung**

PROJECT PROFILE

February 2013

Halcrow

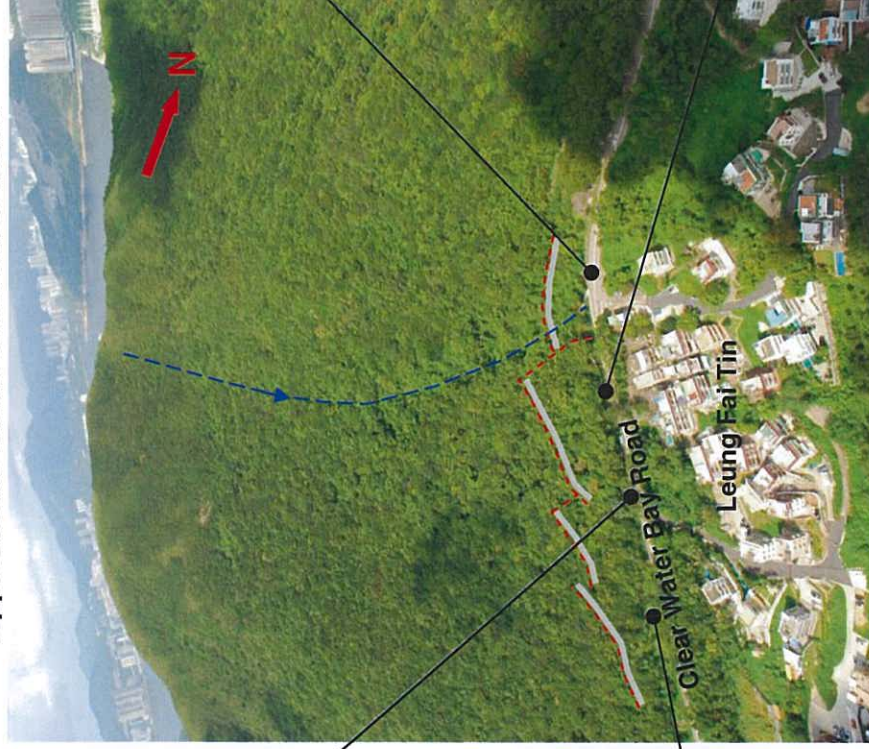
Plate 2

- Legend:
- Stream course
 - - - Approximate location of the maintenance access
 - Approximate alignment of the flexible barrier

Approximate Location of the Proposed Alignment of the Flexible Barriers and Views Around the Works Area

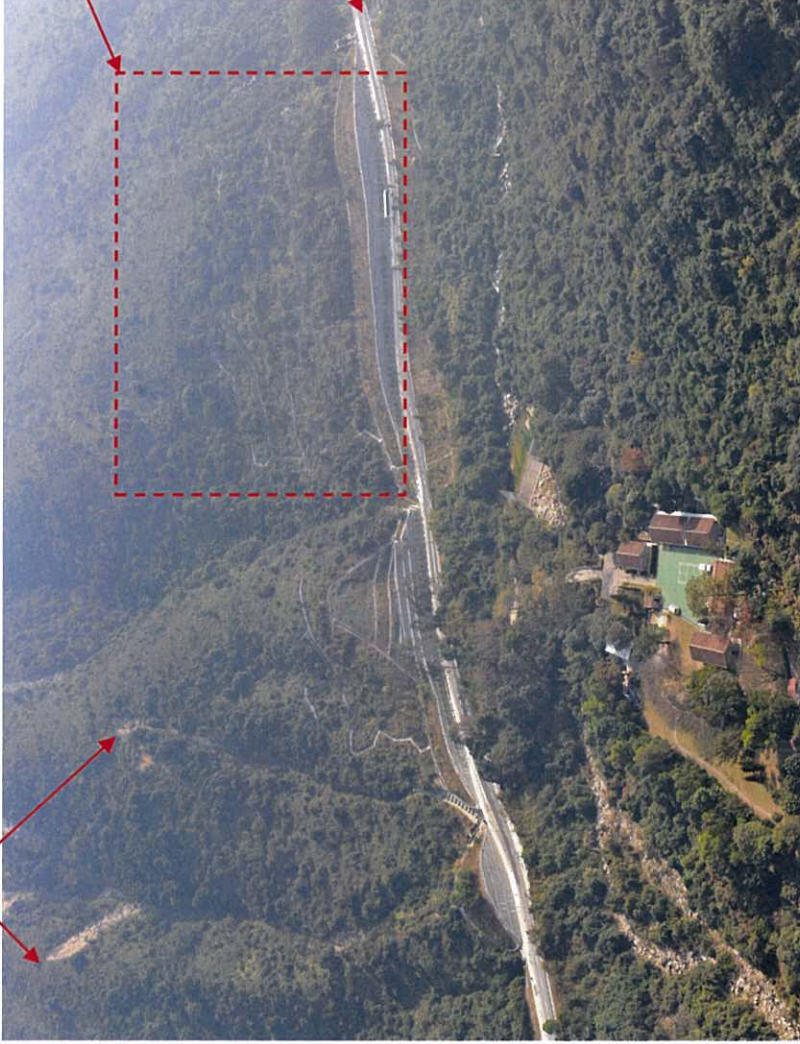
Area with flexible barriers with maintenance access

Aerial View of Natural Terrain Mitigation Measures on the Hillside above Tung Chung Road

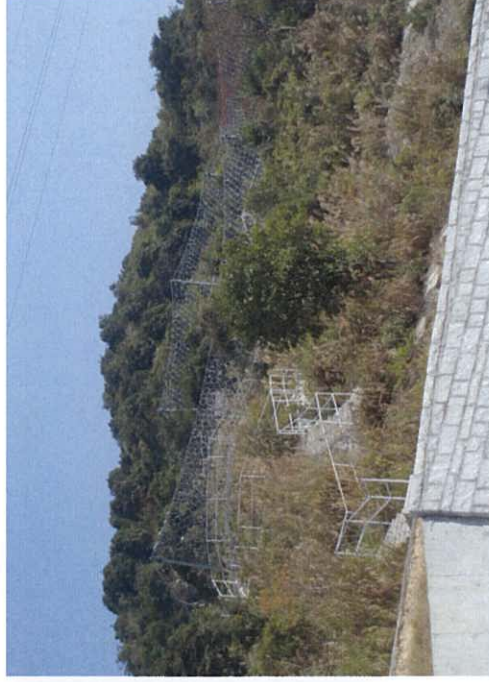
View of Flexible Barriers Close to Roadside of Tung Chung Road

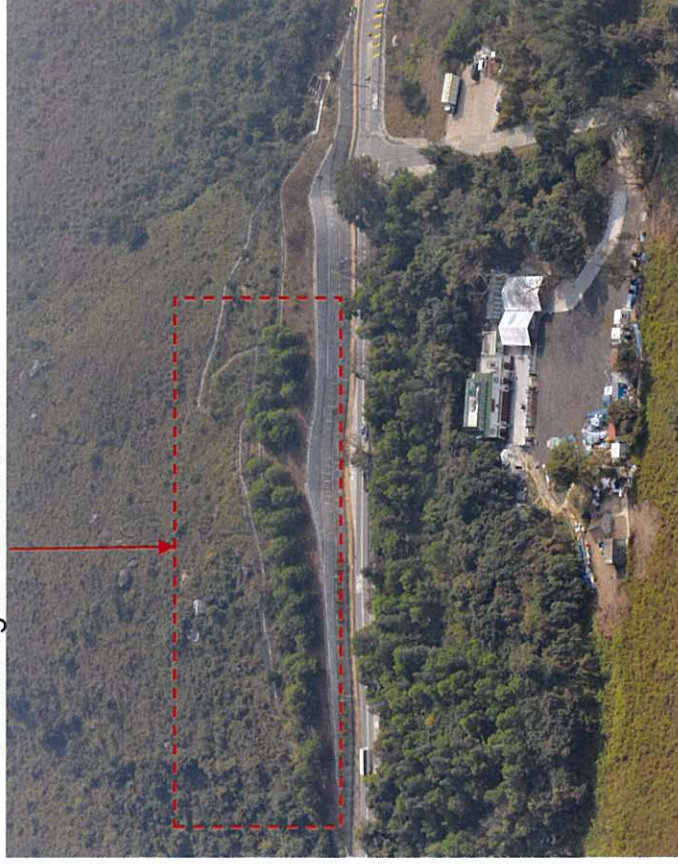
Plate 5a – Aerial View Showing Pit-planting in front of the flexible barrier for screening
(Example: Tung Chung Road)

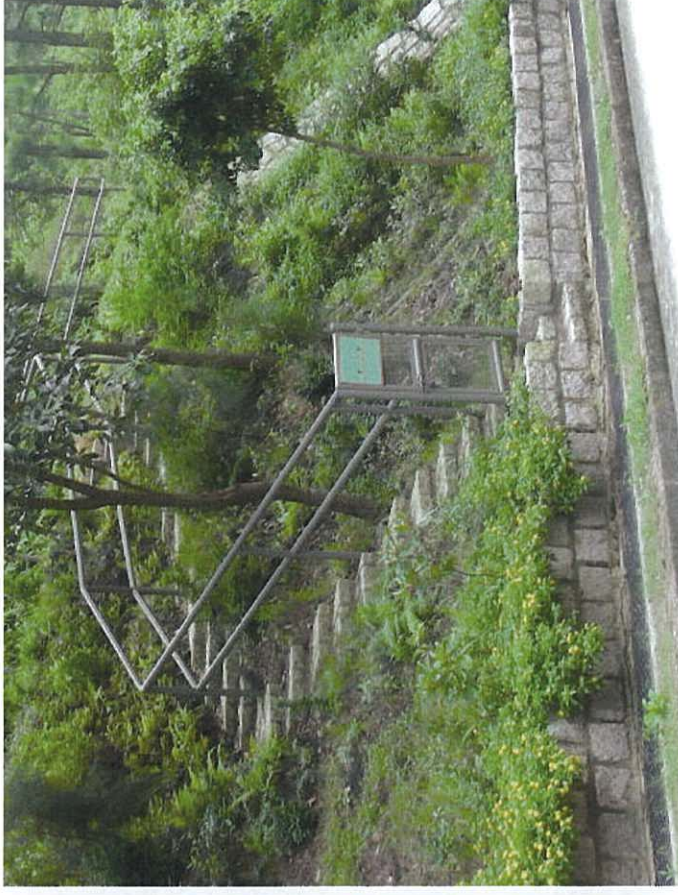
Plate 5b – Masonry finish to the maintenance access with painted handrails and gates to blend the design with surroundings
(Example: South Lantau Road)

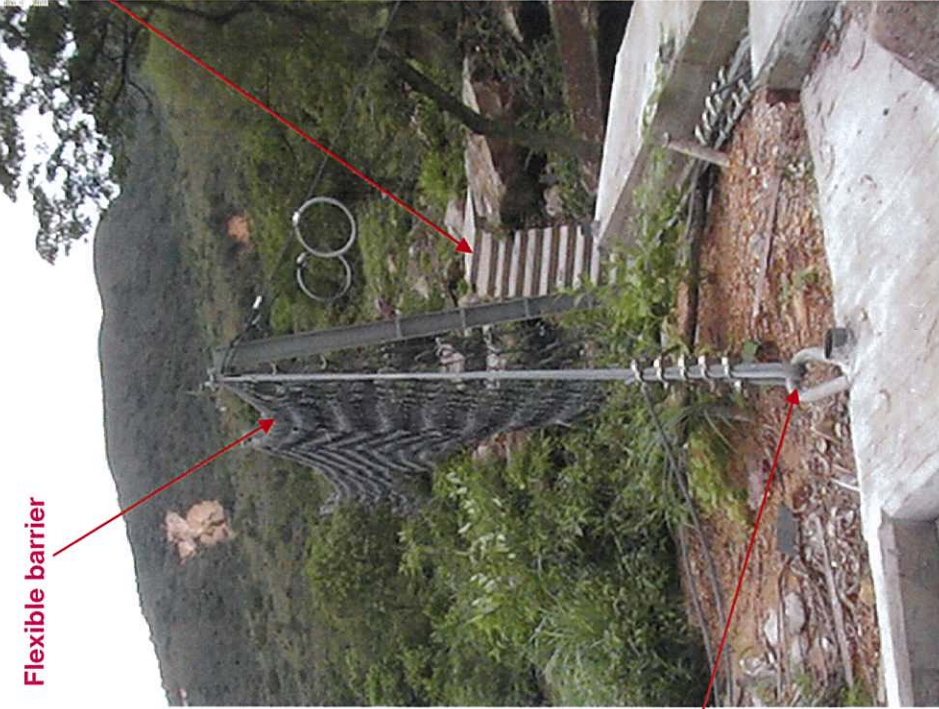
Flexible barrier

Maintenance staircase

Lateral anchor

Supporting post

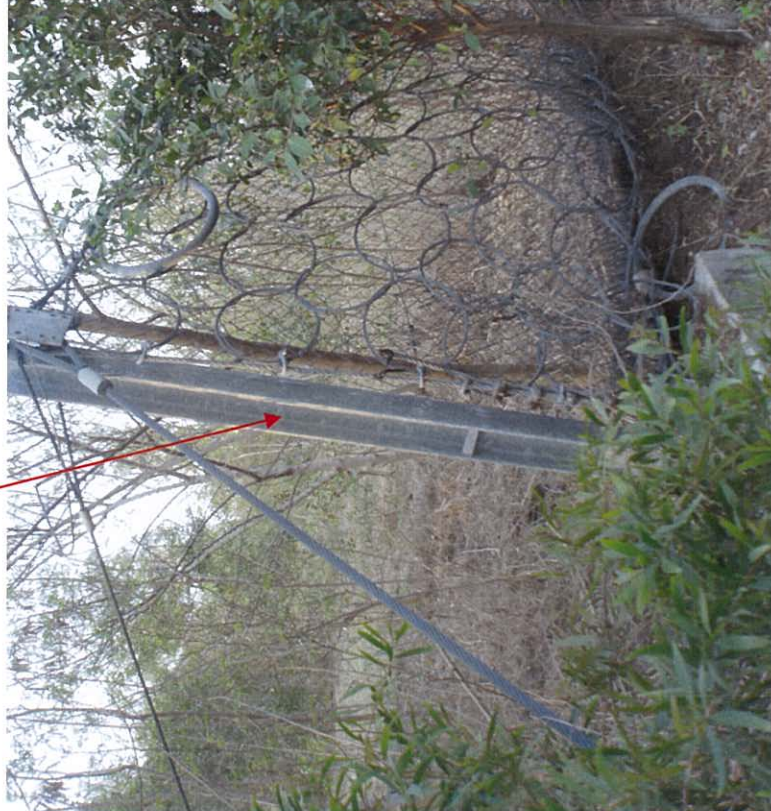
Close-up View of Lateral Anchor and Maintenance Staircases

Close-up View of Flexible Mesh and Supporting Post

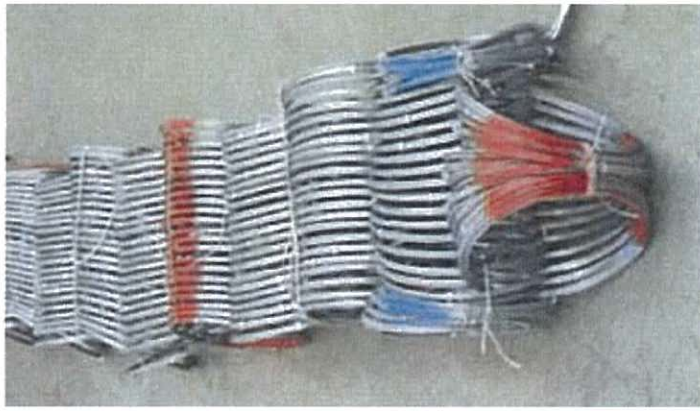
View of the flexible barrier prior to installation

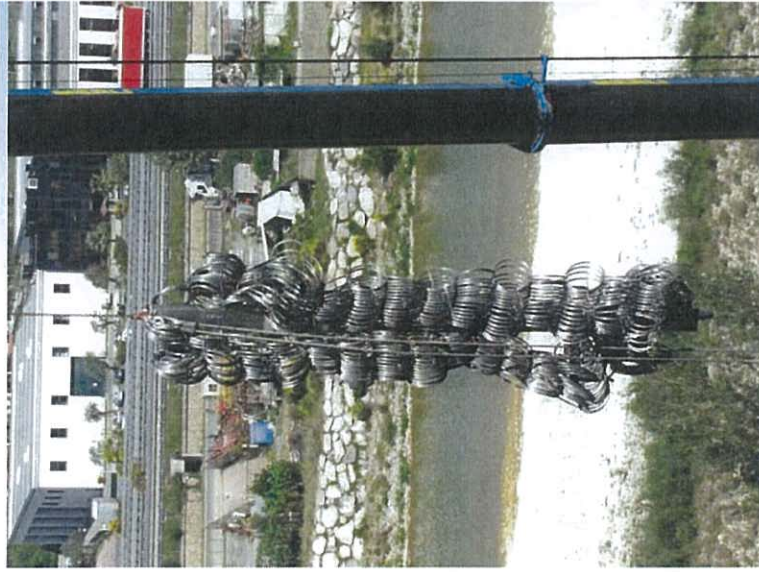
Example of installation process of the proprietary flexible barrier

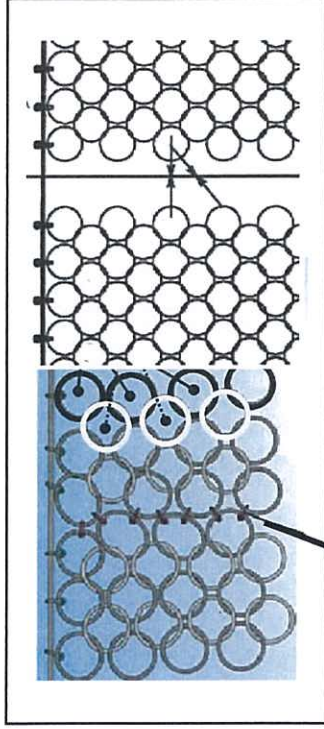
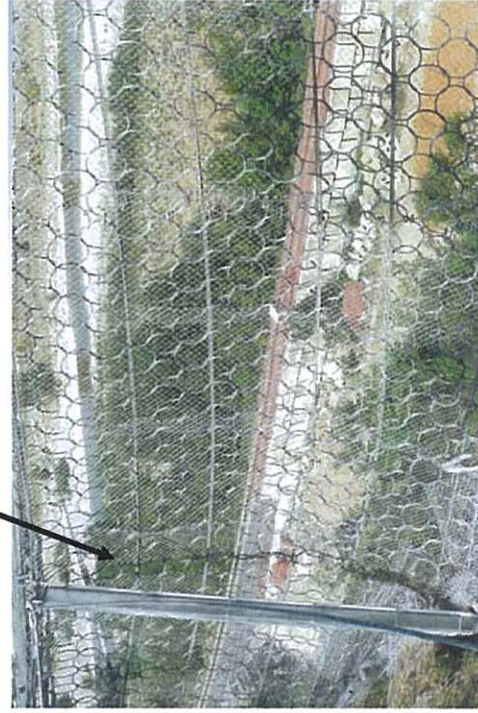
View of proprietary flexible barrier after installation

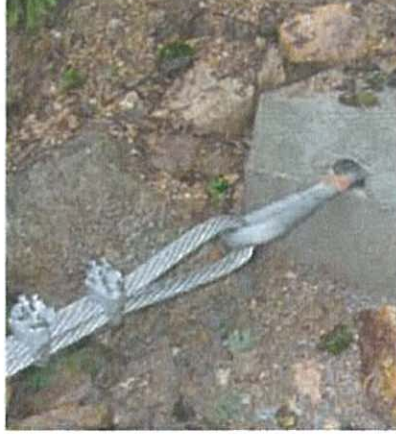
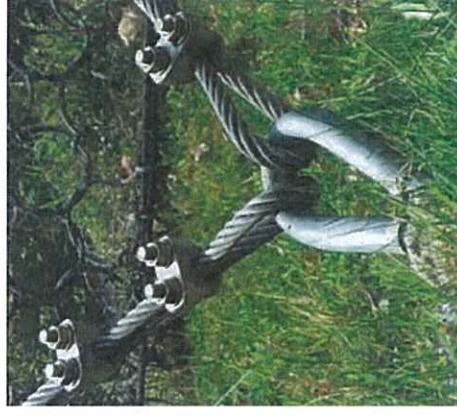
Views of the anchors
