Decommissioning of Clinical Waste Incinerators and Associated Chimneys at the Main Block of Pamela Youde Nethersole Eastern Hospital, Chaiwan H.K.

PROJECT PROFILE

January 2015

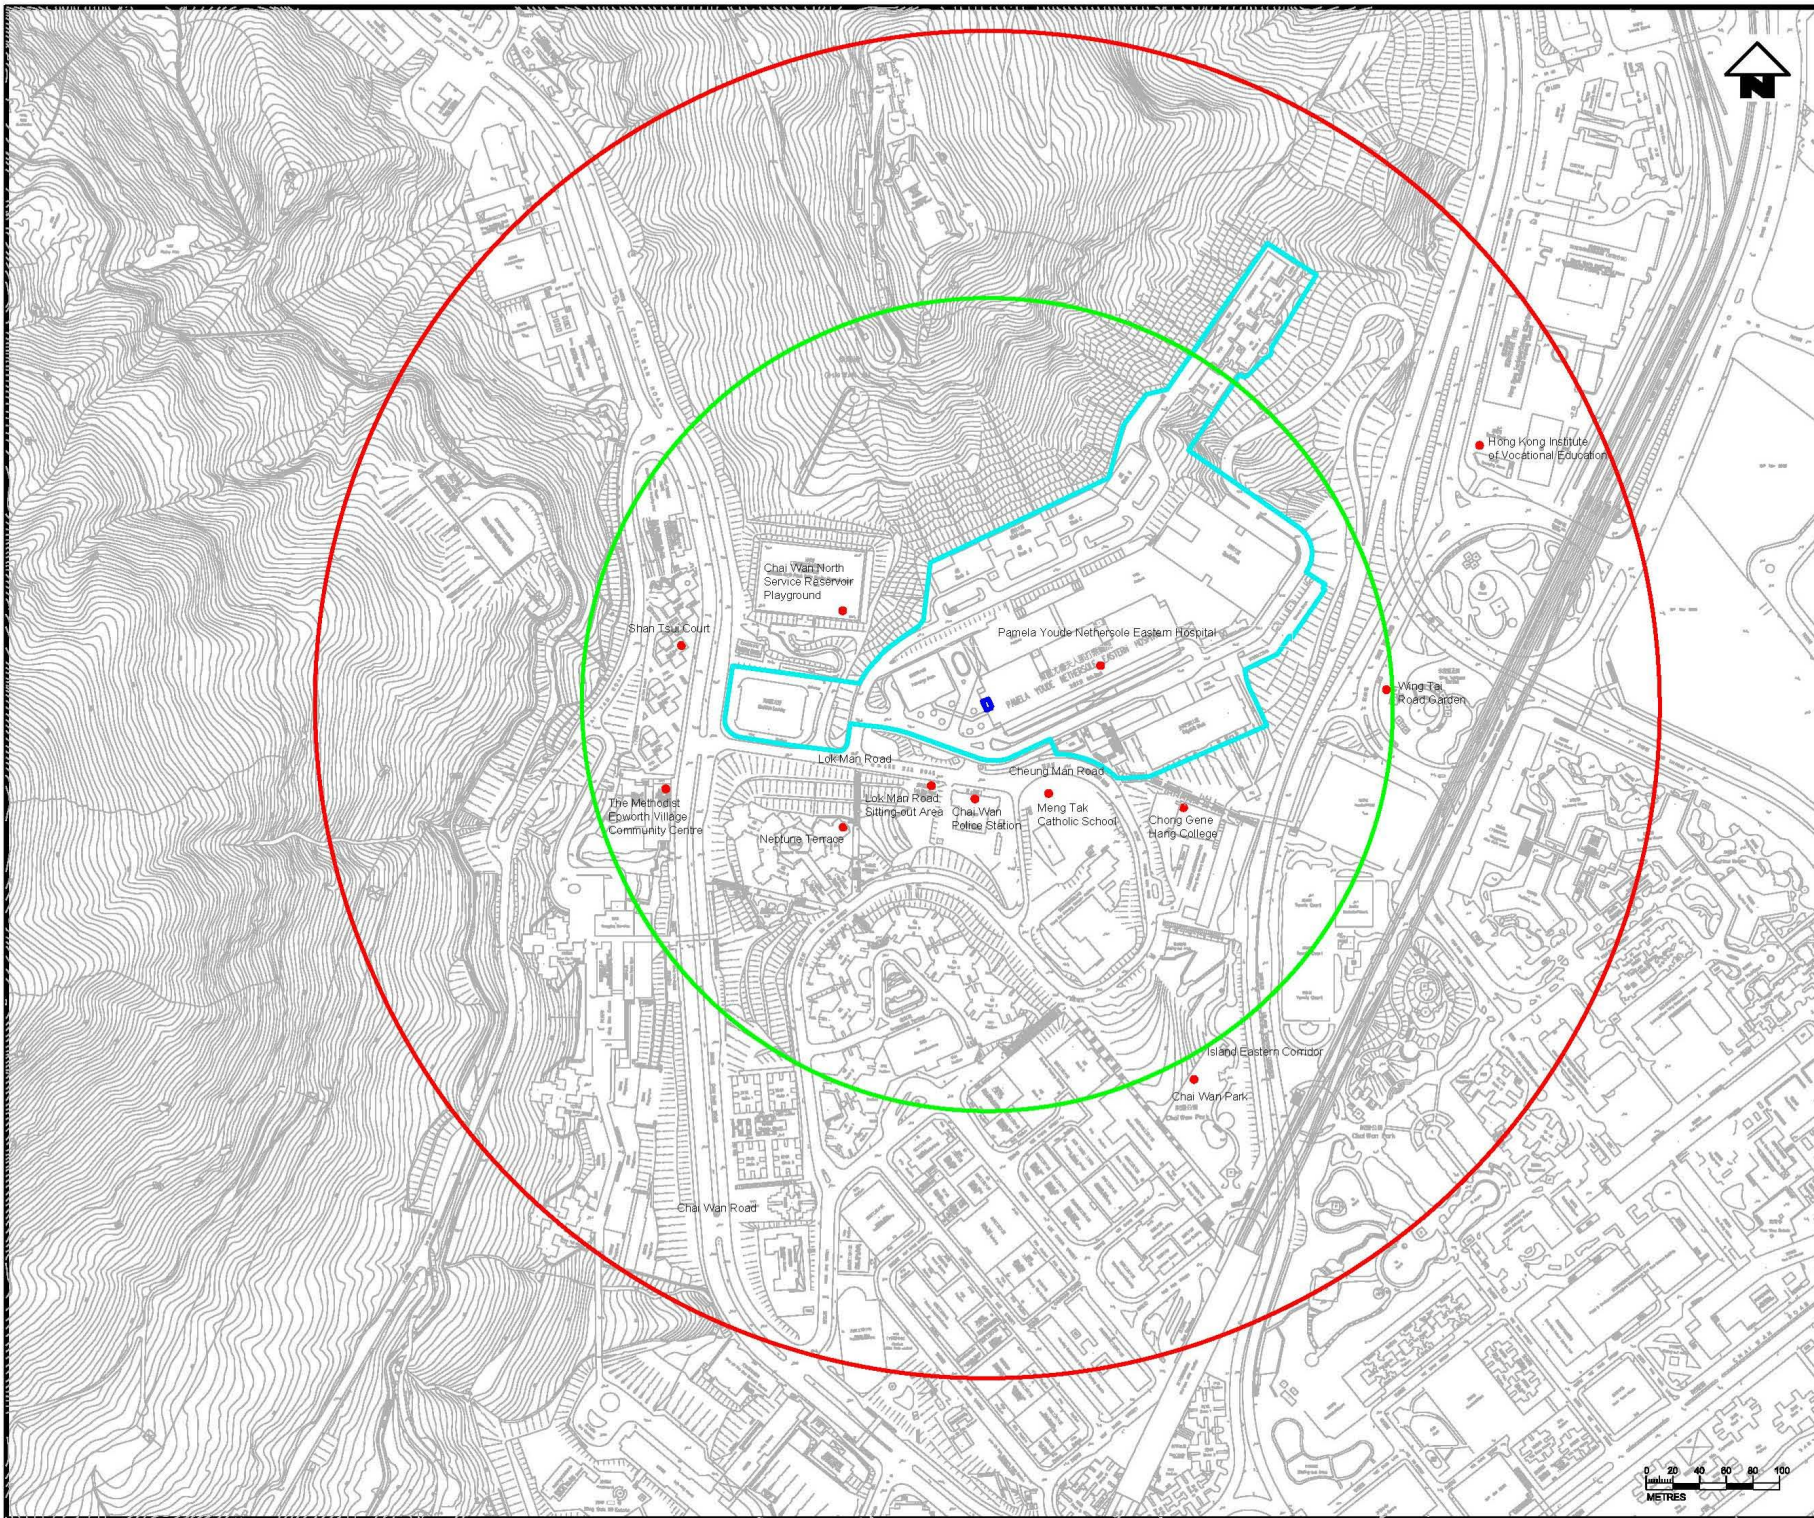
Figure 1.1 Location of the Pamela Youde Nethersole Eastern Hospital

1.4.1 Pamela Youde Nethersole Eastern Hospital is located at 3 Lok Man Road. The location of the hospital and proposed works site are shown in **Figure 1.1**.

3.1.1 Representative Air Sensitive Receivers (ASRs) and Noise Sensitive Receivers (NSRs) in the vicinity of the Project have been identified and summarized in Table 3-1. Their locations are shown in Figure 1-1.

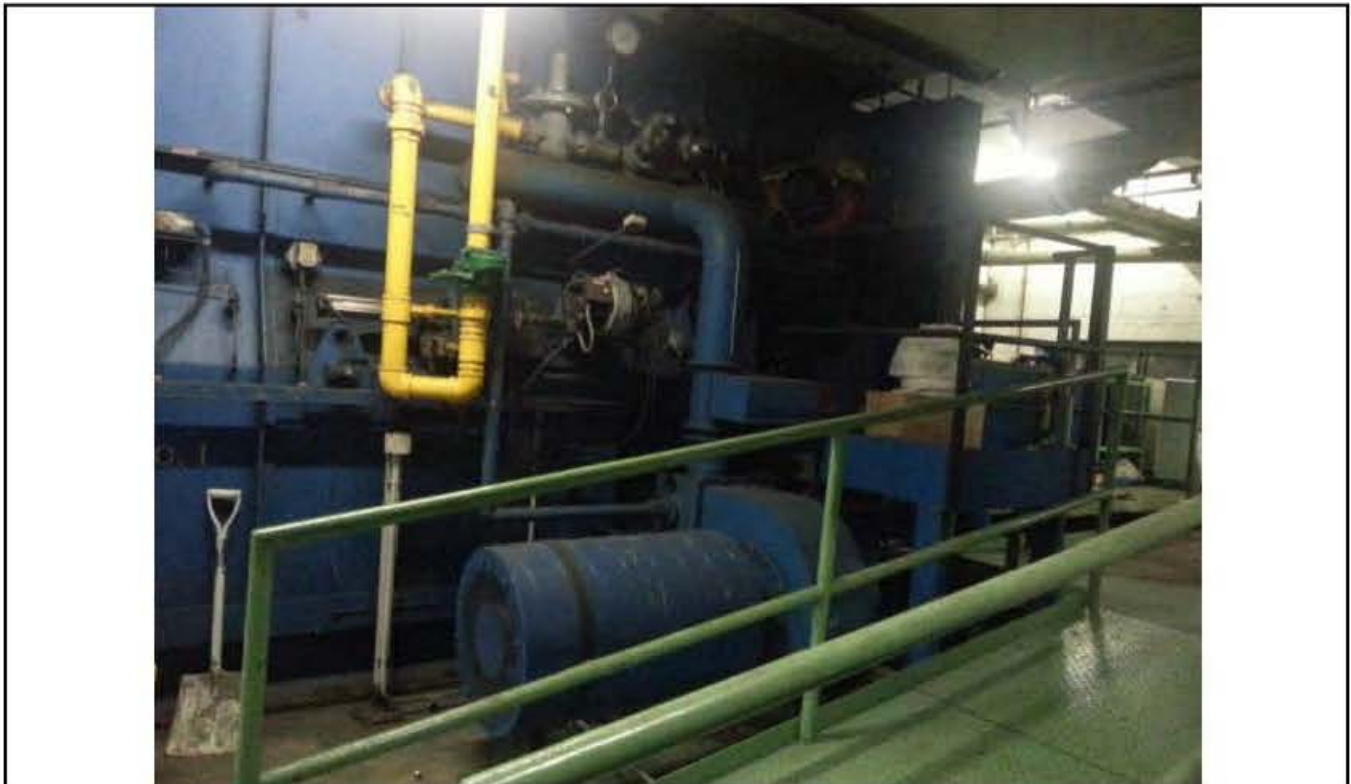
The Incinerator

- 4.6.1 The incinerators are made of durable steel fabrication components with temperature resistance internal lining and installed on a concrete floor. The incinerators are fueled by Towngas and were operated for once or twice after installation for trial tests. During the site visit, the incinerators and concrete floor were observed to be in good condition. Potential land contamination is unlikely to be arisen from the past operation of the incinerators.

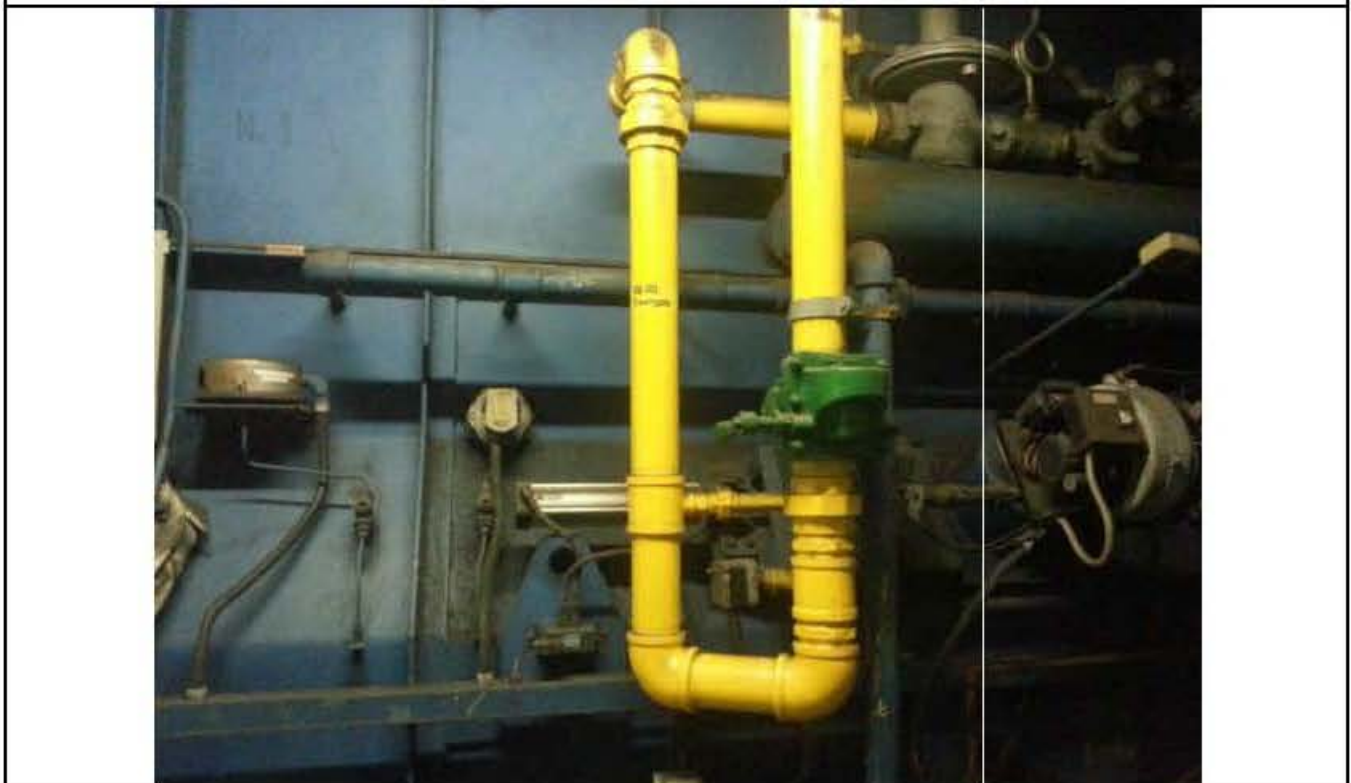
Town gas pipe to the incinerator

- 5.1.12 A Towngas technician shall be employed to disconnect the gas supply to minimize the potential risk.
- 5.1.13 After completion of the decommissioning work, all surfaces in the incinerator and E&M plant room shall be decontaminated by a HEPA vacuum and wet wipes. Then the innermost polythene sheet shall be sprayed with Polyvinyl Alcohol (PVA) and the inner polythene sheet shall be peeled off when the PVA is dried. The PVA spraying shall then be repeated for the second and third layers of the polythene sheets. All polythene sheets used shall be disposed of at a designated landfill site.

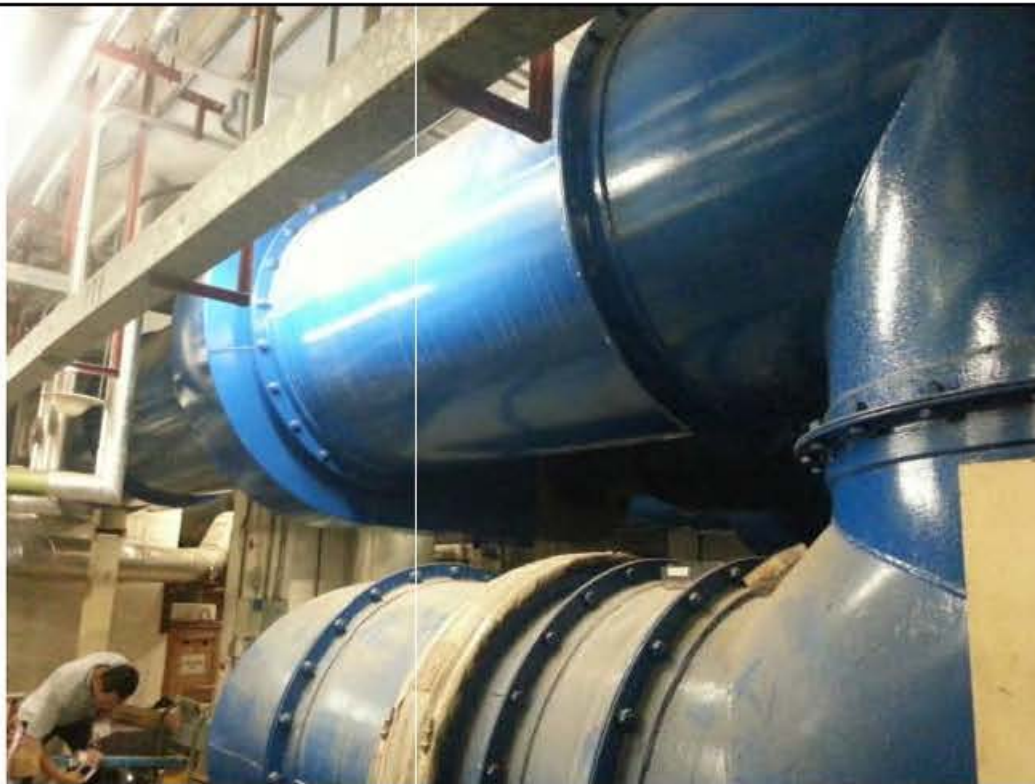
Ductworks

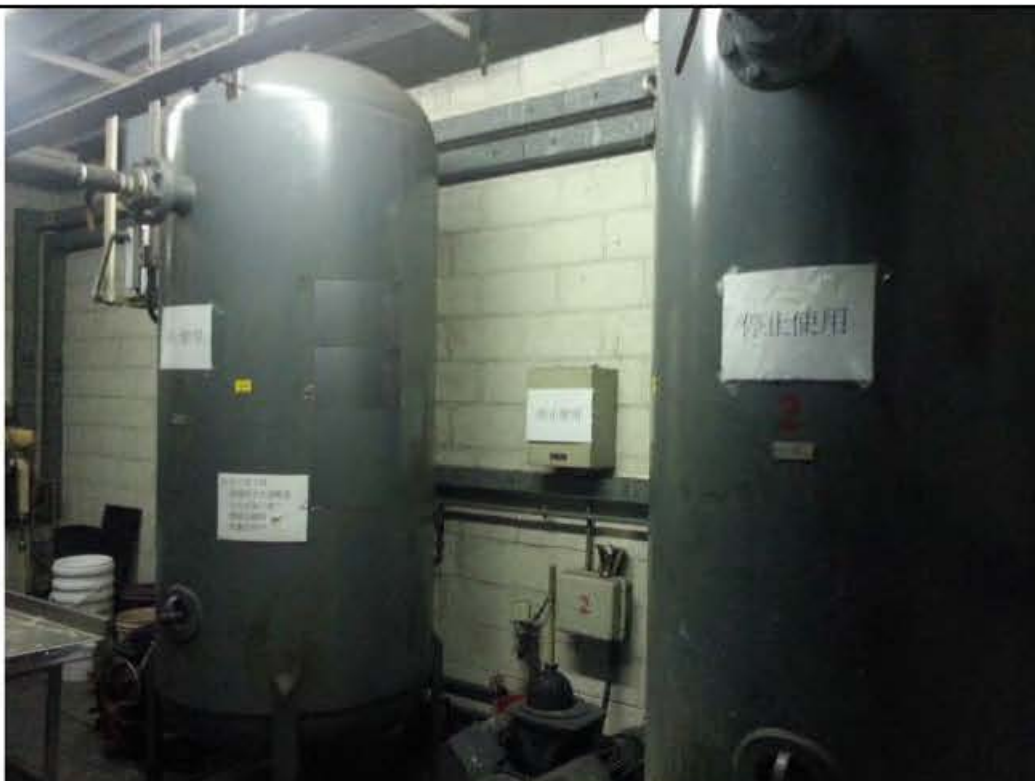
Air receivers and compressors

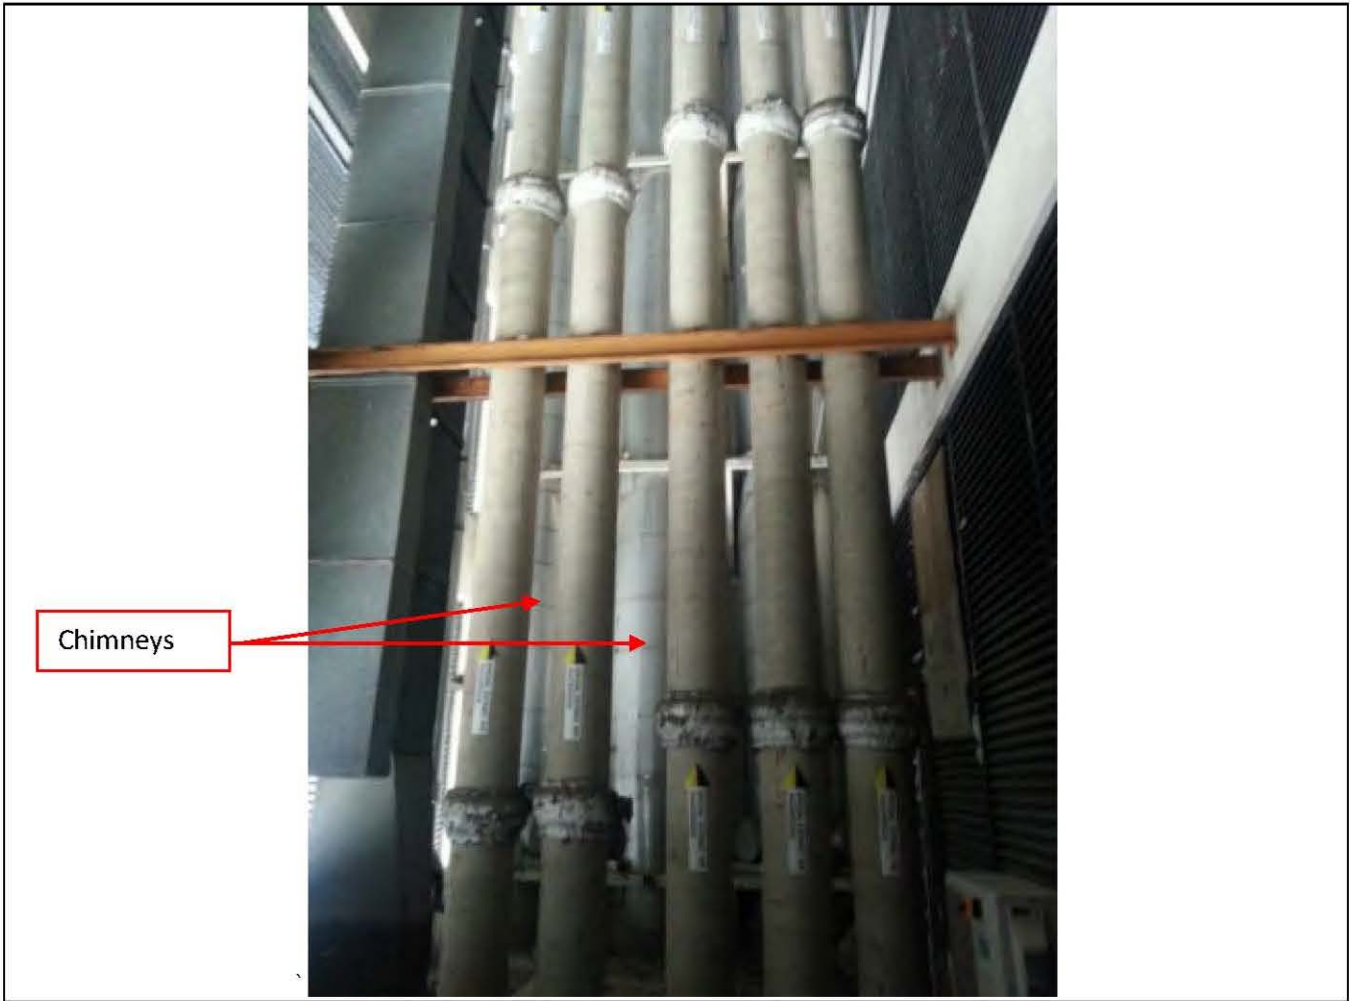
Chimneys (only 2 chimneys for incinerators)

- 5.1.7 The incinerator chimney shall be removed from top down starting from the roof area. Any residual ash attached to the flues, chimneys and panels shall be removed by scrubbling and HEPA vacuuming. The detached sections of flue and chimney shall be wrapped with three layers of fire retardant polythene sheets and secured with duct tape.

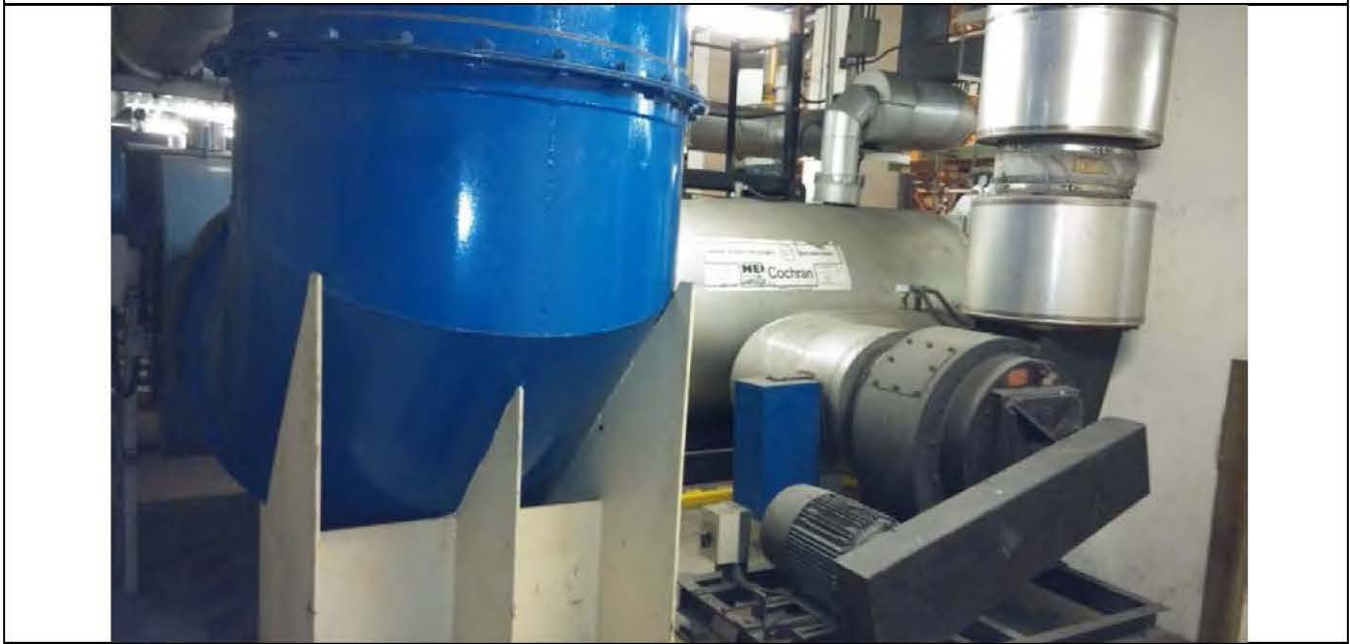
Boiler

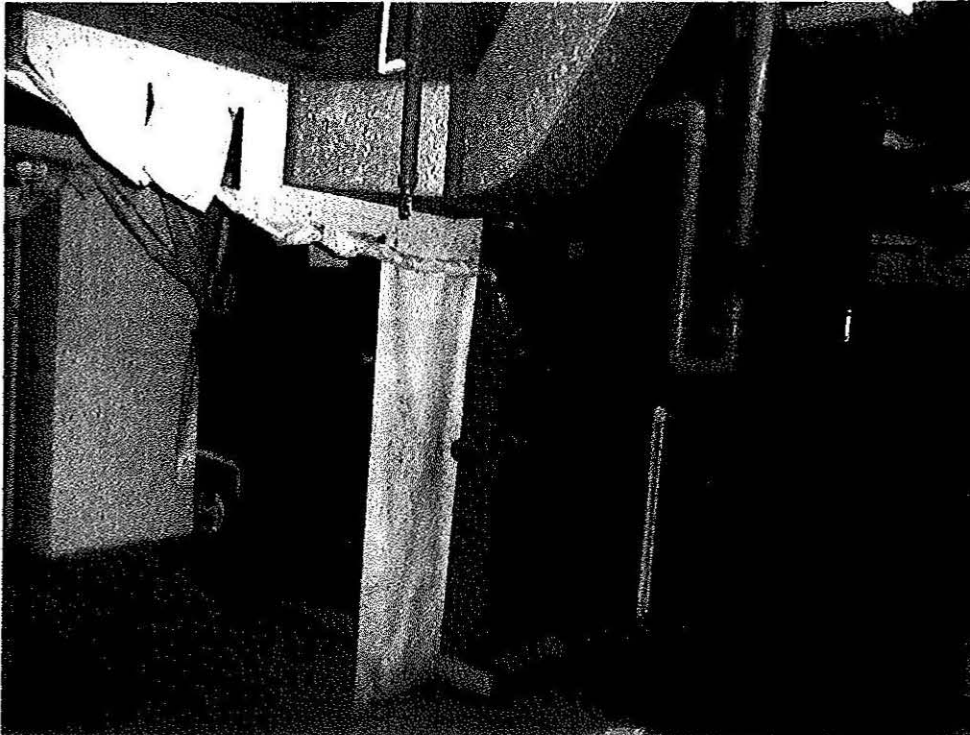
General view of Incinerator No. 1

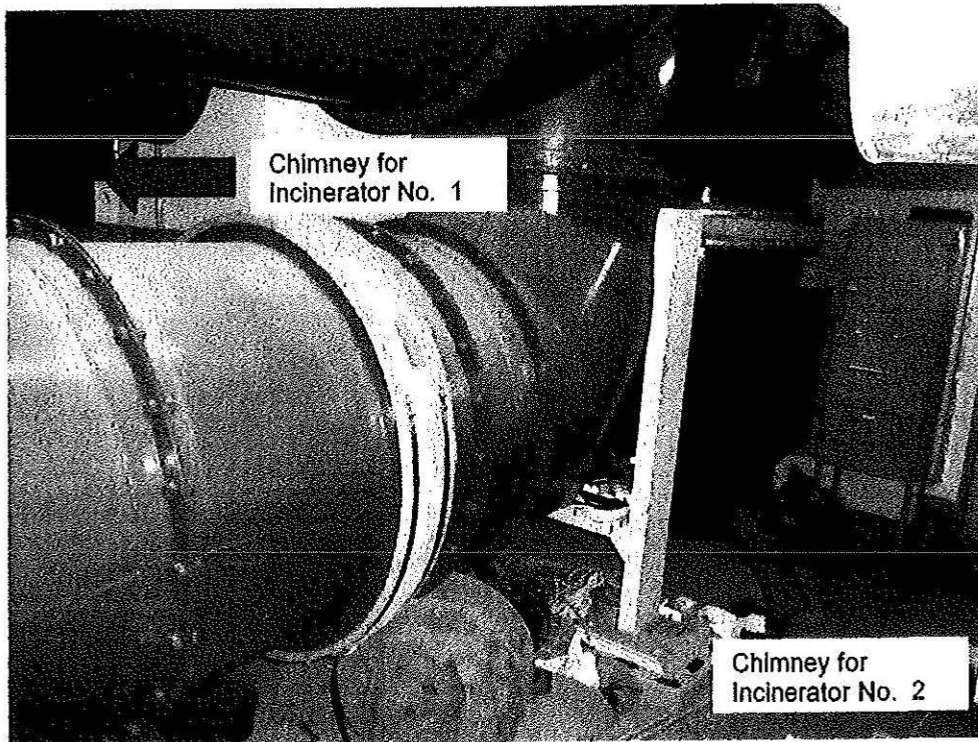
General view of Chimneys

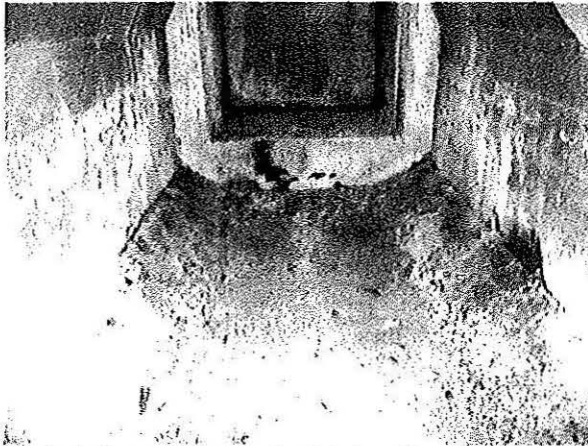
Photo 1. General view for the interior of Incinerator No. 1. Photo taken at Incinerator Room, LG 2/F, Main Block.

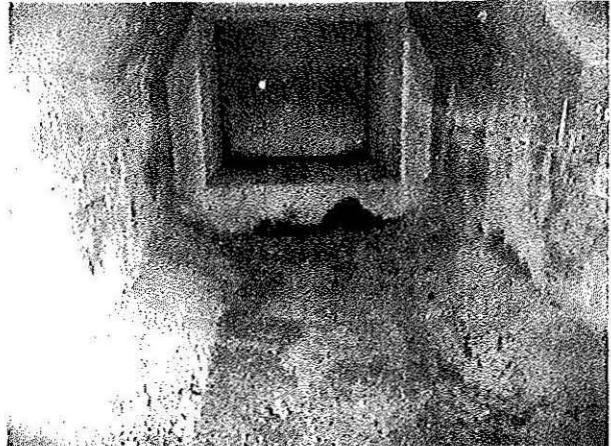
Photo 2. General view for the interior of Incinerator No. 2. Photo taken at Incinerator Room, LG 2/F, Main Block.

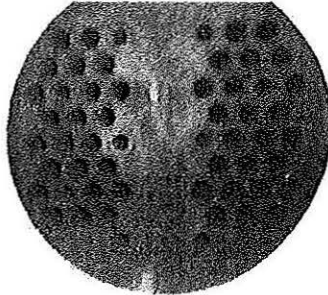
Photo 3. General view for the interior of Waste Boiler (rear side). No ash / debris was found. Photo taken at Boiler Room, LG 2/F, Main Block.

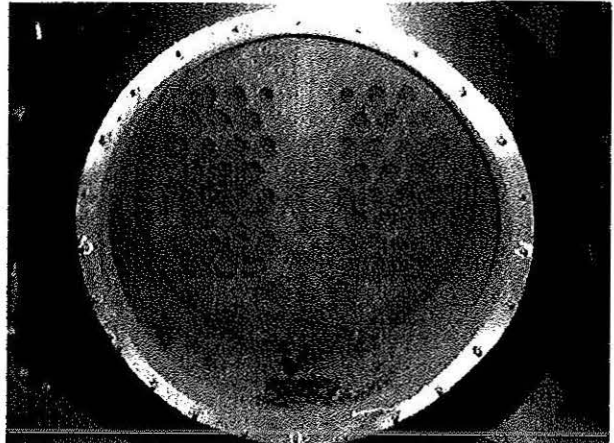
Photo 4. General view for the interior of Waste Boiler (front side). No ash / debris was found. Photo taken at Boiler Room, LG 2/F, Main Block.

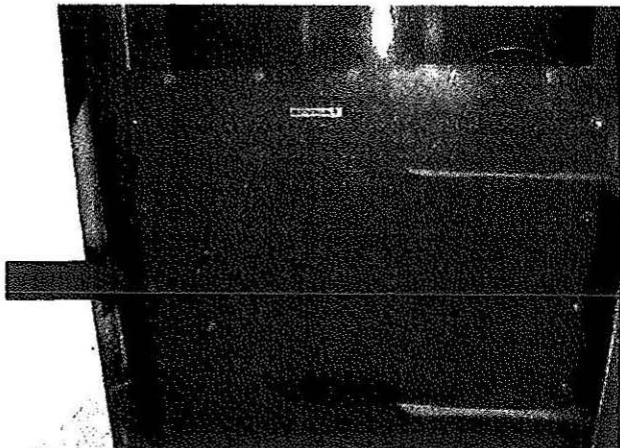
Photo 5. General view of Chimney for Incinerator No. 1. Photo taken at Plant Room, LG 1/F, Main Block.

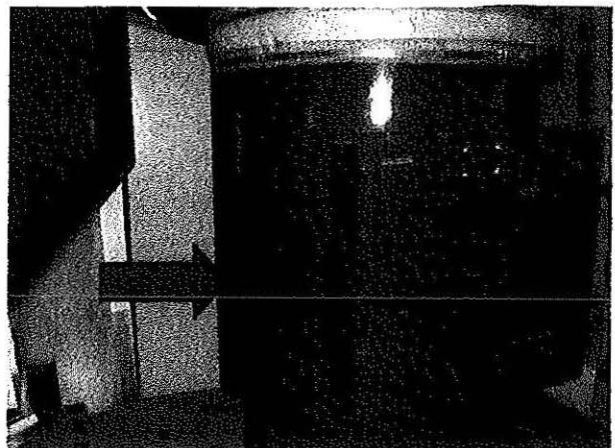
Photo 6. General view of Chimney for Incinerator No. 2. Photo taken at Plant Room, LG 1/F, Main Block.

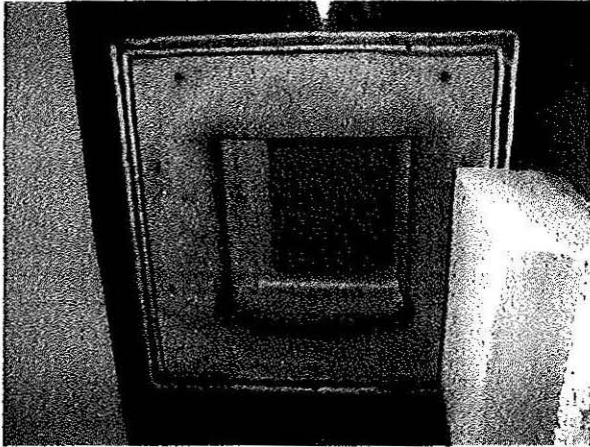
Photo 7. General view of Chimney for Incinerator No. 1. Photo taken at Plant Room, LG 1/F, Main Block.

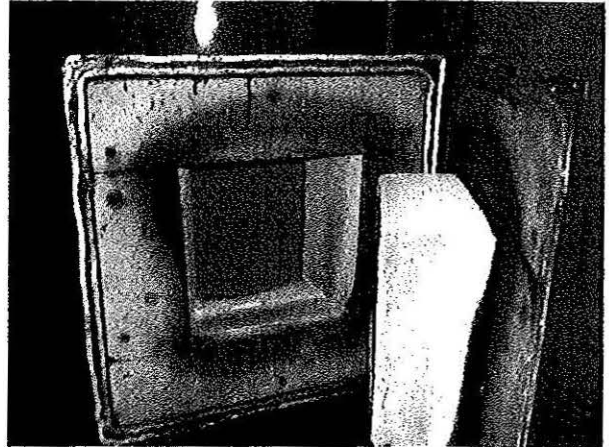
Photo 8. General view of Chimney for Incinerator No. 2. Photo taken at Plant Room, LG 1/F, Main Block.

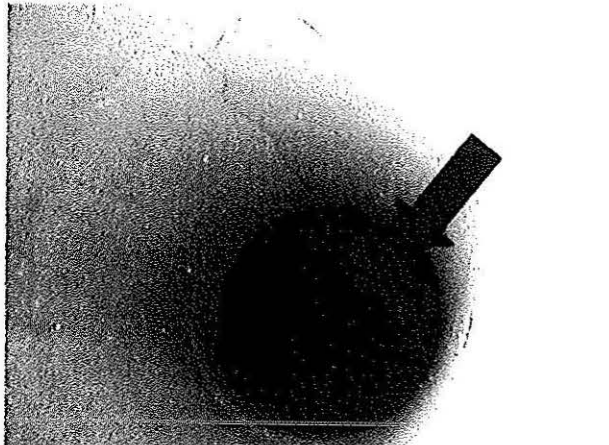
Photo 10. Typical view of the bottom part of Chimney for Incinerator No. 2 Photo taken at Plant Room, LG 1/F, Main Block.

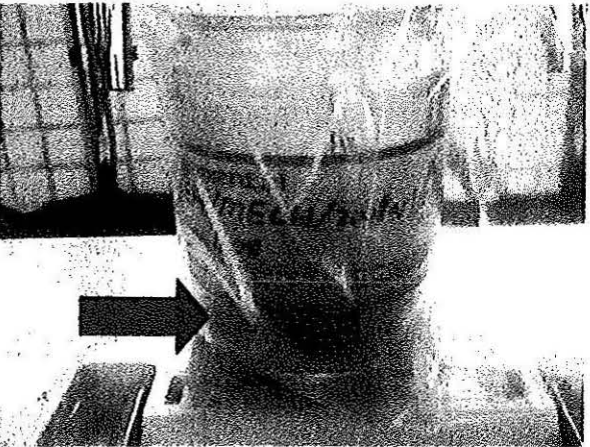
Photo 11. Typical view of ash / debris sample collected from the interior of Incinerator No. 1. (Sample No. PYNEH/MECH/2008a/1).

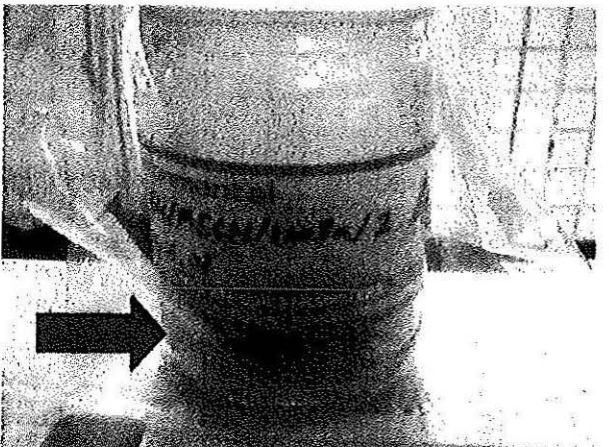
Photo 12. Typical view of ash / debris sample collected from the interior of Incinerator No. 2. (Sample No. PYNEH/MECH/2008a/2).

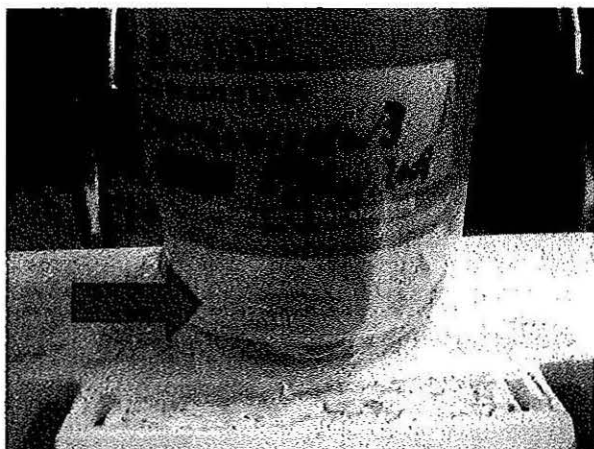
Photo 13. Typical view of ash / debris sample collected from the chimney of Incinerator No. 1. (Sample No. PYNEH/MECH/2008a/3).

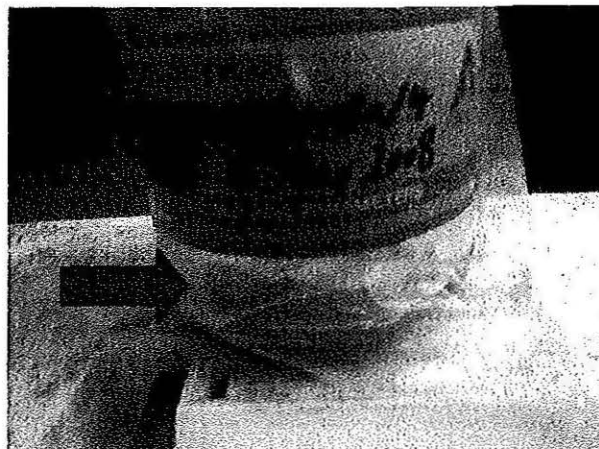
Photo 14. Typical view of ash / debris sample collected from the chimney of Incinerator No. 2. (Sample No. PYNEH/MECH/2008a/4).

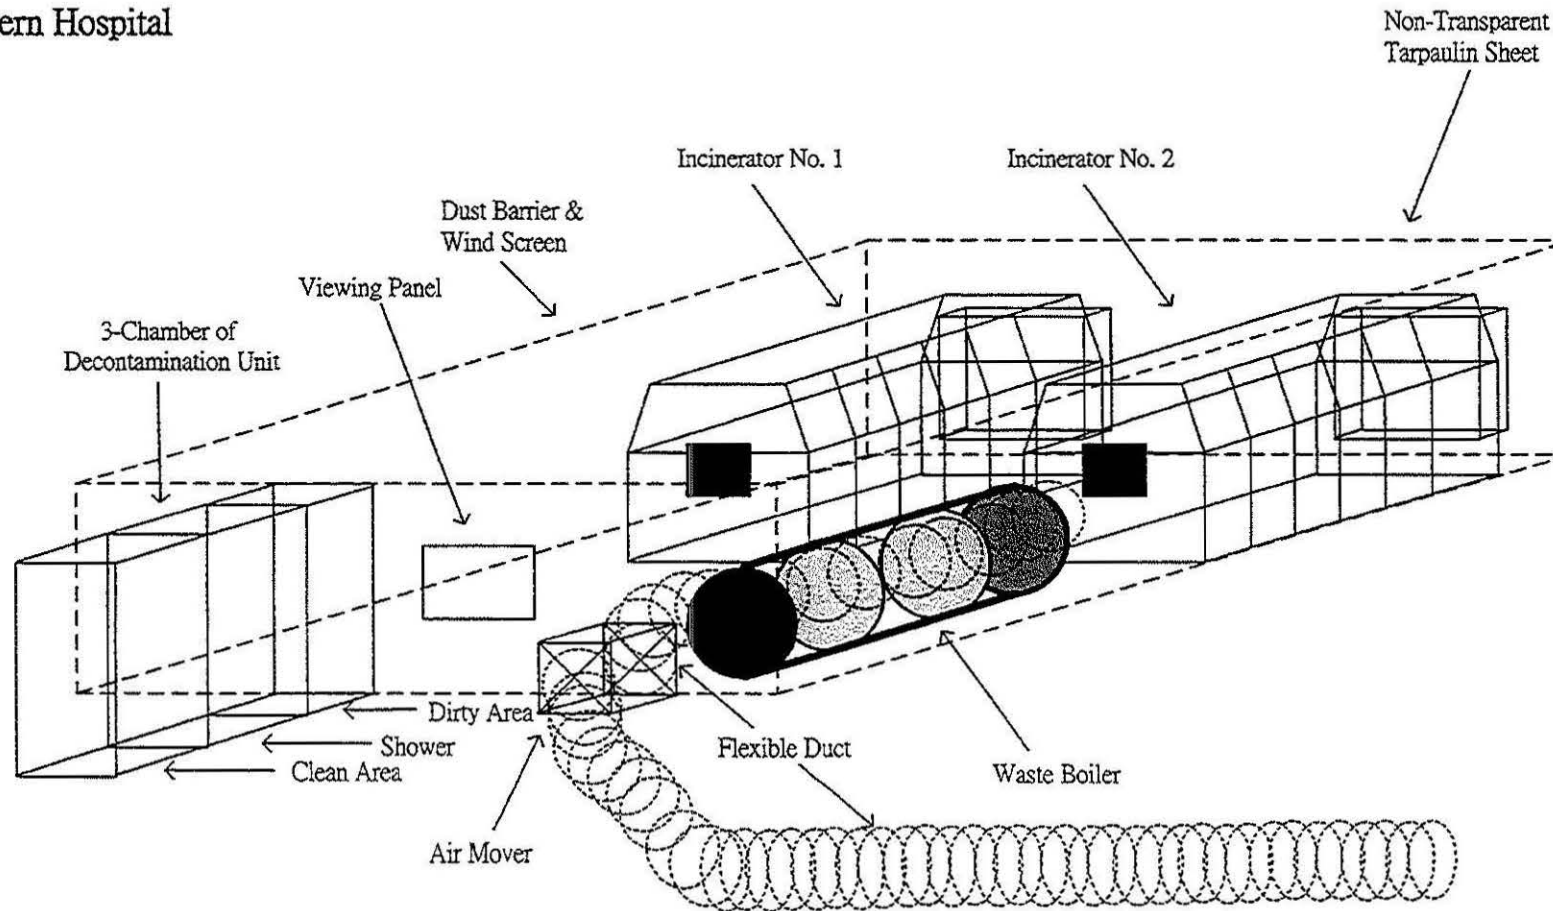
Drawing Title:
Plan Layout of
Containment (3-D)

Incinerator and Waste Boiler
Room, LG 2/F, Main Block,
Pamela Youde Nethersole
Eastern Hospital

- 5.1.2 Decommissioning of the incinerator room shall be undertaken under full containment to avoid the potential release of any residual ash to the environment during the decommissioning works. At the entrance to the works area, a 3-chamber decontamination unit shall be constructed to isolate the works area and provide safe access and egress of authorized personnel working inside the works area. The decontamination unit shall include three sealable compartments, namely a dirty room, a shower room and a clean room. Each room shall have a minimum size of 2m (height) x 1m (width) x 1m (length). All working personnel shall go through the decontamination procedures before leaving the works area. In addition, the area of the shower room shall be 1 square meter with 2m headroom for every shower head provided. Warning notices shall be positioned conspicuously at the clean entrance of the decontamination unit at natural eye level height. Warning signs in both Chinese and English shall be displayed conspicuously outside the incinerator room and decontamination unit throughout the decommissioning work.

- 5.1.3 HEPA-filtered air movers shall be used continuously to exhaust the air in the enclosed works area. Openings made in the full containment to accommodate the air movers must be airtight. The minimum air moving capacity shall be six air changes per hour and the ventilation system a static negative air pressure of 1.5 – 4 mm water gauge shall be maintained inside the containment across all faces. In addition, a standby air mover shall be provided. A negative pressure monitor with an audible alarm shall be installed at the location of containment with the lowest pressure differential to monitor the static negative pressure inside the containment. The pressure monitor shall produce hard copy time record of pressure differential on a continuous basis and the records (in form of chart recording) shall be kept on site for inspection.
