**The Government of the Hong Kong Special Administrative Region  
Civil Engineering and Development Department**

**Agreement No. CE 24/2012 (GE)  
Landslip Prevention and Mitigation Programme, 2012, Package A  
Landslip Prevention and Mitigation Works -  
Investigation, Design and Construction**

**Project Profile  
for  
Landslip Prevention and Mitigation Works at  
Feature Nos. 11SW-A/R94 and 11SW-A/FR218,  
Caine Lane, Mid-Levels**

**June 2016**

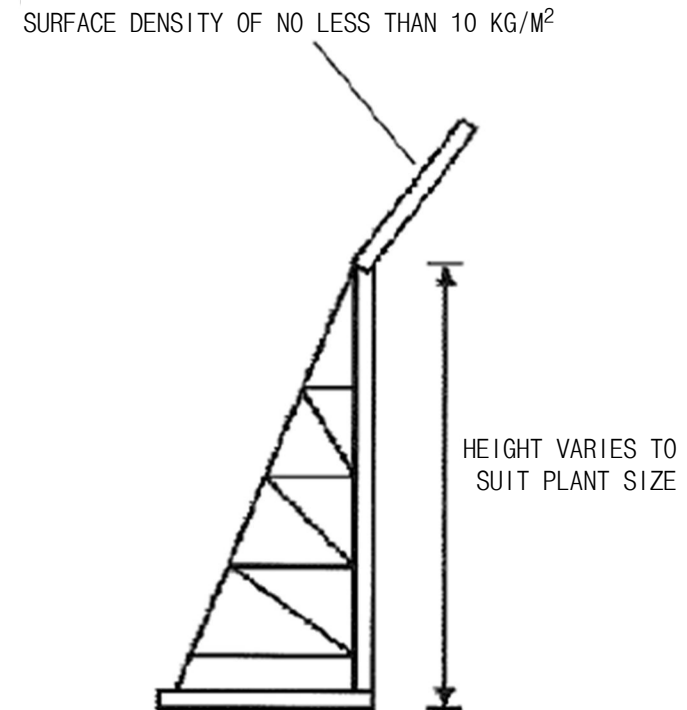
TYPICAL MOVABLE NOISE BARRIER  
~ 3 - 5 METRES TALL

5.1.2.1. Noise mitigation measures including the use of quieter PME, full enclosure and use of movable noise barrier and noise insulating fabric for certain PME are recommended for the construction activities. The use of standard enclosure with surface density no less than 10kg/m<sup>2</sup> has been considered in this assessment to shelter relatively static plant such as air compressor and generator. These enclosures can provide about 10 dB noise reduction. Movable noise barriers that can be placed close to the construction equipment and moved along with the PME are effective for screening noise from NSRs. A typical design which has been used locally is a wooden framed barrier with a cantilevered upper portion of superficial density no less than 10kg/m<sup>2</sup> on a skid footing with internal sound absorptive lining. This measure is particularly effective for low level zone of NSRs. A longer cantilevered top cover would be required to achieve screening benefits at upper floors of NSRs. The contractor shall be responsible for the design and actual position of the movable noise barriers with due consideration given to the position and size of the PME, and the requirement of intercepting the line-of-sight from the NSRs to the PME, as well as ensuring that the barriers should have no opening and gap. It is anticipated that properly designed noise barriers can achieve a 5 dB(A) reduction for mobile PME and a 10 dB(A) reduction for static PME. Considering that the Project site would be close to the NSRs, only 5 dB(A) reduction was assumed for both mobile and static PME in this assessment as a conservative approach. Noise insulating fabric is proposed for drill rig and a noise reduction of 10 dB(A) is expected. The indicative designs of the enclosure and noise barrier are shown in **Appendix C**.

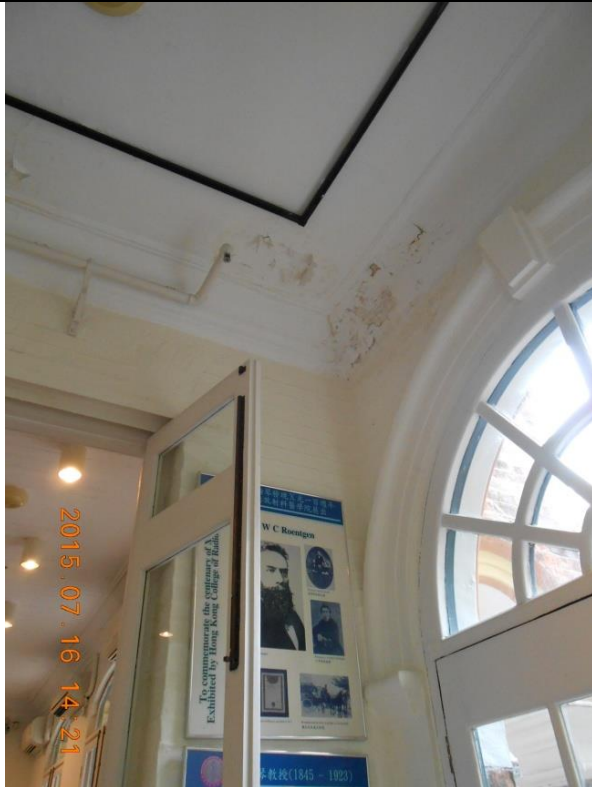
1) Cracks on the ceiling on the first floor

- 3.6.1.3. No visible crack or damage was seen on the exterior of the Main Building but minor cracks were found on floor tiles, ceiling and walls inside the Main Building during recent site inspection (See **Appendix D**).

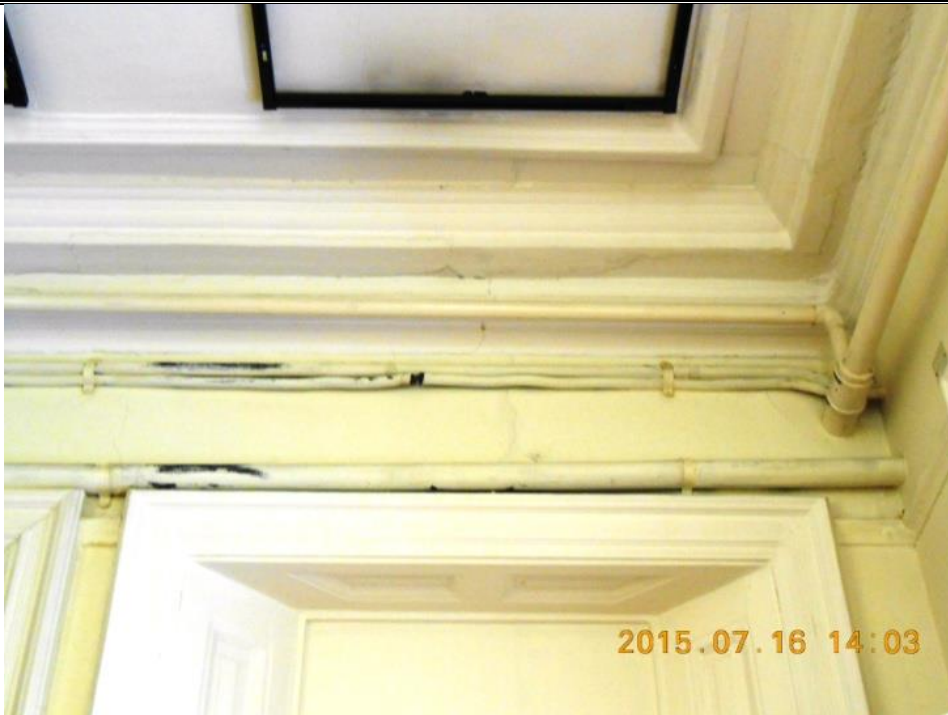
3) Cracks on wall above the door on the ground floor

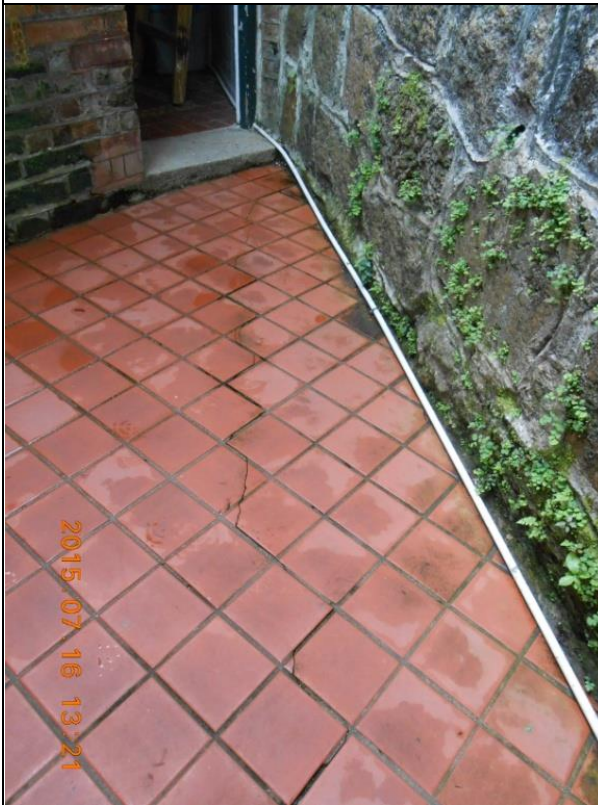
1) Settlement cracks in front of the eastern corner of the area enclosed by the Annex Block and Feature No. 11SW-A/R94

- 3.6.1.4. Minor building and fence walls cracks and small settlement cracks were observed in the eastern side of the Annex Block and the areas enclosed by Feature No. 11SW-A/R94 and the Annex Block (See **Appendix D**).

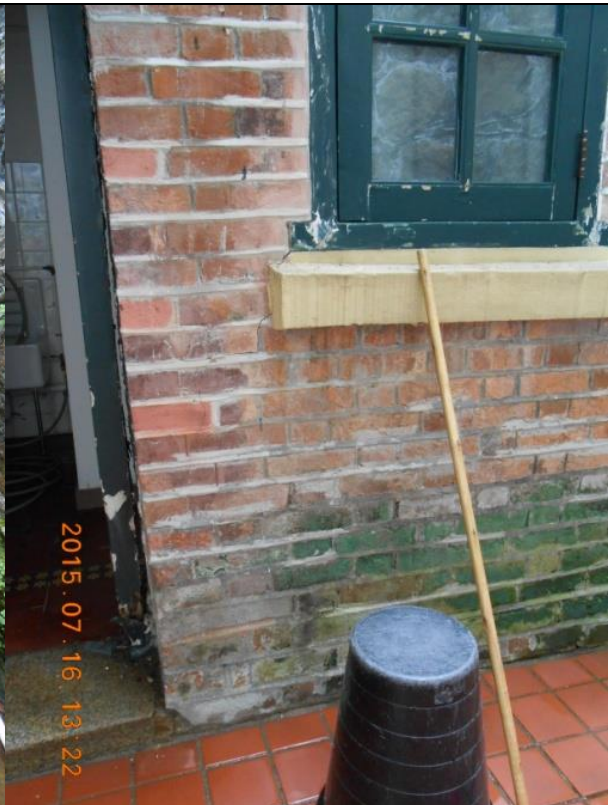
2) Cracks on the external brick wall of the Annex Block

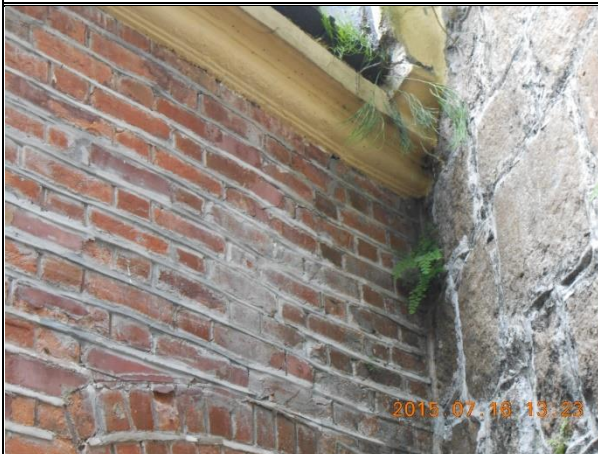
3) Wall cracks on the Annex Block adjacent to Feature No. 11SW-A/R94

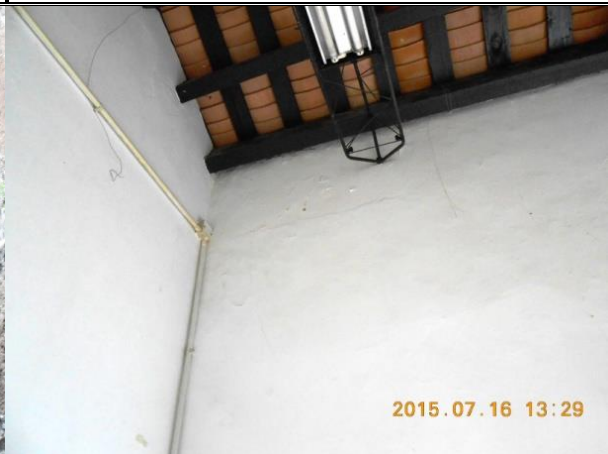
4) Cracks on the ceiling inside the Annex Block

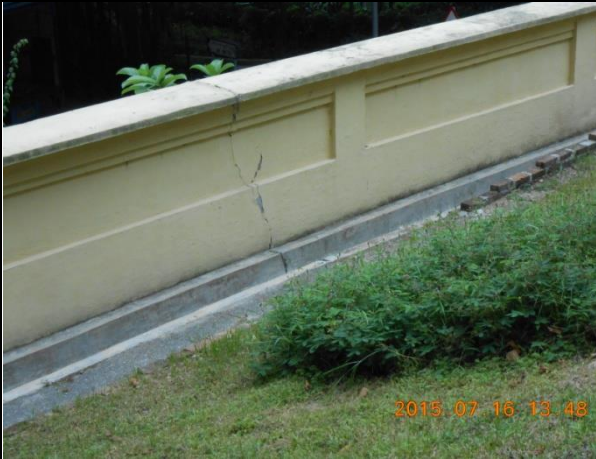
1) Crack on the fence wall next to Feature No. 11SW-A/R218, south to the lawn of the Main Building of the Hong Kong Museum of Medical Sciences

- 3.6.1.5. Minor cracks were observed on the fence wall of Feature No. 11SW-A/FR218 south to the lawn behind the Main Building. The upper compartment of the western stone gate post was observed to be slightly dislocated from its original location while the edge of the upper compartment of the eastern stone gate post was slightly damaged or eroded (See **Appendix D**).

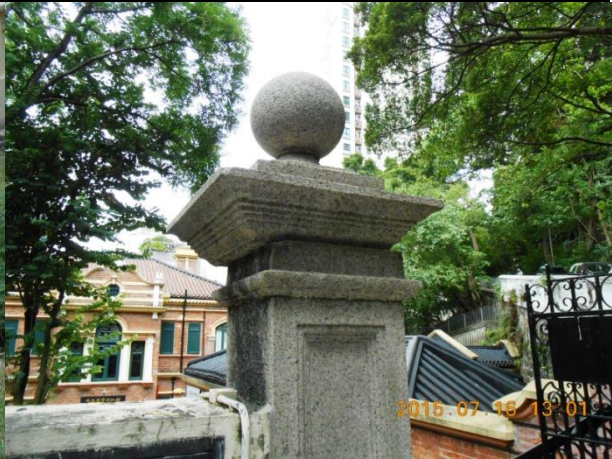
2) Dislocated upper compartment of the western gate post by Caine Lane

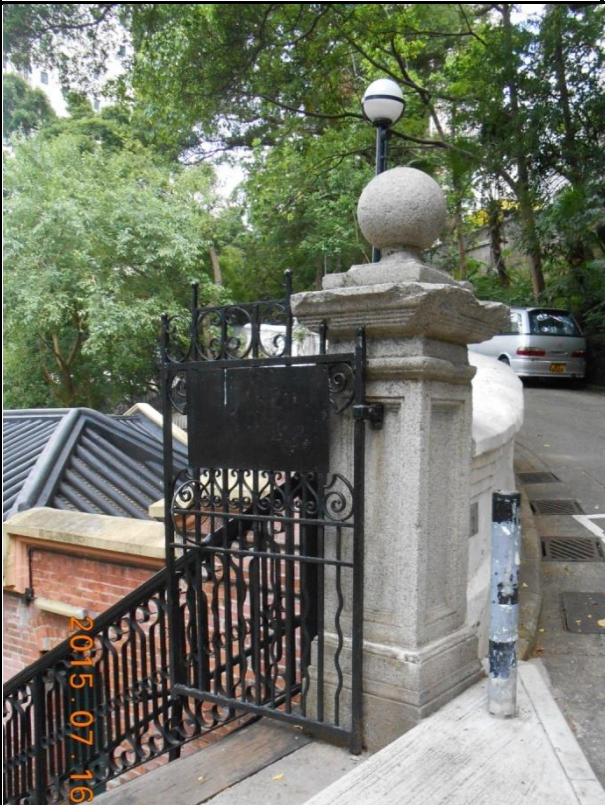
3) Eroded/damaged upper compartment of the eastern gate post by Caine Lane
