**Slope Upgrading Works of Feature No. 12NW-C/C8
Above Ha Yeung and Leung Fai Tin Along Clear Water Bay Road, Sai Kung**

Project Profile

Fugro (Hong Kong) Limited

May 2018

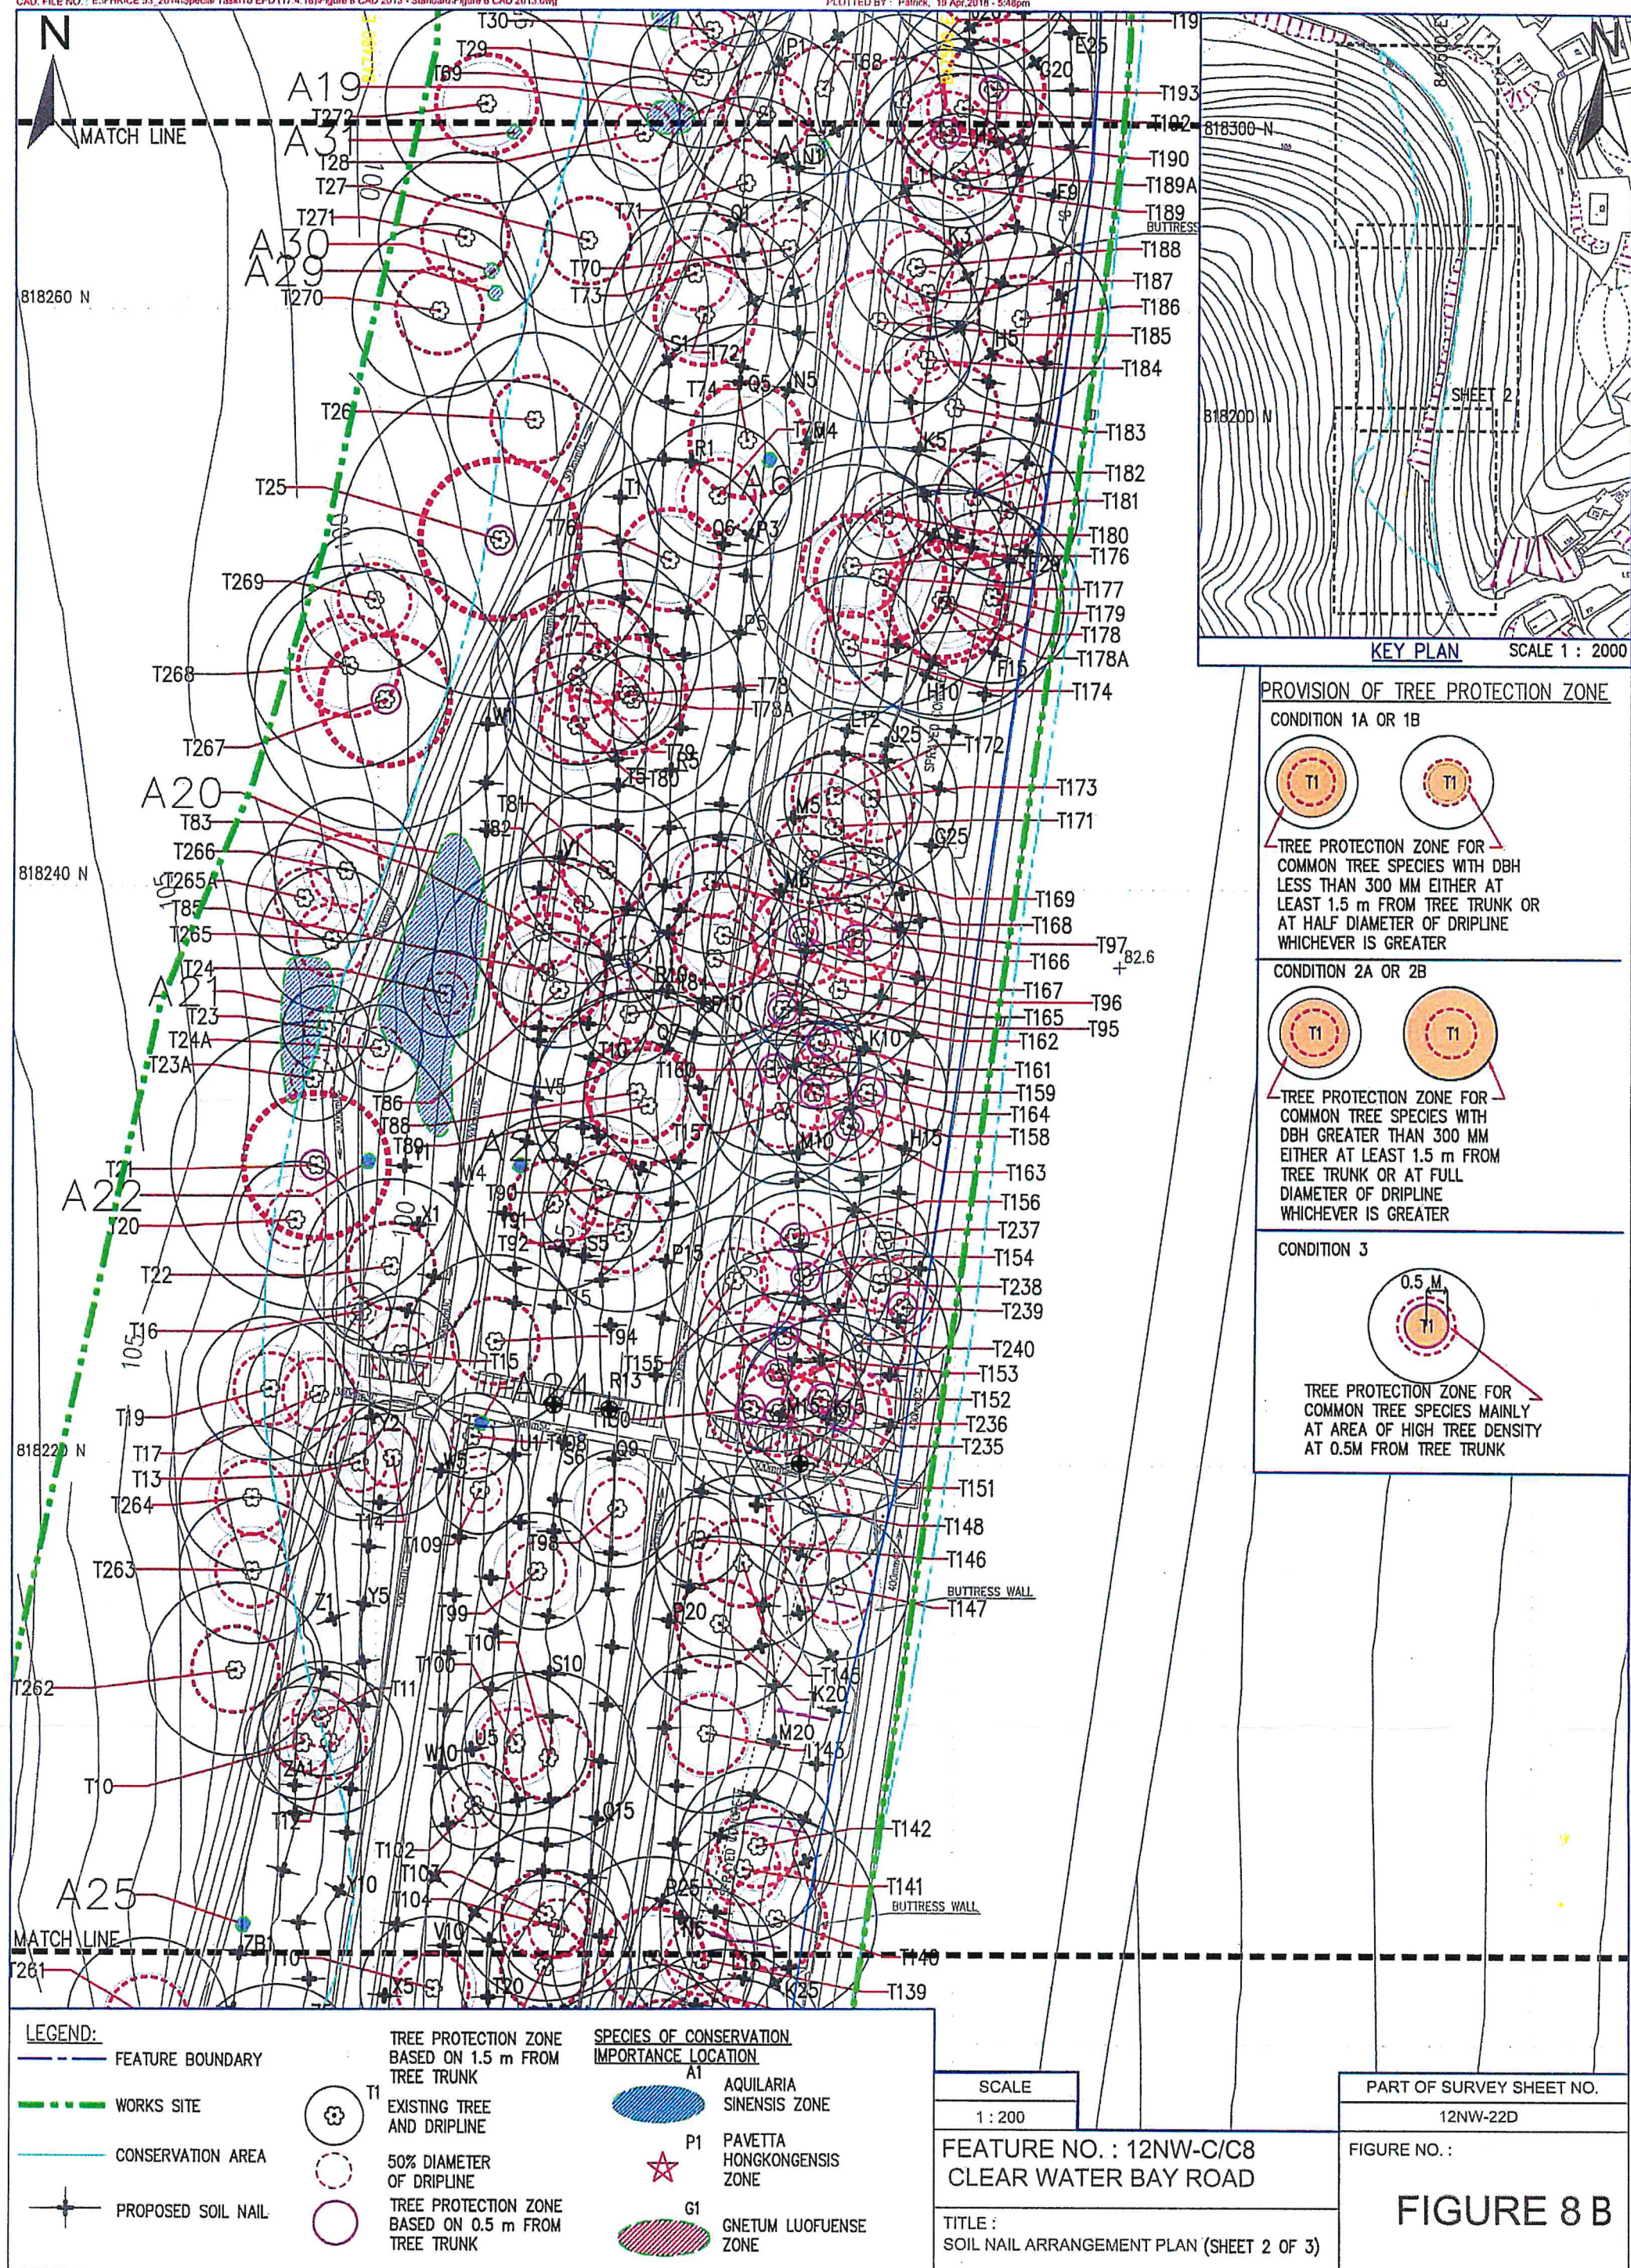
- FEATURE BOUNDARY
- WORKS SITE
- CONSERVATION AREA
- PROPOSED SOIL NAIL

To avoid potential damage on existing trees, if the proposed soil nails are inevitably verified on site as falling within the TPZ, the proposed drill holes shall be adjusted onsite to avoid disturbance to any roots, in particular, the anchoring roots. Such onsite adjustment of drill holes disposition, if found necessary, shall be supervised by a competent person (such as qualified arborist) and timely liaison with the Engineer. Nevertheless, the onsite adjustment of drill holes disposition would be carried out in accordance with specifications on Preservation and Protection of Trees in the General Specification (GS) for Civil Engineering Works and Particular Specification (PS) of Contract No. GE/2016/01. It is a common practice that soil nail drill holes will be located in a way that the structures to be placed into the drill holes, including the surface elements of the structures such as soil nail heads, are at a minimum distance of 500mm from the trunks of common species (see GS Cl. 26.12(1)(a)). The proposed soil nail arrangement with the incorporation of TPZ is shown in **Figures 8A, 8B and 8C**.

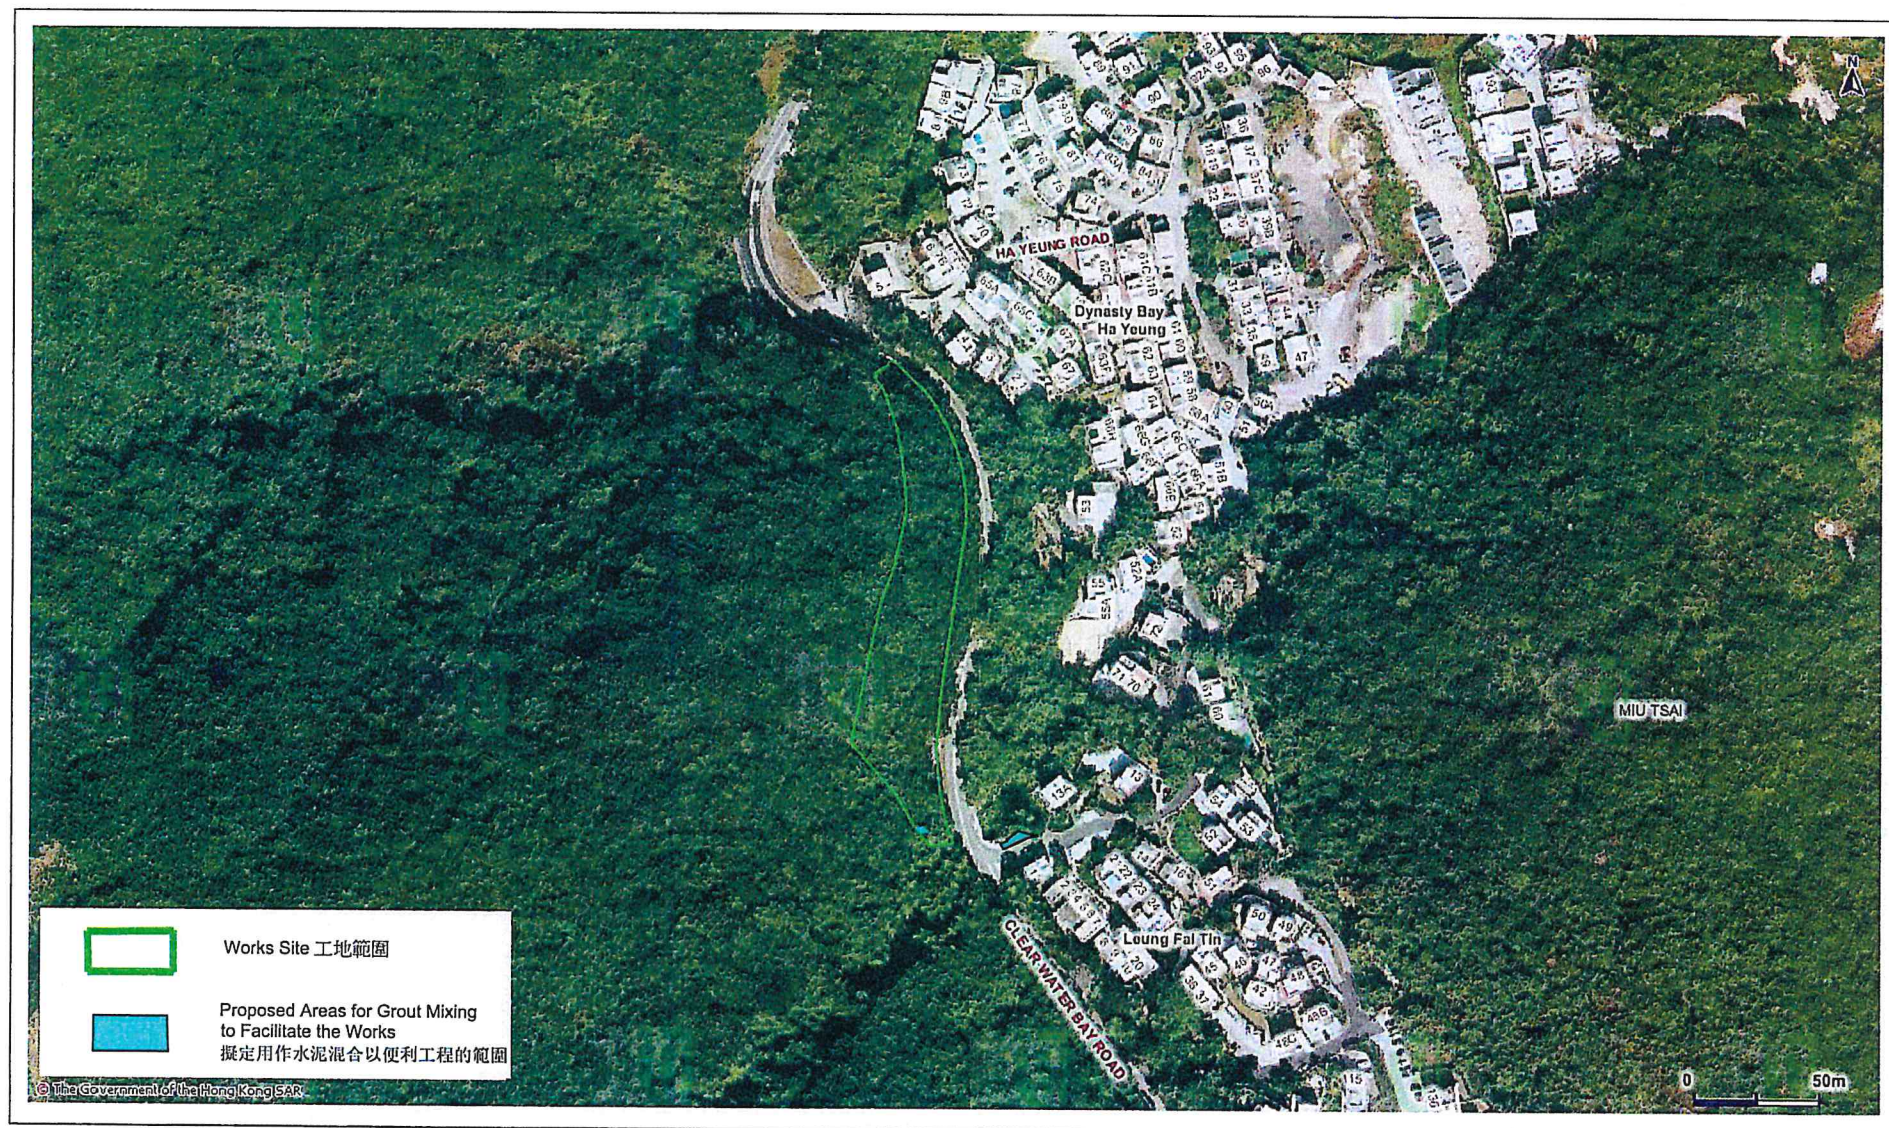
Plate 1 Overview of the Surrounding Environment of the Project

The Works Site is located at Clear Water Bay Road above Ha Yeung and Leung Fai Tin. Two proposed areas for grout mixing, one located at the southern tip of the Feature No. 12NW-C/C8 while the other near the junction of Clear Water Bay Road and Leung Fai Tin Upper Road to avoid encroachment to an existing stream course. The location of the proposed slope upgrading works is shown in **Figure 1**. Overview of the surrounding environment of the Project is shown in **Plate 1**.

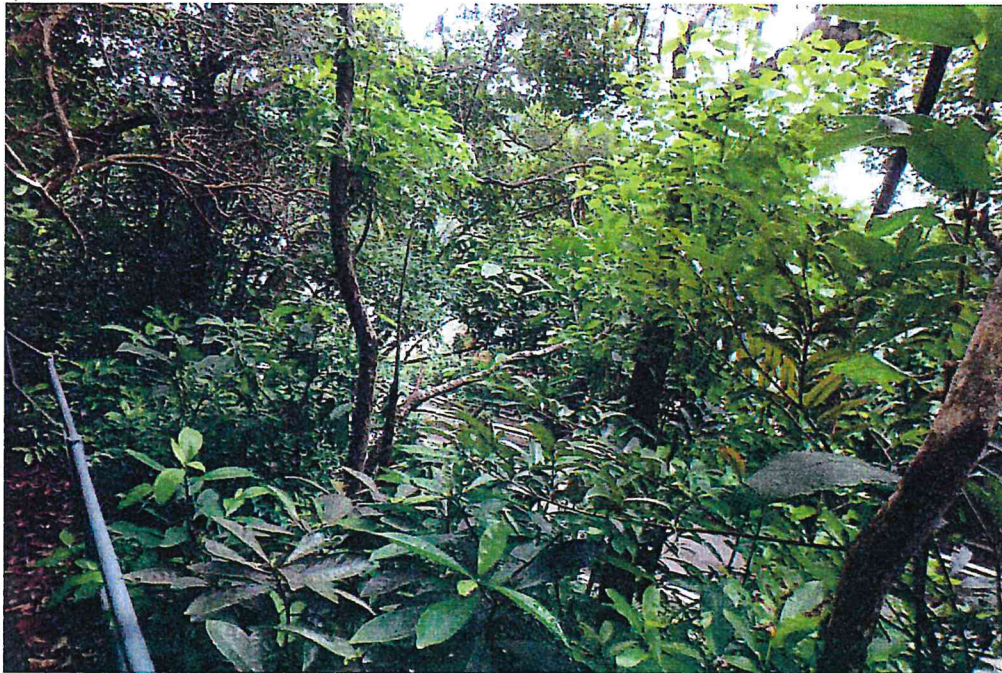
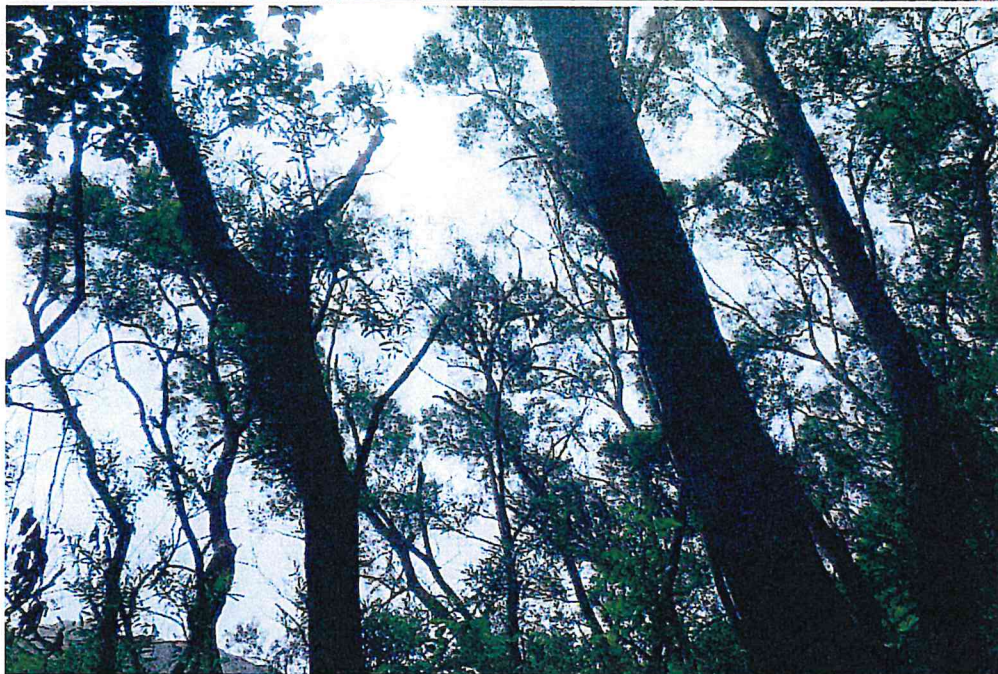
Plate 2 Representative Photographs of Habitats. Secondary forest (above) and exotic plantation of *Acacia confusa* (台灣相思).

Desktop Study shows the Proposed Works Site locates at the edge of continuous woodland. Field survey conducted on 14th August and 3rd November 2016 verified the habitat contained a secondary forest at western part with plantation of exotic tree species *Acacia confusa* (台灣相思) near the road at the east (**Figures 4A and 4B; Plate 2**). Dominated native tree species includes *Alangium chinense* (八角楓) and *Machilus chekiangensis* (浙江潤楠), with the understory occupied by some dominant local shrub and herbaceous species, e.g. *Desmos chinensis* (假鷹爪), *Maes aperlarius* (鯽魚膽) and *Psychotri asiatica* (山大刀). The canopy cover of the woodland is moderately dense in general. The height of the forest is ranged from 5m to 10m. No stream was identified in the proposed Works Site while a stream course is located about 2m outside the southern tip of the Works Site, the works boundary is mainly cut off by parallel concrete ditches.

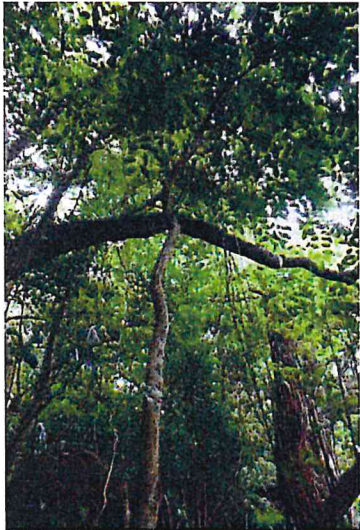
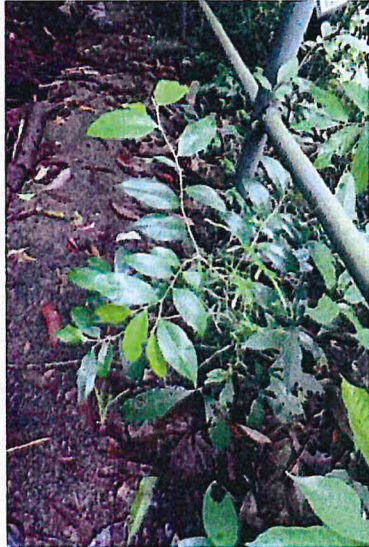
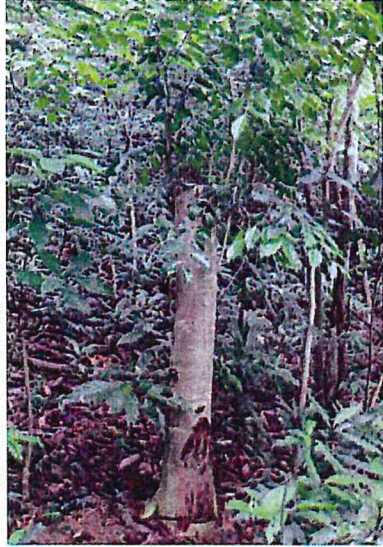
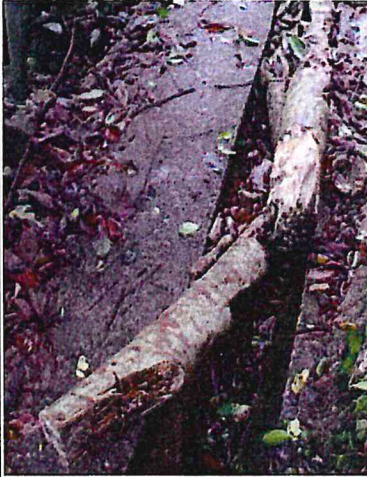
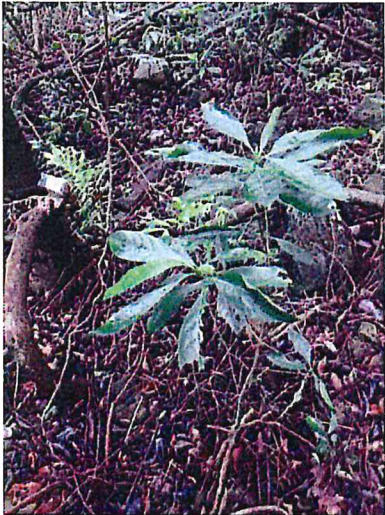
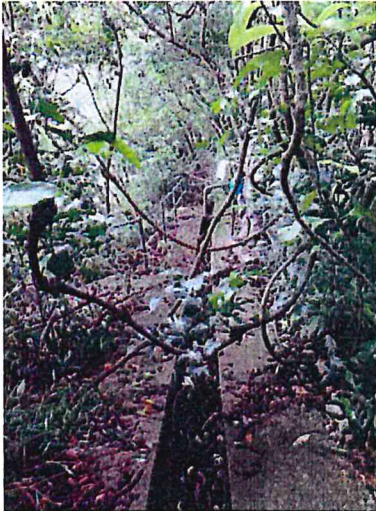
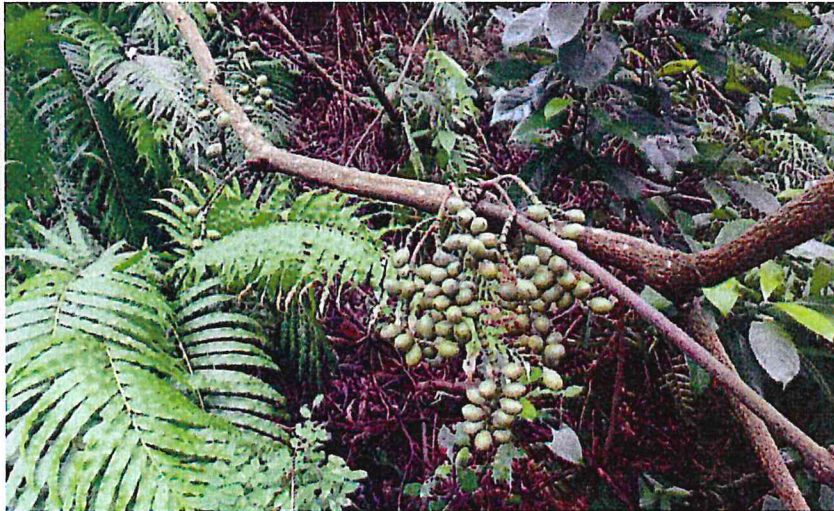
Plate 3 Representative Photographs of Plant Species of Conservation Importance Recorded in the Southern Portion of Proposed Works Area 12NW-C/C8.

First row left to right: *Aquilaria sinensis* (土沉香) seedlings, sapling near the ditch, trunk of adult tree being topped, fallen log observed in ditch.

Second row left to right: *Pavetta hongkongensis* (香港大沙葉), climbing vines of *Gnetum luofuense* (羅浮買麻藤), fruits of *Gnetum luofuense* (羅浮買麻藤).

In terms of both healthiness and form (refer to **Appendix B**), all saplings were generally in good to fair condition. Tree group A32 at the northern tip near T275 and T276, as well as the mature T38, were in fair to poor health and form. Three of their trunks have been topped while the other three were also harvested or damaged (**Plate 3**).

Two saplings and one seedling of *Pavetta hongkongensis* (香港大沙葉) were recorded within the Proposed Works Site (**Figures 4A and 4B; Plate 3**). All of them located outside the soil nailing area behind the concrete ditch. This species is protected by the Forestry Regulations under the Forests and Countryside Ordinance (Cap 96).

Two patches of *Gnetum luofuense* (羅浮買麻藤), a climbing gymnosperm, were recorded in the southwestern part of the Proposed Works Site. This climber grows up in tree canopy with hanging vine network above ground level. The growing point is difficult to be traced under woodland but usually in area with more vines in larger diameter (**Figures 4A and 4B; Plate 3**).

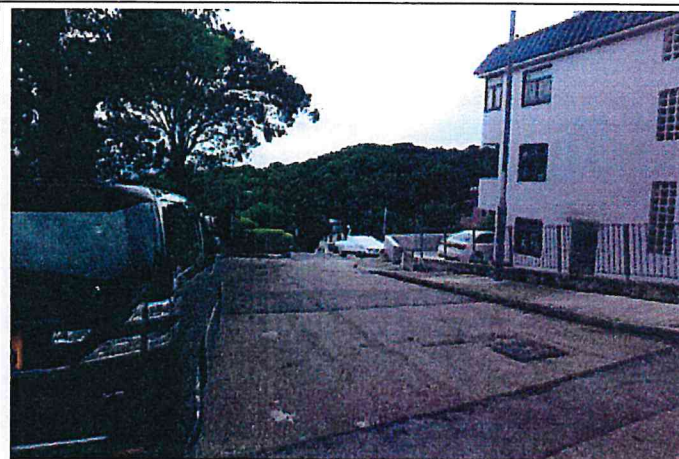
Hillside Woodland (LR1); Hillside Landscape (LCA1)

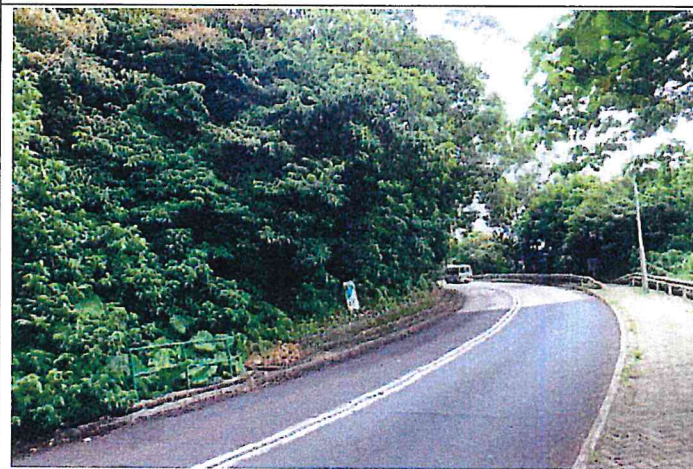
Village Development Area (LR2); Urban Fringe Village Landscape (LCA2)

Major Transportation Corridor (LR3); Transportation Corridor Landscape (LCA3)

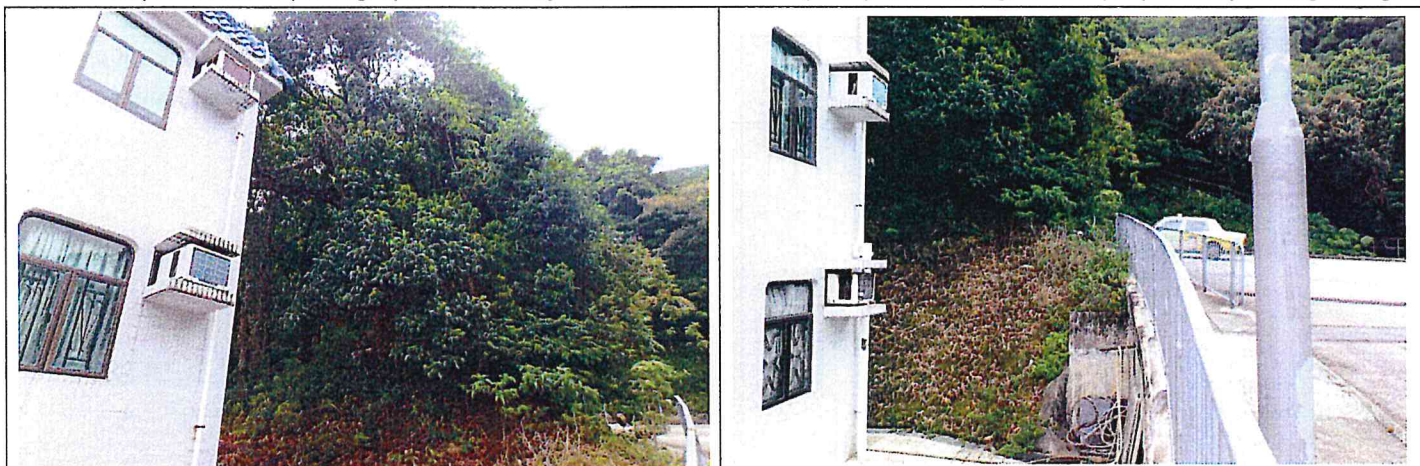
VP1: View of the second and third floor is blocked by green belt of trees between the house and the Proposed Works Site. First floor located at lower elevation than the Clear Water Bay Road and can hardly view the Proposed Works Site

The first VSR are identified as the localized residents of Ha Yeung and Leung Fai Tin, with one block close to the junction of Clear Water Bay and Ha Yeung Road, and the other two blocks near the junction of Leung Fai Tin Upper Road adjoining Clear Water Bay Road (VSR1); the second VSR is identified as the highly mobile travellers along these road sections (VSR2). Residents in other blocks further away from the two road junctions are at lower elevation. With further screening by the existing woodland in between the separation distance, these residents would hardly experience a glimpsed view towards the Works Site. Location and visual area of each VSR, and locations of Vantage Point (VP) are mapped on **Figures 5A and 5B**. Corresponding photographs are shown in **Plate 5**.

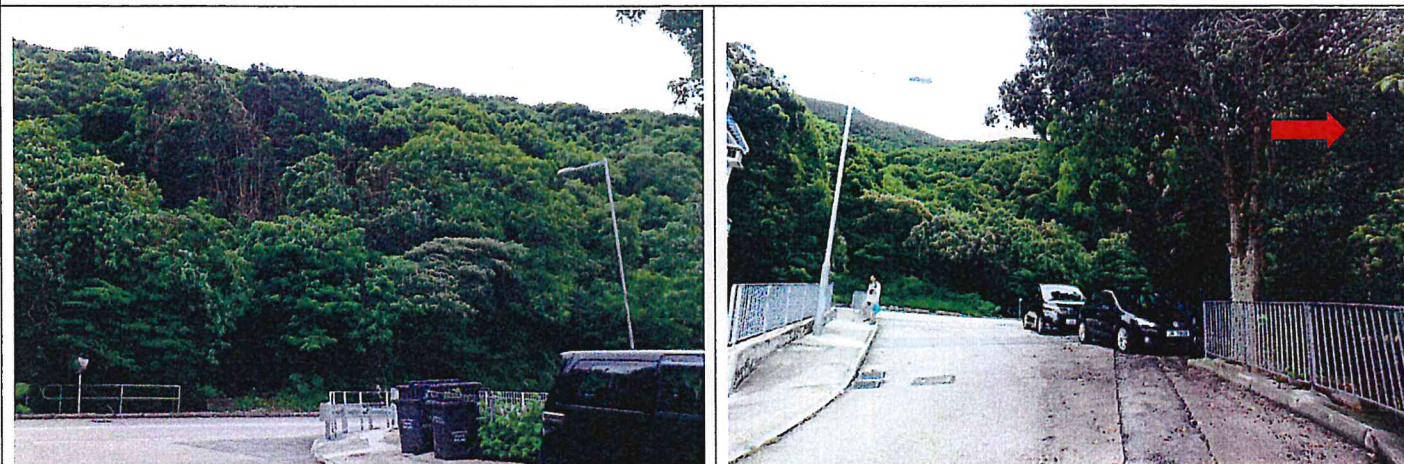
VP2: Road junction of Leung Fai Tin Upper Road and Clear Water Bay Road

VP3: Further down of VP2 at a lower elevation of Clear Water Bay Road. Red arrow will be used for the next photo

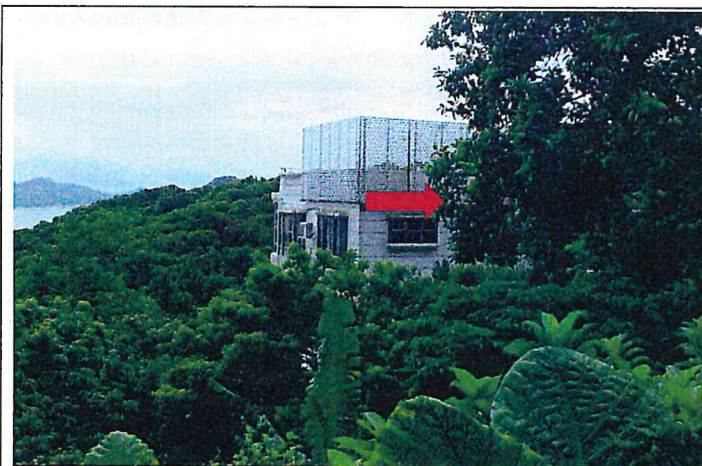
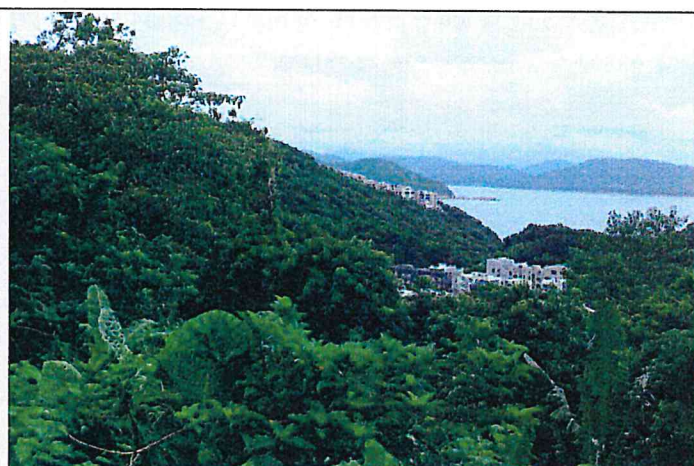
Another block opposite to VP1: View of the third floor is largely blocked by green belt of trees between the house and the Proposed Works Site (left). Red arrow denotes the same patch of woodland of the previous photo. Other village houses at Leung Fai Tin locate further down below embedded by the green belt (right)

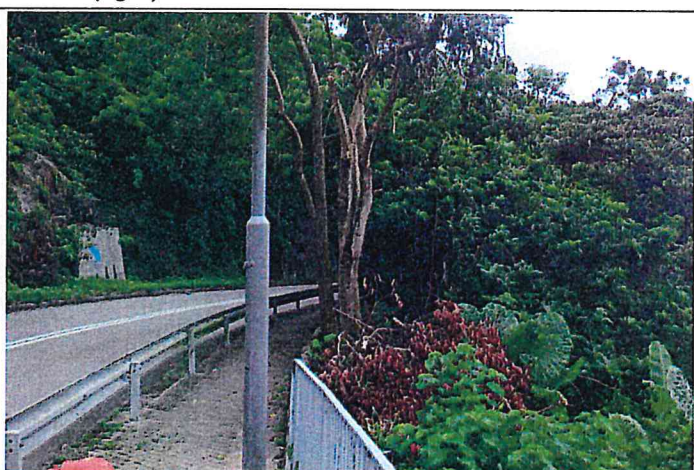
VP5: View of the Proposed Works Site is confined by the curve of Clear Water Bay Road (southern end)

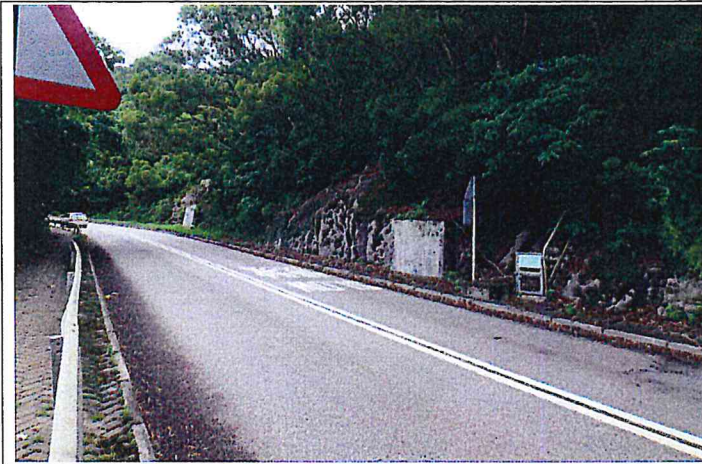
VP6: Road opposite to the middle section of the Proposed Works Site

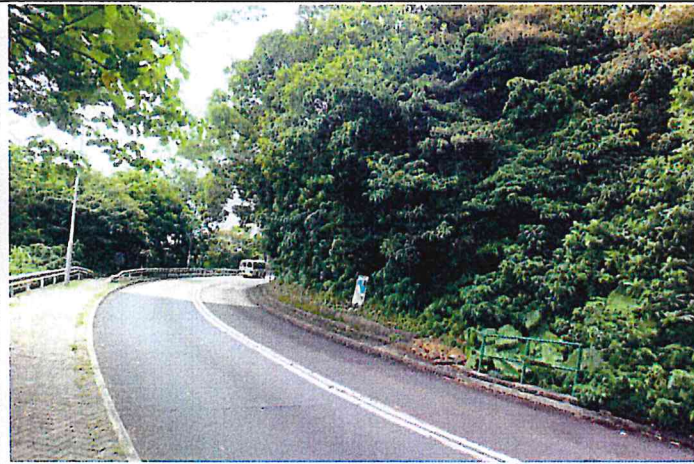
VP7: View of the Proposed Works Site is confined by the curve of Clear Water Bay Road (northern end)

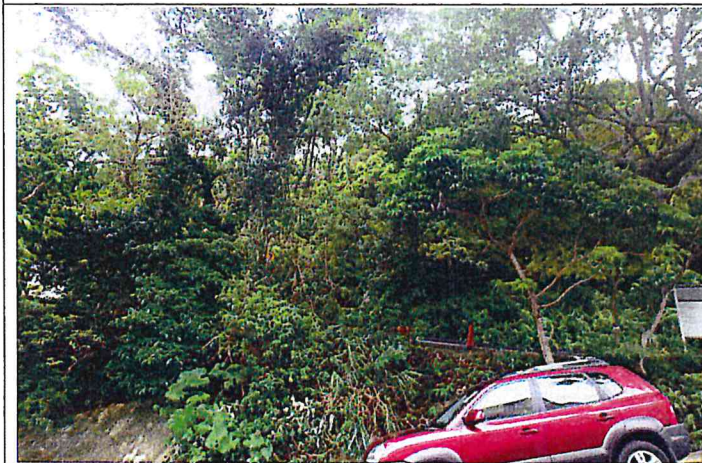
VP8: View from VSR1 at Ha Yeung Road is largely blocked by the woodland in green belt.

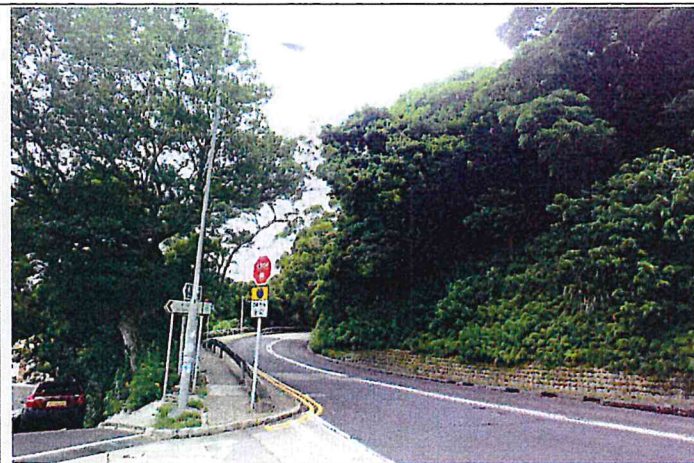
Northern tip of Proposed Works Site is actually not visible at road junction of Ha Yeung Road and Clear Water Bay Road.

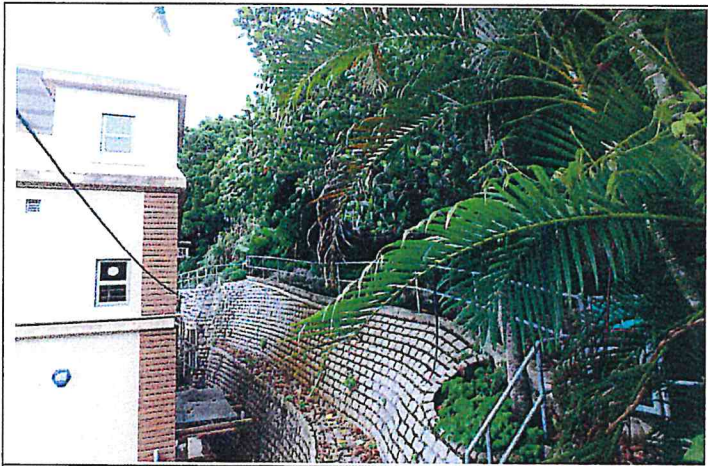
Despite opposite to the northern tip of the Proposed Works Site, this residential block locates at lower elevation of Clear Water Bay Road and falls outside the Zone of Visual Influence (ZVI). Moreover, its view to the Work Site is totally blocked by the woodland of green belt.
