## **8.0 ECOLOGY**

8.1.1 This section comprises of the ecological assessment of the EIA. The broad objectives of the ecological study are as follows:

## **8.4 Initial Ecological Survey**

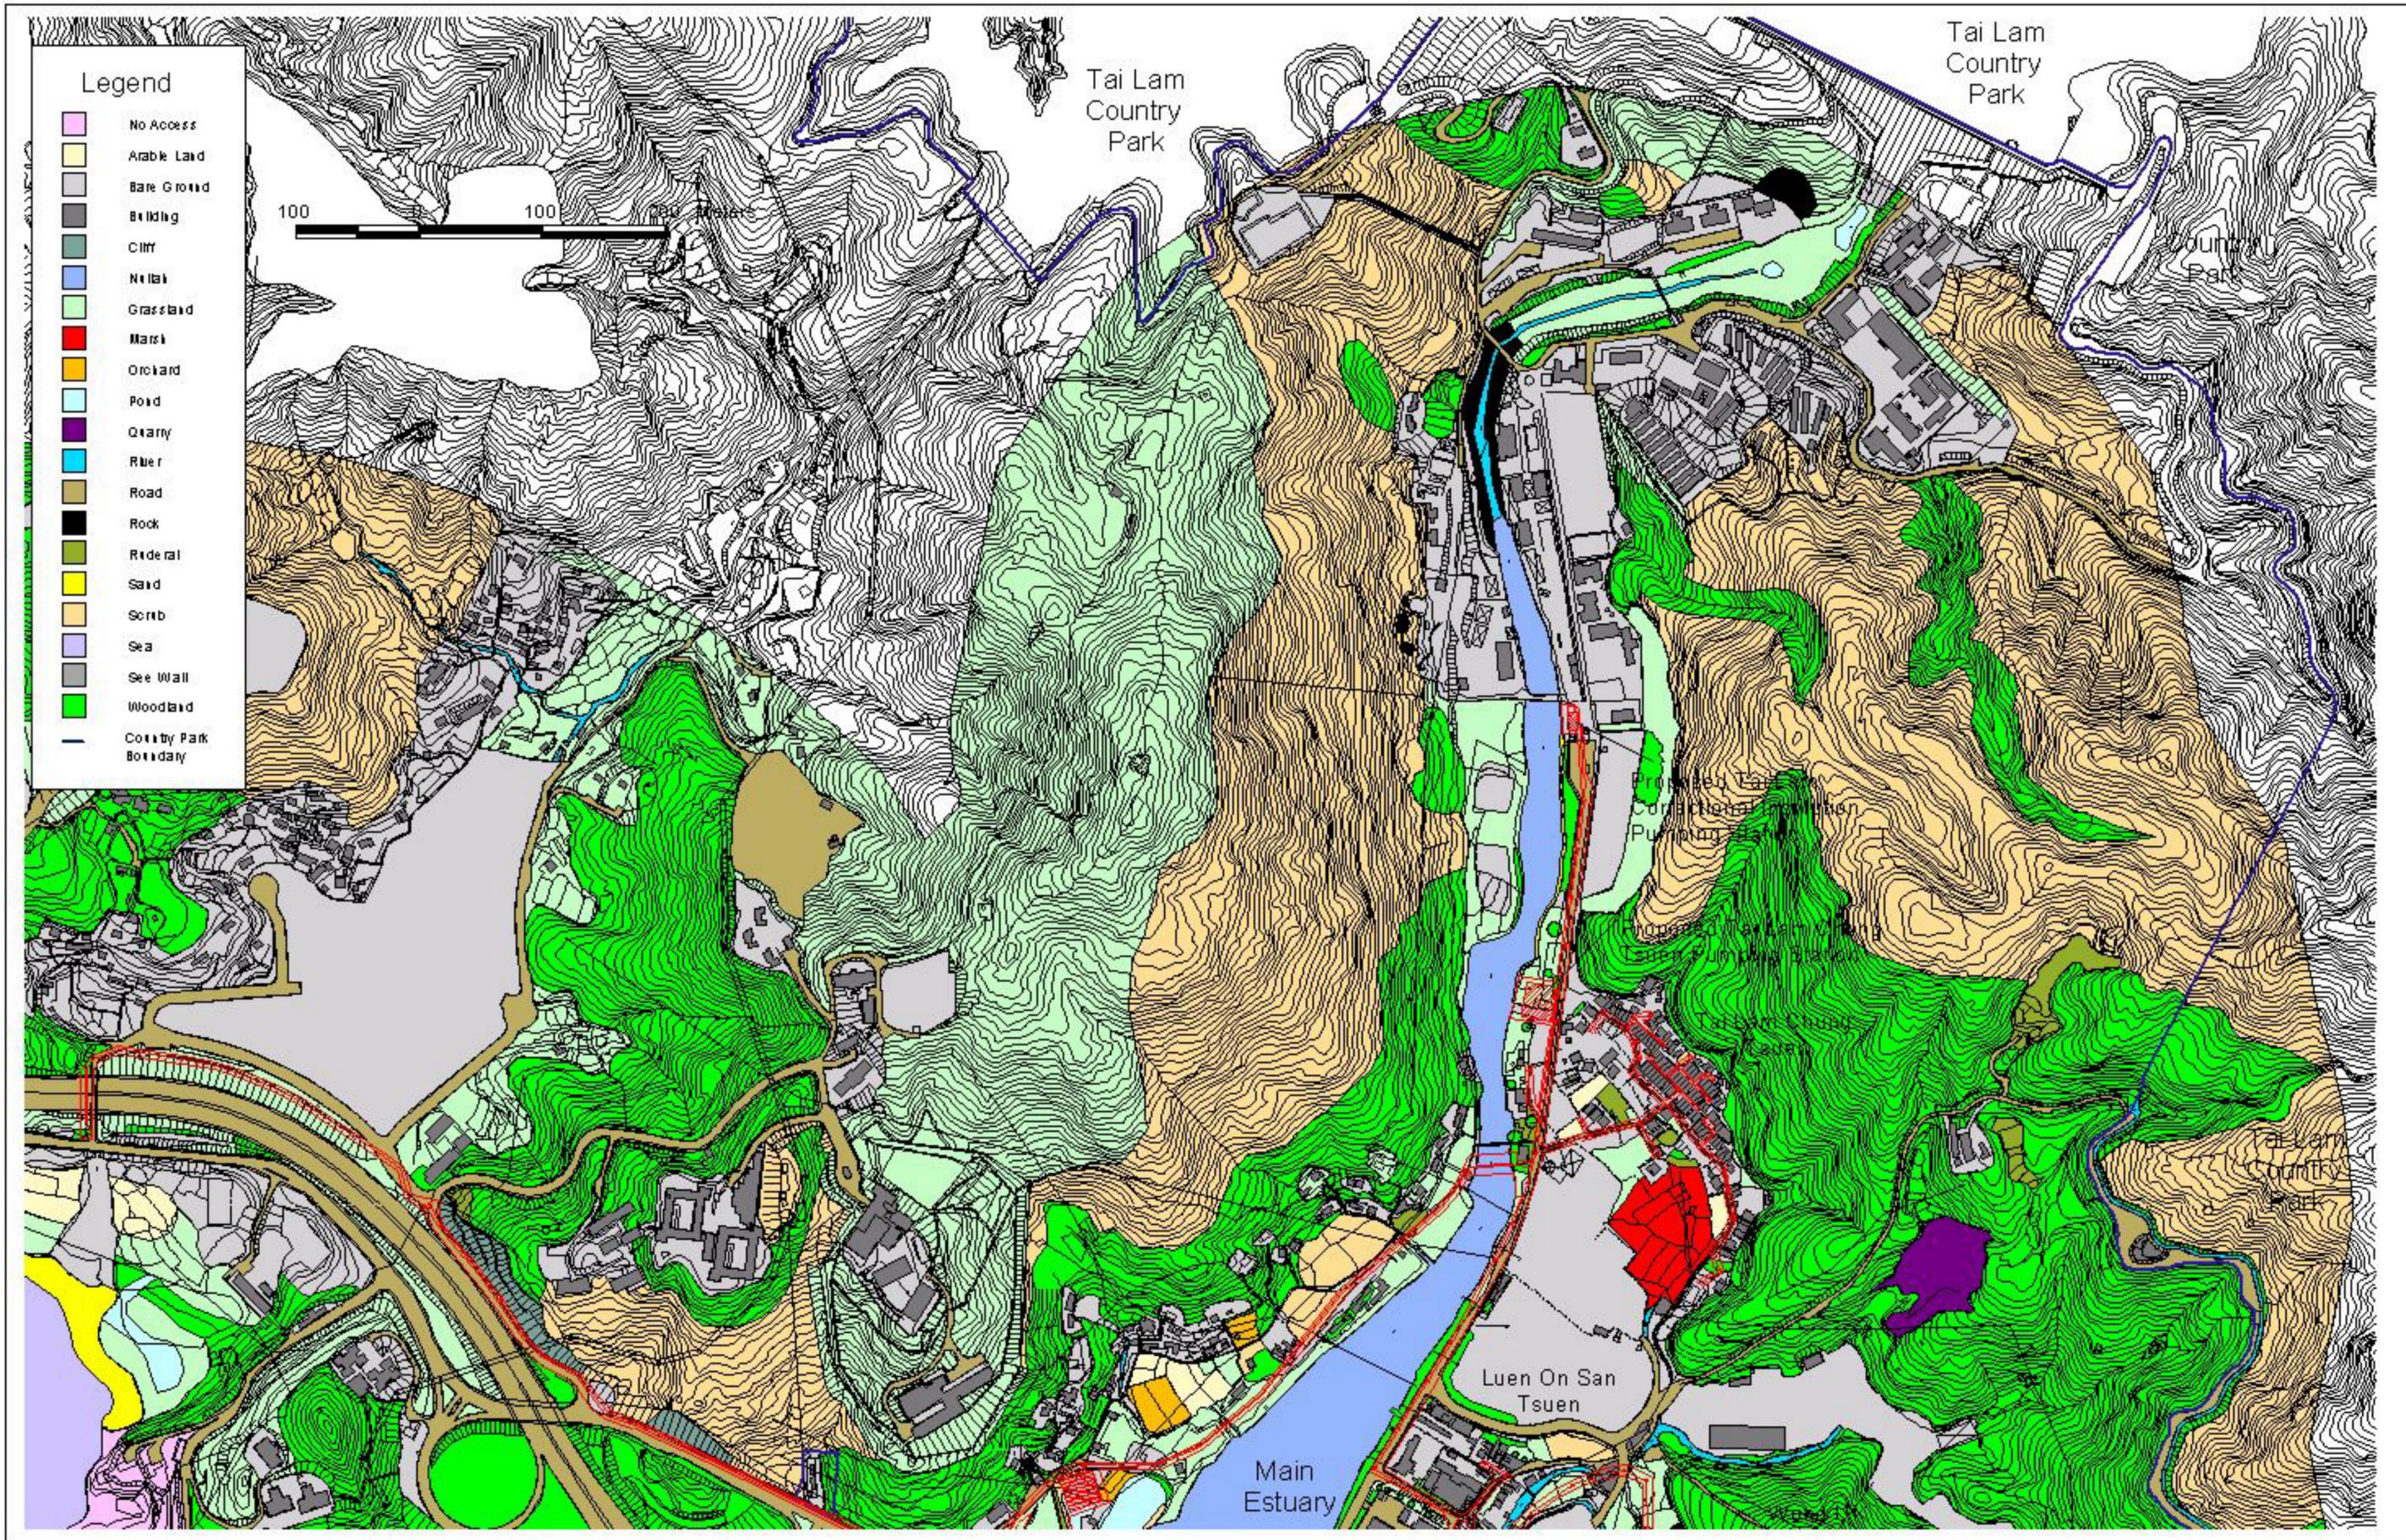
Drawing No. 8.1

**Ecological Habitat Map of Tai Lam Chung ( 1 of 3)**

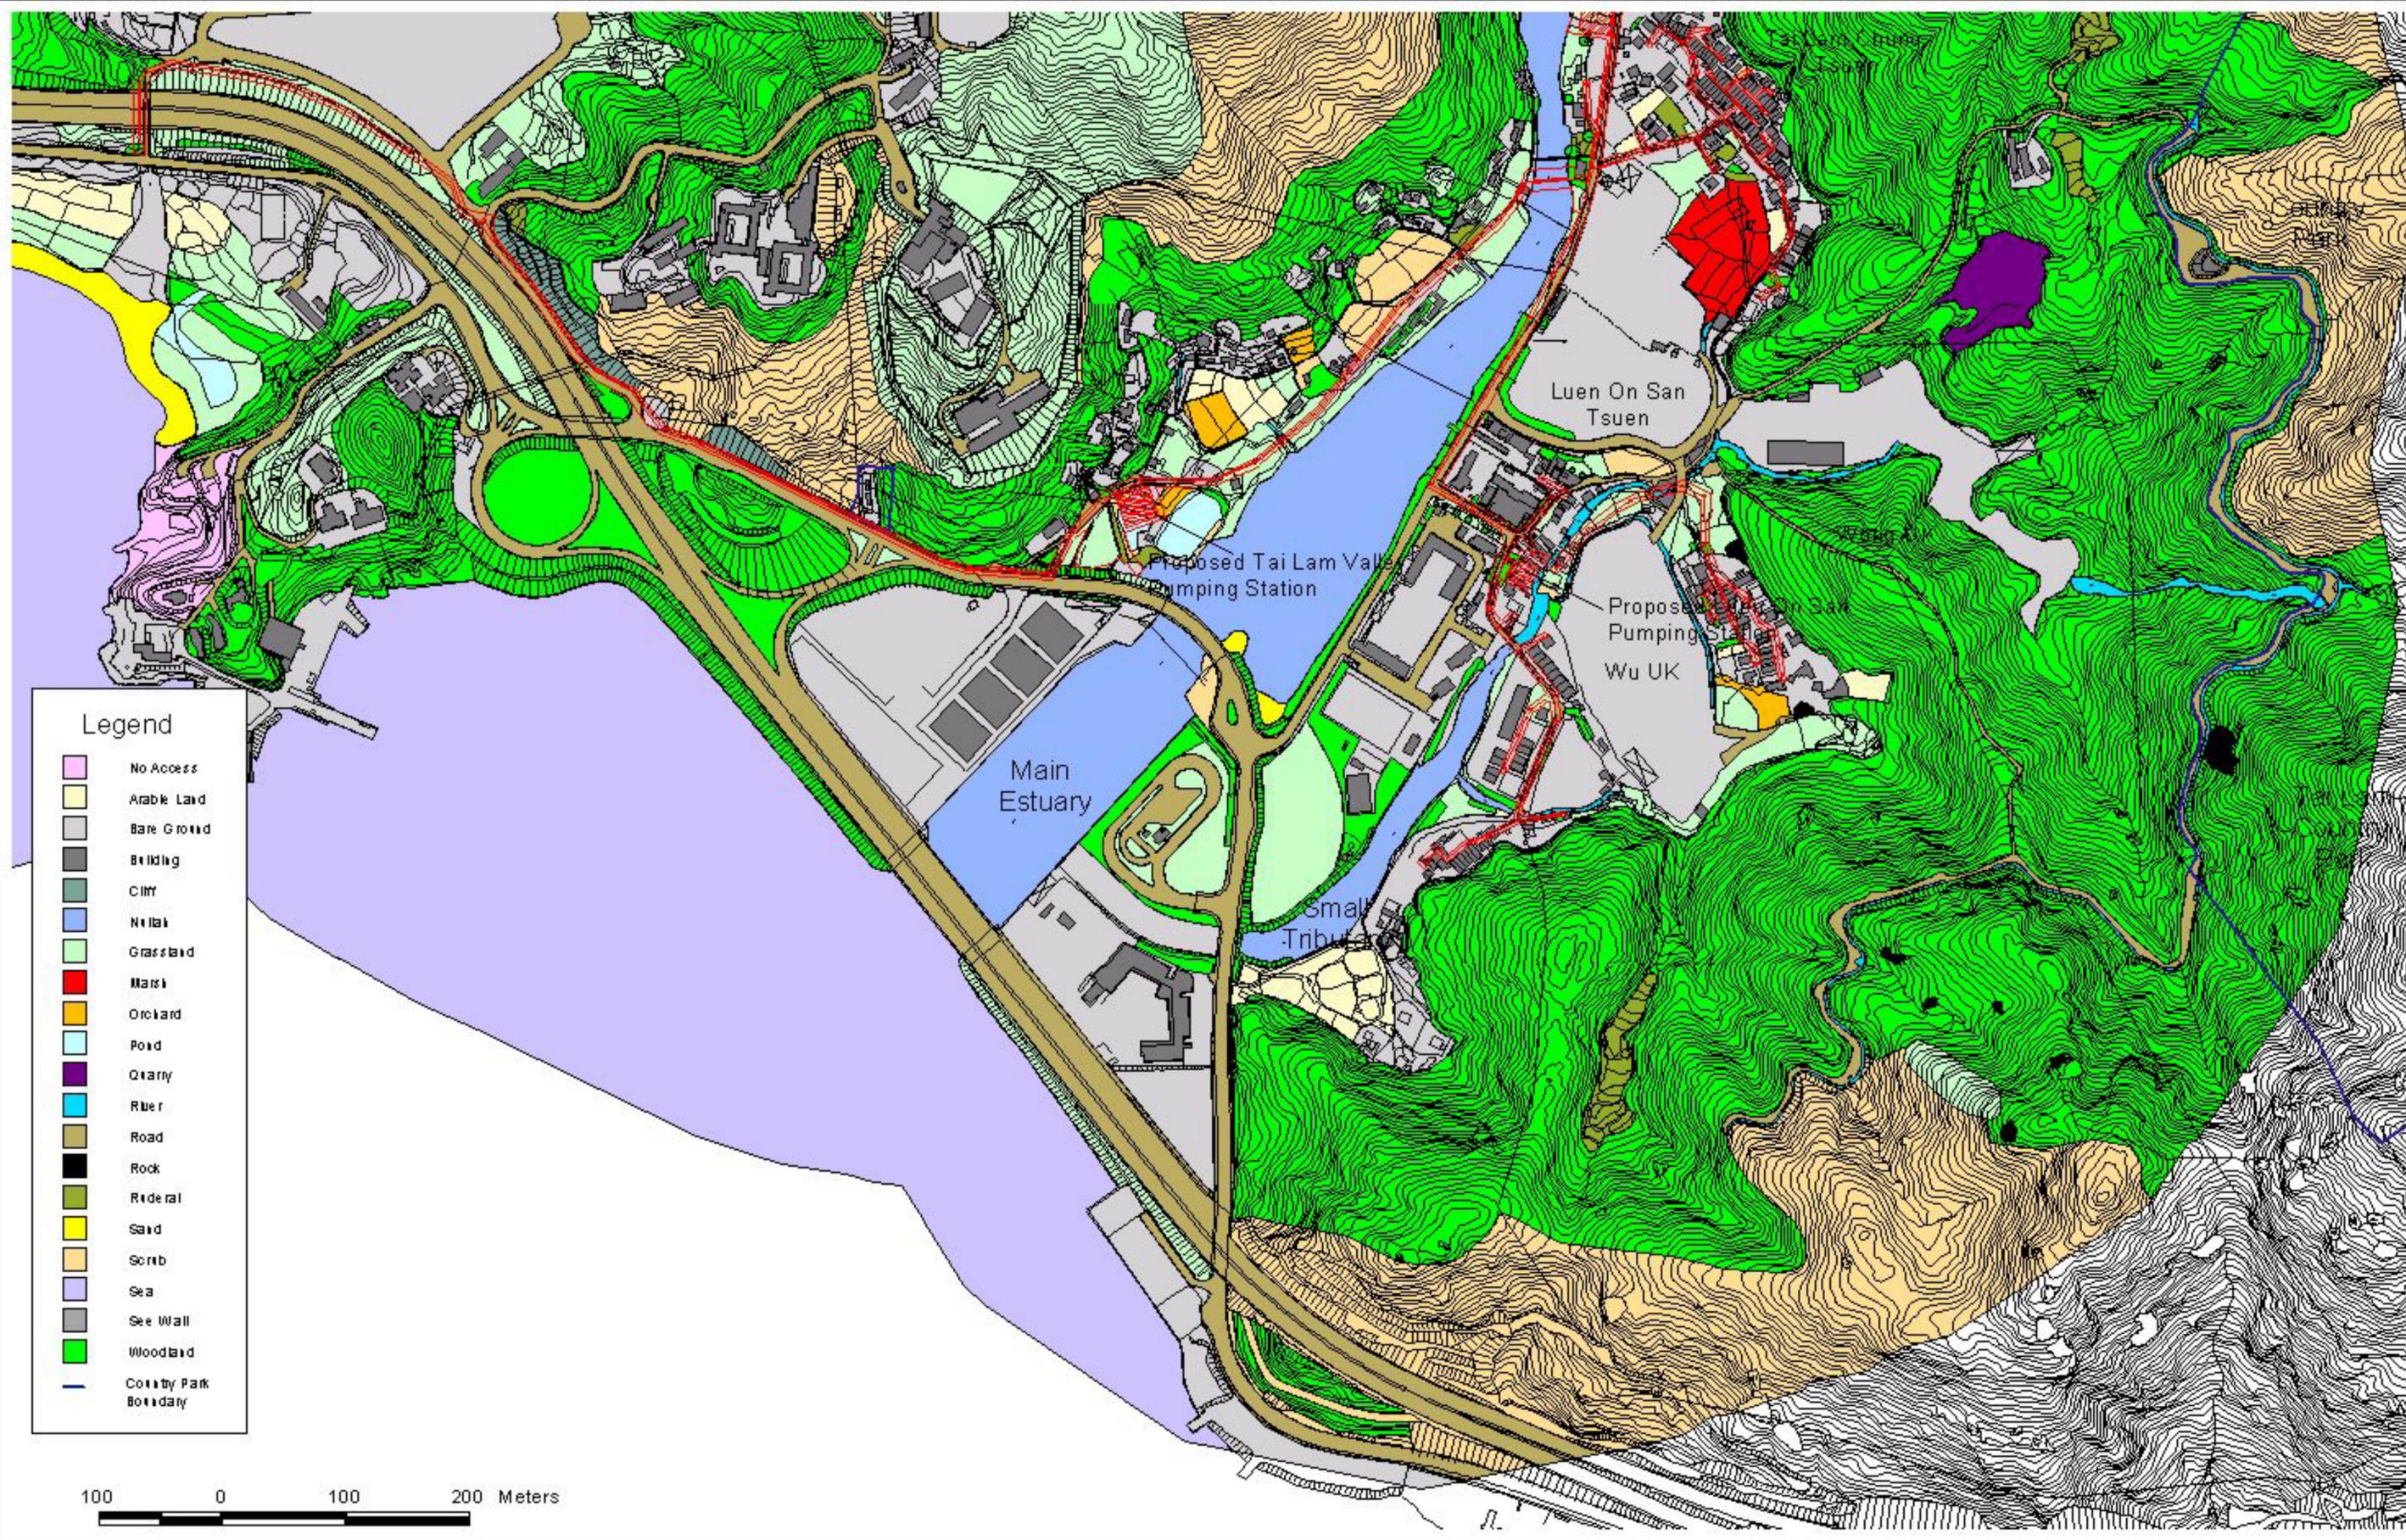
Drawing No. 8.2

**Ecological Habitat Map of Tai Lam Chung ( 2 of 3)**

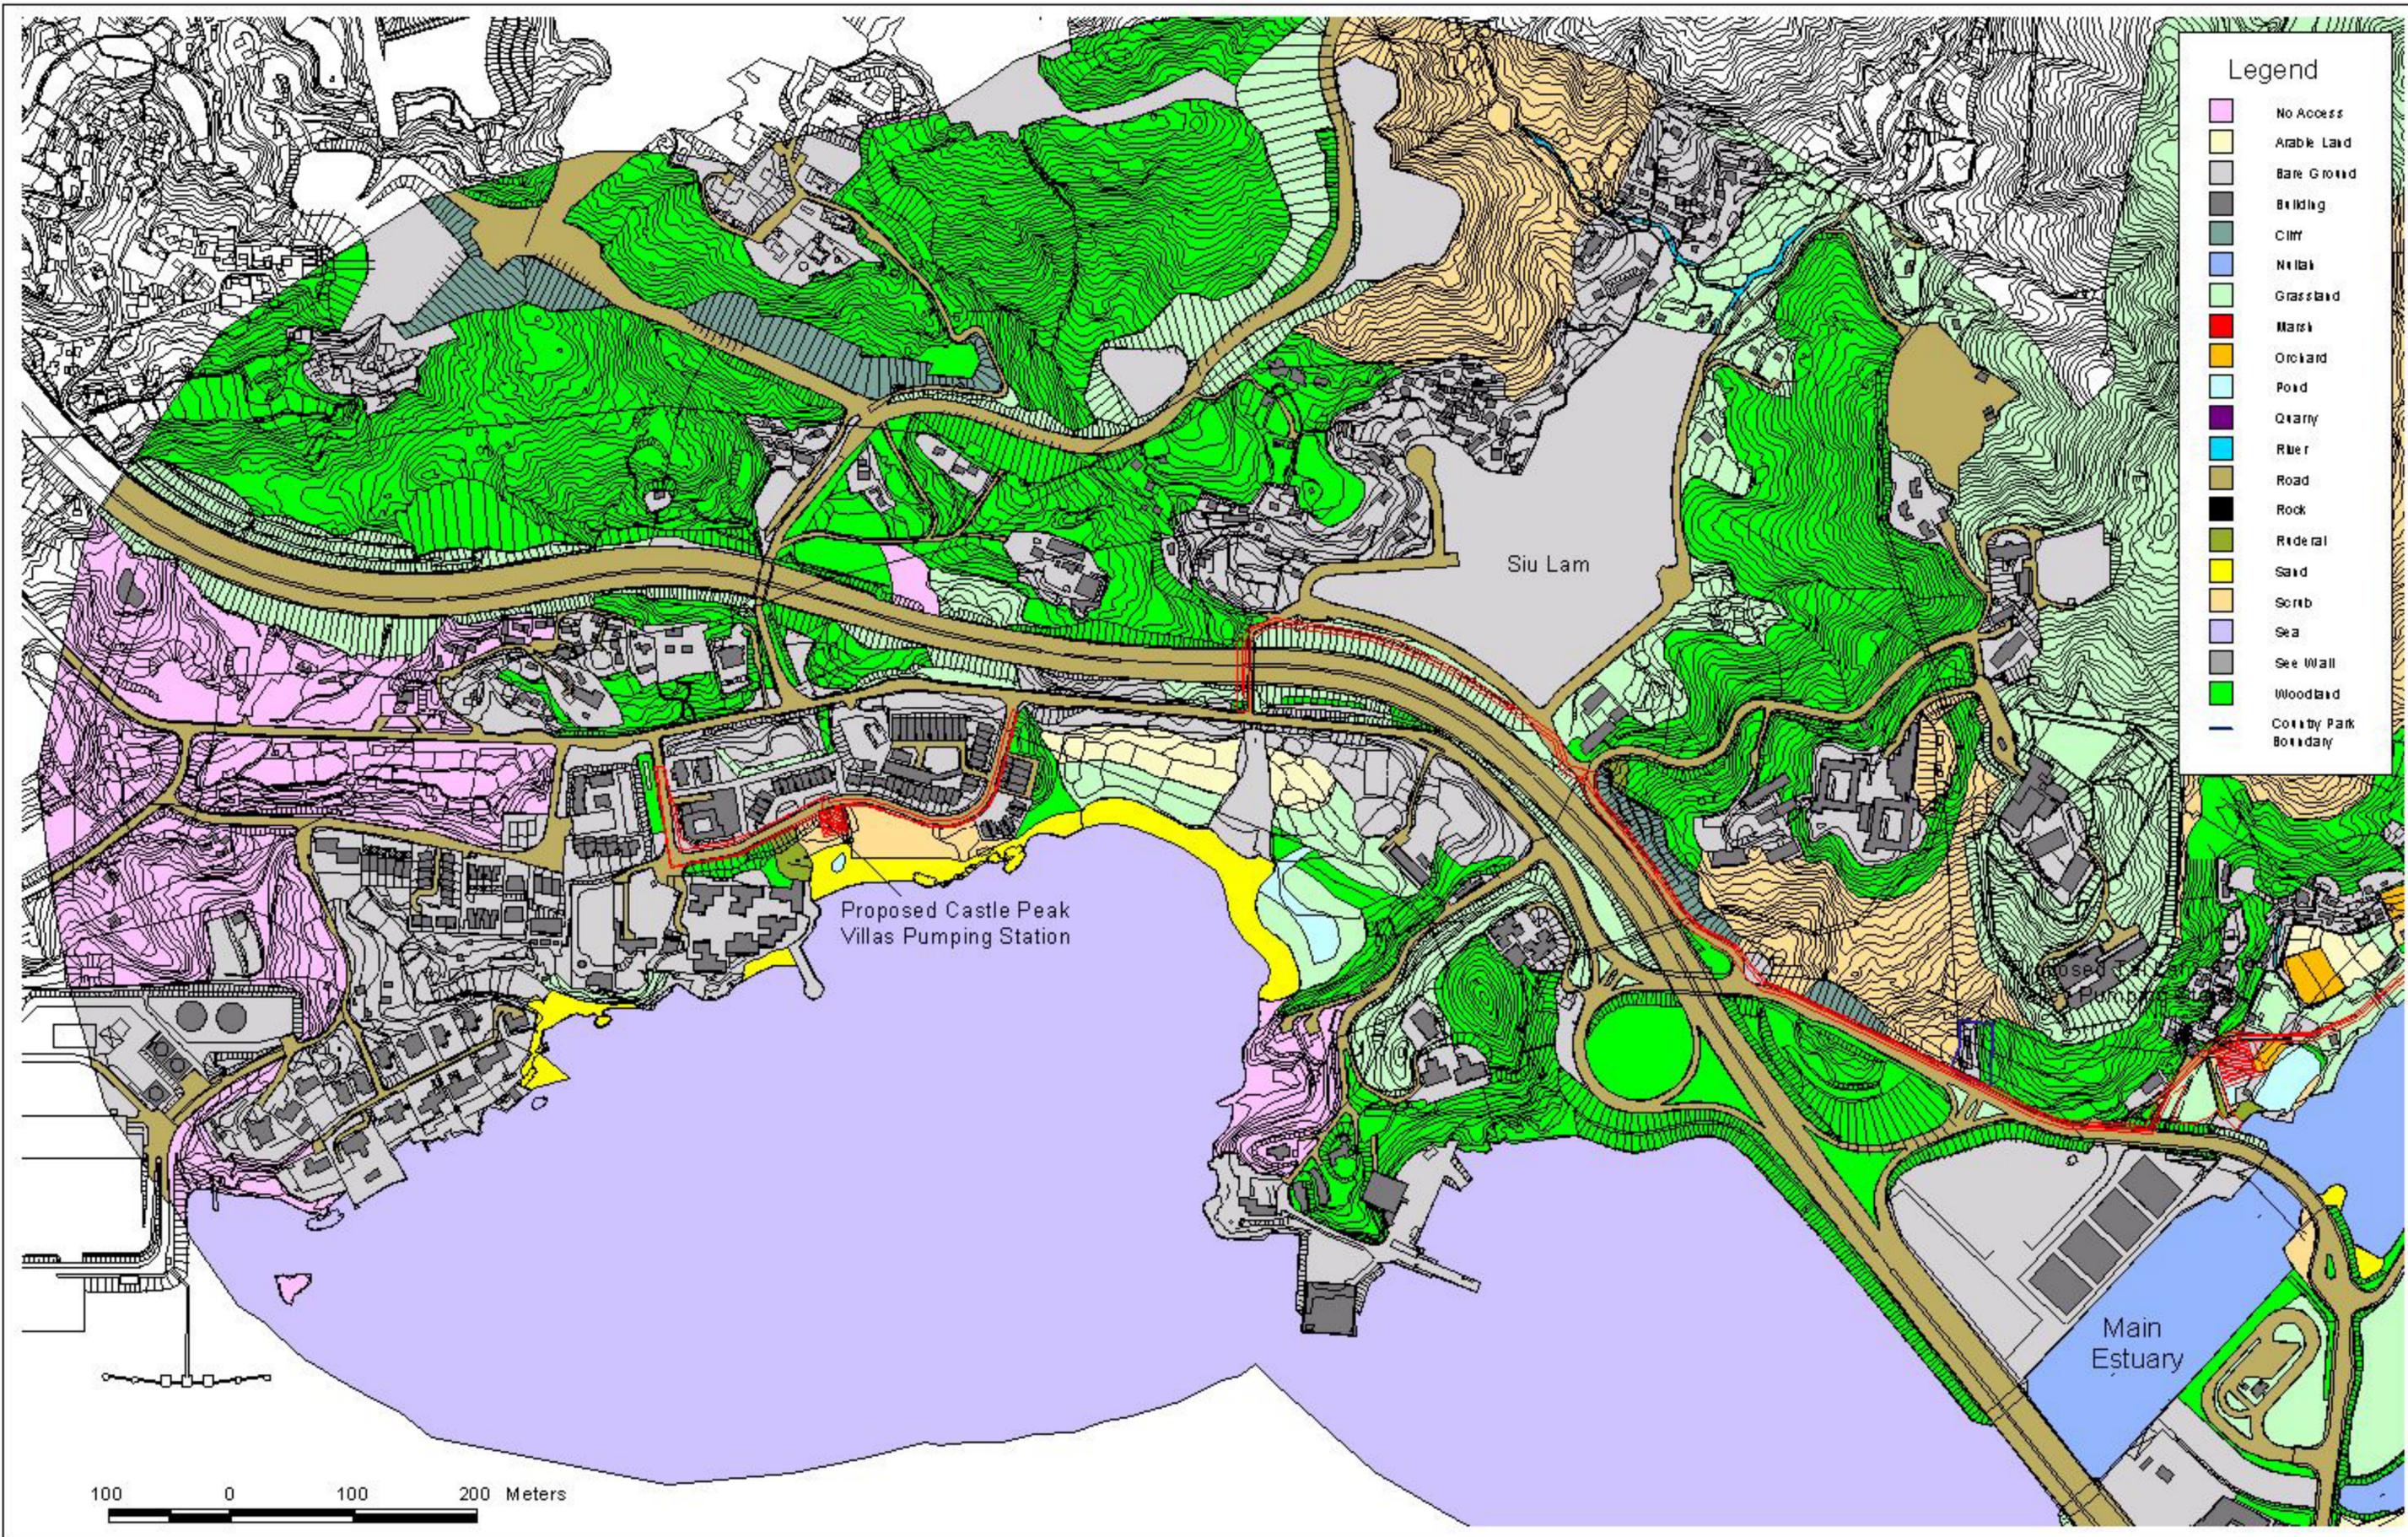
Drawing No. 8.3

**Ecological Habitat Map of Tai Lam Chung ( 3 of 3)**

- 8.7.35 The main coastal habitats consists of sea defence walls, rocky outcrops of headlands and more sheltered sandy bays. The bay at east of Castle Peak Villas and South of Siu Lam, Drawing 8.3, provides a good example of seral change from sea to land. A large bar of sand heads the bay behind which a pool of brackish water has developed. The sand bar is topped by coastal creeping grasses. The pool was observed to contain some small individual fish of unknown species and small individual specimens of mangrove trees. A belt of trees on the landward side of the pool are of the species *Hibiscus tiliaceus*, a coastal species which is found throughout the tropics. Such habitat types are becoming rarer in Hong Kong through coastal development pressures.

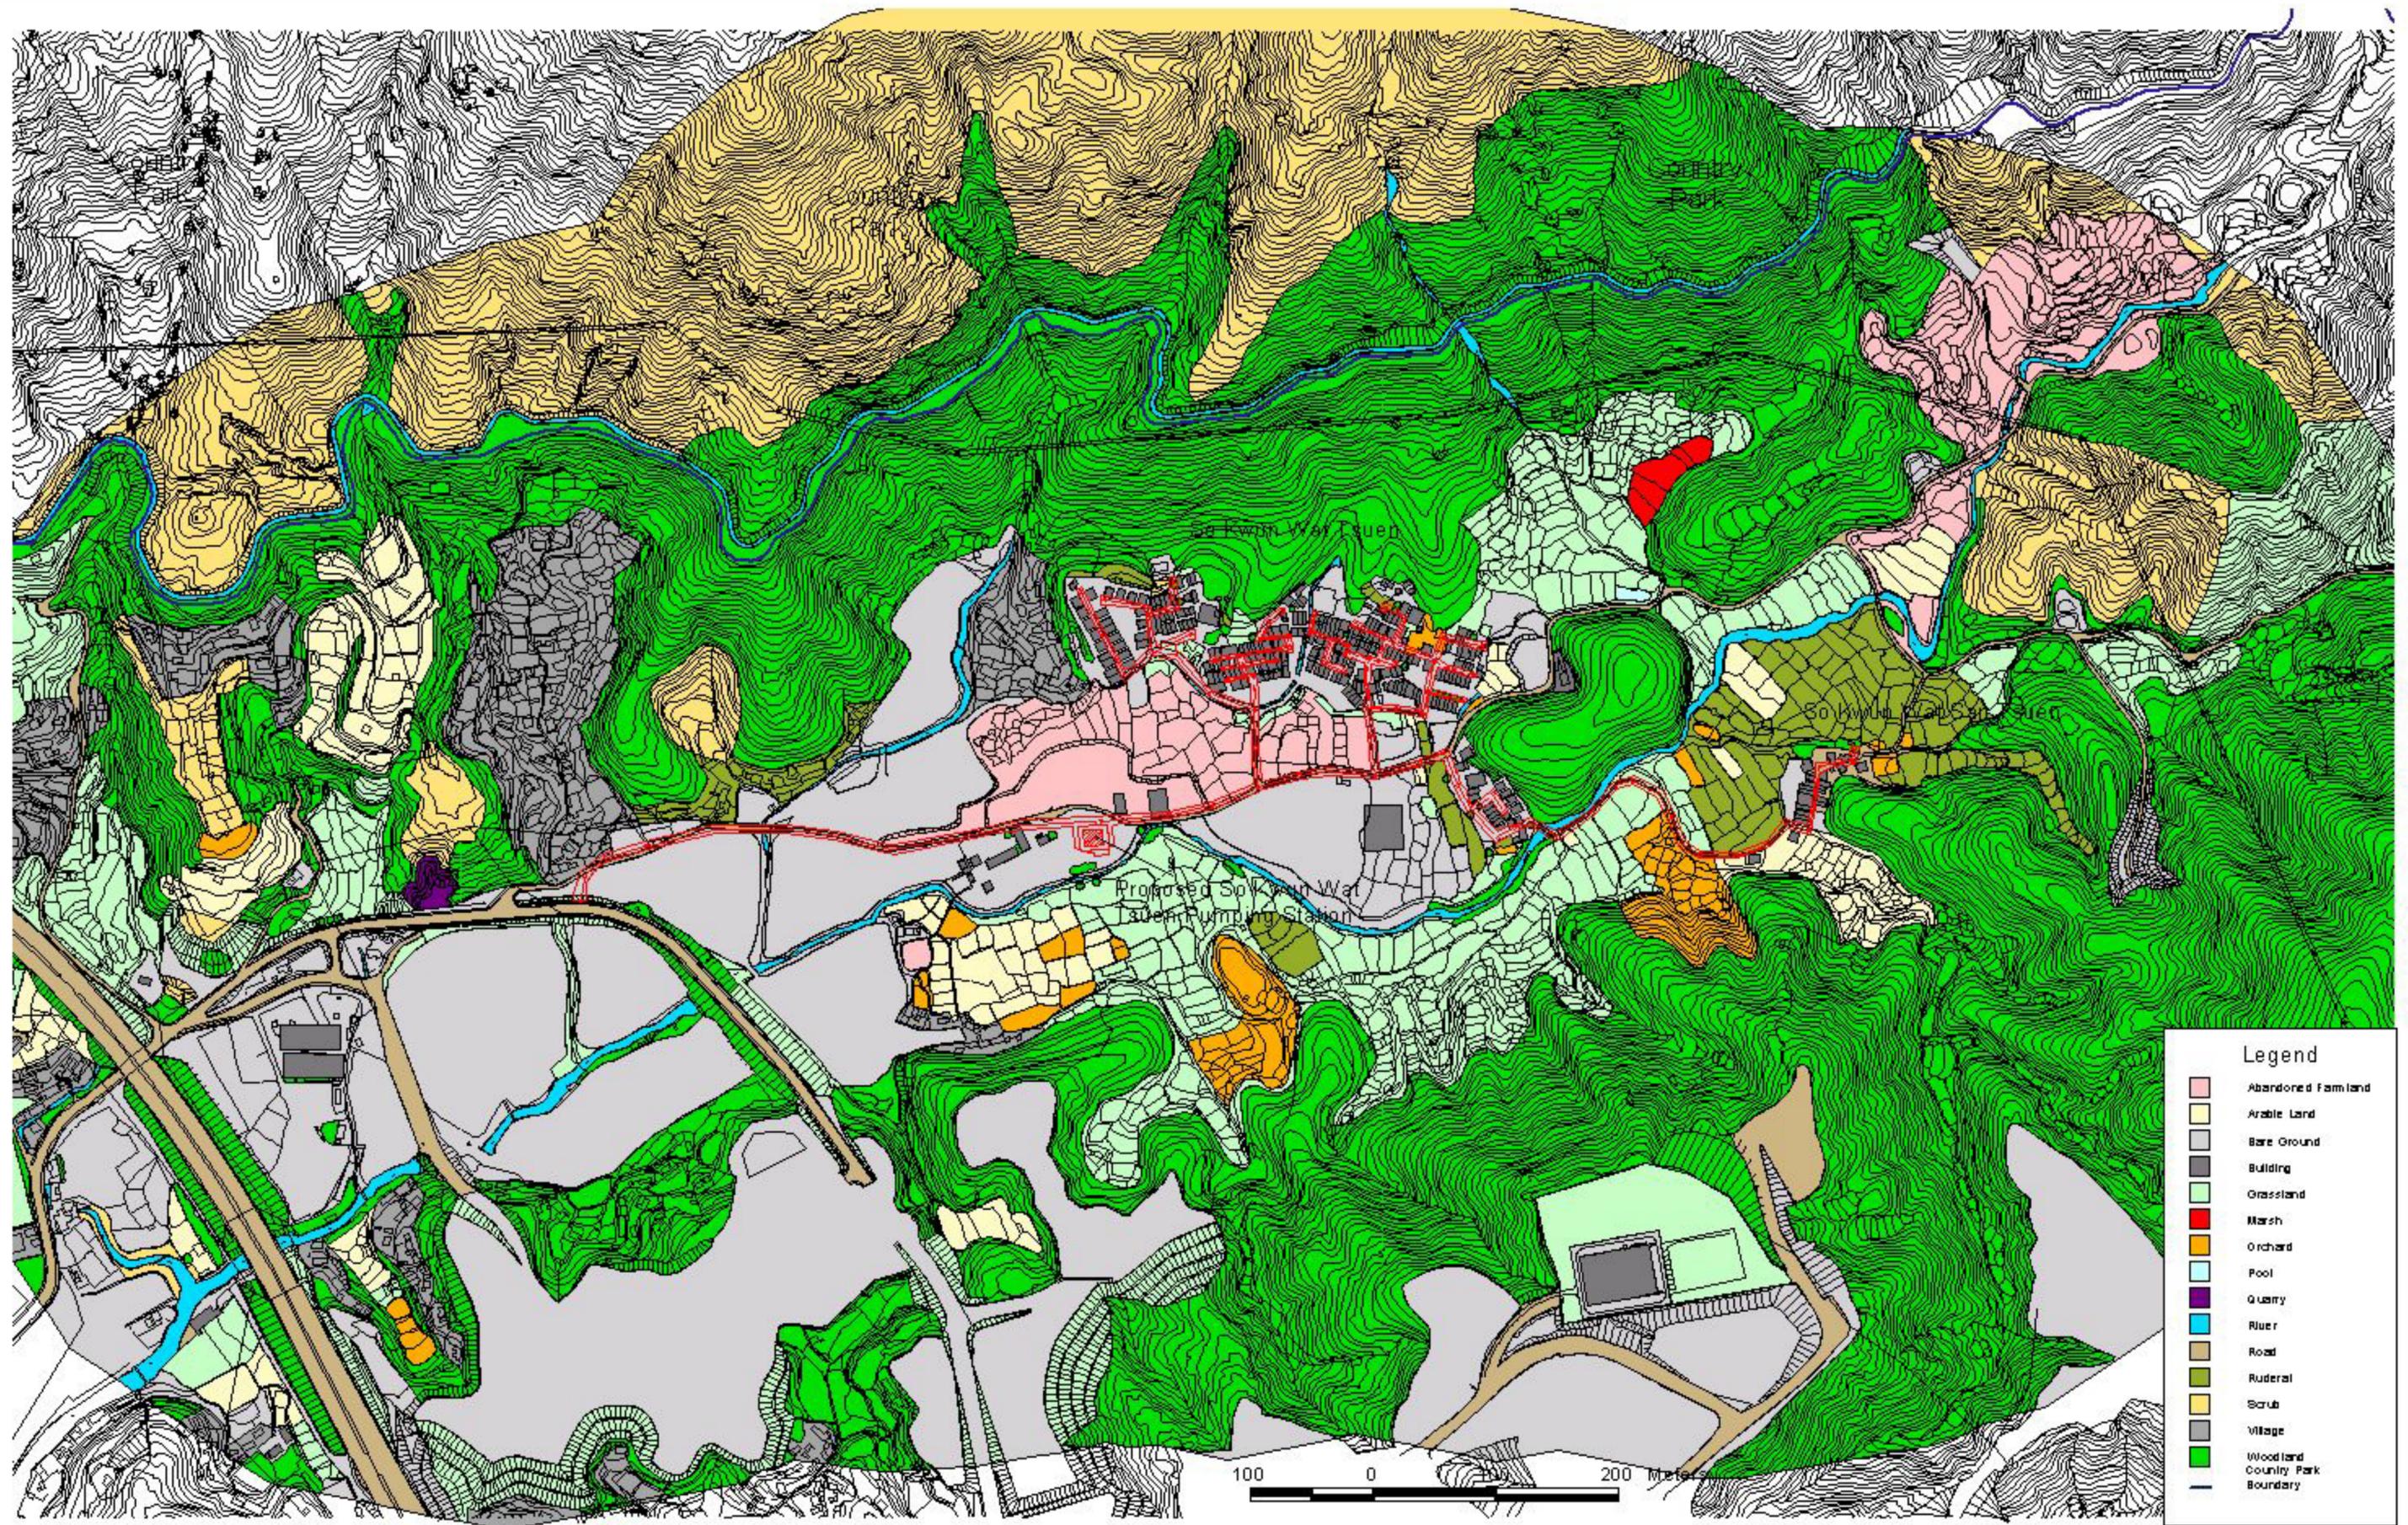
Drawing No. 8.4

## Ecological Habitat Map of So Kwan Wat

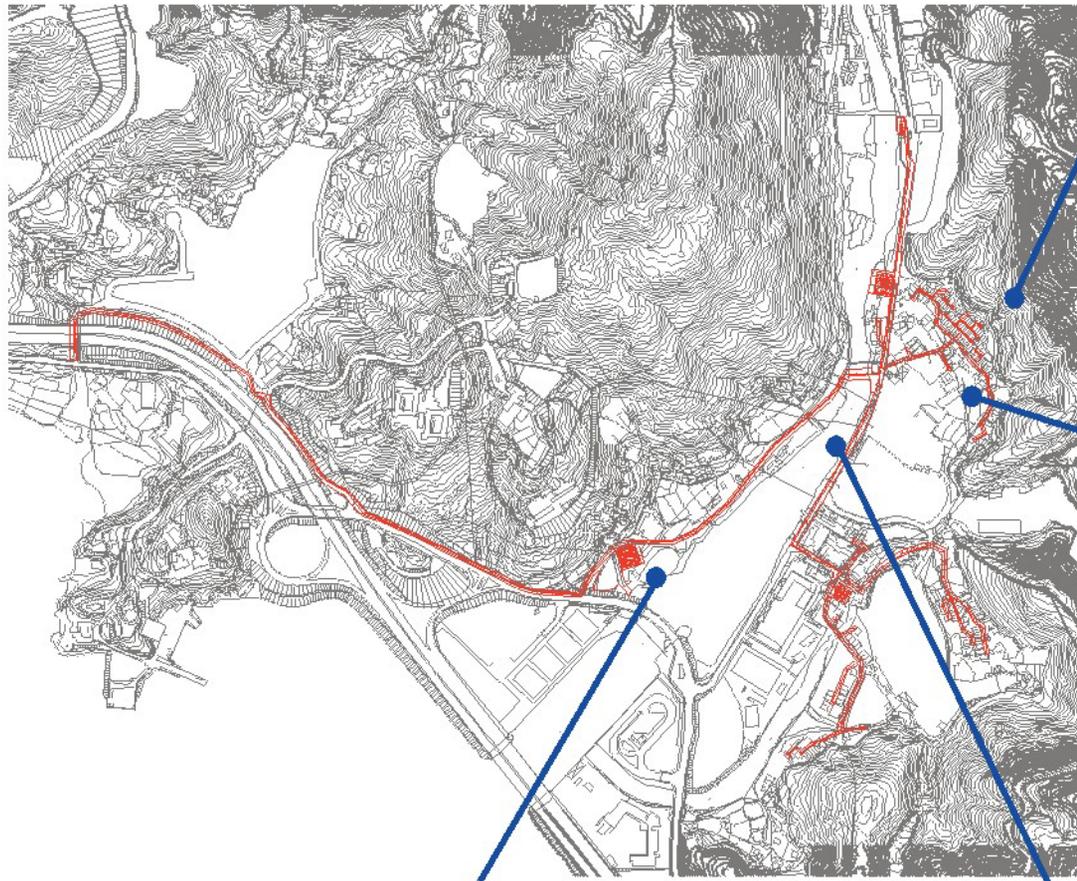
Woodland habitat containing a diverse floral community and likely to support a diverse faunal community.

- 8.7.6 Woodland in the upland areas is semi-mature, of varying ages. Diversity of tree species was found to be medium for the two woodland blocks surveyed at Tai Lam Chung and So Kwun Wat. Composition of the woodland in these areas was found to be typical for Hong Kong. A list of the species found is given in Appendix C.7.

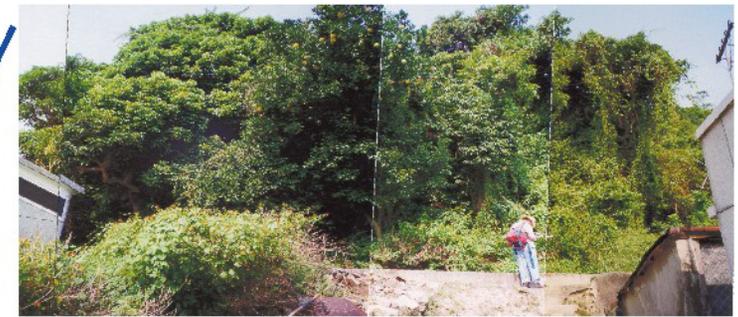
Marsh has evolved from disused wet agricultural land and still retains a few agricultural species. Marsh as a habitat is becoming rare in Hong Kong, this example being the only one found within the local area.

8.7.18 The area of marshland located south of Tai Lam Chung Tsuen probably originated from abandoned wet paddy fields. A photograph at the marsh is shown in Drawing 8.5 and its location indicated in Drawing 8.7. Floristically, the plant community present is typical of wet grassland/ marshland. Nine species were recorded, the plant community being a mixture of feral agricultural and native marshland species. A list of these species is given in Appendix C.1. The northern part of the marsh possesses a small pool which has been degraded by physical refuse (old tyres) and some engine oil. The damage is mostly cosmetic, however, and the remainder of the marsh appears to be fairly unaffected by gross disturbance and plant growth appeared healthy.

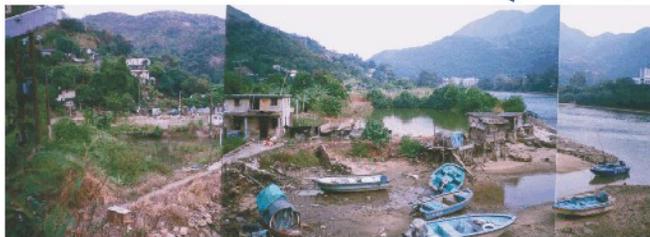
Water quality of the main estuary is considered to be fair. Juvenile species of commercial fish were observed.

- 8.7.41 From the sampling data and subjective observations, it would appear that the area is a nursery ground for mainly Grey Mullet, a ubiquitous fish, and the infrequent *Acanthopagrus latus* and *Monotaxis grandoculis* which is found widely in Hong Kong. From a fisheries point of view, it is likely that both the main estuary and the small tributary are, therefore, not of great importance.

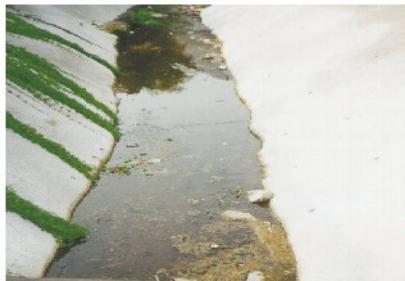
River channel has been strengthened with shotcrete and the existing water quality is poor with algal mat attached on rocks. The naturalness and diversity of the stream is greatly reduced.

- 8.7.33 Progressing down the stream towards the village areas, the clarity of the water is gradually reduced, with algal mats attached to rocks becoming more prevalent. Feeder streams originating from village areas were contaminated with overflow from ill maintained septic tanks. It is, therefore, likely that the algal growth and cloudy water is caused by sewage pollution. The banks of the stream have also been shot-created as a strengthening measure. The naturalness of this part of the stream is therefore low. Diversity of flora and fauna is also expected to be low. It would be relatively easy to recreate the pre-existing habitat by removing the sewage input and restoring the banks to their previous condition. The ecological value of this habitat is, therefore, considered to be low.

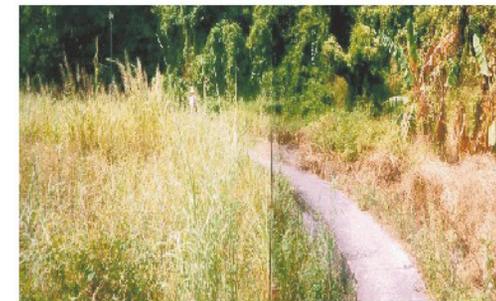
Dry Grassland, with low floral species diversity

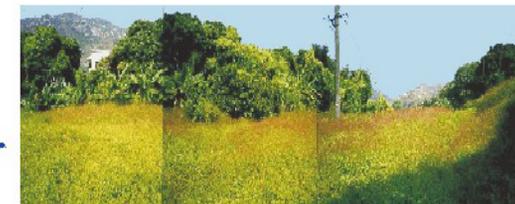
Wet Grassland, of medium species diversity.

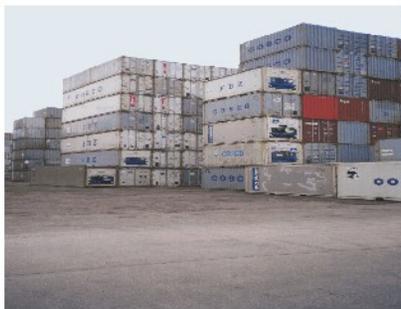
Open storage area is the major land use along the So Kwun Road the value to wildlife is very limited.

- 8.7.13 The large open storage areas offer little opportunity to native flora and fauna. They form large barriers due to their lack of cover and unnatural terrain which inhibit the movement of ground dwelling animals. The various roads that criss-cross the valley bottoms also fragment and reduce connection between various habitats. Other areas that have been cleared for housing projects or are part of village open spaces also exhibit similar characteristics, although villages tend to have a higher number of trees. These areas are considered to be of low ecological value.

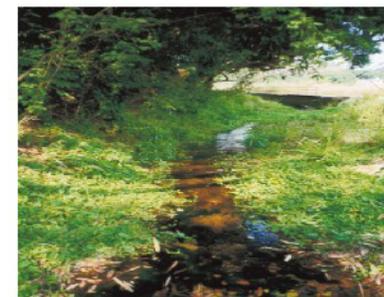
Upper So Kwan Wat stream east of So Kwan Wa Tsuen possess clean waters, with diverse riparian habitats and flora, supporting a range of faunal species.

- 8.7.28 There is one main stream in the So Kwun Wat Valley. In the upper valley, east of So Kwun Wat Tsuen, the waters are clean, with little anthropogenic input and the stream bed is composed of coarse gravel and sands. At the time of survey during the dry season, the flow was minimal. Where woodland shades the waters, the undergrowth vegetation was limited, while in more open areas, the banks and stream margins were well vegetated with herbs and grasses typical of stream banks. Plant species found along the open banks were *Mikania guaco* (F), *Polygonium hydropiper* (F), *Commelina nudiflora* (F), *Colocasia esculenta* (O), *Ageratom conzoides* (O), the sedge *Cyperus radiatus* (O), *Minosa pudica* (R), an alien

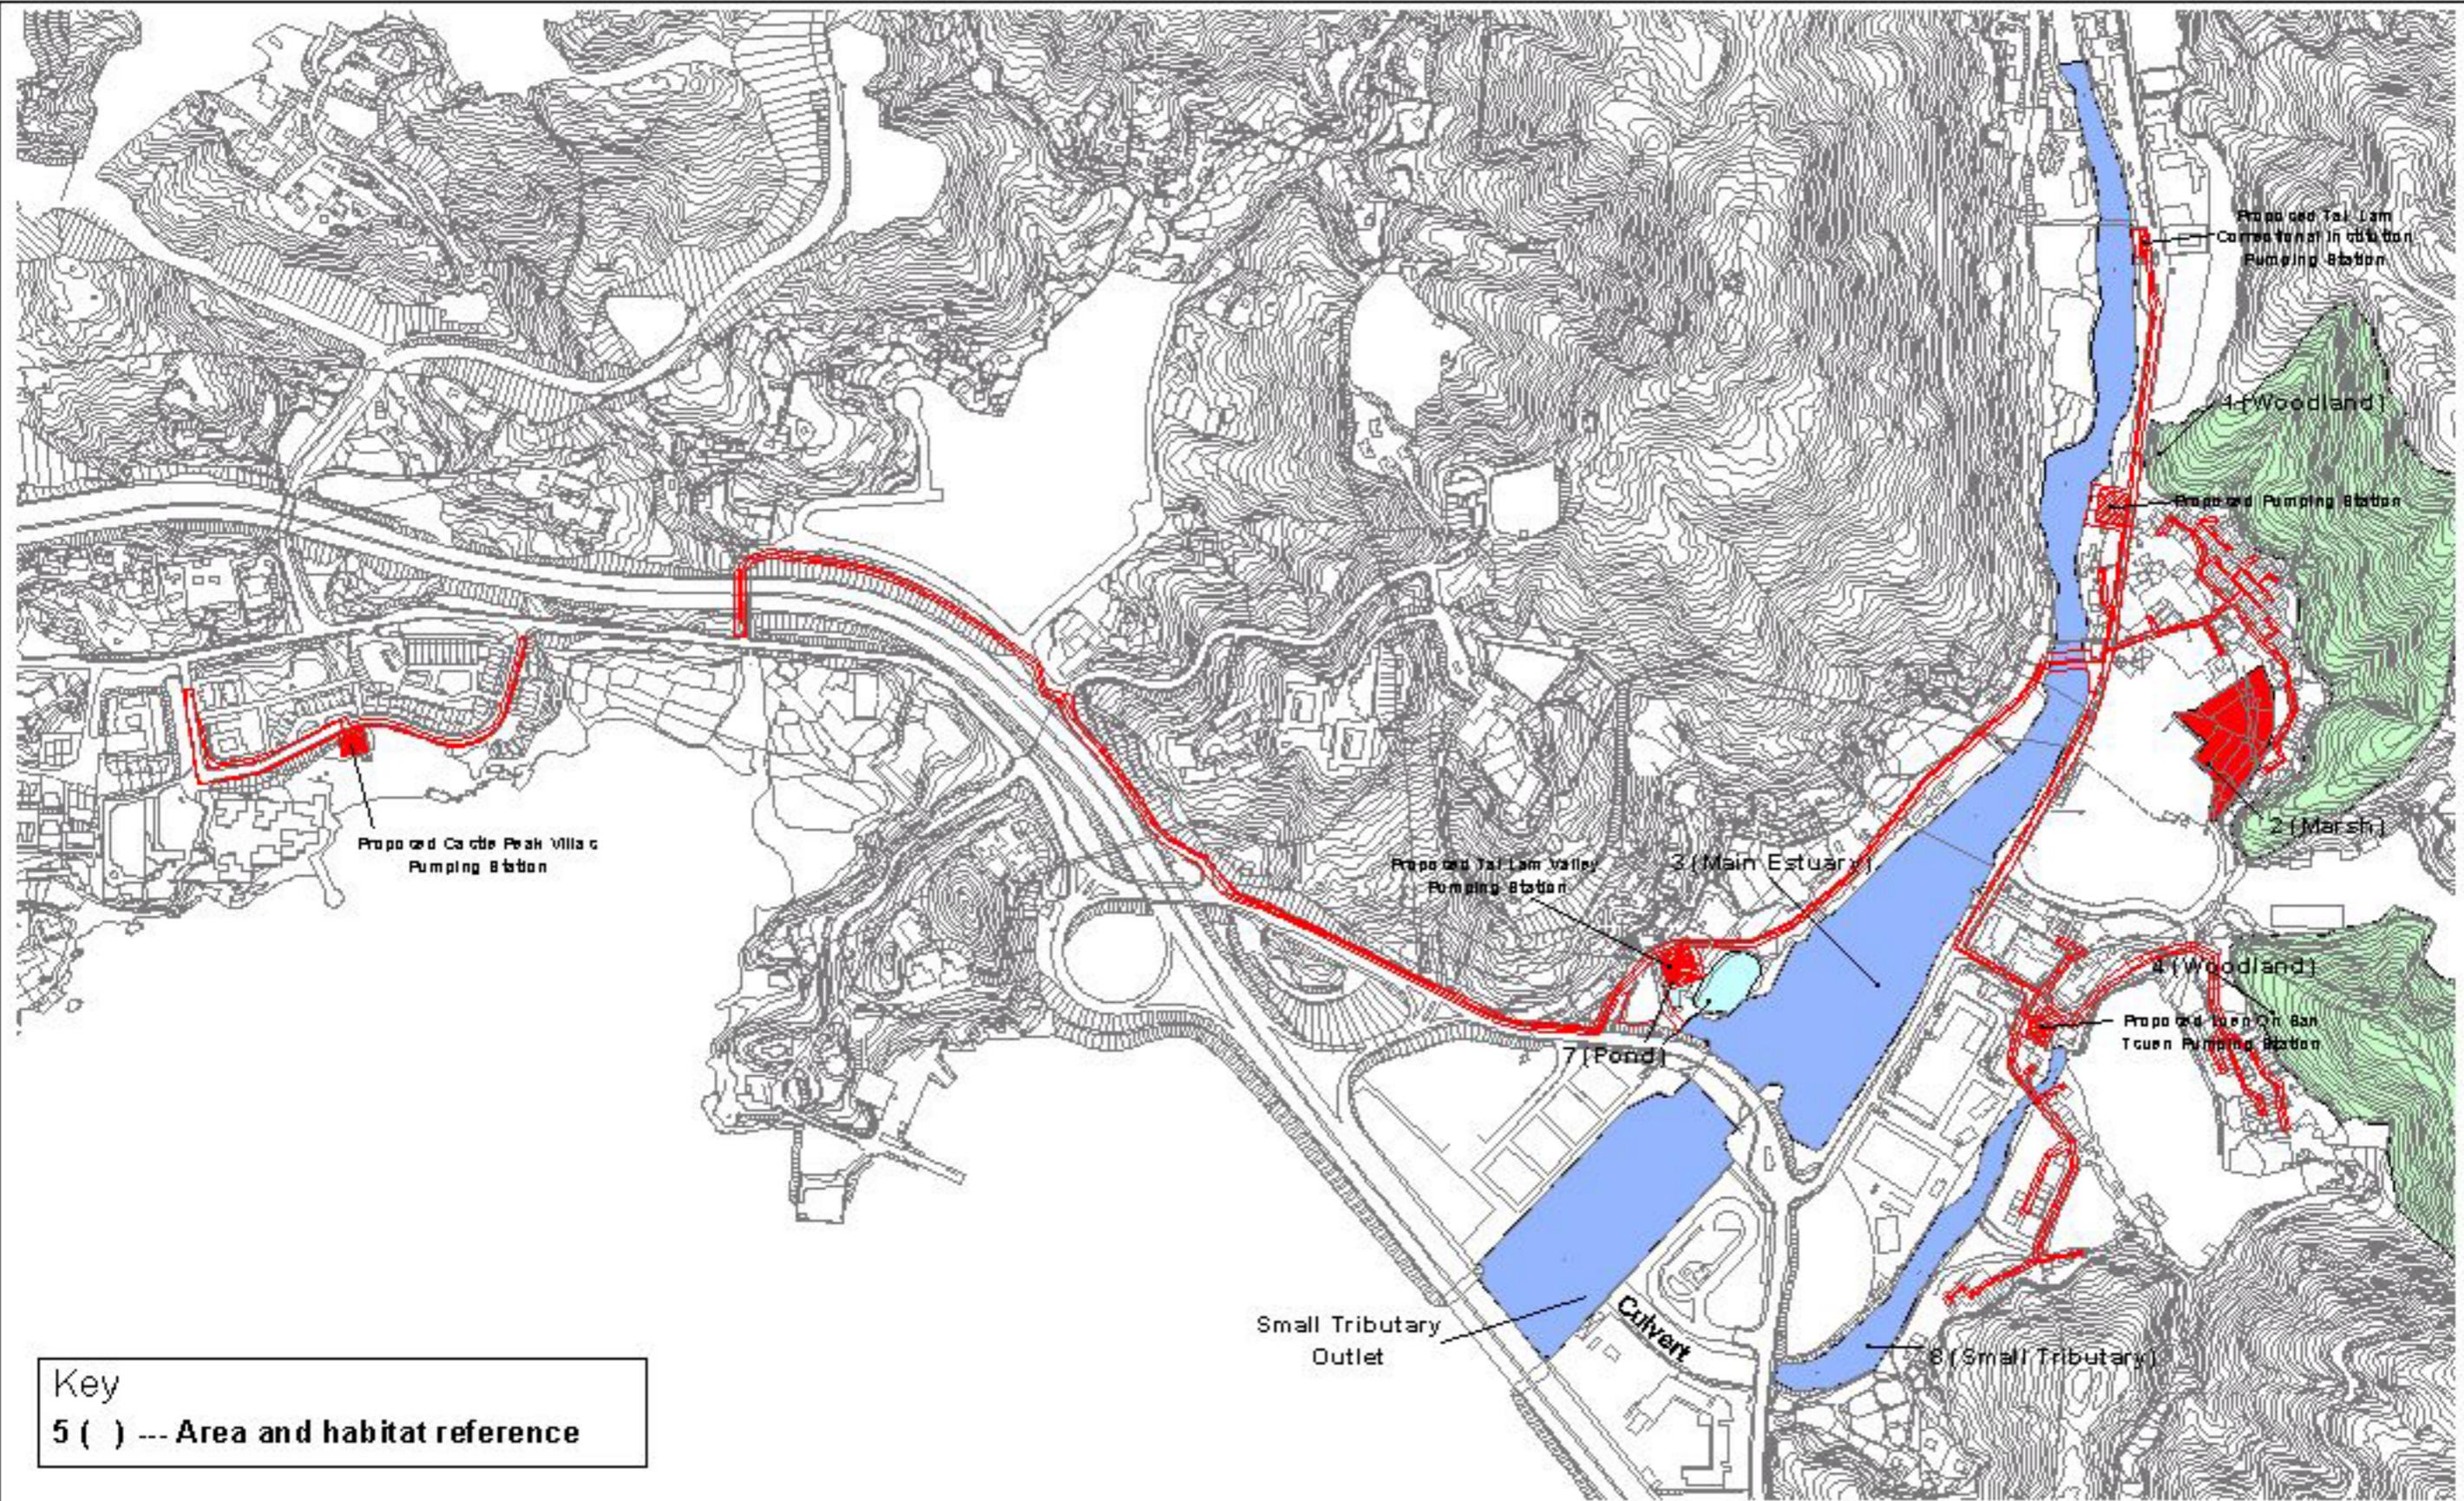
**Location of Potentially Important Ecological Sites**

8.5.6 The main estuary and small tributary at Tai Lam Chung (Area 3 & 8), Drawing 8.7, may contain juvenile fish of commercially valuable species. Construction of the pipeline across these areas may generate quantities of suspended solids that could adversely stress any juvenile fish present. Possible operational impacts may result from emergency discharge of raw sewage into these areas following a pump or power supply failure.

- 8.9.11 *Woodland*: The possible damage to the woodland to the north of Tai Lam Chung Tsuen (Woodland Area 1, Drawing 8.7) as a result of the original site boundary being close to the edge of the wood and the roots of the trees was not considered to be of great magnitude, as damage was not expected to be widespread, although some individual trees may have been affected. The woodland is of medium ecological value and no important species were observed. However, it is likely to provide a habitat for some of Hong Kong's protected mammals and the duration of the impact is likely to be long term. Thus, while the impact would be ranked as minor, the site boundary has been revised to avoid any impacts on this area. The original and revised works limit can be seen in Drawing 8.10.

- 8.9.12 The woodland at Wong Uk (Woodland Area 4, Drawing 8.7) is of medium ecological value due to the age and diversity of flora identified and although no important species were observed, it is likely to provide a habitat for some of Hong Kong's protected mammals. Thus, while magnitude of the impact from the original sewer alignment would be small and ranked as moderate, the sewer alignment has been modified to avoid any impacts on this wooded area and is now located along the village access. The original and revised sewer alignment in this area can be seen in Drawings 8.10.
