## **8.0 ECOLOGY**

8.1.1 This section comprises of the ecological assessment of the EIA. The broad objectives of the ecological study are as follows:

## **8.4 Initial Ecological Survey**

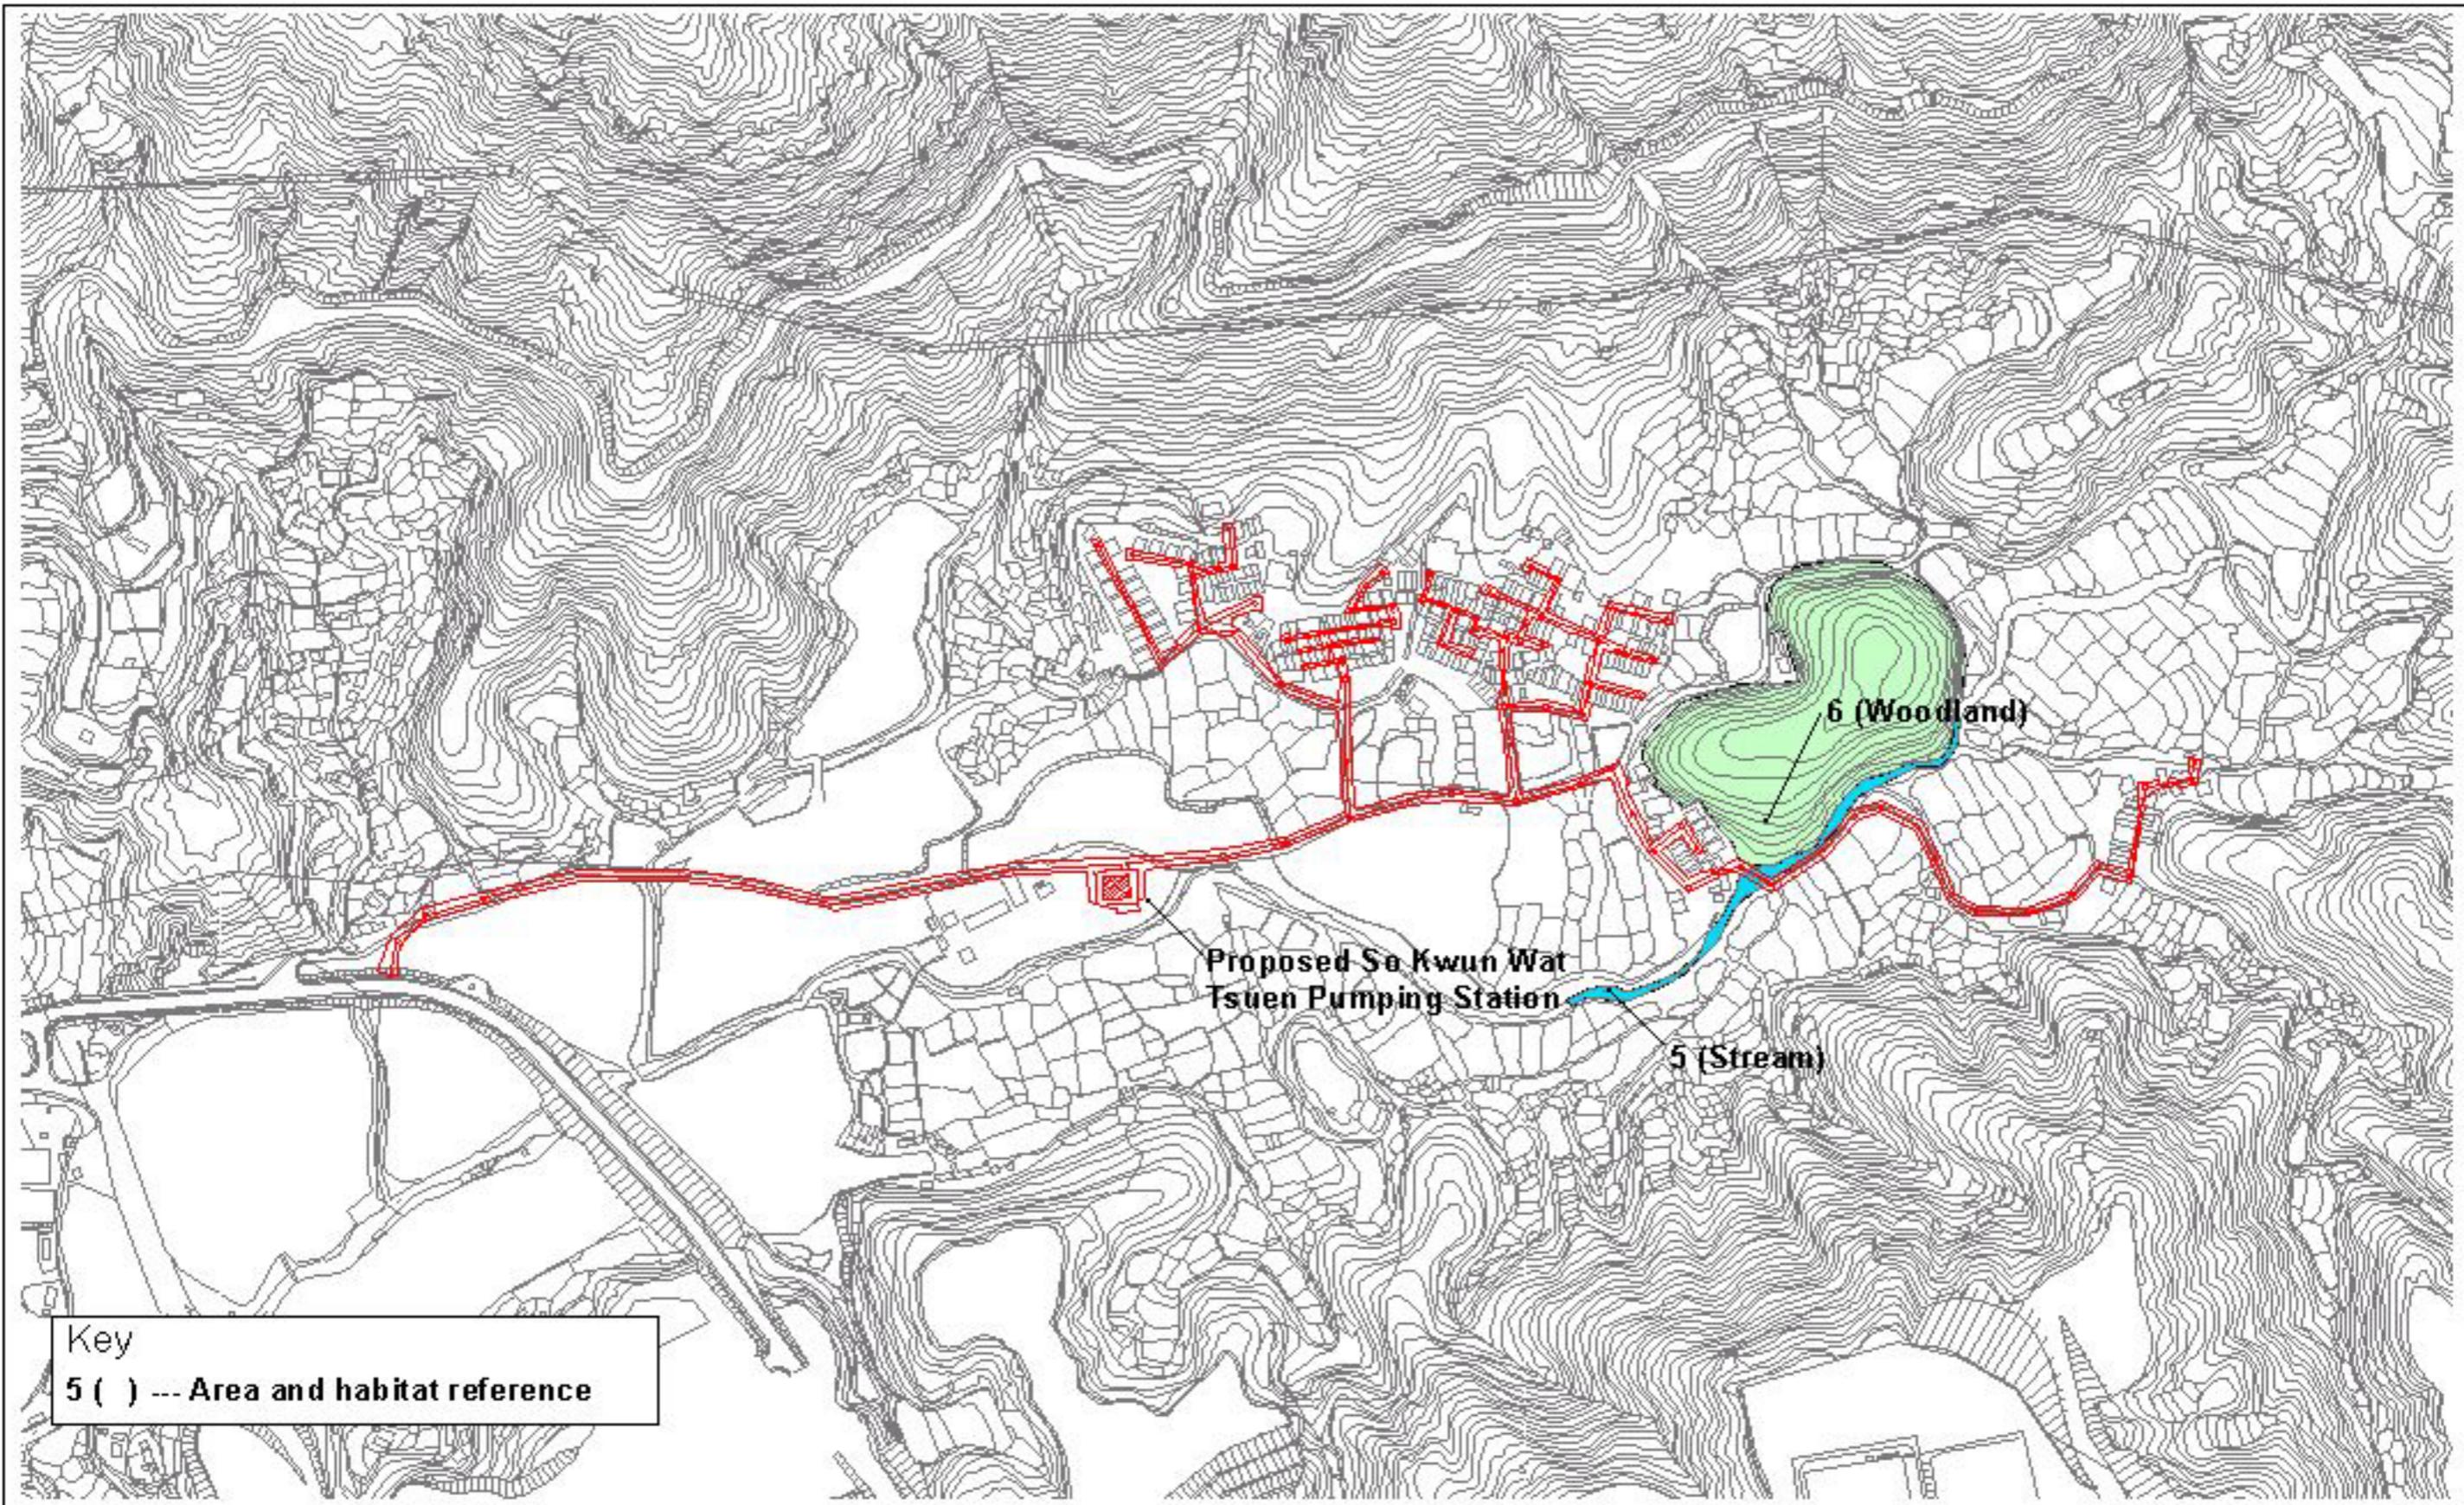
**Location of Potentially Important Ecological Sites**

8.5.5 Native fish present in a stream located east of So Kwun Wat Tsuen (Area 5), Drawing 8.8, were identified as potentially vulnerable to suspended solids generated during construction, which may adversely stress them. Possible operational impacts may result from emergency discharge of raw sewage into the stream following a pump or power supply failure.

- 8.9.38 *Woodland*: The woodland to the east of So Kwun Wat Tsuen (Woodland Area. 6, shown on Drawing 8.8) is of medium to high ecological value due to the age and diversity of flora identified although no important species were observed. It is also likely to provide a habitat for some of Hong Kong's protected mammals. The original sewer alignment followed the edge of this wood and would have resulted in some trees having to be felled. While, magnitude of this impact will be small and ranked as moderate, the sewer alignment has been modified to avoid any impact on this wood. The original and revised sewer alignments can be seen in Drawing 8.11.

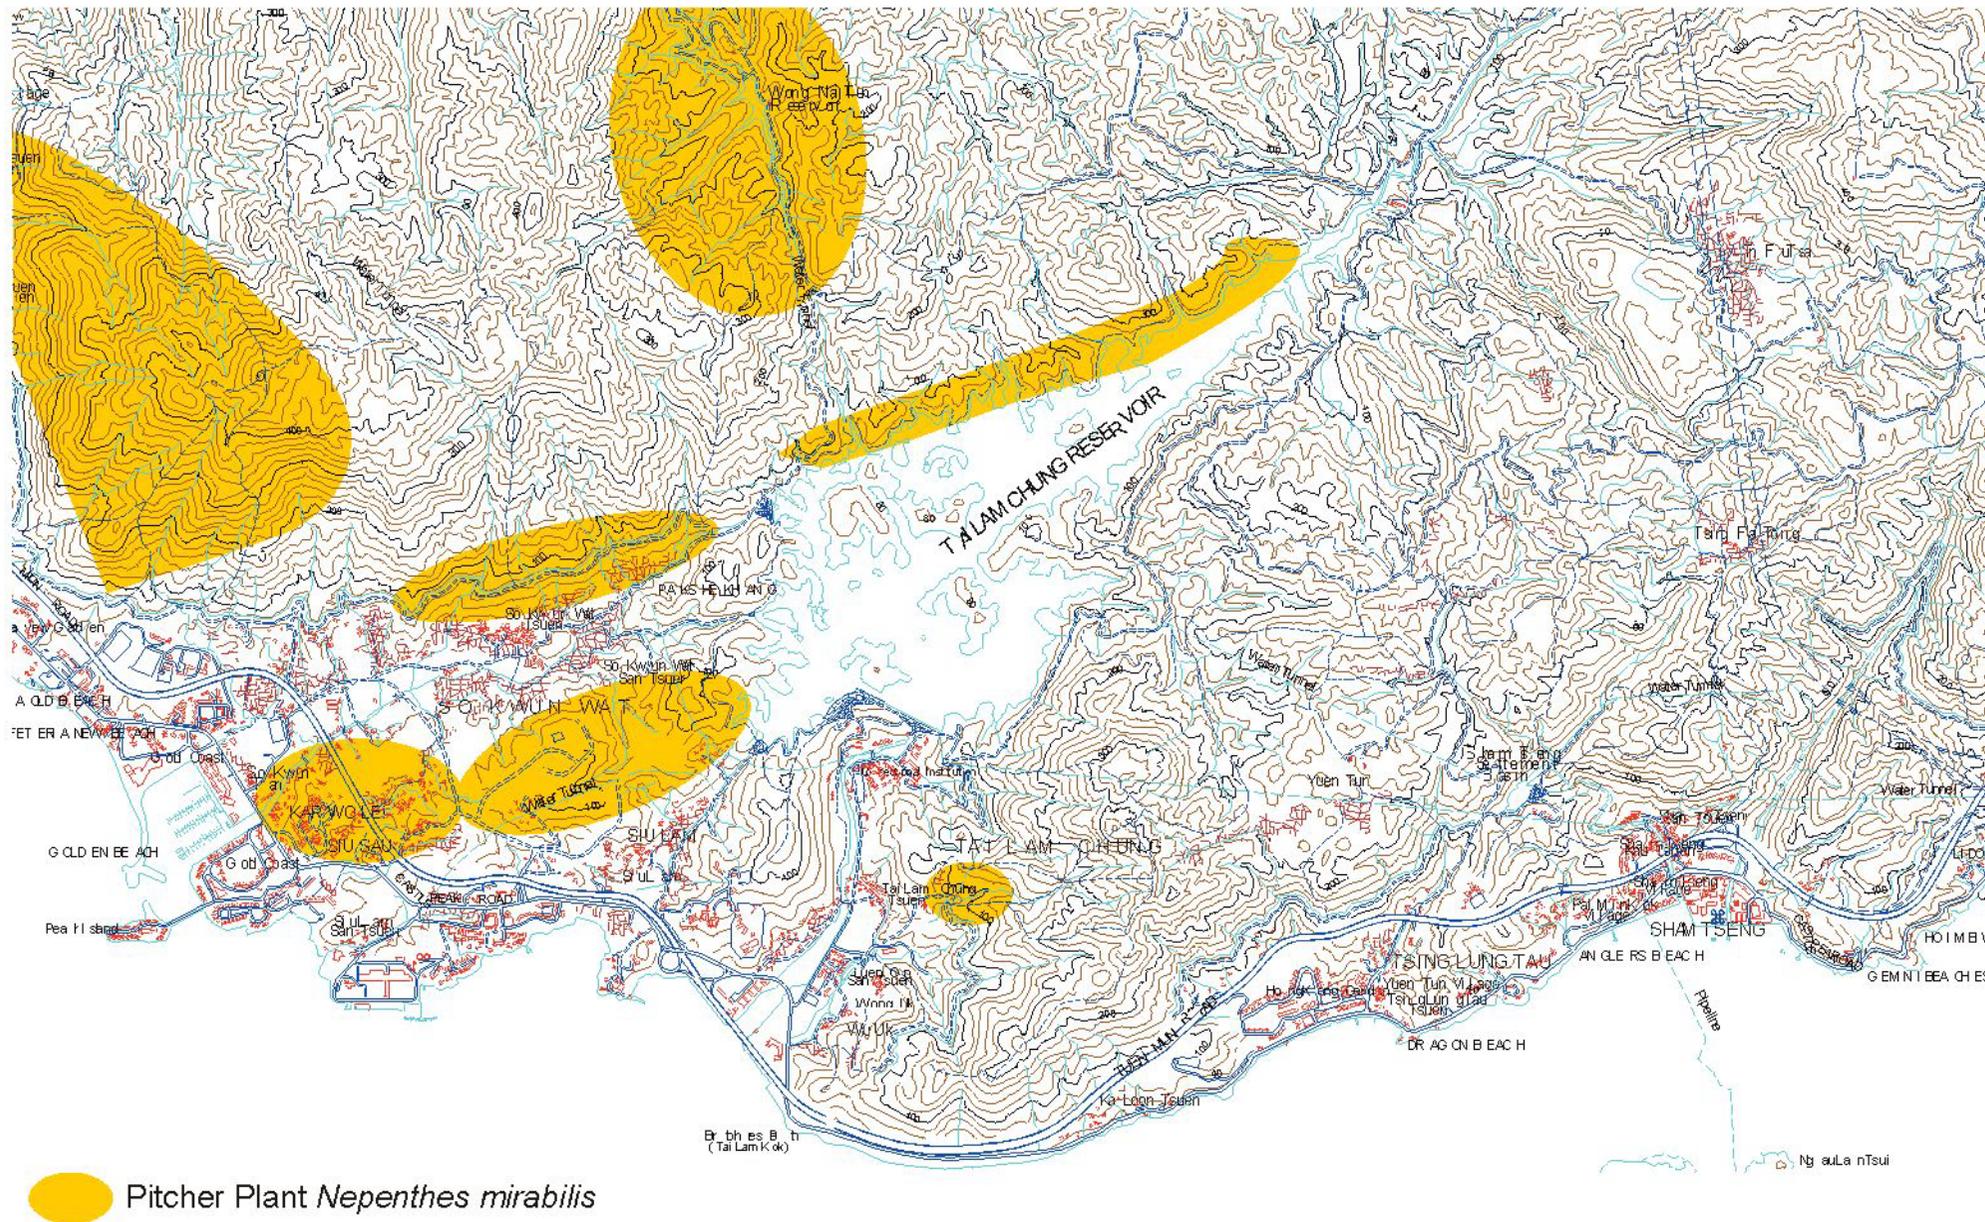
Distribution of Pitcher Plant (*Nepenthes mirabilis*) around the Study Area  
 (Source: Weatherhead, undated)

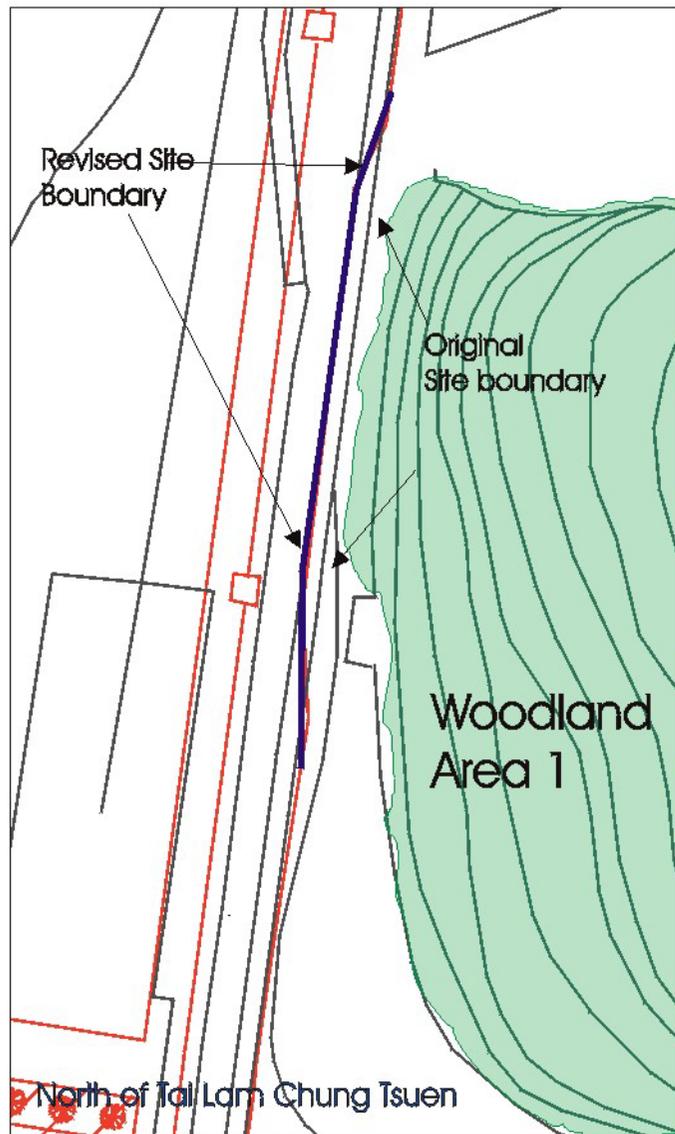
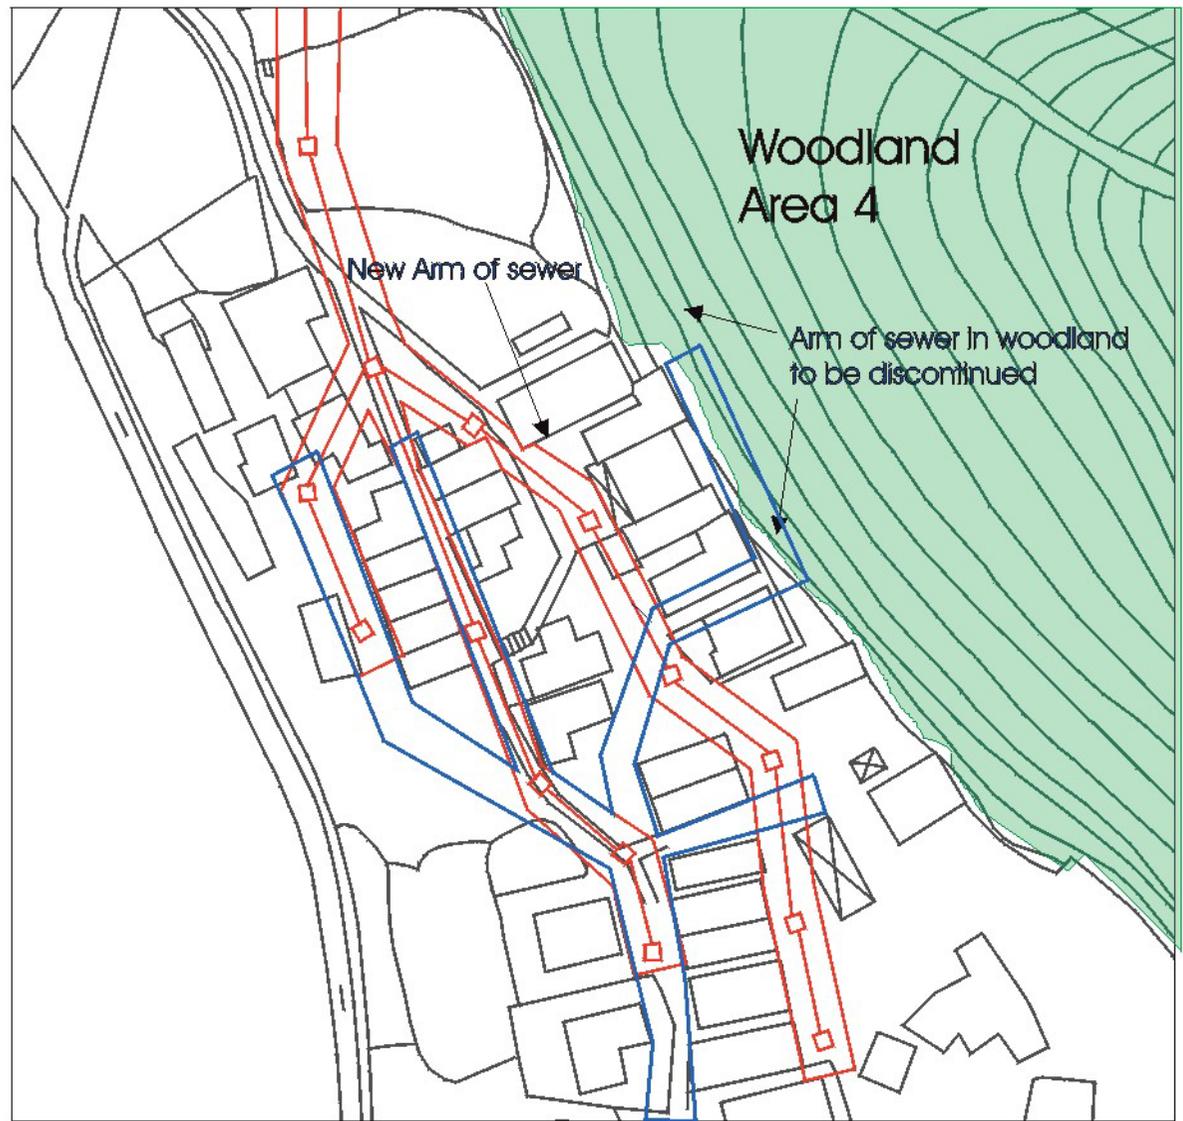
— Revised sewer layout

— Original sewer layout

Proposed changes to site boundary and sewer alignment in order to avoid loss of woodland and damage to trees

8.5.3 The originally proposed sewer alignment directly encroached on the edge of woodland blocks just east of Wong Uk (Area 4) and east of So Kwun Wat Tsuen (Area 6), as shown in Drawings 8.10 and 8.11. While not resulting in habitat fragmentation, laying of the route would result in the removal of some trees within the site boundary and possible damage to the root systems of adjacent trees. In addition, the site boundary just north of Tai Lam Chung Tsuen (Area 1) was very close to the edge of a wooded area leading to the potential for tree roots to be damaged during construction.

- 8.9.11 *Woodland*: The possible damage to the woodland to the north of Tai Lam Chung Tsuen (Woodland Area 1, Drawing 8.7) as a result of the original site boundary being close to the edge of the wood and the roots of the trees was not considered to be of great magnitude, as damage was not expected to be widespread, although some individual trees may have been affected. The woodland is of medium ecological value and no important species were observed. However, it is likely to provide a habitat for some of Hong Kong's protected mammals and the duration of the impact is likely to be long term. Thus, while the impact would be ranked as minor, the site boundary has been revised to avoid any impacts on this area. The original and revised works limit can be seen in Drawing 8.10.

- 8.9.12 The woodland at Wong Uk (Woodland Area 4, Drawing 8.7) is of medium ecological value due to the age and diversity of flora identified and although no important species were observed, it is likely to provide a habitat for some of Hong Kong's protected mammals. Thus, while magnitude of the impact from the original sewer alignment would be small and ranked as moderate, the sewer alignment has been modified to avoid any impacts on this wooded area and is now located along the village access. The original and revised sewer alignment in this area can be seen in Drawings 8.10.

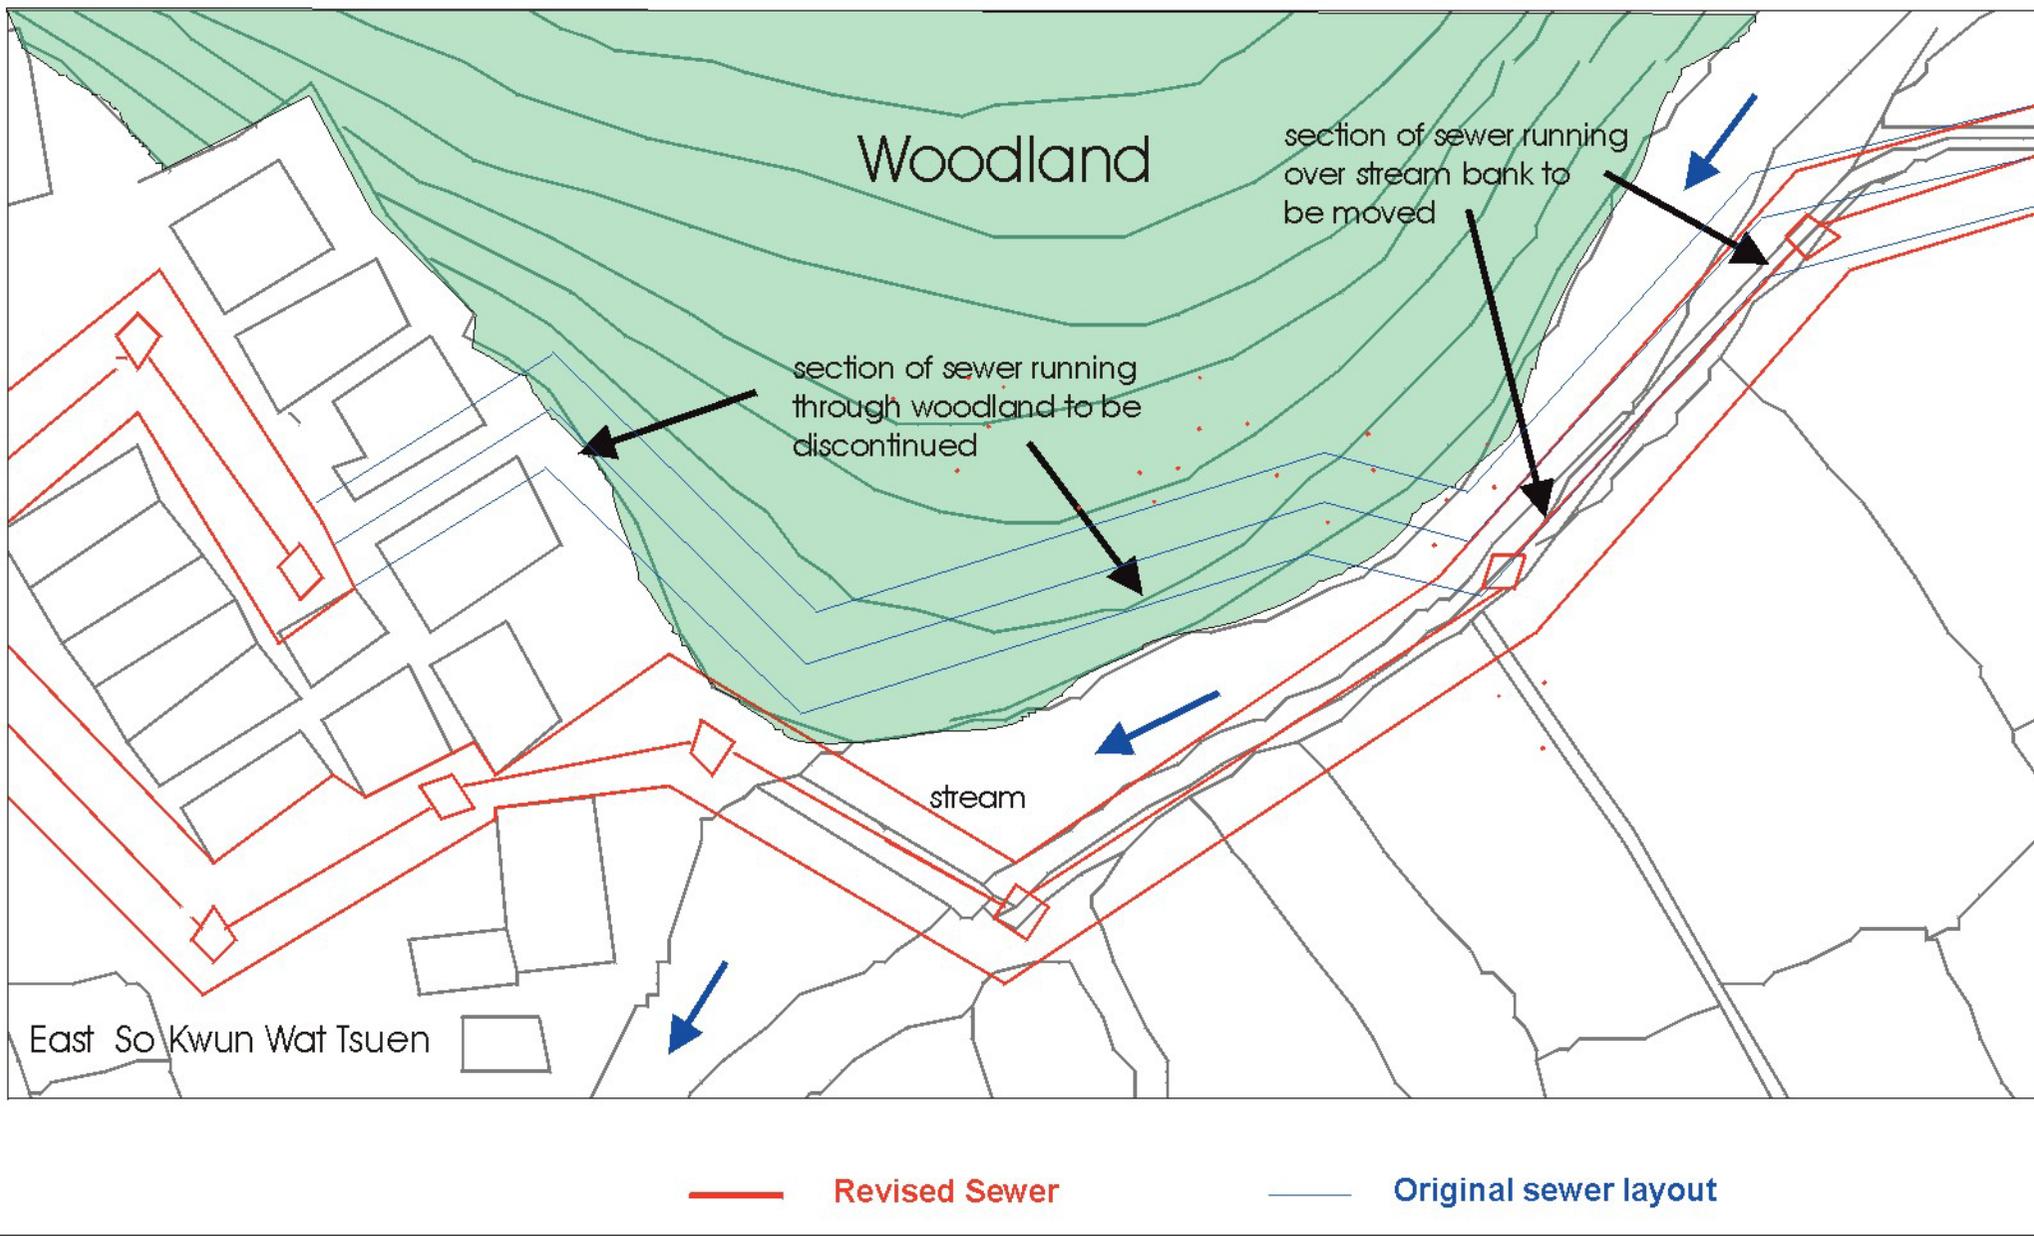
Revision to sewer alignment in order to avoid loss of woodland and stream bank vegetation
