Chapter 9

CULTURAL HERITAGE

- 9.1 This Section presents the assessment results of the potential impacts on cultural heritage resources in the Study Area, which may be impacted as a result of the Project. The discussion is based on an archaeological survey conducted by AMO in August-November 2001. Mitigation measures required to preserve the cultural heritage have been recommended. Rescue plan has been prepared for the affected area, where preservation on site is infeasible.

Title	Agreement No. CE 68/99 Infrastructure for Penny's Bay Development - Engineering Design and Construction Decommissioning of Cheoy Lee Shipyard		Scale	1:2500	Project No.	R06100
	Location of Survey Areas		Date	Feb 2002	Figure No.	9.1

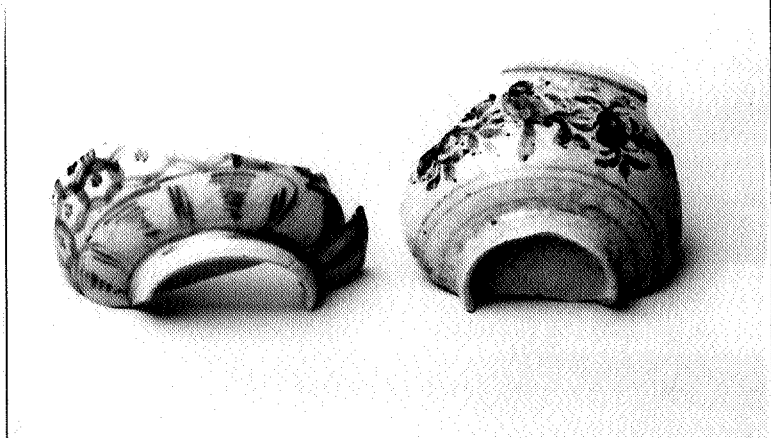
Photo : 9.6 Blue-and-white Porcelain Shards

- A substantial amount of "blue-and white porcelain shards" from Jinngezhen of Ming Dynasty (1368 AD to 1644 AD), were recovered (Photos 9.6 –9.9).
 - Pottery and porcelain shards, from Ming and Ching Dynasty, were recovered.
