**Figure 1.6**  
Emergency Discharge Scenarios  
for the Existing San Wai STW  
and Ha Tsuen PS

Agreement No. CE62/2000  
EIA Study for the Upgrading and  
Expansion of San Wai Sewage  
Treatment Works and the Expansion  
of Ha Tsuen Pumping Station

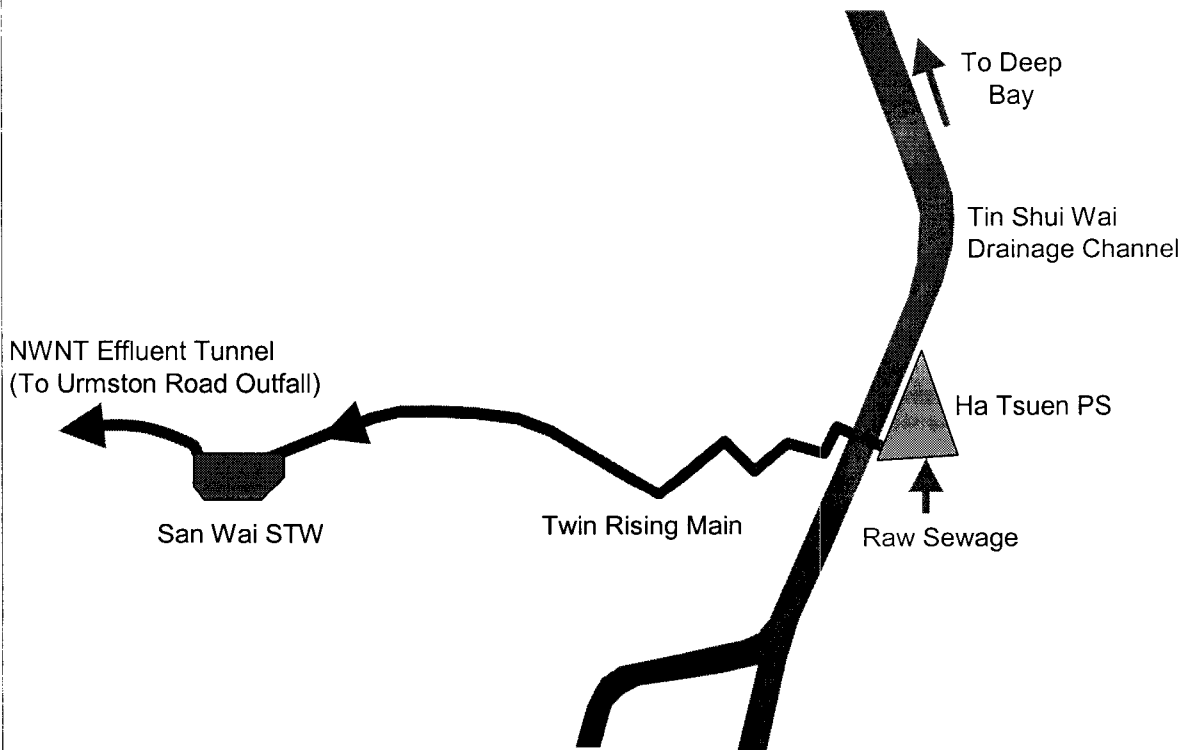
**Existing Condition (Without Emergency Bypass Culvert)**

Status of Facilities (✓ = Normal Operation, ✗ = Totally Out of Operation)			Effluent	Discharge Location
San Wai STW	Ha Tsuen PS	NWNT Tunnel		
✓	✓	✓	Treated Effluent	Urmston Road Outfall
✓	✓	✗	Raw Sewage	TSW Drainage Channel/Deep Bay
✗	✓	✓	Raw Sewage	Urmston Road Outfall
✓	✗	✓	Raw Sewage	TSW Drainage Channel/Deep Bay
