Figure 11.14
Photomontages of the Expanded San Wai STW from Viewpoint #8

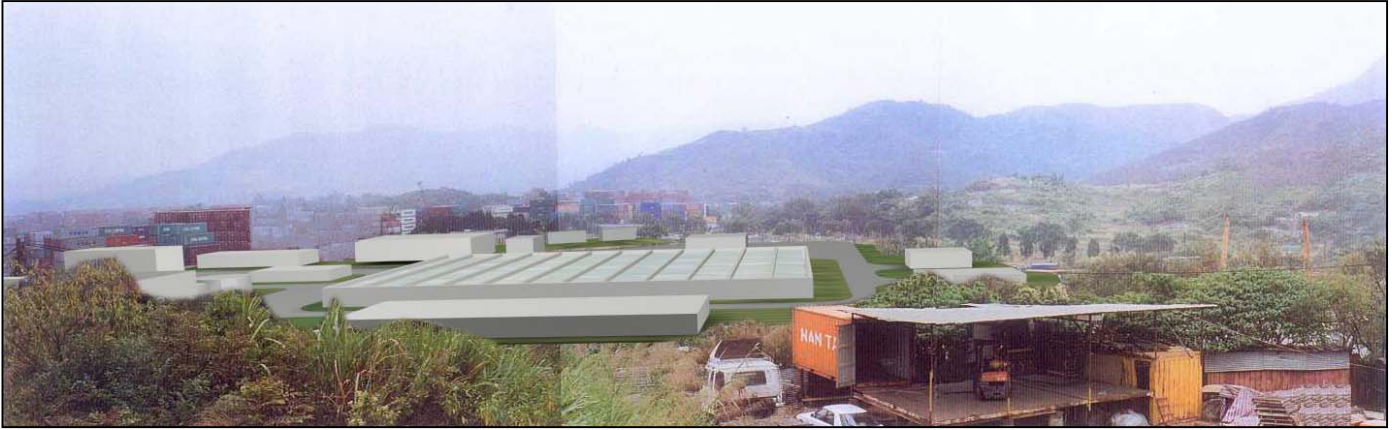
a. With no mitigation

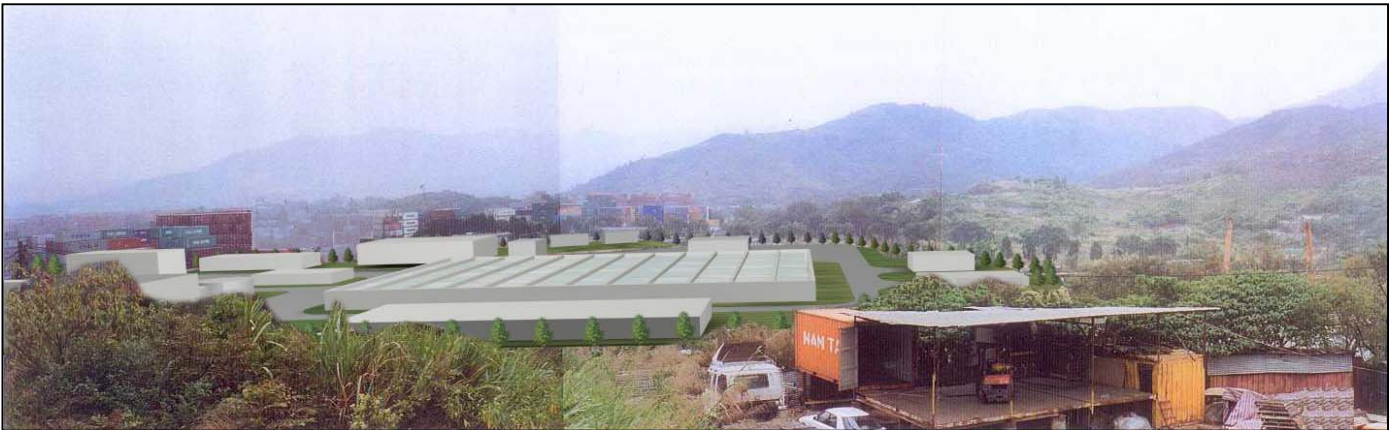
b. With mitigation at start of operation

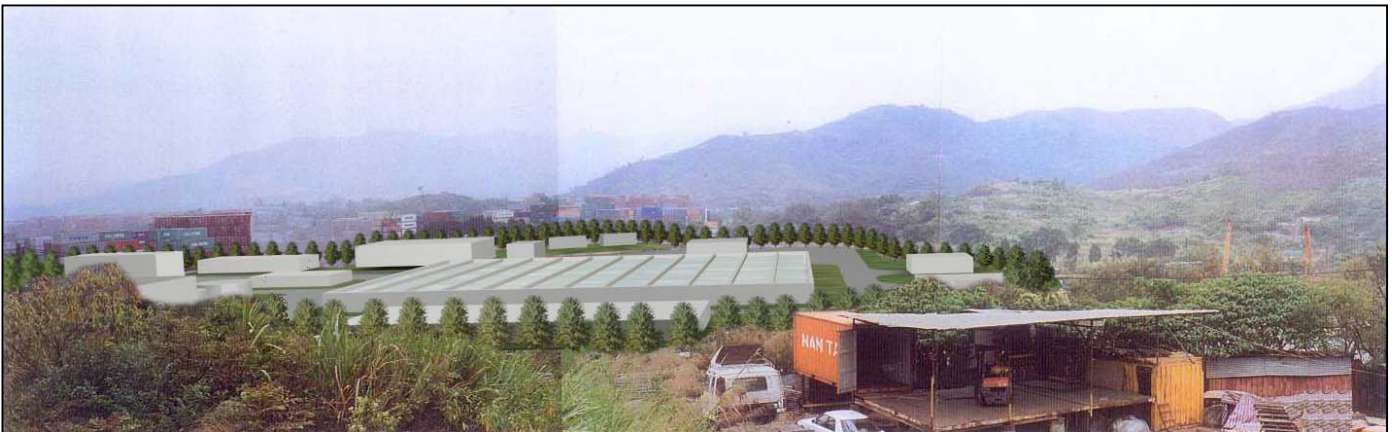
c. With mitigation after 10 years operation
