Project: Tung Chung Cable Car Project Environmental Impact Assessment Title:

Photomontage – Tower 4 (Sheet 7 of 7)

Figure no: 8.24

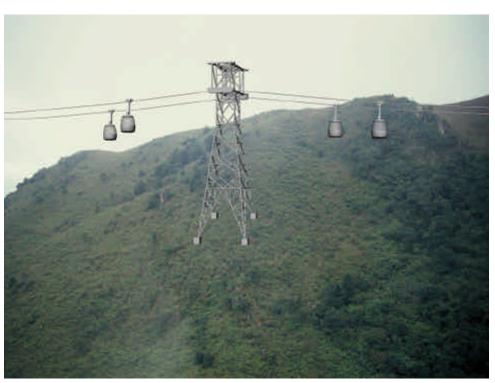
Upon completion with landscape mitigation (Slope profile retained. Grass and shrub vegetation reinstated)

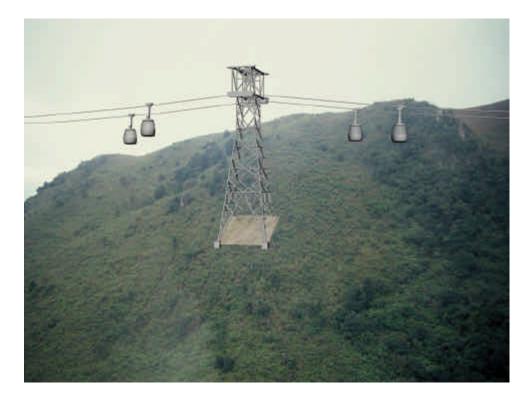
Upon completion without landscape mitigation (Slope stabilised by shotcrete)

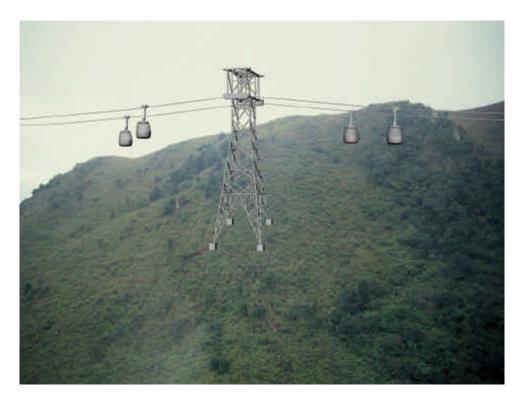
After 10 years operation with landscape mitigation (Similar to view upon completion)
