APPENDIX A9.1
DIVE SURVEY REPORT

Appendix 9.1 DIVE SURVEY REPORT

Subtidal surveys were conducted at Kau Sai Chau, Sai Kung, as part of the Environmental Impact Assessment being conducted according to EIA Study Brief No. ESB-064/2000. The project mainly involves the extension of the public golf course on Kau Sai Chau and related infrastructure.

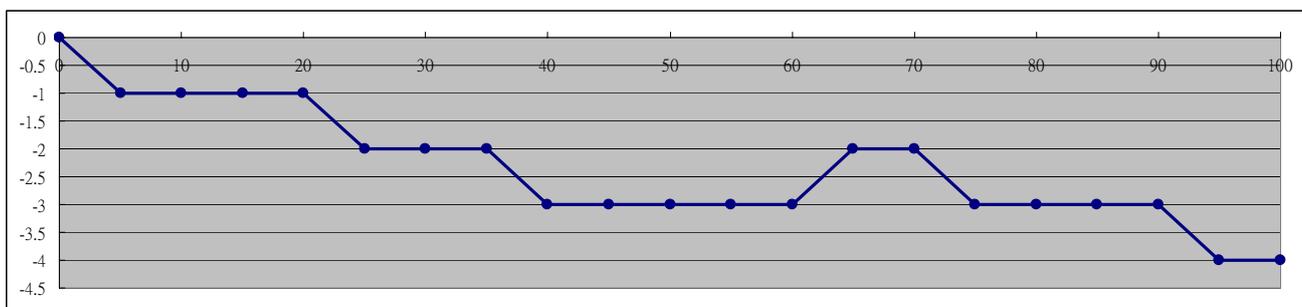
Table 1 The profile of P Transect at Site M and schematic chart

Except the boulders at the beginning of the P transect and the northern ends of the two H transects, the seabed was almost entirely muddy and sandy substrate.

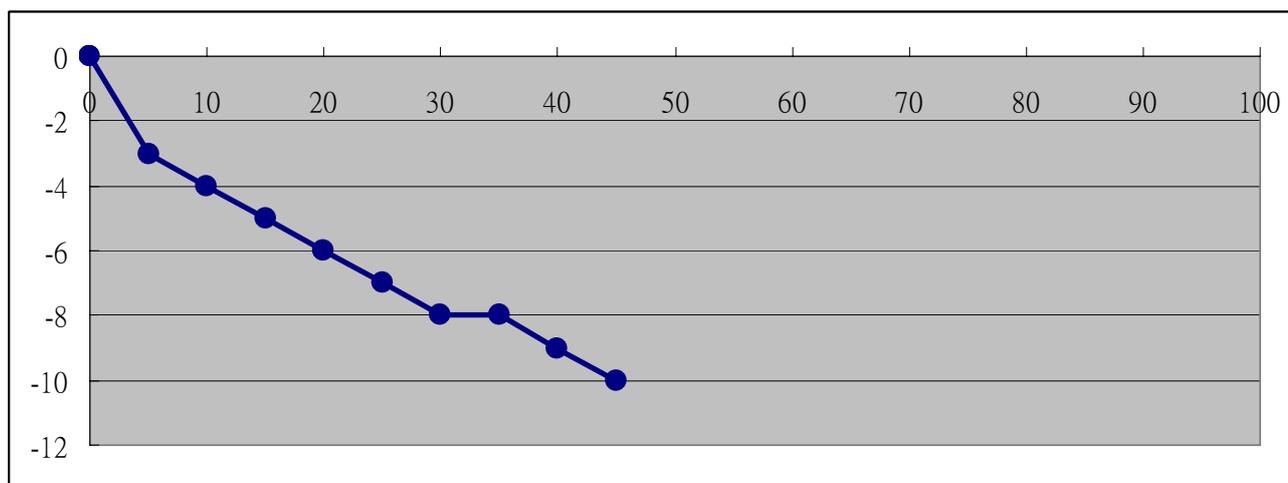
Table 3 The profile of P Transect at Site B1 and schematic chart

The seabed could be divided into three sections according to the substrate. From 0 m to 3 m along the transect, the substrate was granite rocks. From 3 m to 6 m, the substrate was a steeper slope mainly sandy bottom with occasional boulders. From 7 m to 40 m, it was abundant sandy with gravel and occasional boulders.

Along the P transect, only two coral colonies were found (6.5m and 25.4m from the shore).

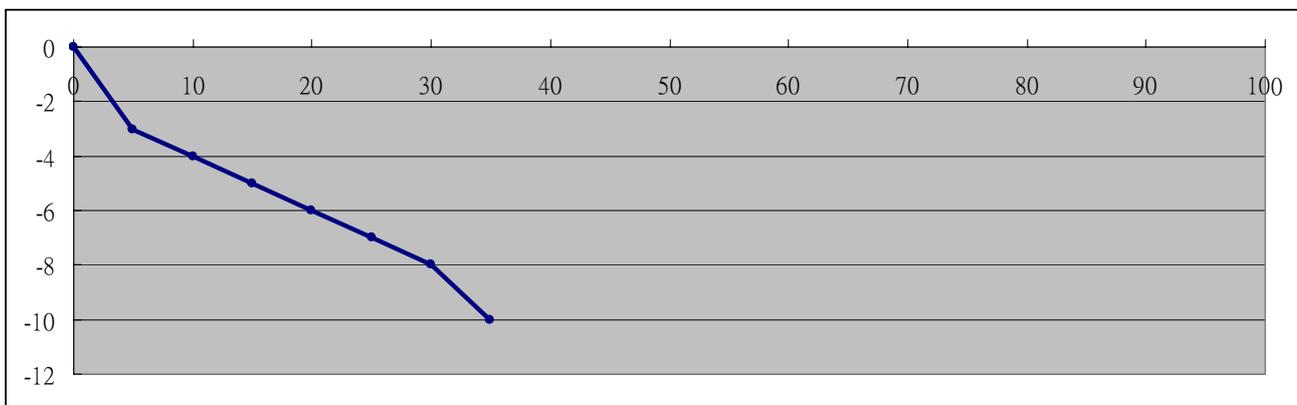
Table 5 The profile of P Transect at Site B2 and schematic chart

Similar to B1 Site, the seabed further offshore was muddy or sandy and not suitable for hard coral colonisation. Only several coral colonies were found on P transect at 3m, 4.2m, 5.9m, 7m, and 13.5m from the shore. Sponges (23.8m) and anemone (46.8m) were also recorded.

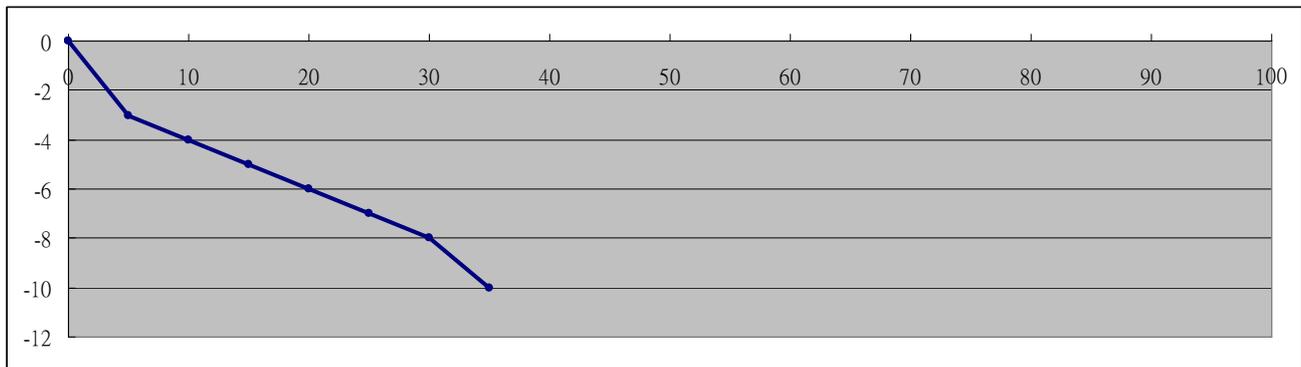
Table 7 The profile of P Transect at Site D1 and schematic chart

On P transect abundant corals colonised the seabed from 0 to 23 m (about 20% coverage within this area). Corals found included *Lithophyllon undulatum*, *Goniastrea aspera*, *Acropora tumida*, *Psammocora superficialis*, *Goniopora columna*, and *Platygyra acuta*. And the sizes of these colonies might reach 30 to 40 cm. Further away, the seabed turned into mainly sandy substrate and the corals were sparse.

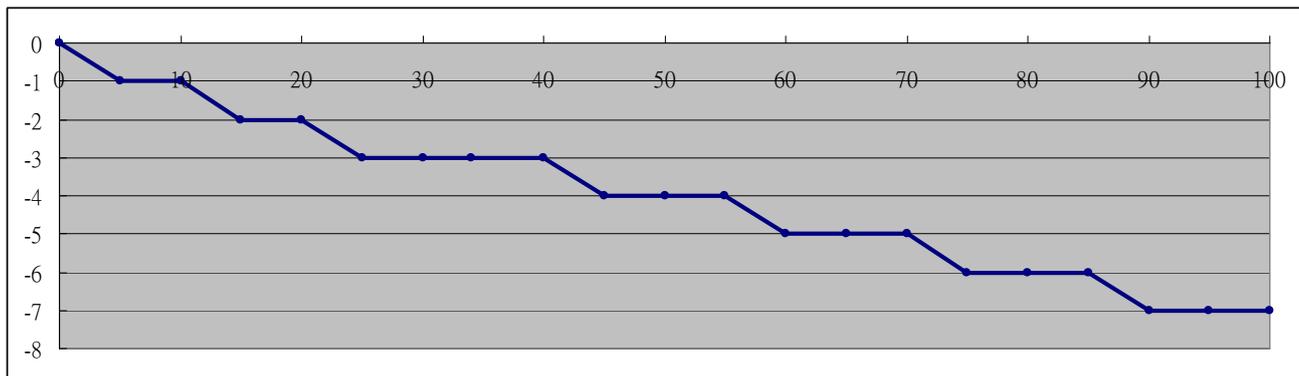
Table 9 The profile of P Transect at Site D2 and schematic chart

On P transect, hard substrate was found from 0 to 15 m, while the remaining was sandy bottom. On H1 transect (about 3m of water depth), sandy bottom occupied the sea bottom from 0 to 80 m, while from 80m to 100m the seabed was bedrock. Corals were found on 82.5m, 83.2m, and 100m distance. H2 transect (about 5m of water depth) had sandy bottom from 0 to 90 m. Corals were found on 318 ft and 99m distance.

Most of the site had a sandy and muddy-sandy substrate, with the sandy substrate at the shallower part and the muddy-sandy substrate further seaward. At the southern part of the site (starting from approximately 80m south of the pier), the seabed was covered by bedrock. The bedrock cover continued to over 100m south from the pier. There were also some large boulders near the coastline approximately 40m south of the dyke. Less than 5% coverage of corals was found on the bedrock area, but the sizes of those colonies were fairly large (some reach 30cm). Species found included *Favia speciosa*, *Favites abdita*, and *Goniastrea aspera*. There was no coral on the remainder of the site, including the large boulders near the coastline. Some seagrass individuals (*Halophila* sp.) were scattered on the sandy substrate in low density in the southern part of the surveyed area, close to the bedrock area (about 70m to the south of the pier).

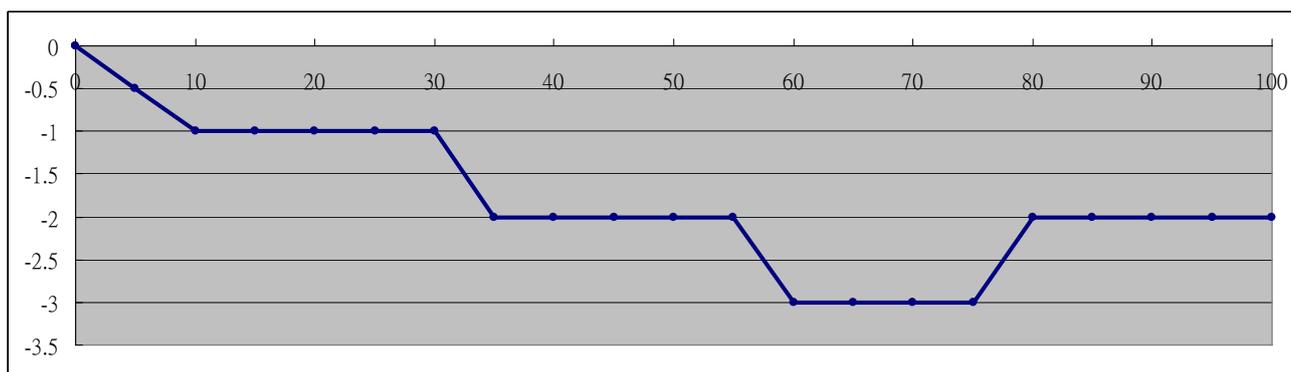
Table 11 The profile of P Transect at Site D3 and schematic chart

P transect was occupied by abundant seagrasses *Halophila ovalis*, in particular from 5 to 27 m. H1 transect was all sandy bottom. Seagrasses occupied about two third of the transect length. H2 transect was also sandy bottom. Seagrasses occupied about half of its length. No coral was found at this site.

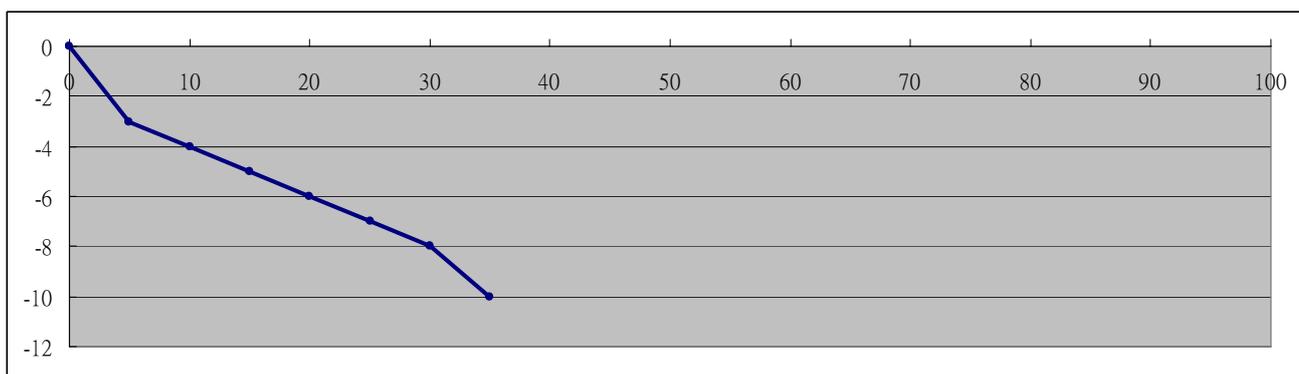
Table 13 The profile of P Transect at Site C and schematic chart

On P transect abundant corals (over 30% coverage) had colonised the seabed from 0 to 20 m. From 20m to 30 m, corals could also be found but at a lower frequency. Further away, the seabed turned into mainly sandy substrate and no coral was found.

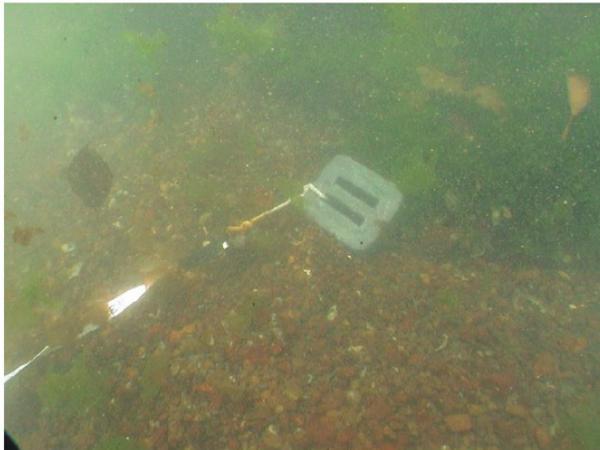
Substrate at the starting point of P transect

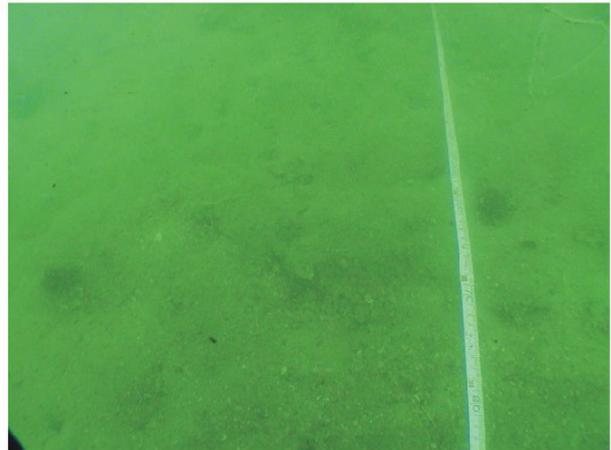
Substrate in the majority of Site M

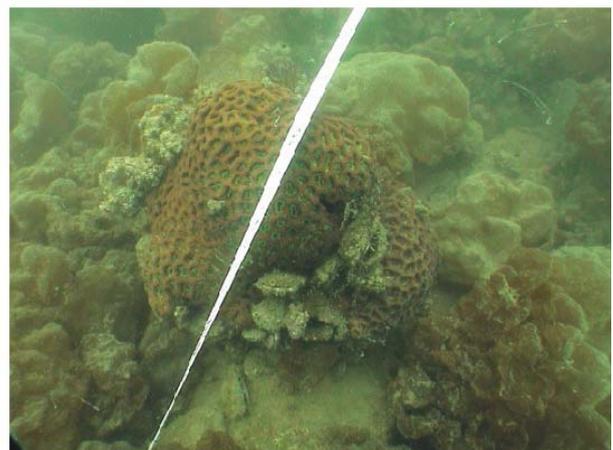
Only a few coral colonies (less than 10 colonies, including *Favia speciosa* and *Platygyra acuta*) were found at the end of the outer H transect close to the northern side of the embayment opening where marine waters were received from outer sea areas.

Corals close to the mouth of the embayment

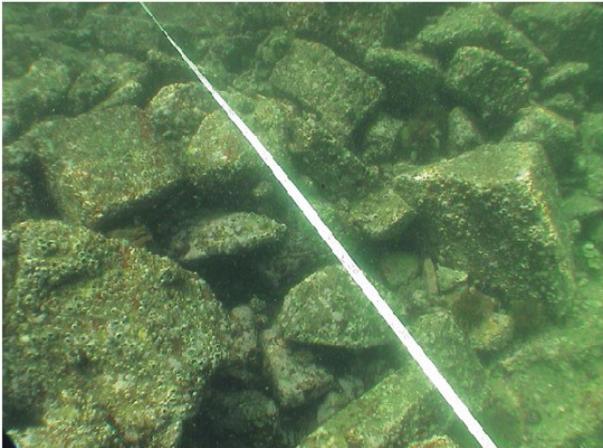
P transect near shore

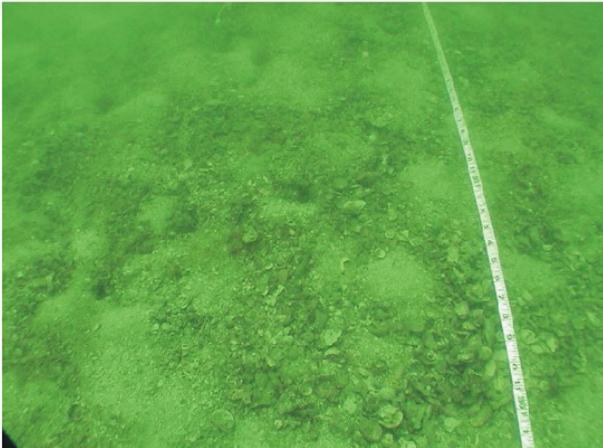
P transect off shore

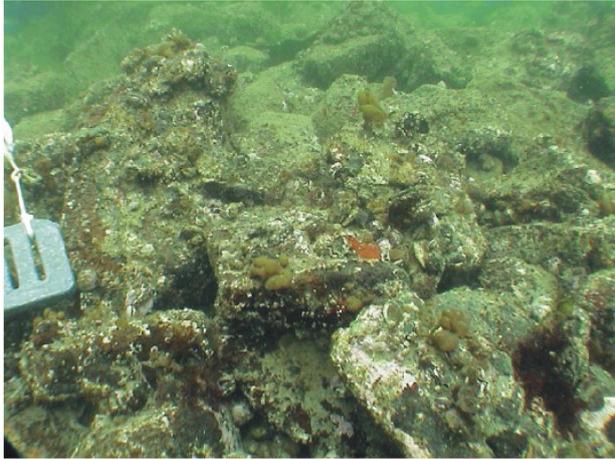
P transect near the shore

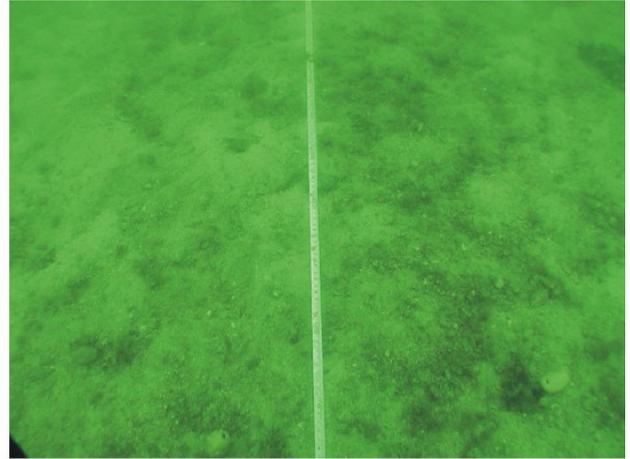
P transect off shore

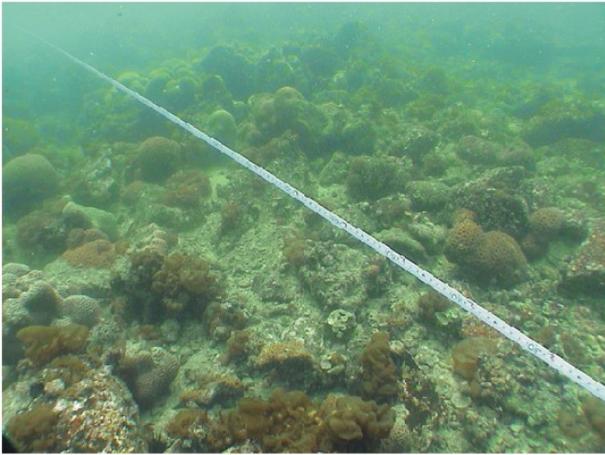
P transect near the coast

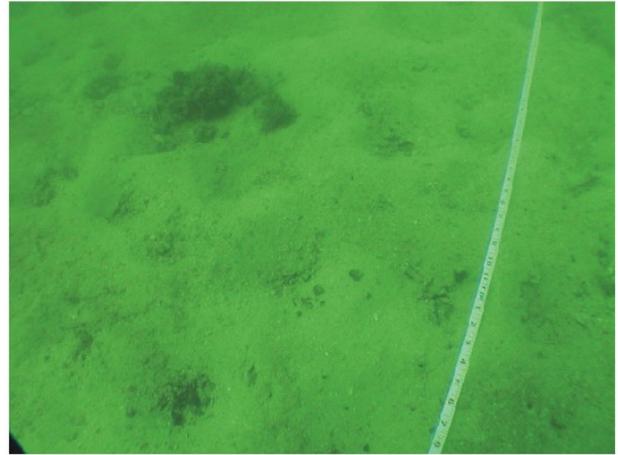
P transect away from the coast
