Provision of Cremators at Wo Hop Shek Crematorium

Contamination
Assessment Plan

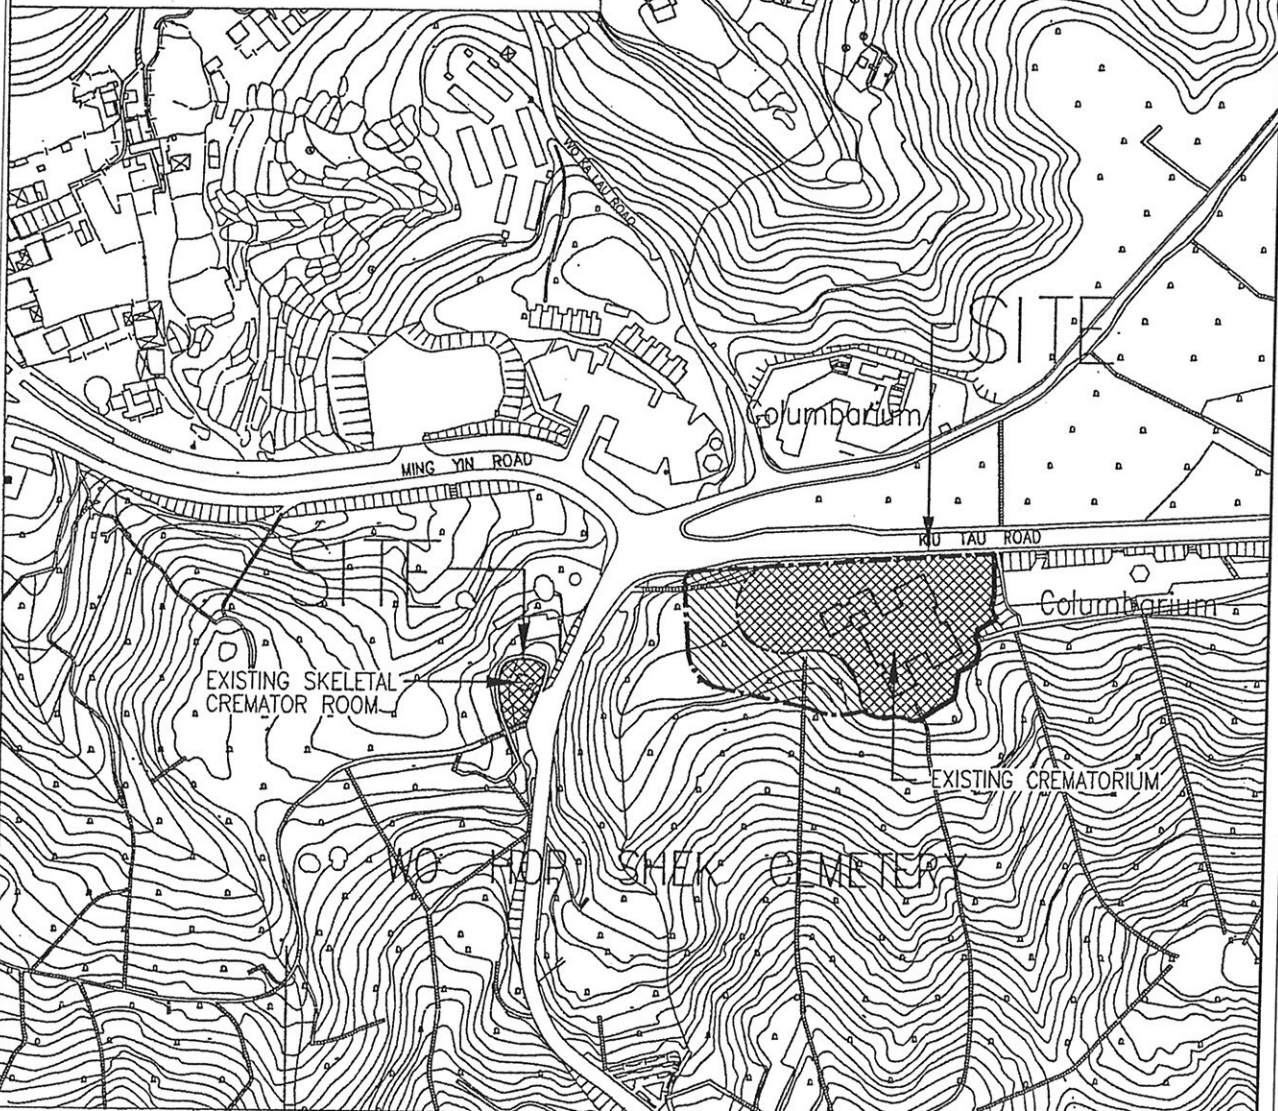
Date
Mar 2006
Figure
1-1
Scale
NTS

Figure Title
Provision of Cremators at Wo Hop Shek Crematorium
The Project Site

The Site falls within the Wo Hop Shek Cemetery area which has been allocated to FEHD under a Government Land Allocation No. DN 81. The Site currently does not fall into any Outline Zoning Plan or any other relevant plan. The locations and boundaries of the existing and new crematorium are shown in Figure 1-1. The layout of existing Wo Hop Shek Crematorium is shown in Figures 1-2a and 1-2b.

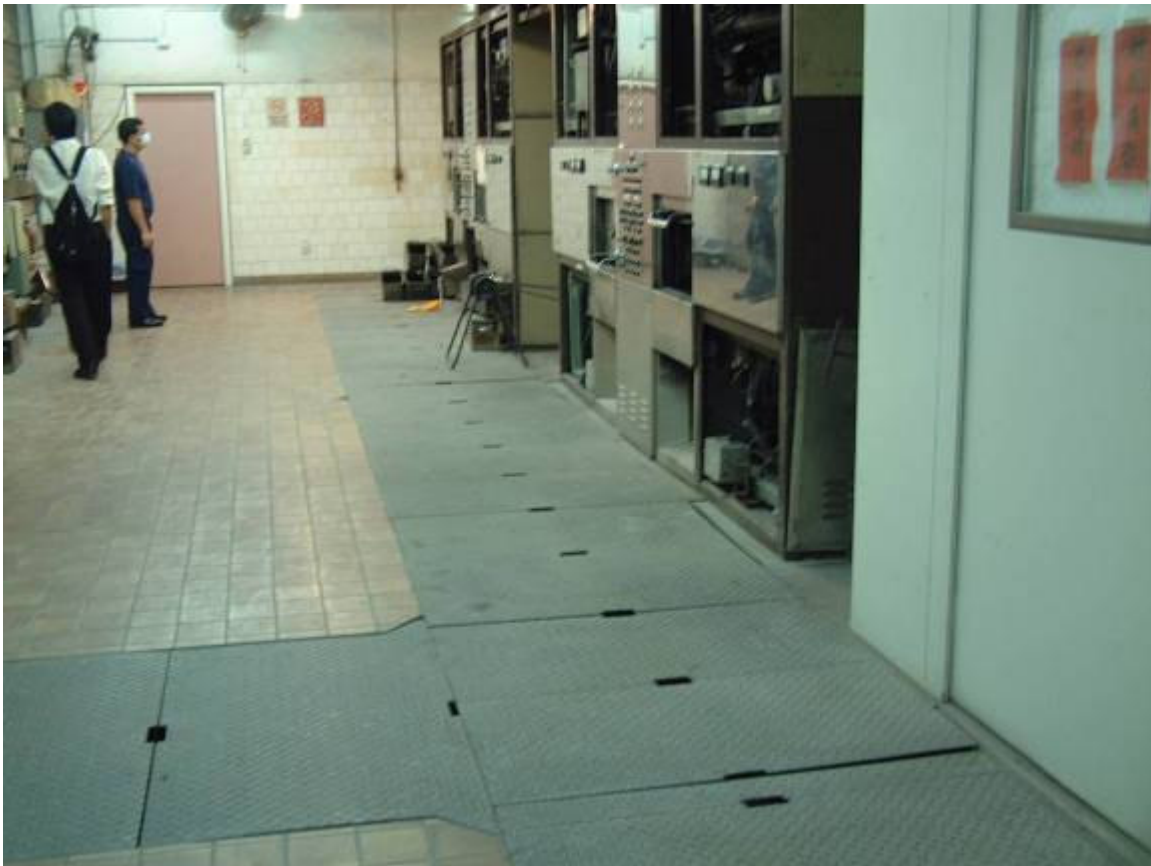
Sunken pipe is placed above the concrete channel at the cremator area in the coffin crematorium. The floors of the day tank room and fuel pump room are concrete paved and no cracks were observed. Drip trays have been provided for collecting leakage, if any. There was no visual or olfactory evidence of any contamination (e.g. oil stain) in these rooms. In addition, no spillage or leakage of fuel oil or chemicals has been reported by EMSD since the operation of the crematorium. Thus, it is considered that the potential contamination due to the leakage of fuel oil from these facilities is unlikely.

Photo 5 – Interior of Coffin Crematorium and Area with Sunken Fuel Pipe

As mentioned in Section 3, the potential contamination due to the leakage of fuel oil from day tank, fuel pump and sunken fuel pipe is unlikely. Since it is not feasible to collect soil sample underneath these facilities as the crematorium is still in operation, sampling and analysis will only possible be conducted after decommissioning of the crematorium to confirm there is no contamination. A sampling and analysis plan will be prepared by the demolition contractor after decommissioning and will be submitted to EPD for endorsement prior to sampling and analysis works.

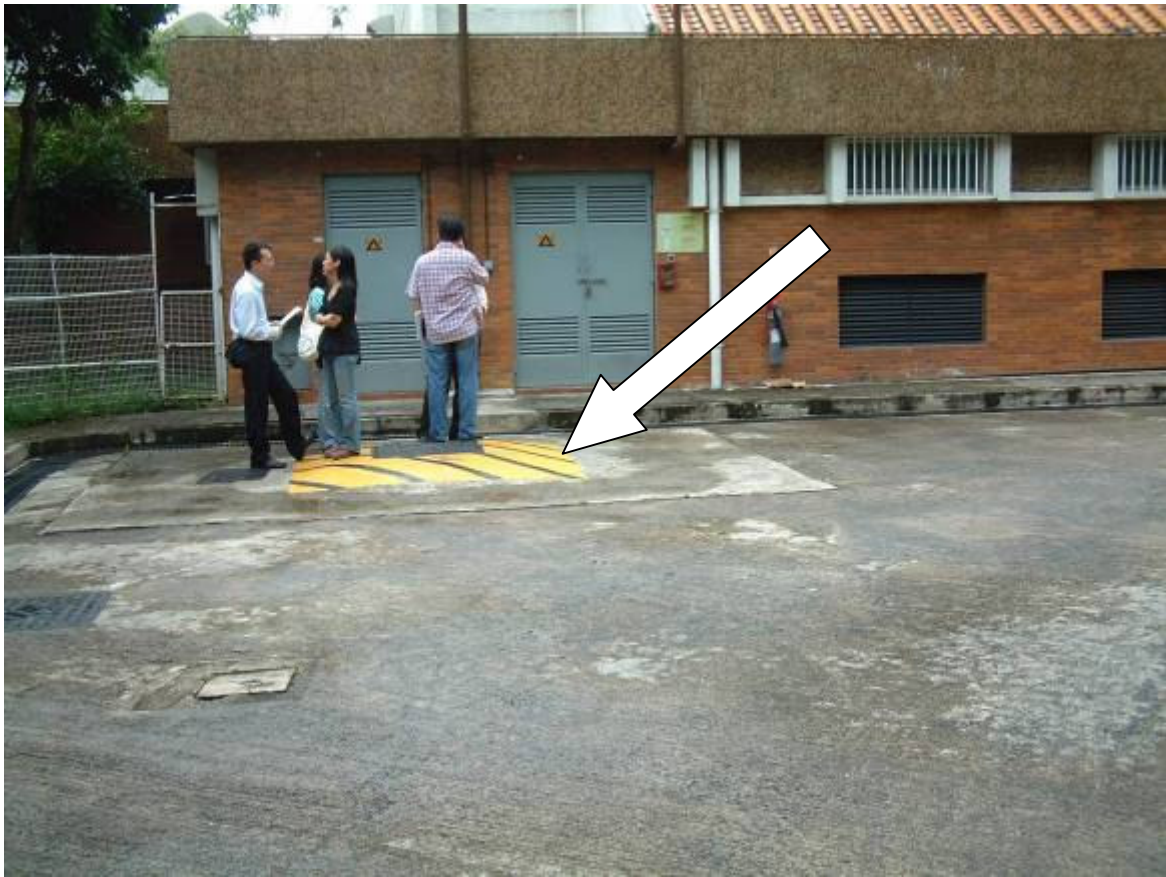
The fuel tank at the coffin crematorium is used for storing diesel rather than petrol. Thus, petroleum fractions of lighter ranges are not likely to be present at the fuel tank. Since the operation of the crematorium and associated facilities, no spillage or leakage of fuel oil or chemicals has been reported by EMSD. However, the interior of the concrete chamber for the underground fuel tank of the coffin crematorium is inaccessible, it is not

possible to confirm that there is no contamination by this underground fuel tank.

Photo 7 – Underground Fuel Tank in Coffin Crematorium

In the vicinity of the underground fuel tank in the coffin crematorium area, two boreholes, BH1 and BH2, to a depth of approximately 3m below the base of the concrete chamber of the tank are proposed. As the base of the concrete chamber is approximately 4m below ground level, sampling will be undertaken at 4m, 5.5m and 7m below ground level at each borehole. If groundwater is encountered during the sampling, groundwater samples will be collected for analysis.

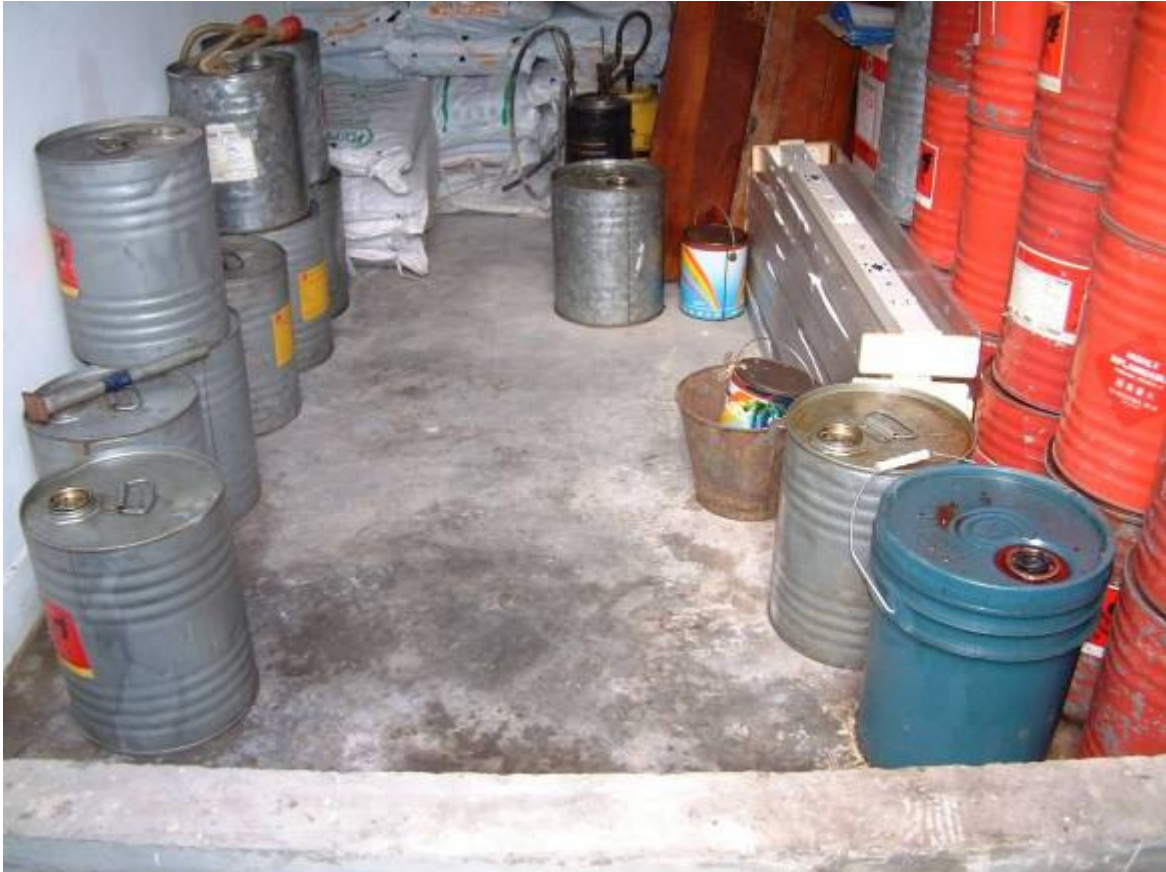
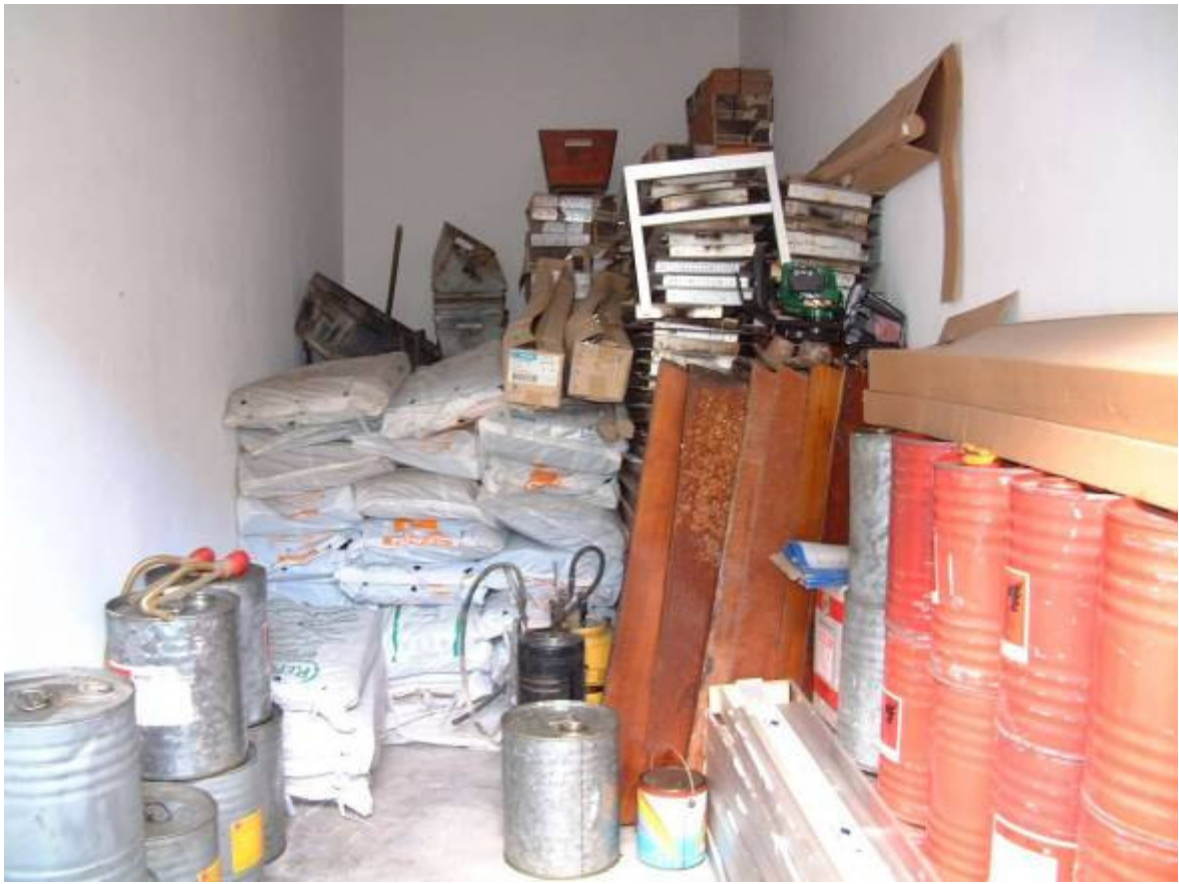
The floor of the dangerous goods store, rooms for the day tank and fuel pumps are concrete paved. As inspected and indicated by the Operator, diesel oil drums for the mower are stored in the dangerous goods store. In addition, it was found that the store is bunded by concrete. Inside the rooms of the day tank and fuel pump, it was observed that drip trays are provided for collecting leakage, if any. The floor slabs of the dangerous goods store and the rooms housing day tank and fuel pumps are free from oil stain and cracking.

The interior of the stores has been inspected during the site visits. As mentioned in Section 2, these stores are concrete paved and bunded with concrete and no oil stains and cracks were found on the floor slabs of these stores. Thus, potential soil contamination by the diesel oils stored in these dangerous goods stores is unlikely.

Photo 8 – Dangerous Goods Store in Coffin Crematorium

Photo 9 – Dangerous Goods Store in Coffin Crematorium

As mentioned in Section 3, the potential soil contamination due to the diesel oils stored in these dangerous goods stores is unlikely. Since it is not feasible to collect soil sample underneath the dangerous goods stores as the crematorium is still in operation, sampling and analysis will only possible be conducted after decommissioning of the crematorium to confirm there is no contamination. A sampling and analysis plan will be prepared by the demolition contractor after decommissioning and will be submitted to EPD for endorsement prior to sampling and analysis works.

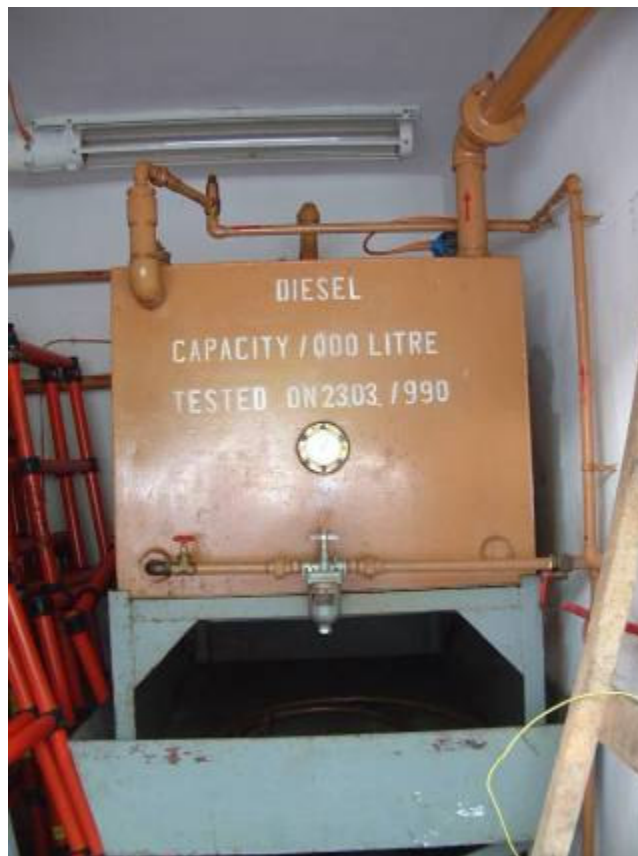
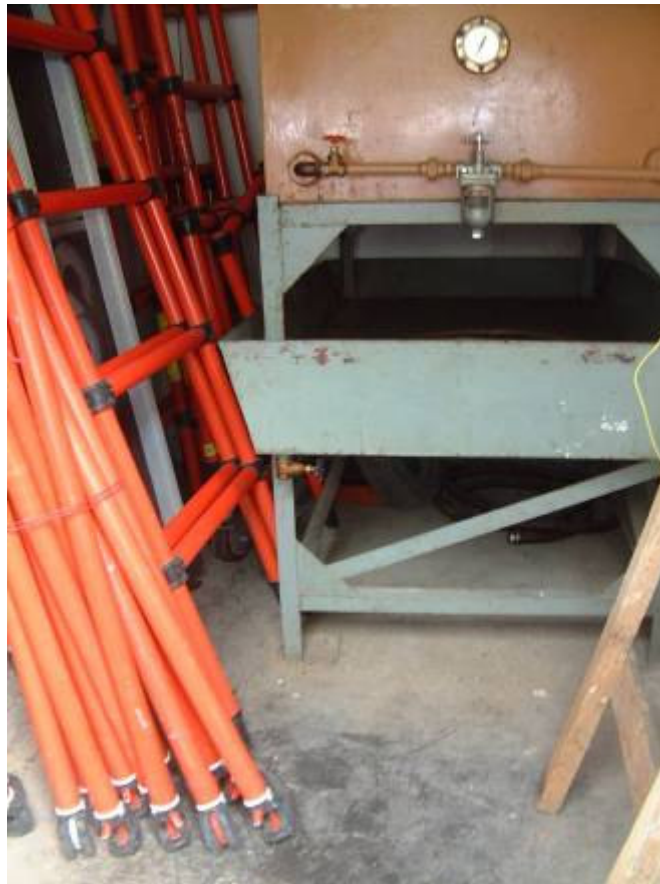
Photo 10 – Day Tank Room

Photo 11 – Day Tank Room

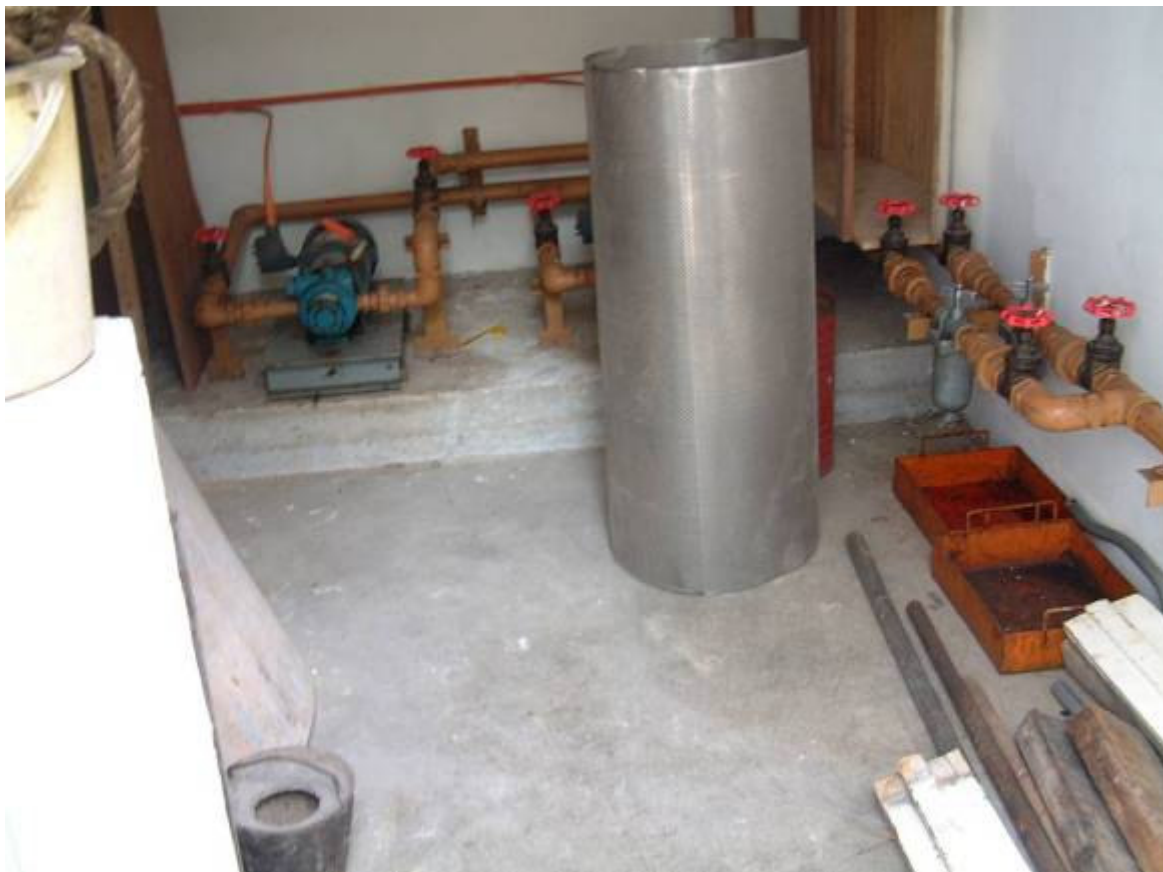
Photo 12 – Fuel Pump Room

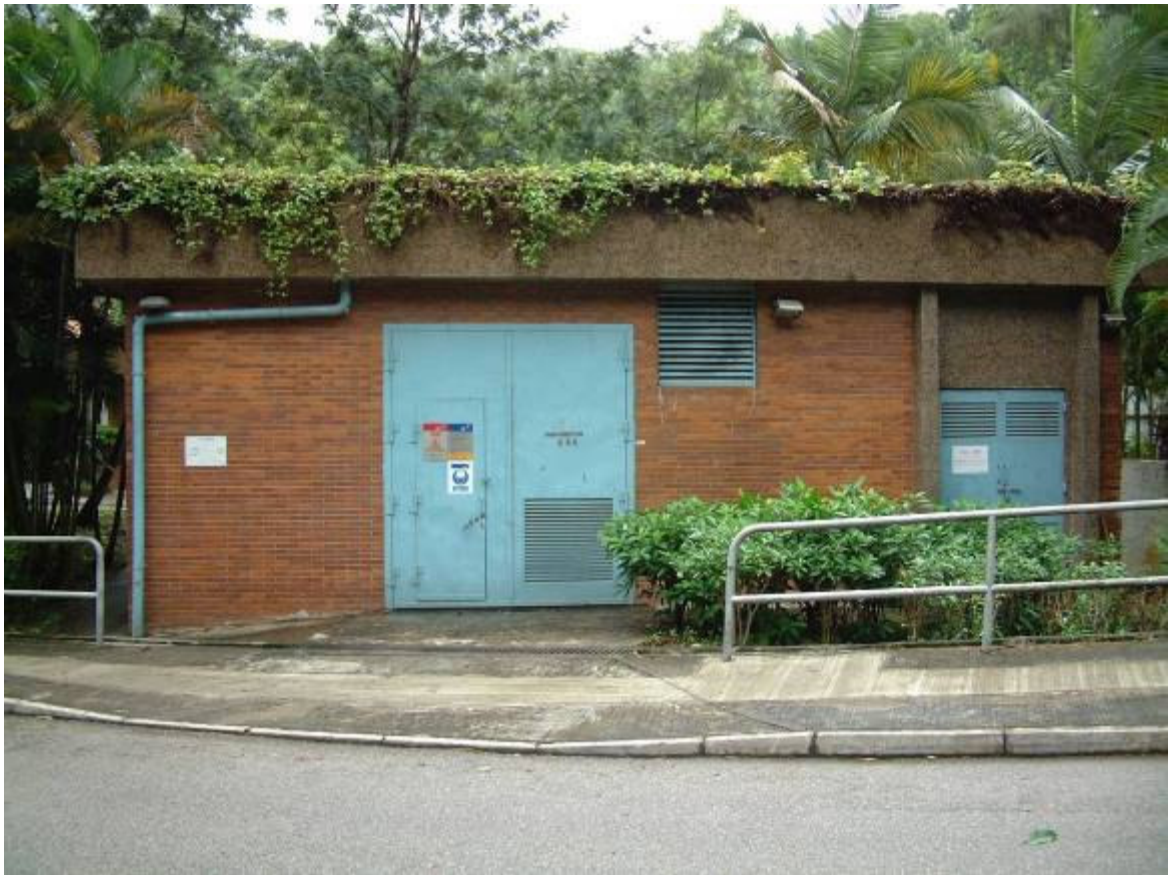
There is a transformer room at the site. The type of transformer operating in this room is unknown as the access to the transformer is still being arranged. However, based on the nature of use of the transformer room, it is considered that the potential contaminant derived from this room is:

- Polychlorinated biphenyls (PCBs)

Photo 13 – Transformer Room

The access to the transformer room is still being arranged. In addition, sampling beneath the transformer room is not feasible as it is still in operation and thus, any sampling would lead to unacceptable risks. Thus, sampling and analysis will only possible be conducted after decommissioning of the transformer to confirm whether there is any contamination. A sampling and analysis plan will be submitted to EPD for endorsement once the transformer room is accessible.

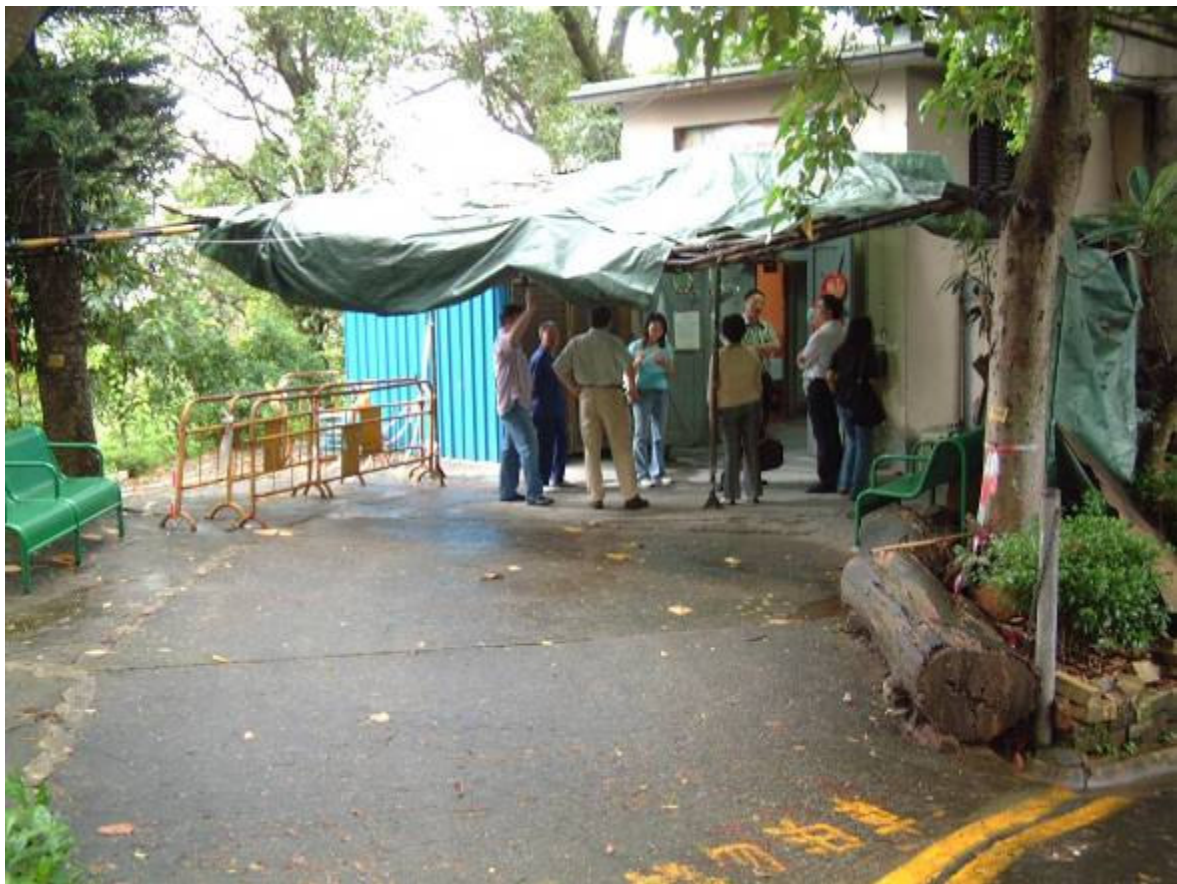
Photo 14 – Skeletal Cremator Building

There is no drawing available showing the details of the skeletal cremator building including the unused underground fuel tank. As indicated by the site operator, the Site has been used as a skeletal cremator since 1960s. The fuel type previously stored in the underground tank is unknown. There is no record of any spillage or accident related to this fuel tank. Major renovation of the facility was wall painting works. The existing dangerous goods store is used to store diesel oil for the operation of the cremator since the fuel tank was unused. No spillage or leakage has been recorded for this store.

For the unused underground fuel tank at the site of skeletal cremator building, it is lack of information to confirm whether there is potential soil contamination due to the leakage of the underground fuel tank. In addition, the type of fuel previously stored in this tank is unknown.

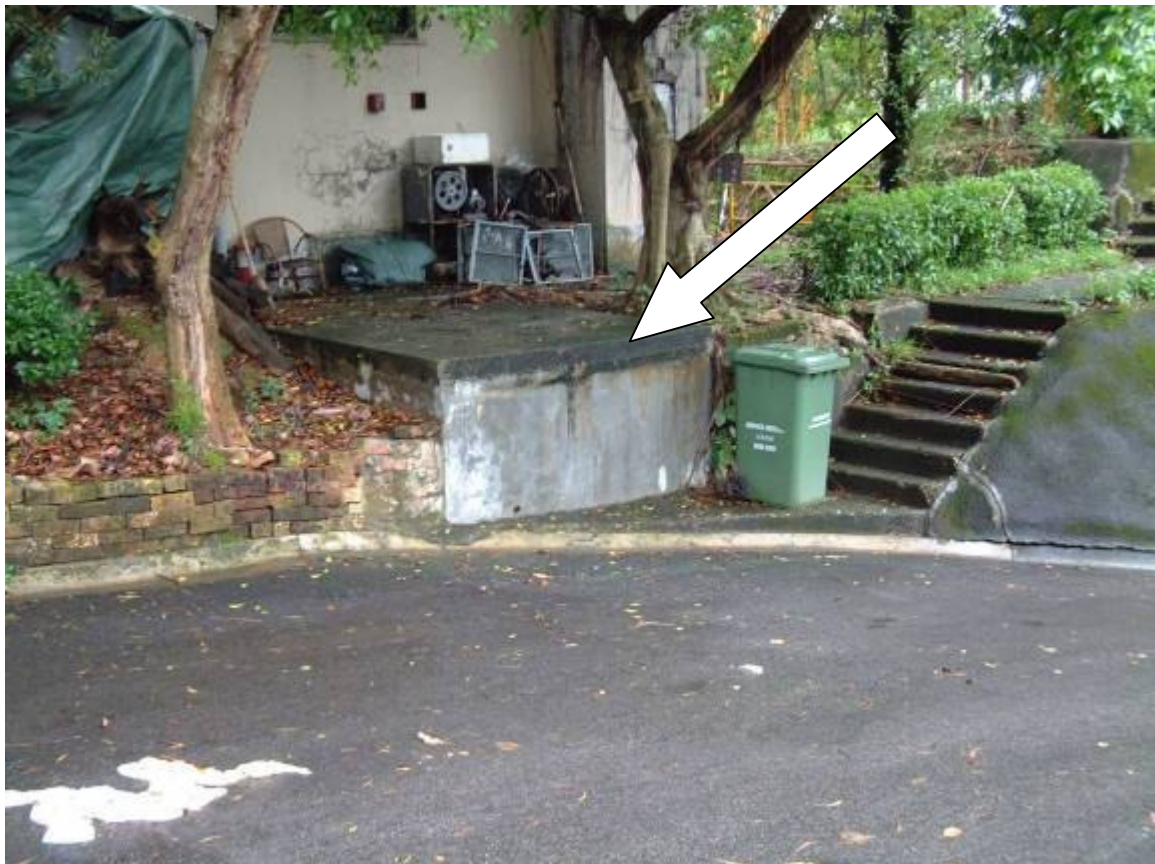
Photo 16 – Underground Fuel Tank in Skeletal Cremator Building

Due to the site constraints, only one borehole, BH3, to a depth of approximately 3m below the base of the unused underground fuel tank at the skeletal cremator is proposed. The depth of the underground fuel tank is unknown and this will be confirmed prior to sampling works. Sampling will be undertaken starting from the depth of the base of the fuel tank to 3m below the base of the tank with the interval of 1.5m.

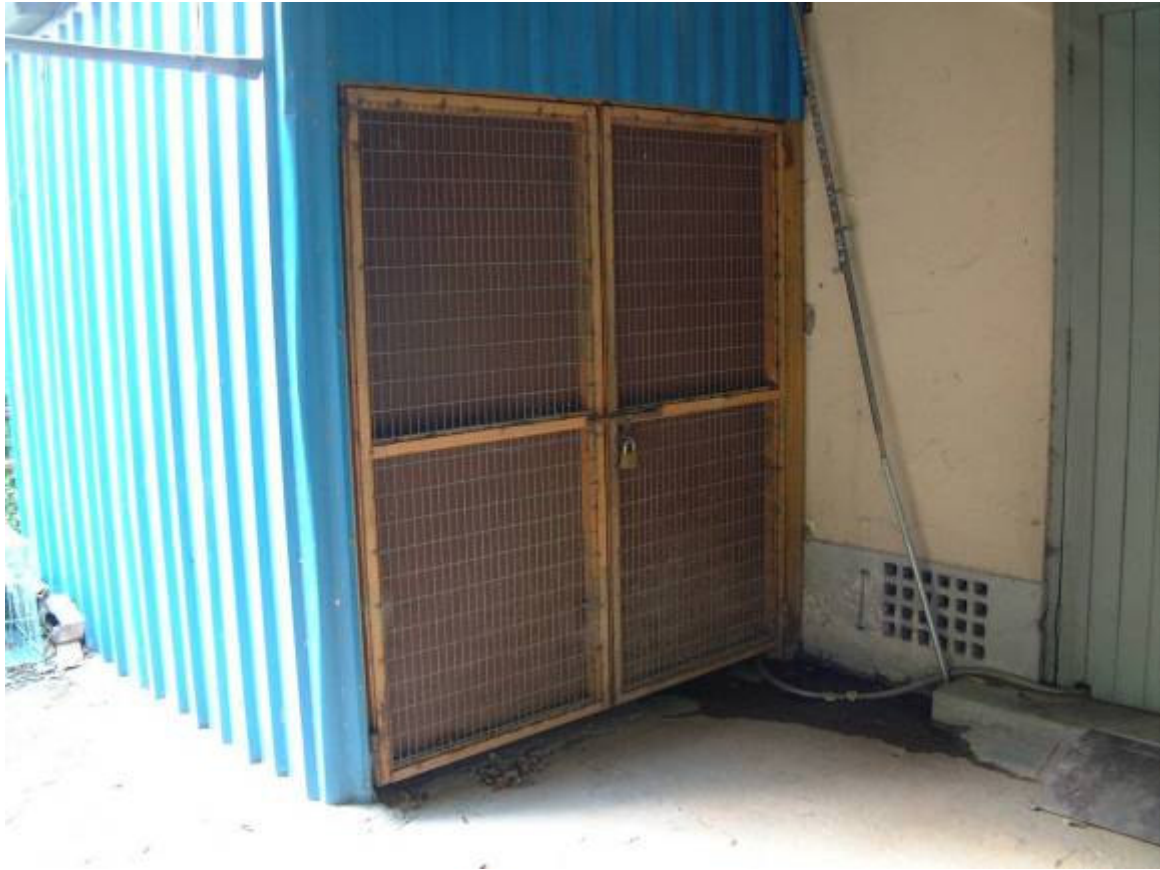
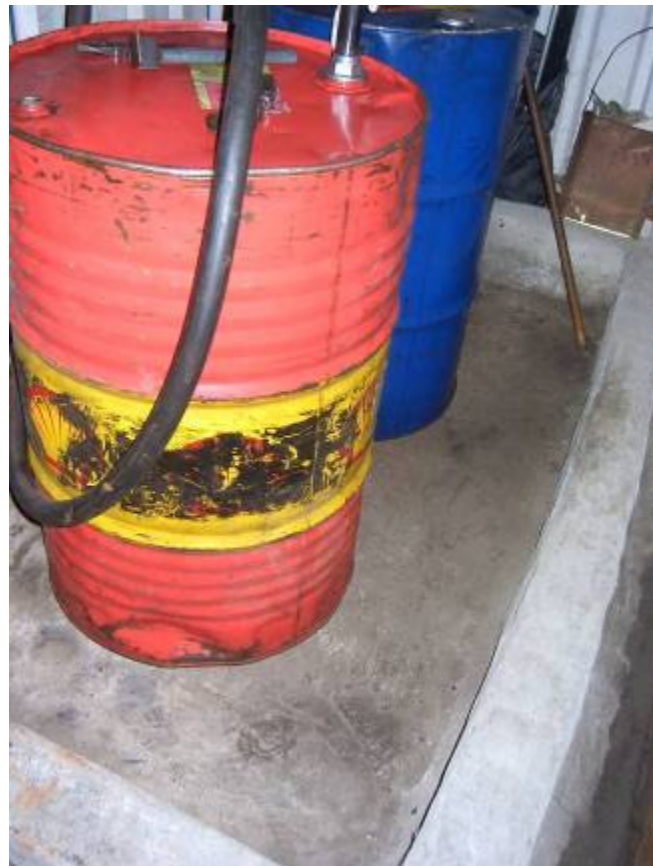
It was observed that the diesel oil drums are placed within an area with concrete bund in the dangerous goods store. No oil stain and crack were observed on the concrete floor of the store even within the bunded area. In addition, there was no oil stain within the site area of skeletal cremator outside the store and cremator.

Photo 17 – Dangerous Goods Store in Skeletal Cremator Building

Photo 18 – Interior of Dangerous Goods Store of Skeletal Cremator Building

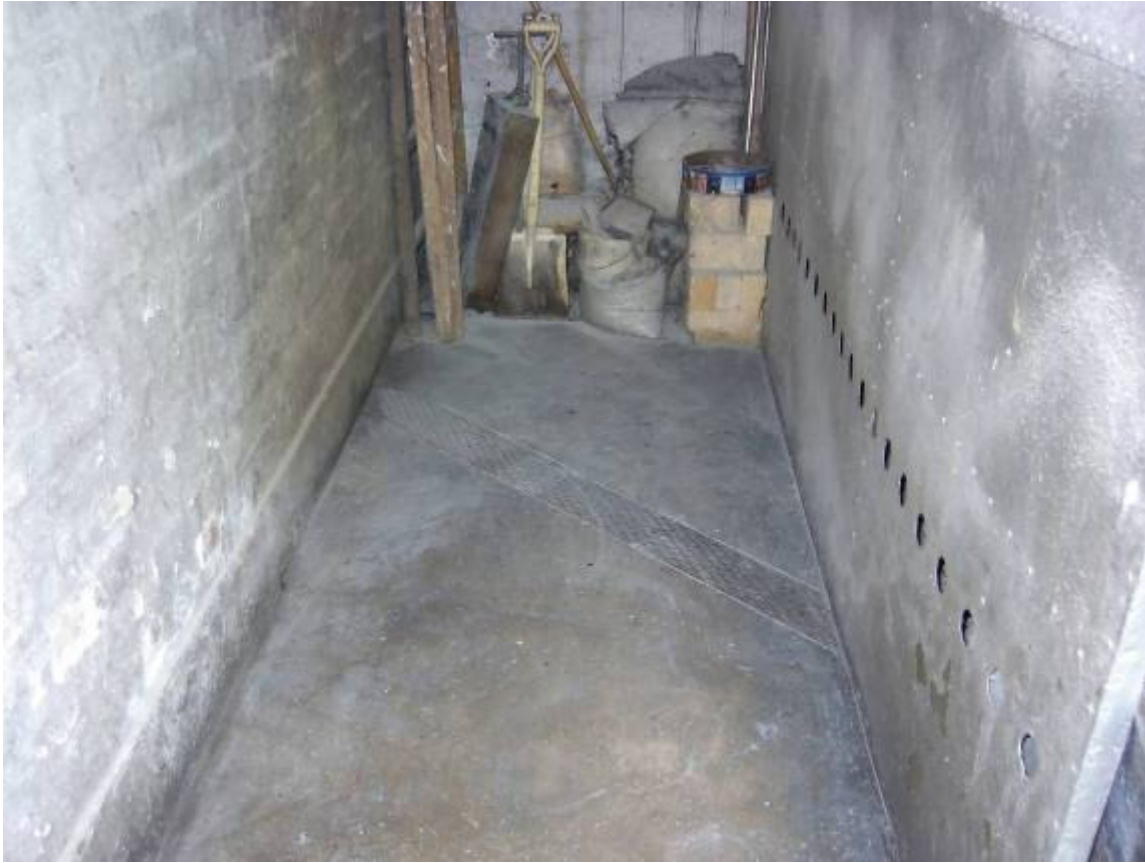
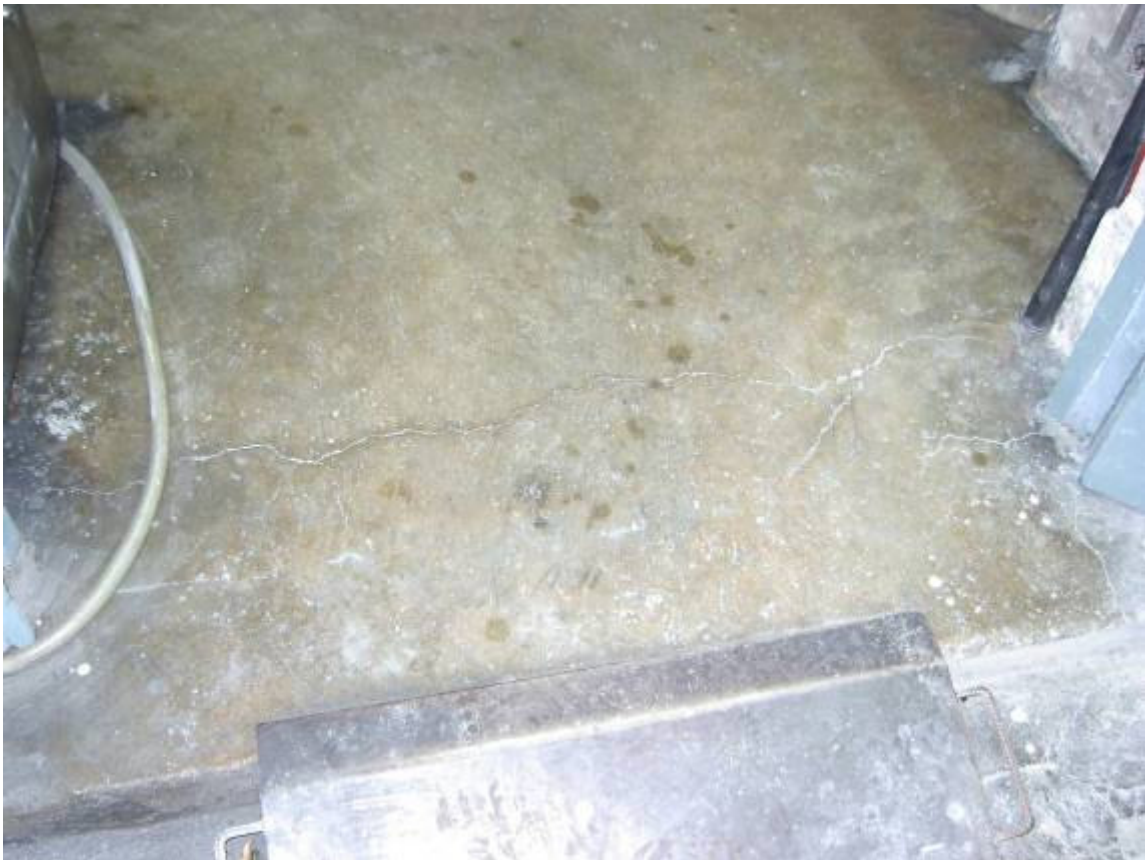
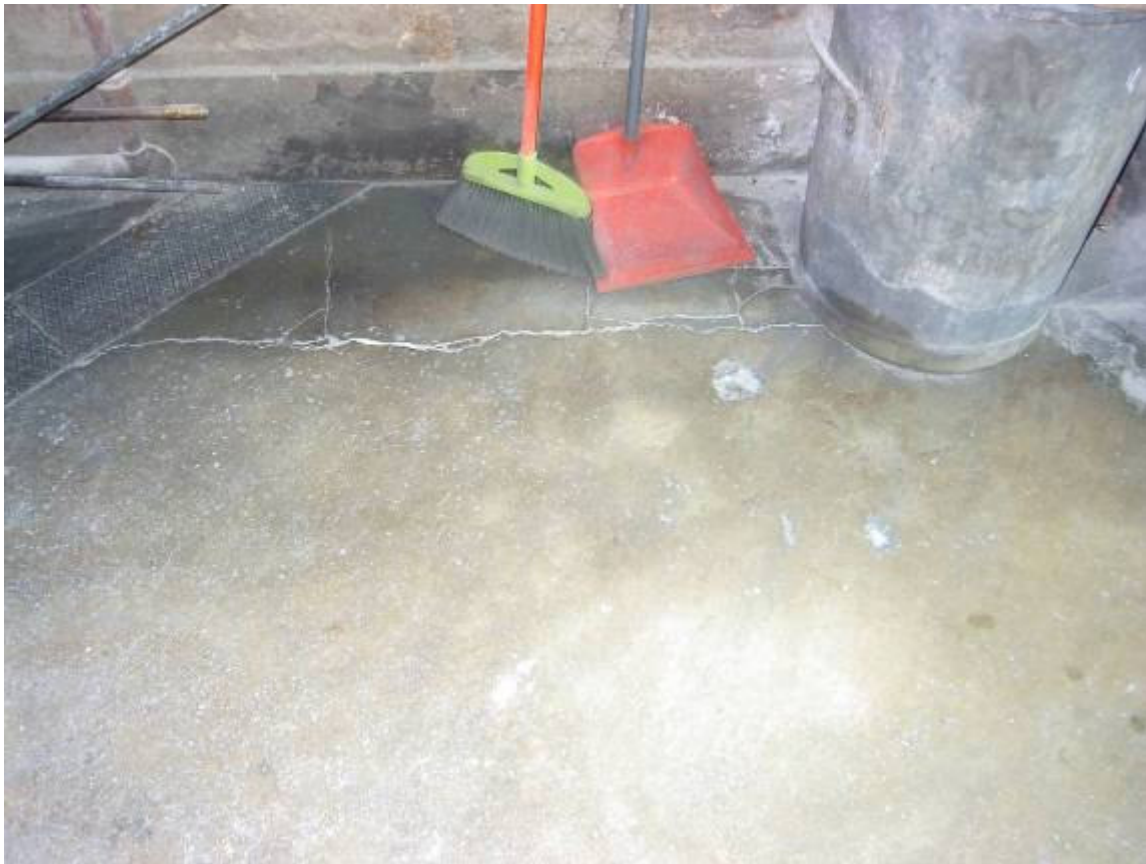
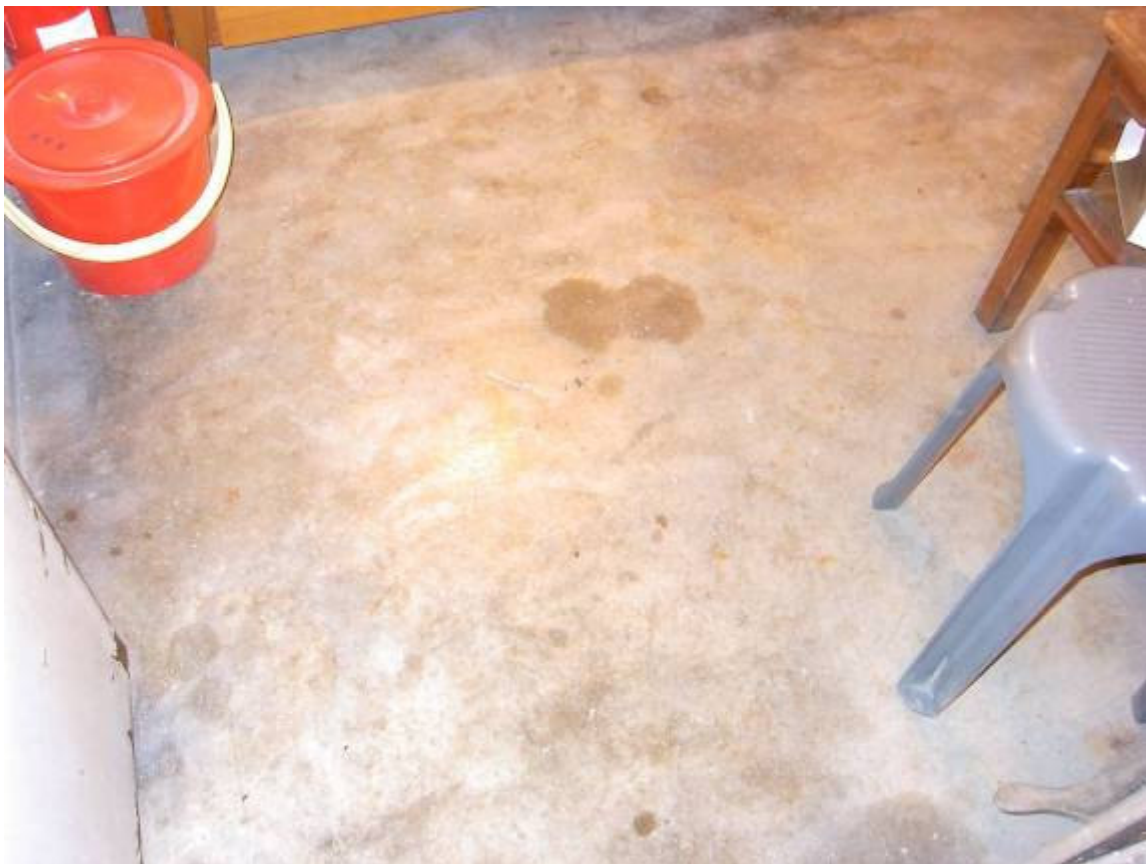
Some cracks were observed on the concrete floor in the skeletal cremator building. However, no oil stain was observed inside the skeletal cremator building.

Photo 19 – Interior of Skeletal Cremator Building

Photo 20 – Interior of Skeletal Cremator Building

Photo 21 – Interior of Skeletal Cremator Building

Photo 22 – Interior of Skeletal Cremator Building

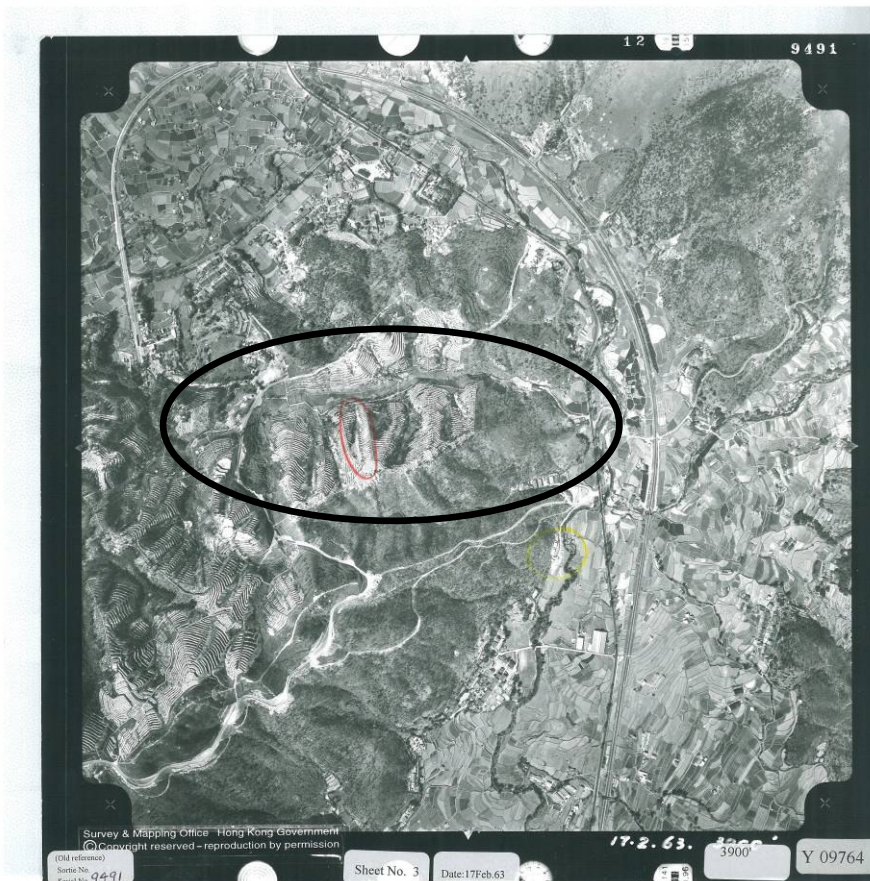
The 1963 photo reveals that the Site and surrounding hillsides were largely occupied by grave-like structures. Besides, a part of the Site was also covered with some pond-like structures. These ponds are believed to serve as water storage ponds for the downhill farmland. The 1975 photo shows that the pond-like structures disappeared and the entire site area was occupied by grave-like structures and roads. In addition, tree clumps and vegetated areas on the hillside to the south and west of the site are found. The 1986 photo reveals that the Site was surrounded by grave-like structures. However, most grave-like structures within the Site were subsequently removed. The existing coffin crematorium and related structures appears at the Site in 1991 photo. Afterwards, except the increasing in size of the tree clumps surrounding the Site, the layout of the site did not alter significantly as observed from the 1995 and 2004 photos.

Photo 1 – 1963
