# Provision of Cremators at Wo Hop Shek Crematorium

Interim Contamination  
Assessment Report &  
Remediation Action Plan

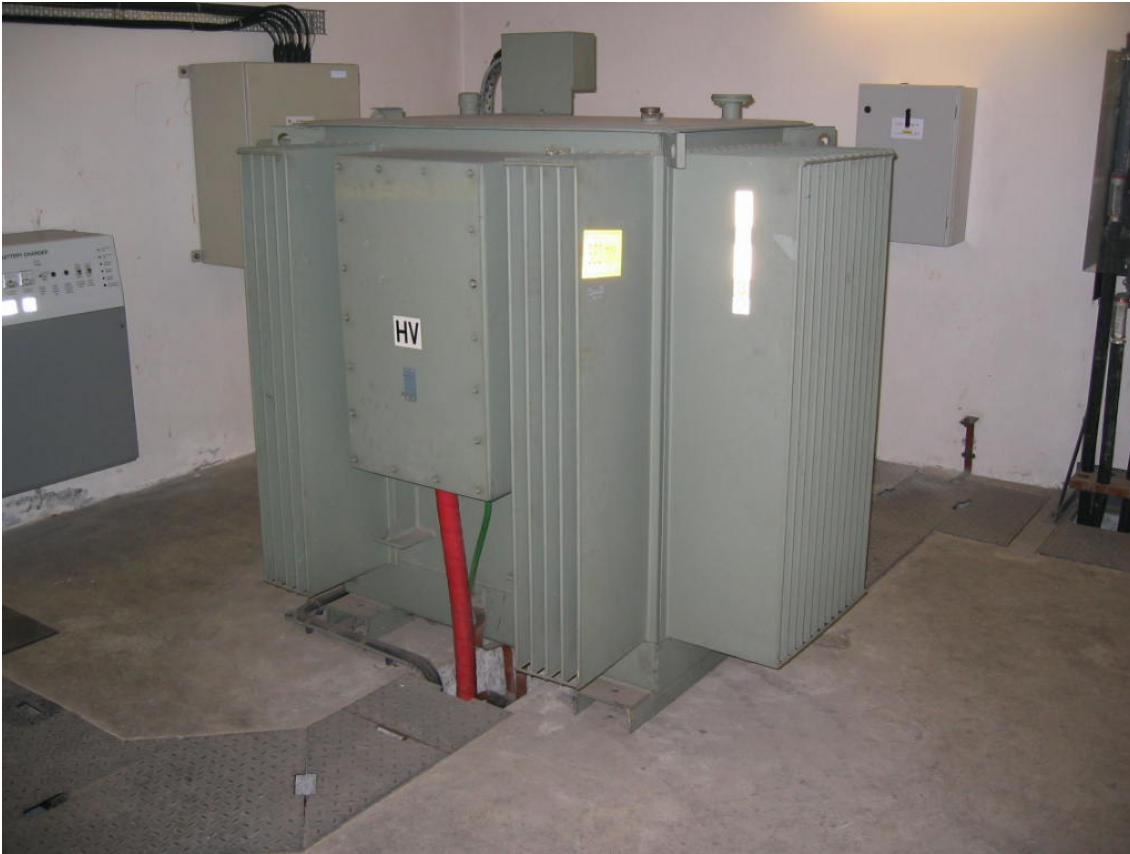
**Photo 1 Transformer inside Transformer Room**

Inspection of the transformer room was carried out on 21 August 2006. It was observed that there is one transformer inside the room and one electrical panel as shown in Appendix 3. A gap was found between the transformer and the concrete floor slab. As advised by China Light & Power (CLP), the transformer is an oil type transformer. However, no oil stain on the floor was observed. Moreover, there is no observable crack on the concrete floor slab. Thus, it is considered that the potential of soil contamination due to the operation of the transformer is unlikely. Nevertheless, further site investigation at the transformer room should be carried out as recommended in CAP.
