Contamination Assessment Report (CAR)

Contamination Assessment Report for Decommissioning of the Co-Combustion Pilot Plant at Tap Shek Kok

Green Island Cement Company Limited

11 April 2008

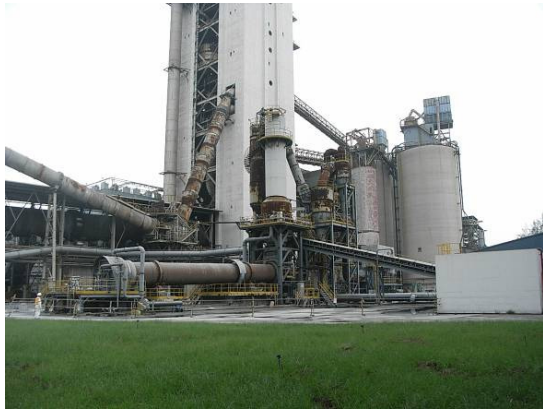
Photo 1 – CCPP

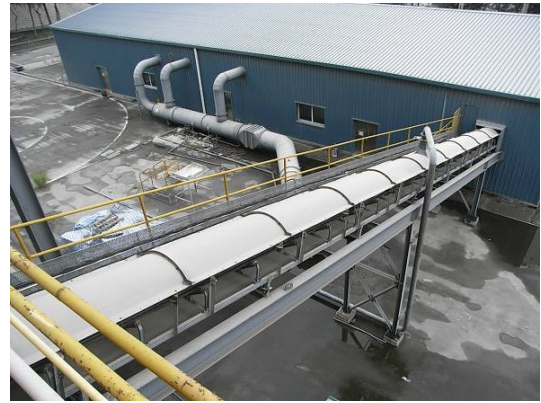
Photo 2 – Conveyor belt connecting the CCPP unit with the material recovery building

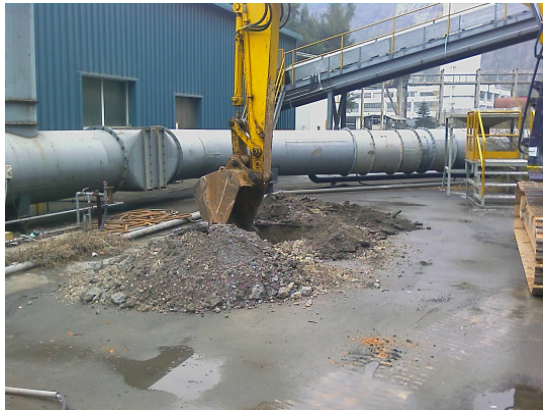
Photo 3 – Breaking of concrete surface at S1/S2

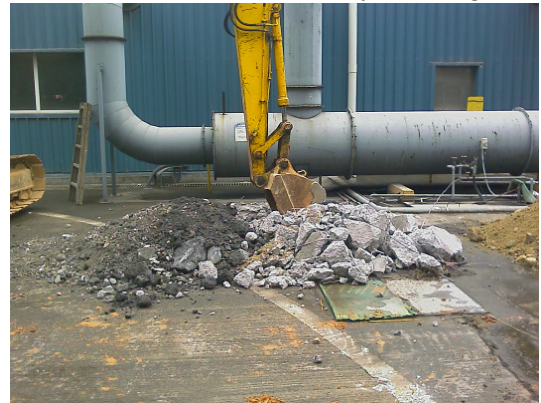
Photo 4 – Excavation at S3/S4

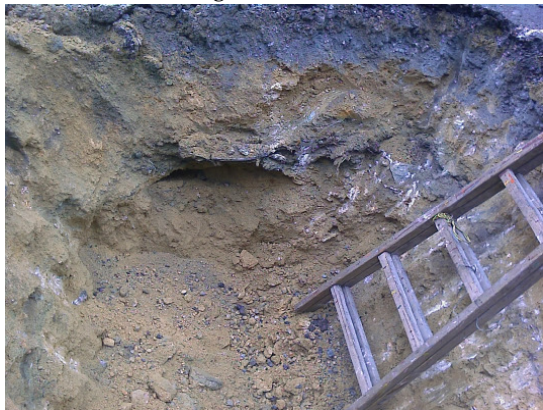
Photo 5 – Excavation Pit

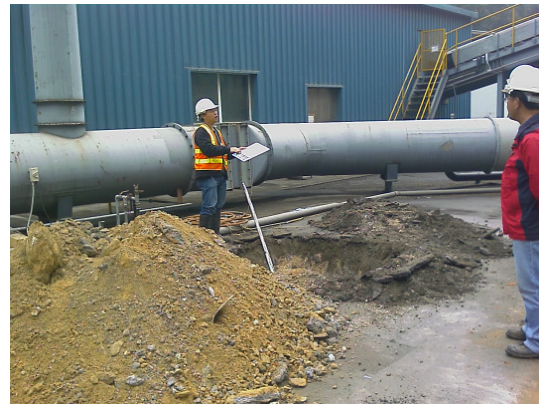
Photo 6 – Identification of soil profile by contractor
