TREE SURVEY REPORT

Development of a Poultry and Processing Plant in Sheung Shui

May 2009

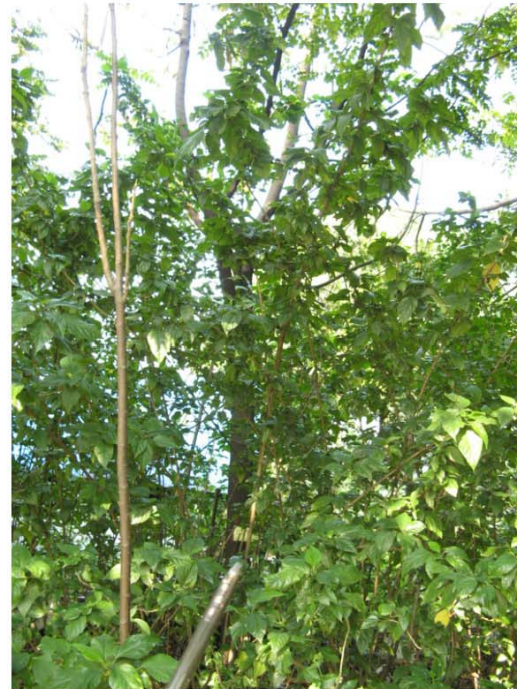
T7	<i>Spathodea campanulata</i>	火焰木	LCSD	7.0	0.15	5.0	Fair	Fair	1 1	2	L	A	B	B	B	Retain			
T8	<i>Spathodea campanulata</i>	火焰木	LCSD	7.0	0.14	4.0	Fair	Fair	1 1	2	L	A	B	B	B	Retain			
T10	<i>Eucalyptus spp.</i>	桉(屬)	LCSD	5.0	0.10	4.0	Fair	Poor	1 1	2	L	A	B	B	C	Retain			
T11	<i>Spathodea campanulata</i>	火焰木	LCSD	6.0	0.11	4.0	Fair	Poor	1 1	2	L	A	B	B	B	Retain			
T12	<i>Bauhinia spp.</i>	羊蹄甲(屬)	LCSD	6.0	0.13	5.0	Fair	Fair	2 2	4	M	A	A	A	A	Retain			
T13	<i>Khaya senegalensis</i>	非洲棟	LCSD	8.0	0.23	6.0	Fair	Fair	1 1	2	L	A	B	B	B	Retain			
T14	<i>Eucalyptus spp.</i>	桉(屬)	LCSD	6.0	0.16	4.0	Fair	Fair	1 1	2	L	A	B	B	C	Retain			
T15	<i>Khaya senegalensis</i>	非洲棟	LCSD	7.0	0.26	6.0	Fair	Fair	1 1	2	L	A	B	B	B	Retain			
T16	<i>Bombax ceiba</i>	木棉	LCSD	8.0	0.23	4.0	Fair	Fair	2 2	4	M	B	B	B	B	Retain		co	
T17	<i>Macaranga tanarius</i>	血桐	ASD	5.0	0.16	4.0	Poor	Poor	1 2	3	M	B	B	A	B	Retain			
T18	<i>Michelia x alba</i>	白蘭	ASD	10.0	0.36	8.0	Fair	Fair	2 1	3	M	A	B	B	B	Retain		mu

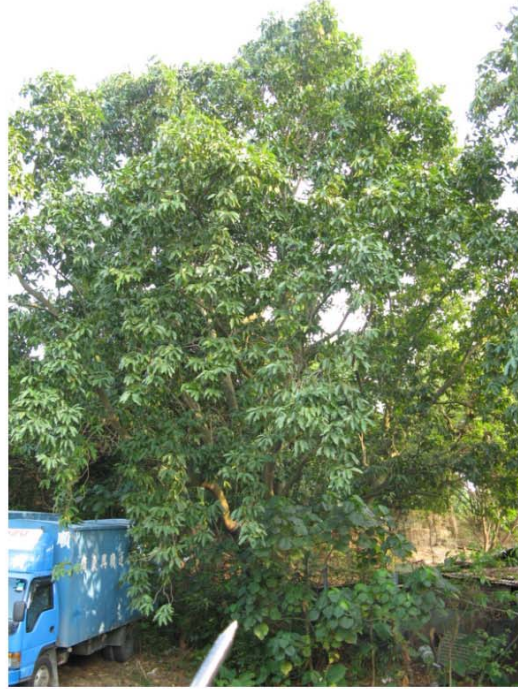
T19	<i>Michelia x alba</i>	白蘭	ASD	10.0	0.54	8.0	Fair	Fair	2 1	3	M	A	B	B	B	Retain		mu	
T20	<i>Macaranga tanarius</i>	血桐	ASD	4.0	0.12	3.0	Fair	Poor	1 2	3	M	B	B	A	B	Fell	1 4	mu	
T21	<i>Macaranga tanarius</i>	血桐	ASD	5.0	0.10	4.0	Fair	Poor	1 2	3	M	B	B	A	B	Fell	1 4	mu	
T22	<i>Macaranga tanarius</i>	血桐	ASD	4.0	0.12	4.0	Fair	Poor	1 2	3	M	B	B	A	B	Fell	1 4	mu	
T23	<i>Macaranga tanarius</i>	血桐	ASD	4.0	0.13	4.0	Fair	Poor	1 2	3	M	B	B	A	B	Fell	1 4		
T24	<i>Macaranga tanarius</i>	血桐	ASD	5.0	0.10	4.0	Poor	Poor	1 2	3	M	B	B	A	B	Fell	1 4		
T25	<i>Ficus hispida</i>	對葉榕	ASD	5.0	0.10	4.0	Poor	Poor	1 3	4	M	A	A	A	A	Transplant			
T26	<i>Macaranga tanarius</i>	血桐	ASD	4.0	0.17	4.0	Poor	Poor	1 2	3	M	B	B	A	B	Fell	1 4	co	
T29	<i>Macaranga tanarius</i>	血桐	ASD	4.0	0.10	3.0	Poor	Poor	1 2	3	M	B	B	A	B	Fell	1 4	mu	
T30	<i>Eucalyptus spp.</i>	桉(屬)	LCSD	5.0	0.18	4.0	Fair	Fair	1 1	2	L	A	B	B	C	Retain			
T31	<i>Eucalyptus spp.</i>	桉(屬)	LCSD	7.0	0.14	4.0	Fair	Fair	1 1	2	L	A	B	B	C	Retain

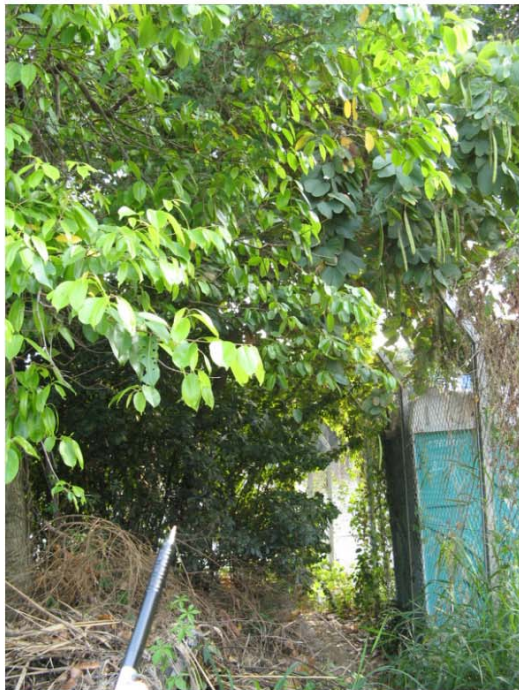
T32	<i>Bauhinia spp.</i>	羊蹄甲(屬)	LCSD	5.0	0.12	4.0	Fair	Fair	2 2	4	M	A	A	A	A	Retain			
T33	<i>Khaya senegalensis</i>	非洲棟	LCSD	6.0	0.23	4.0	Fair	Fair	1 1	2	L	A	B	B	B	Retain			
T34	<i>Khaya senegalensis</i>	非洲棟	LCSD	8.0	0.28	6.0	Fair	Fair	1 1	2	L	A	B	B	B	Retain			
T35	<i>Khaya senegalensis</i>	非洲棟	LCSD	8.0	0.23	5.0	Fair	Fair	1 1	2	L	A	B	B	B	Retain			
T36	<i>Eucalyptus spp.</i>	桉(屬)	LCSD	5.0	0.18	4.0	Fair	Fair	1 1	2	L	A	B	B	C	Retain			
T37	<i>Bauhinia spp.</i>	羊蹄甲(屬)	LCSD	5.0	0.12	4.0	Fair	Fair	2 2	4	M	A	A	A	A	Retain			
T39	<i>Eucalyptus spp.</i>	桉(屬)	LCSD	6.0	0.17	4.0	Fair	Fair	1 1	2	L	A	B	B	C	Retain
